West Willis Apartment - Window Renovations

640 West Willis
Detroit, Michigan

SOUTH & NORTH ELEVATIONS

A5.11

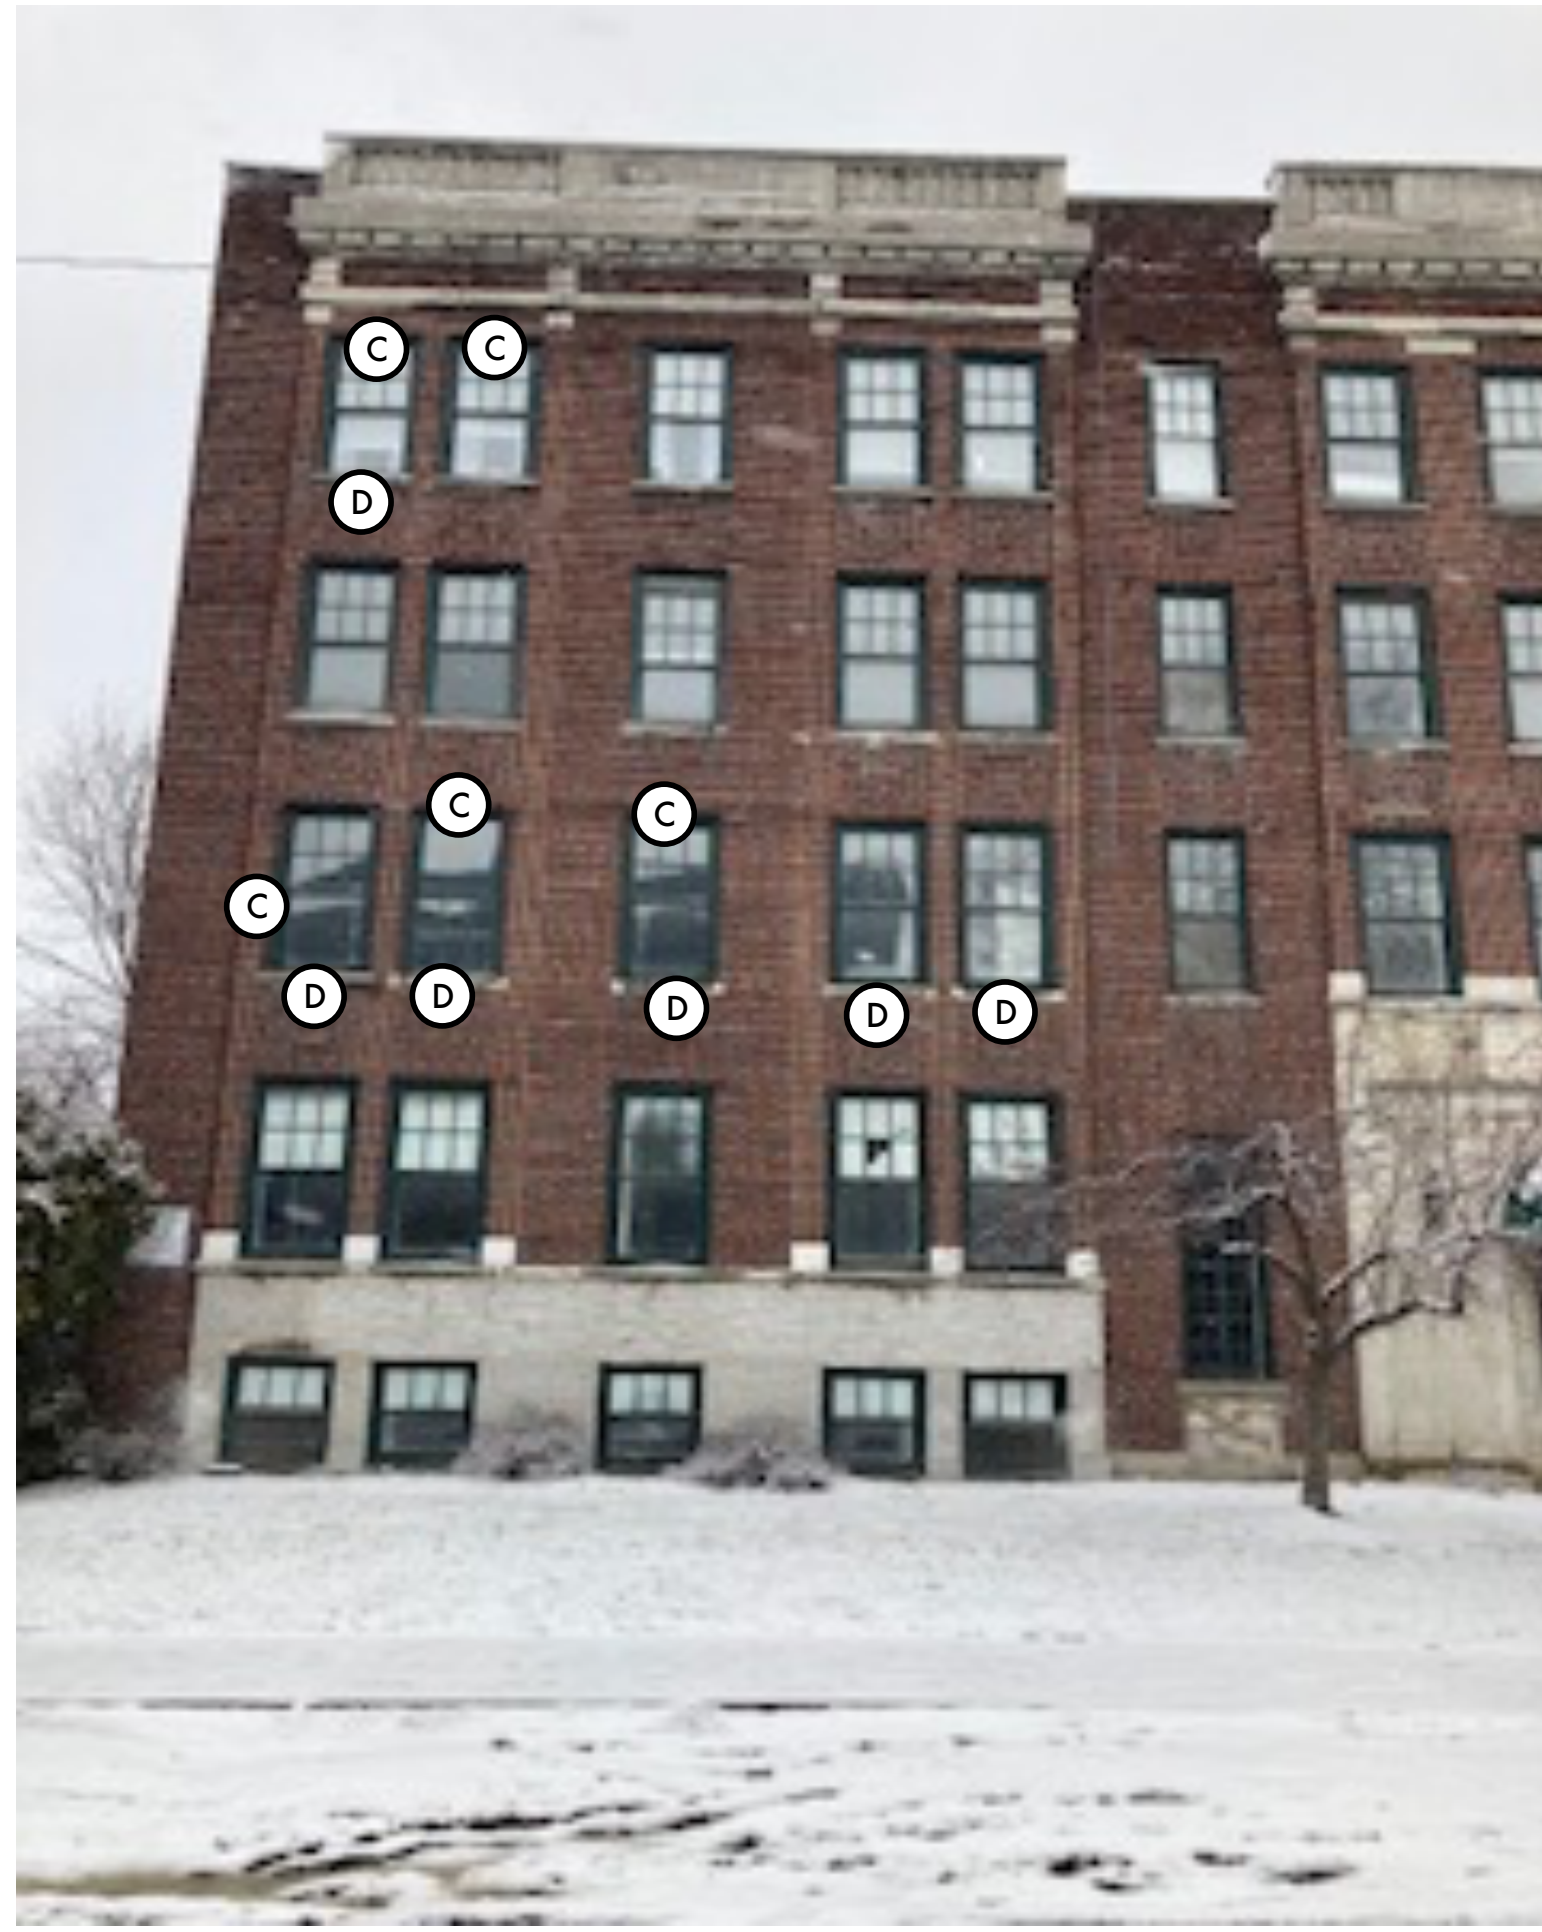
G SOUTH - LEFT PARTIAL ELEVATION
SCALE: NONE

- J** AIR LEAKAGE, SASHES TAPED/CAULKED SHUT - SASHES INOPERABLE
- E** MISSING WINDOW PANE & SCREEN
- A** MISSING WINDOW PANE, DETERIORATED WOOD FRAME
- F** DETERIORATED WEATHER STRIPPING
- B** MISSING BOTTOM RAIL OF TOP SASH, TOP SASH INOPERABLE
- G** TOP & BOTTOM SASH INOPERABLE, WARPED VINYL JAMP, WINDOW BALANCE BROKEN
- C** DETERIORATED BOTTOM SASH, JAMB & SILL TOP & BOTTOM SASH INOPERABLE, WARPED VINYL JAMP, WINDOW BALANCE BROKEN
- H** MISSING WINDOW UNIT
- D** DETERIORATED WOOD SILL
