January 10, 2020

**December 11, 2019 Order to Restore  
5851 West Jefferson Avenue, Detroit Michigan  
Compliant Submission No.: HNV-Y8T9-CH85H6  
Site Name: 82-5851 West Jefferson Avenue-Detroit**

**December 11, 2019 Compliance Communication: Notice of Section 20107a of Part  
201 Obligations  
Former Revere Copper and Brass  
5851 West Jefferson, Detroit, Wayne County, Michigan  
EGLE Site ID No. 82000136**

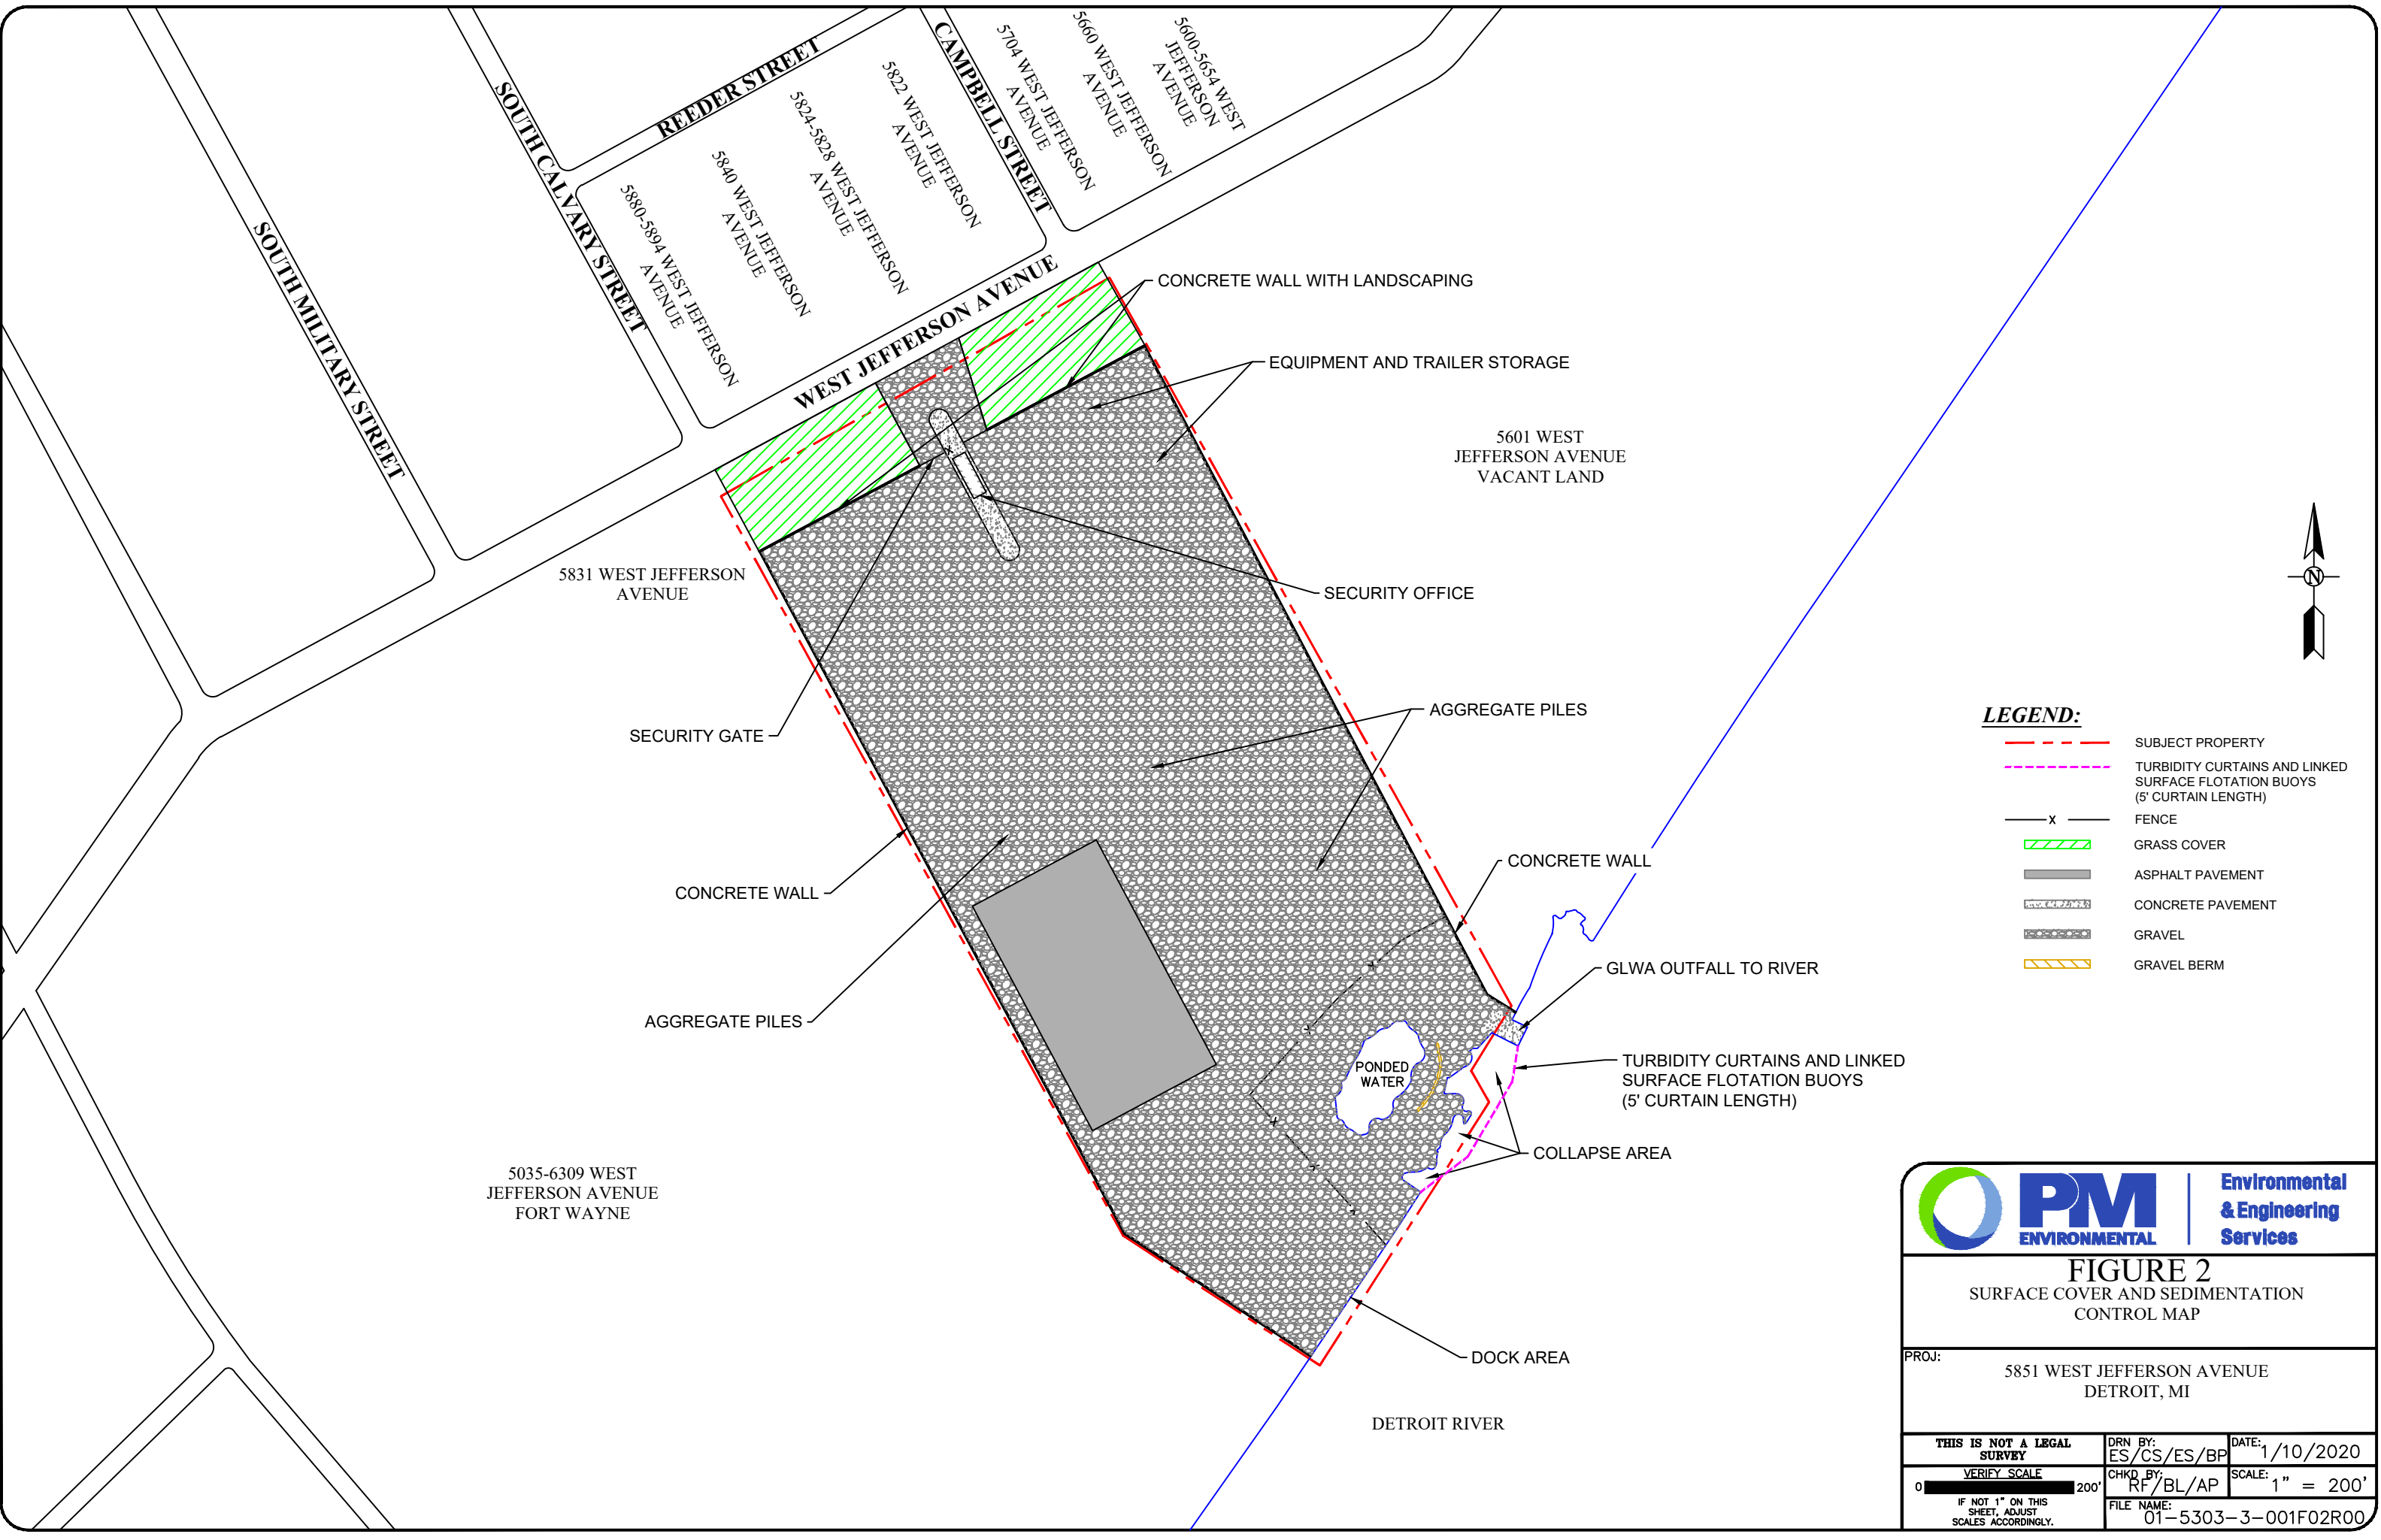
**FIGURE 2**  
SURFACE COVER AND SEDIMENTATION CONTROL MAP

of the subject property where the bank failure occurred contain surface cracking that have not been filled with gravel due to geotechnical concerns associated with the added weight of a gravel blanket in that area. However, that area of the subject property has been isolated with temporary fencing to prevent access. An additional gravel berm was also installed along the southern boundary of the bank collapse area where water has accumulated, to further control erosion and provide sedimentation control (refer to Figure 2).
