Building 207: Post Headquarters

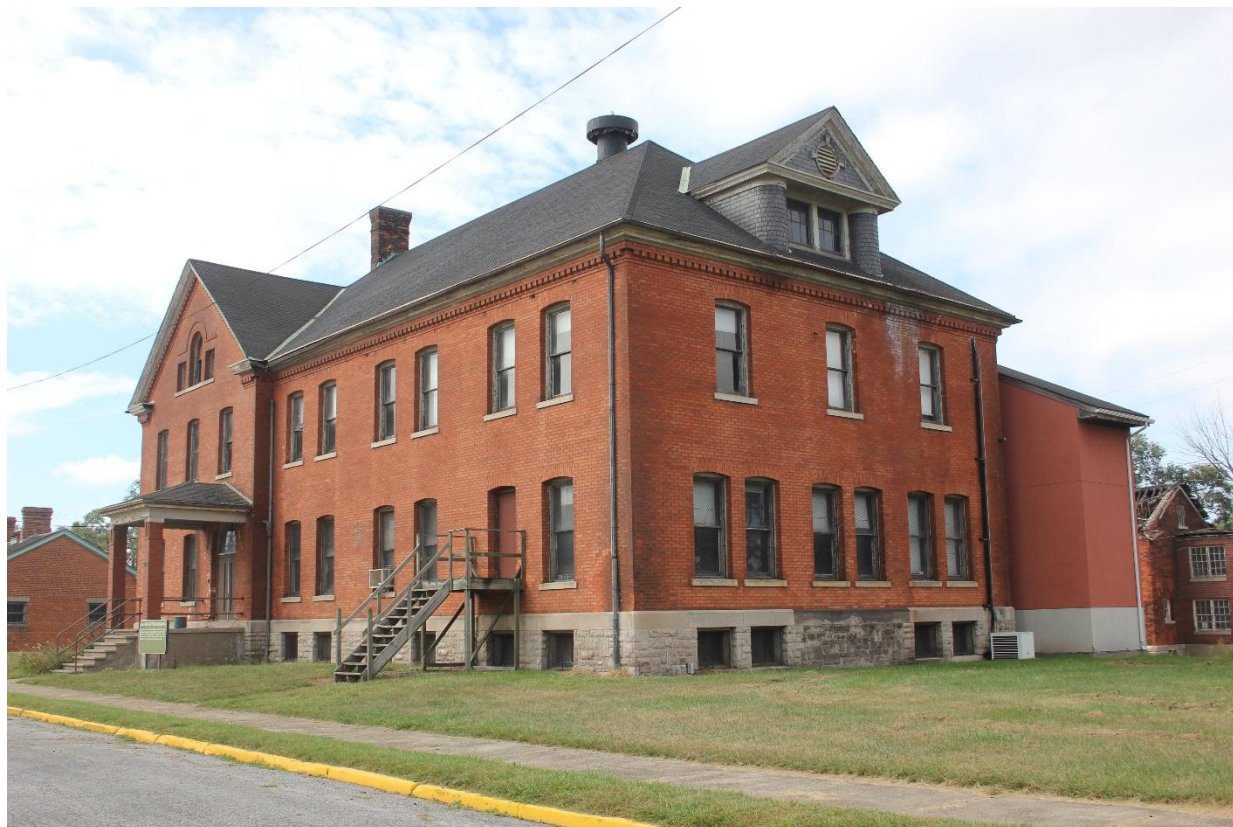
Southeast and northeast facades, February 2017
