## Building 219: Noncommissioned Officer's Quarters

**Construction Date:** 1939

**Condition:** Poor<sup>1</sup>

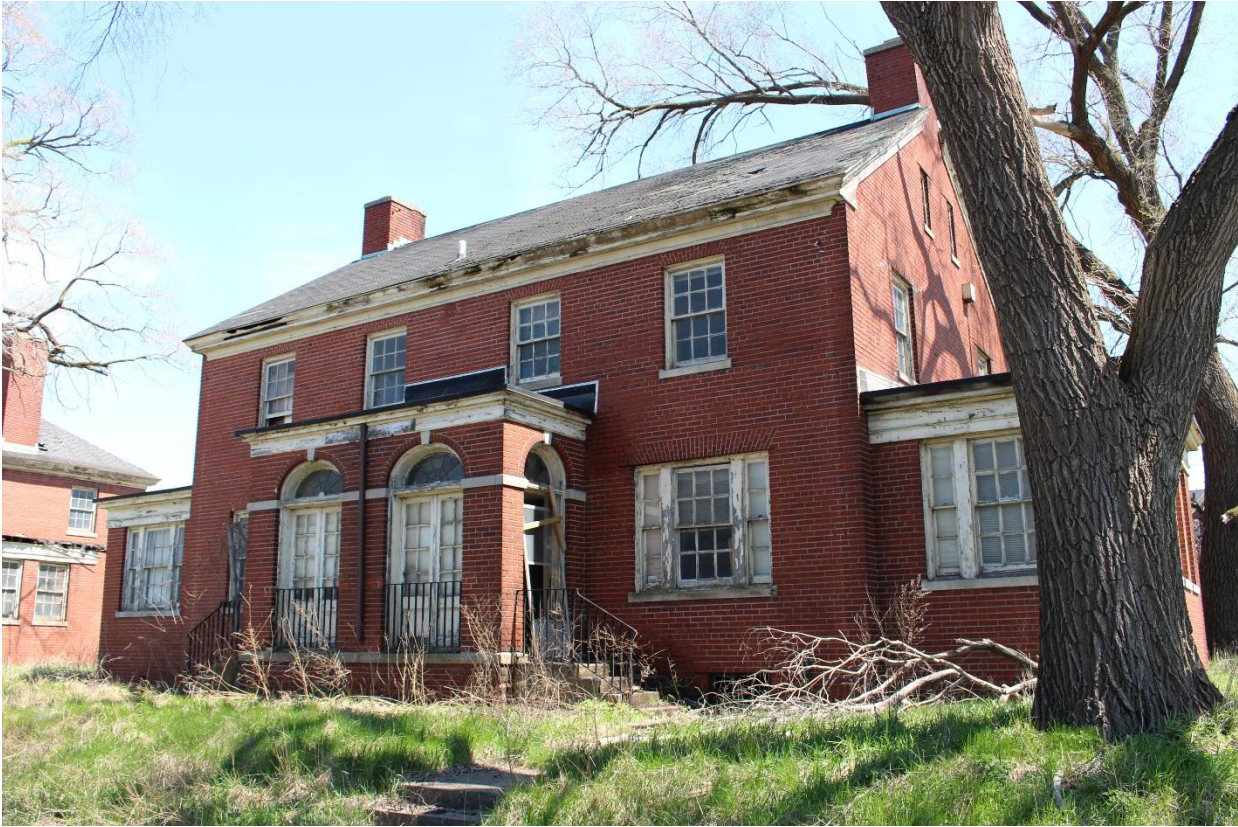
*Front (northwest) facade, April 2019*
