Asbestos-Containing Materials Inspection
2143– 2145 Townsend Street
Detroit, Michigan 48214

Develop Detroit, Inc.

October 7, 2021

Islandview Villages Duplex
Rehabilitation Project

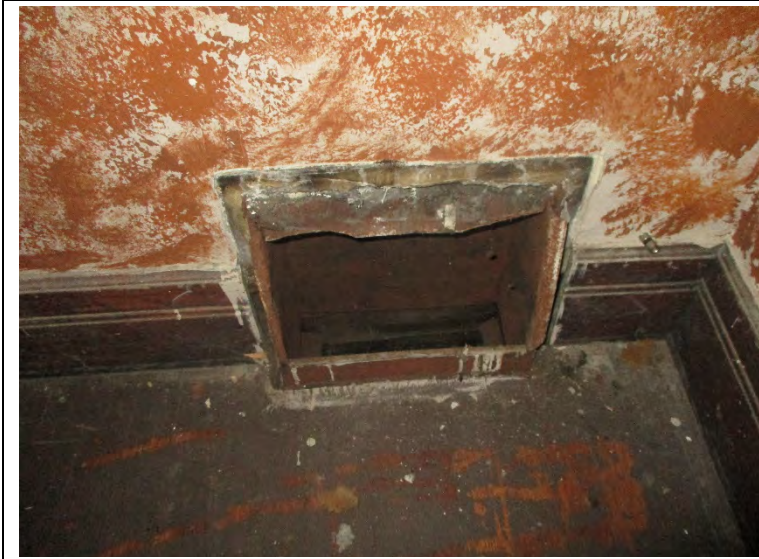
Photo 5. View of asbestos-containing duct paper insulation

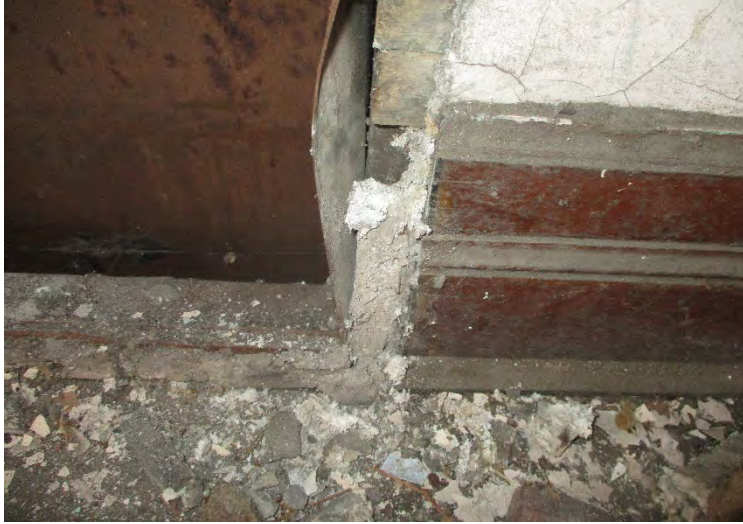
Photo 4. View of asbestos-containing duct insulation

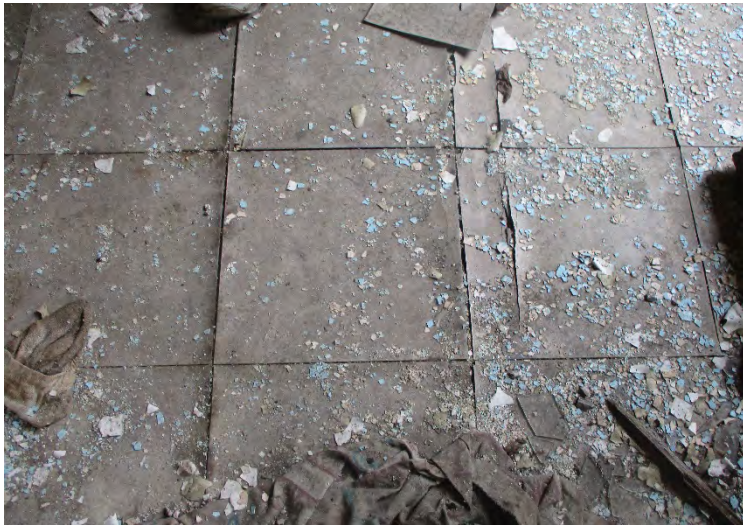
Photo 5. View of asbestos-containing floor tile

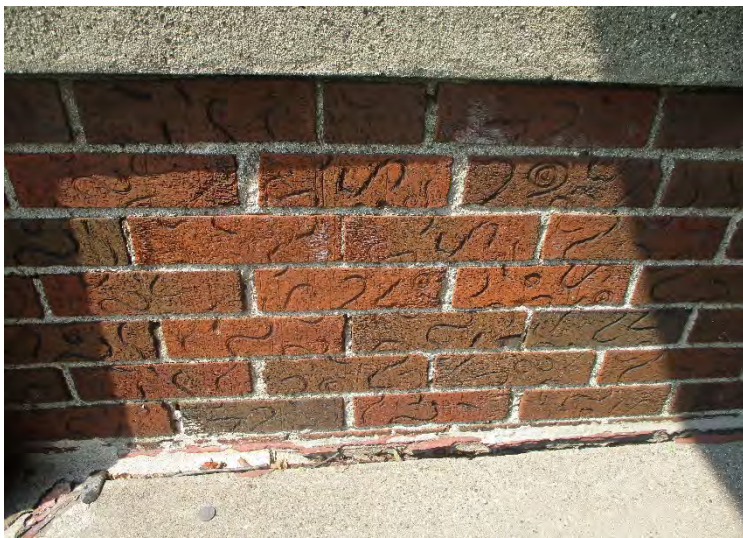
Photo 6. View of asbestos-containing red porch caulk

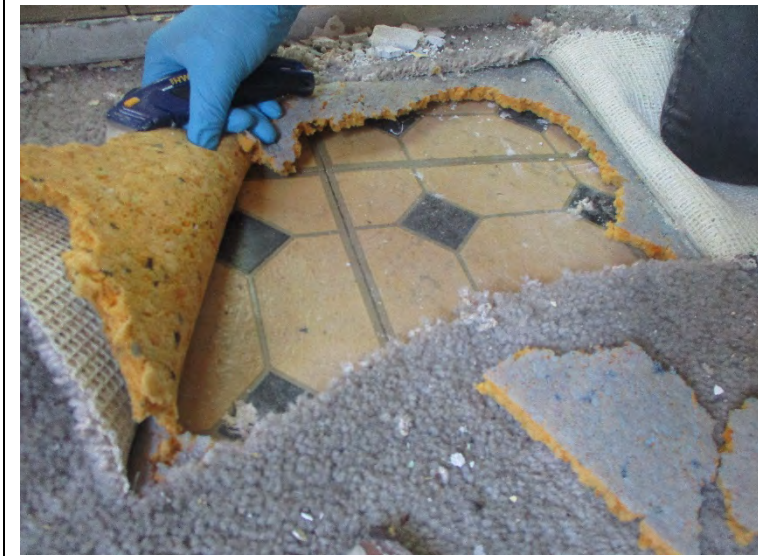
Photo 4. View of black and white 12" x12" floor tile with asbestos-containing Cream floor tile beneath in the southwest bedroom of 2251 Sheridan

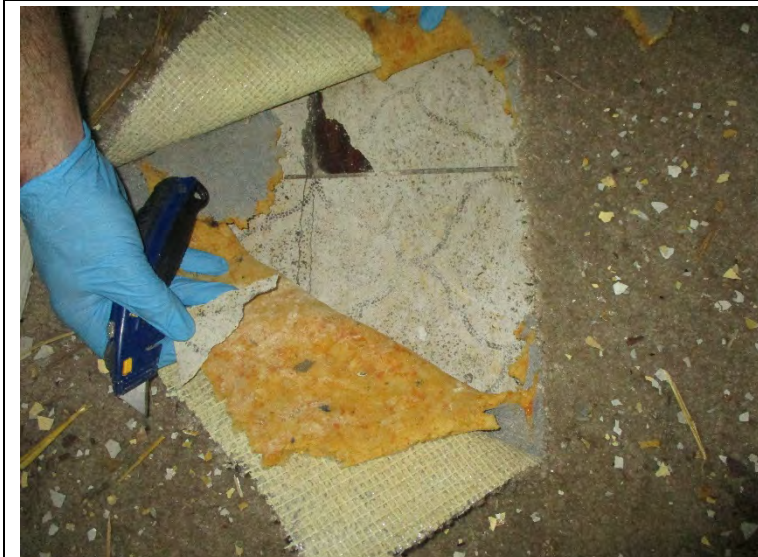
Photo 5. View of asbestos-containing Cream/Brown floor tile in the hallway of 2251 Sheridan, 2nd floor

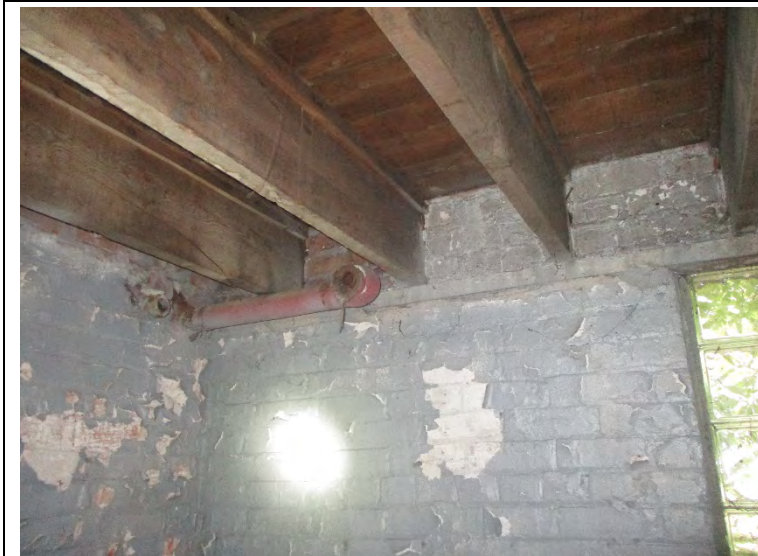
Photo 6. View of asbestos-containing pipe joint insulation

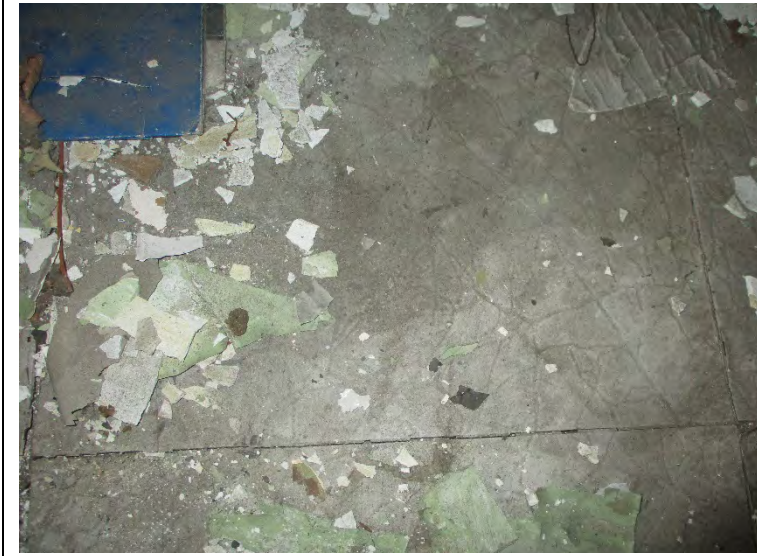
Photo 7. View of asbestos-containing 12" x12" White floor tile in the northwest bedroom of 2253 Sheridan

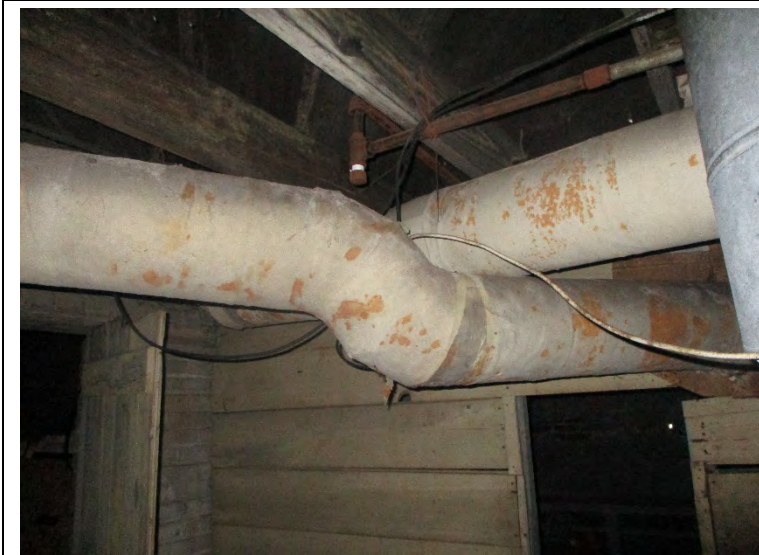
Photo 5. View of asbestos-containing duct insulation

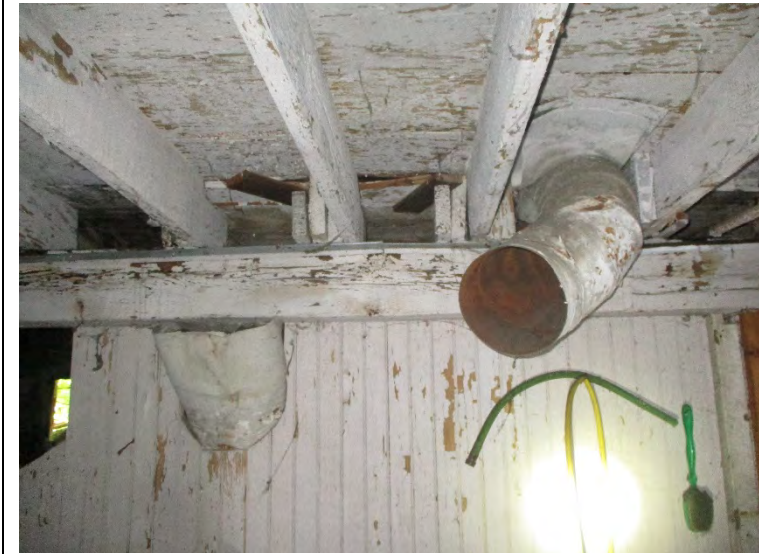
Photo 4. View of Asbestos-containing duct wrap

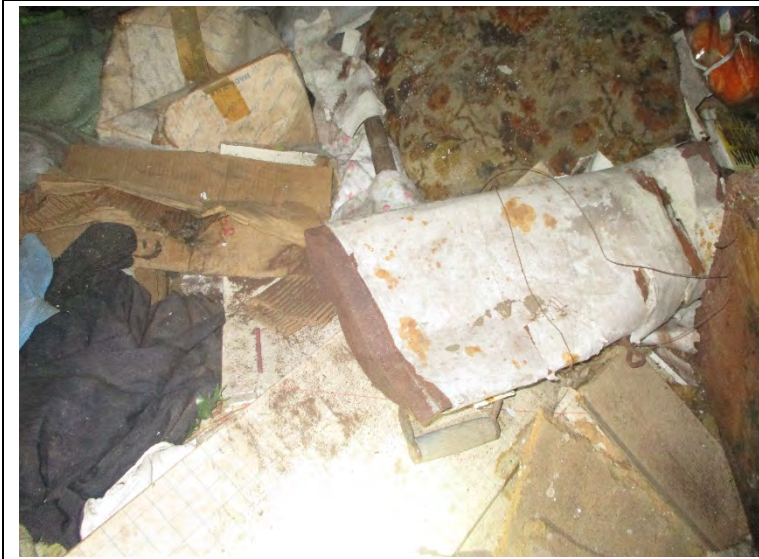
Photo 5. View of Asbestos-containing duct wrap on the ground
