Asbestos-Containing Materials Inspection
CCSEM St. Matthew
6021 Whittier Avenue
Detroit, Michigan 48224

CCSEM St. Matthew LDHA, LP

November 11, 2022

ASTI Project No. 4-11685

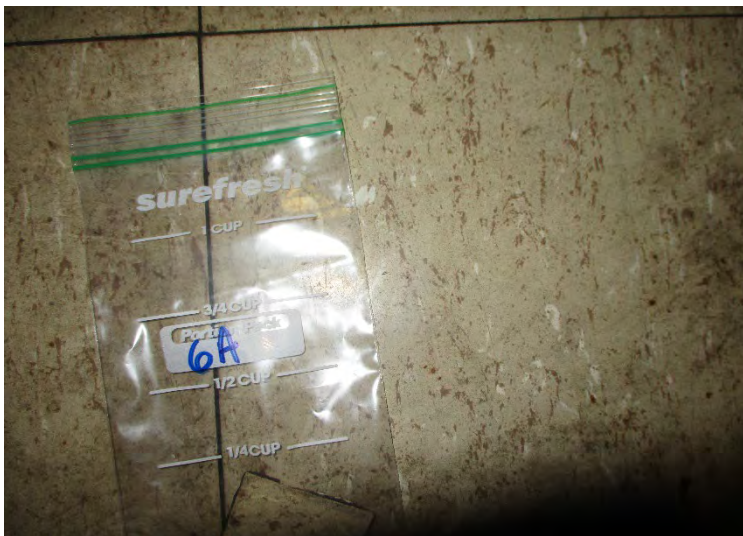
Photo 3. A view of asbestos-containing 9"x9" Floor tile in the 1st and 2nd floor hallways of 5959 Whittier building

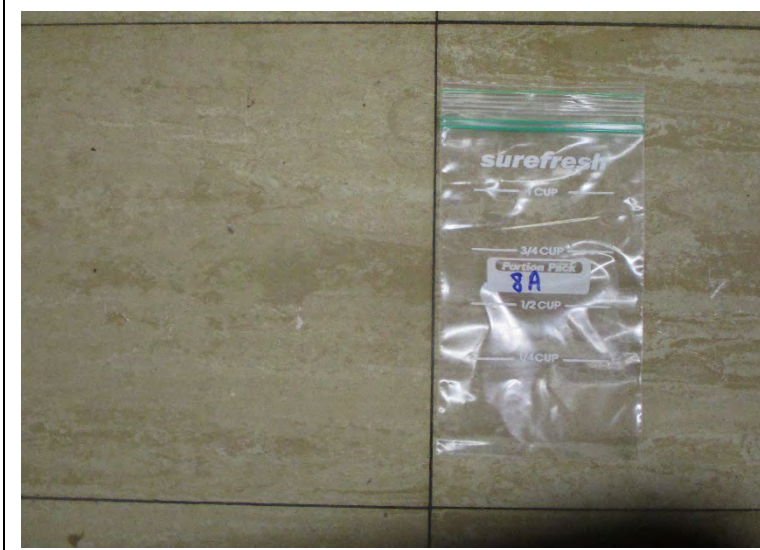
Photo 4. A view of asbestos-containing 9"x9" Floor tile in the 1st and 2nd floor classrooms in 5959 Whittier building

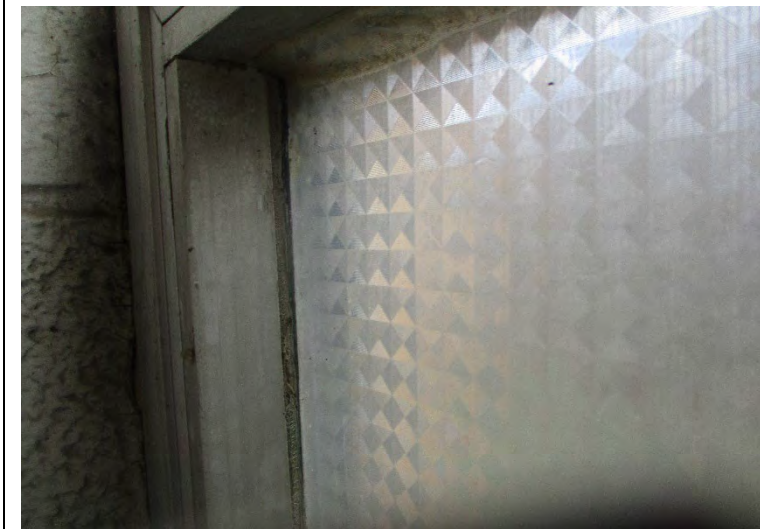
Photo 5. A view of asbestos-containing window glaze

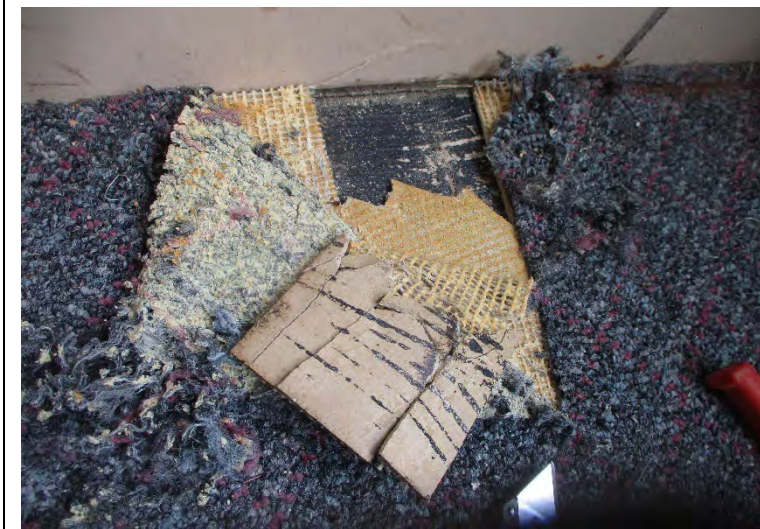
Photo 6. A view of asbestos-containing floor tile beneath carpet in the 5959 Whittier office

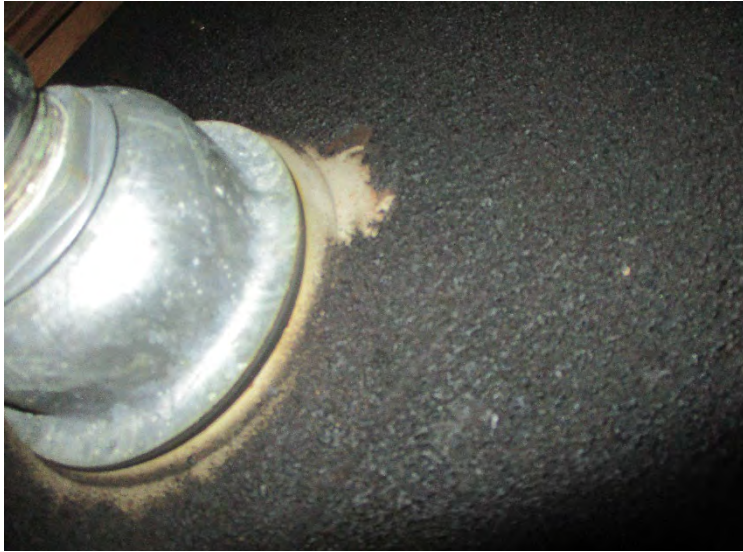
Photo 7. A view of asbestos-containing sink undercoating in the kitchen of 5959 Whittier.

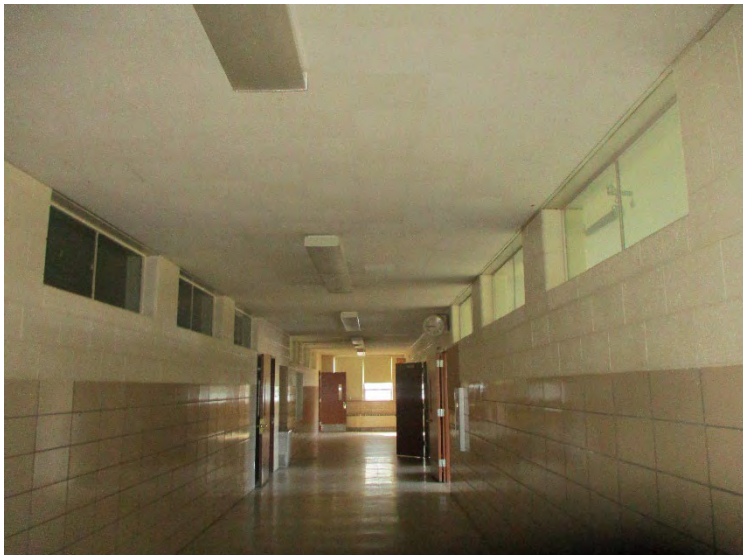
Photo 8. A view of asbestos-containing window caulk on 1st and 2nd floor hallway windows (between hallway and classrooms)

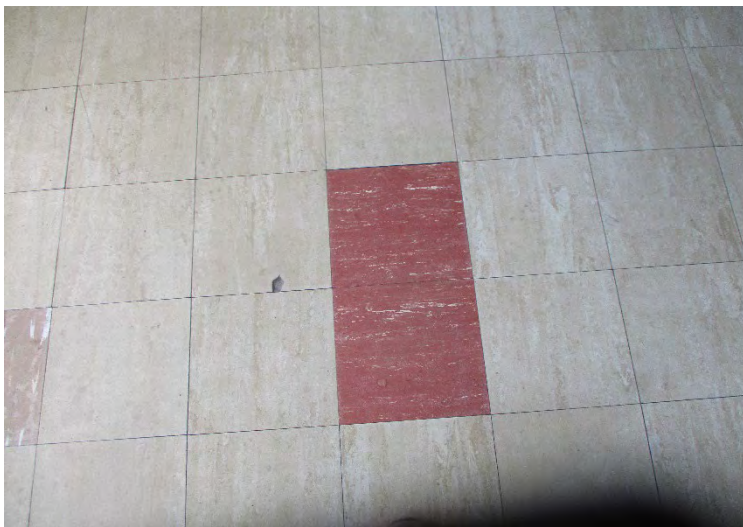
Photo 9. A view of asbestos-containing floor tile in the 5959 Whittier 2nd floor classroom 205

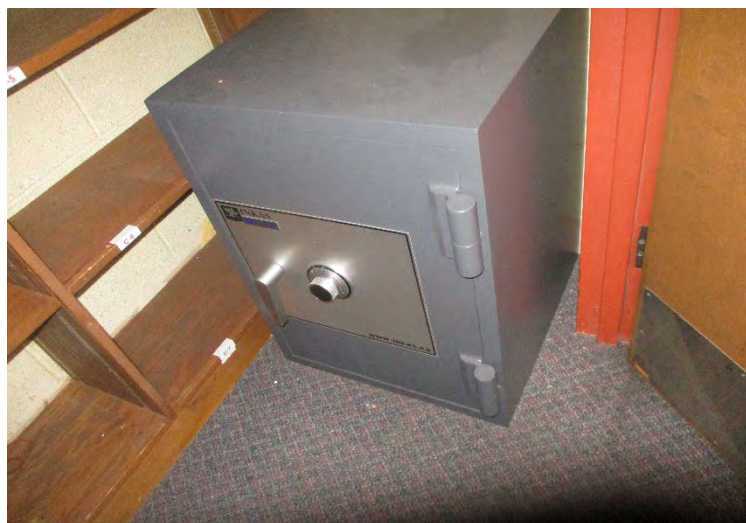
Photo 10. A view of assumed asbestos-containing safe in the 5959 Whittier office

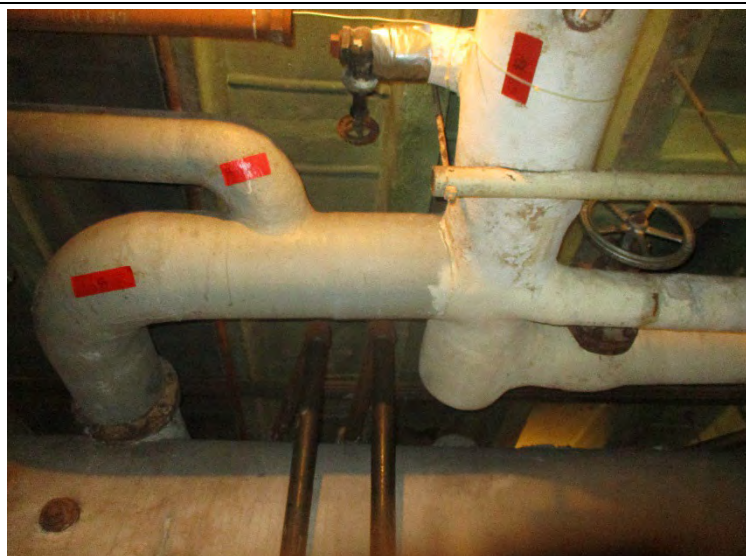
According to classification guidelines set forth in NESHAP, the furnace spacer, pipe insulation, and pipe joint insulation in the School Building (5970 Audubon) are classified as friable ACMs. These materials present the greatest risk of fiber release. These materials in their current condition represent a minimal risk of fiber release. Additional ACM insulation should be anticipated in wall spaces, and above ceiling where visual inspection was restricted. If any future work, such as renovation or demolition, would disturb the material, this material is considered regulated ACM and must be removed by a licensed abatement contractor.

Photo 12. A view of asbestos-containing pipe wrap and mud-joint insulation in the 5970 Audubon building

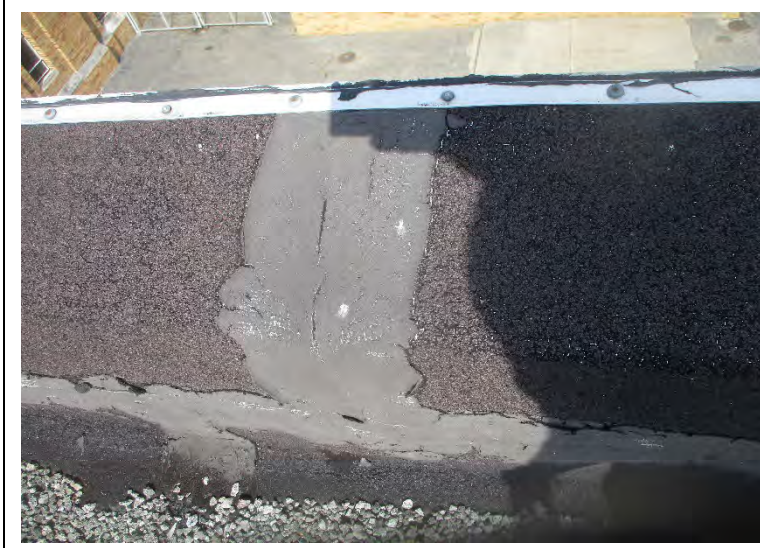
Photo 13. A view of asbestos-containing flashing

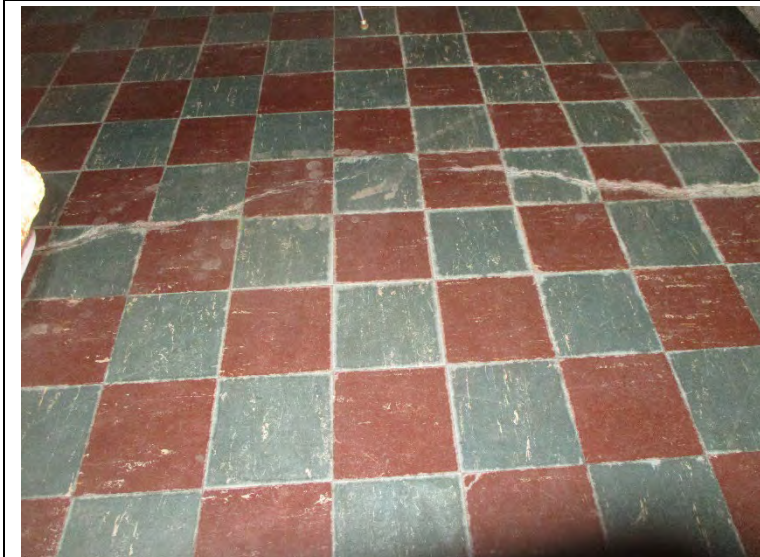
Photo 14. A view of asbestos-containing 9"x9" floor tile in the Cafeteria in the 5970 Audubon building

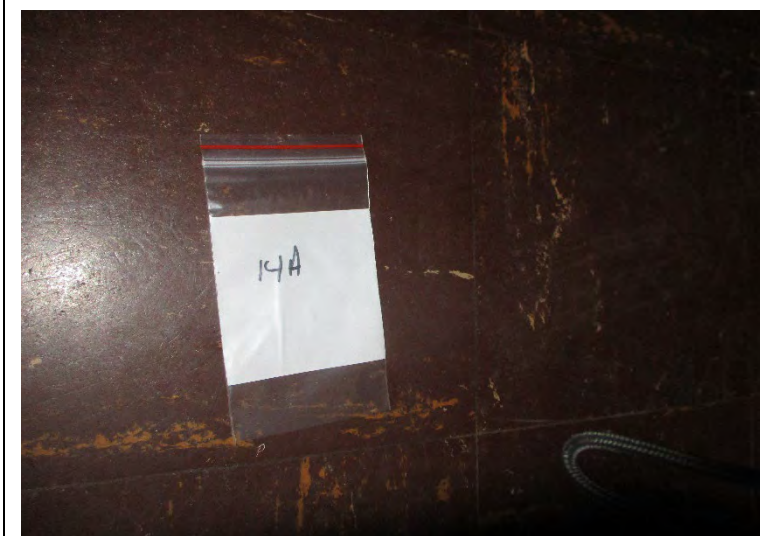
Photo 15. A view of asbestos-containing 9"x9" floor tile in the Kitchen closet in the 5970 Audubon building

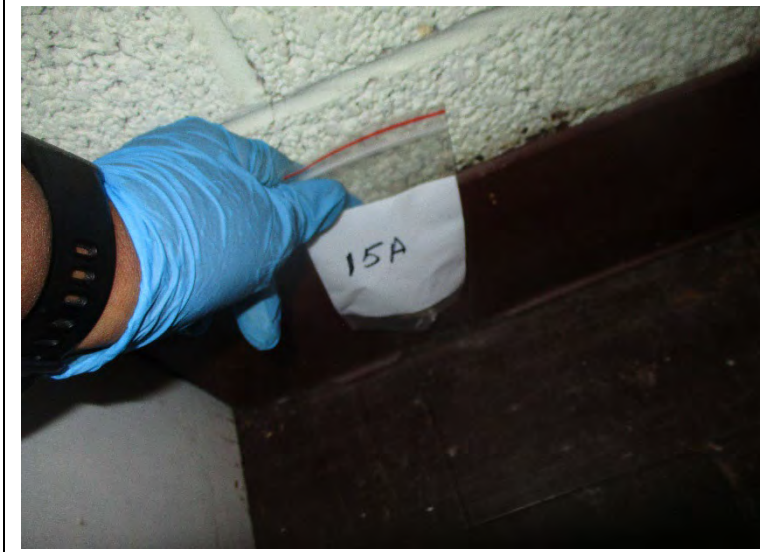
Photo 16. A view of asbestos-containing cove-base in the kitchen closet in the 5970 Audubon building

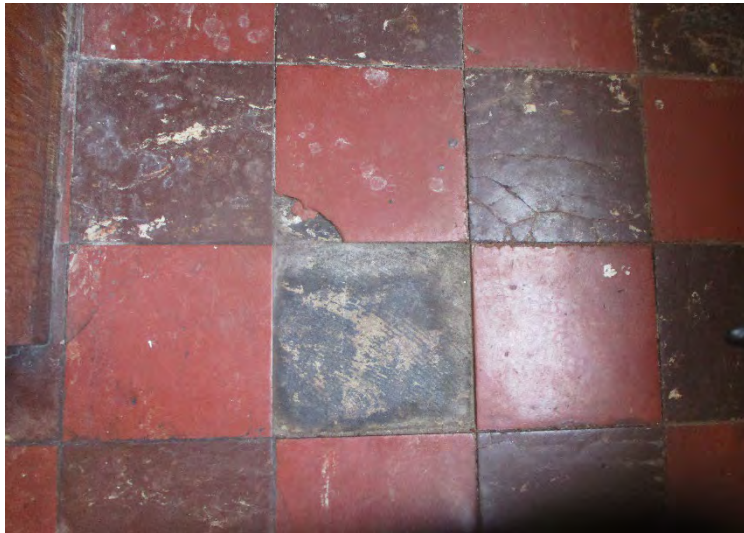
Photo 17. A view of asbestos-containing 9"x9" floor tile in the kitchen in the 5970 Audubon building

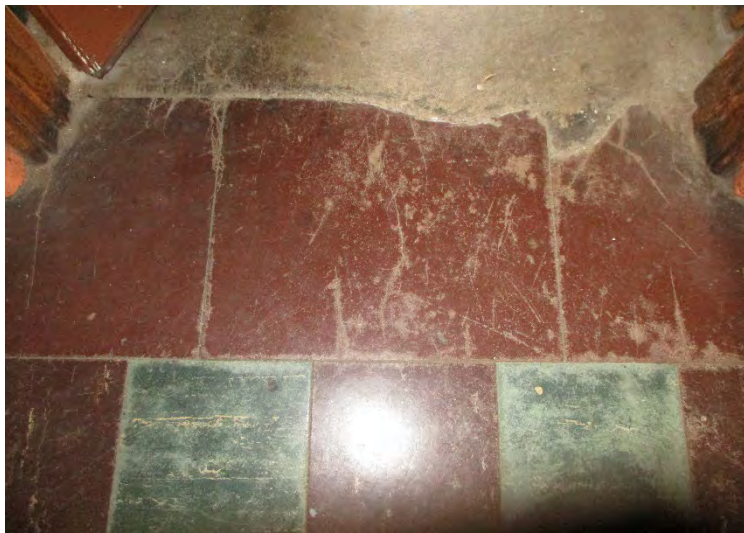
Photo 18. A view of asbestos-containing 16"x18" border floor tile in the kitchen in the 5970 Audubon building

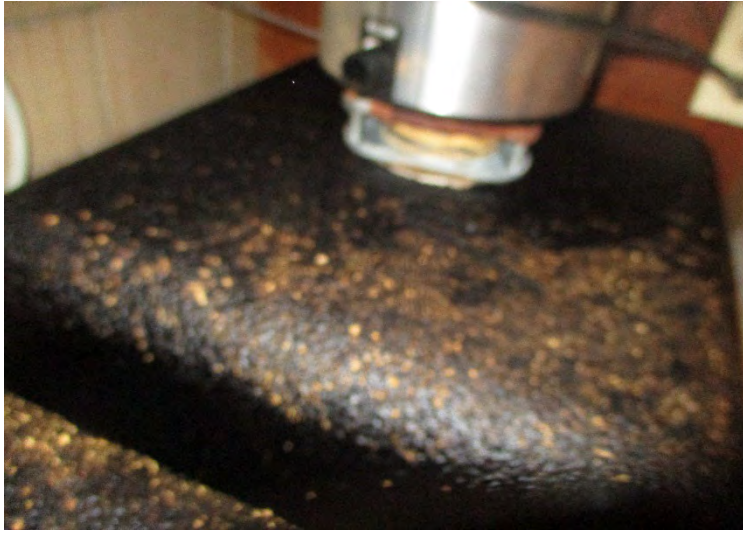
Photo 19. A view of asbestos-containing sink undercoating

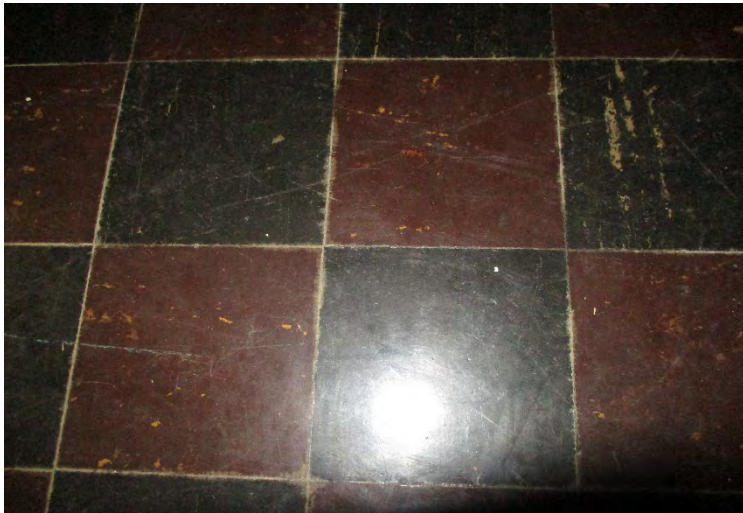
Photo 20. A view of asbestos-containing 9"x9" floor tile in the hallway

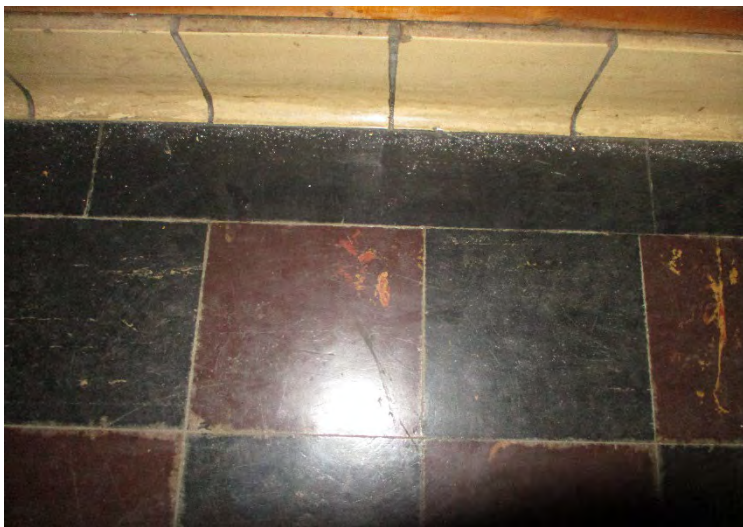
Photo 21. A view of asbestos-containing 12"x4" floor tile border in the hallway

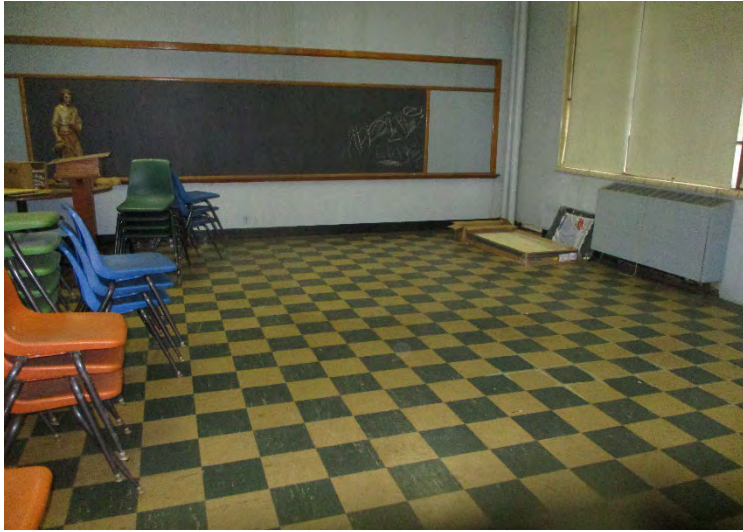
Photo 22. A view of asbestos-containing 9"x9" floor tile in room 102

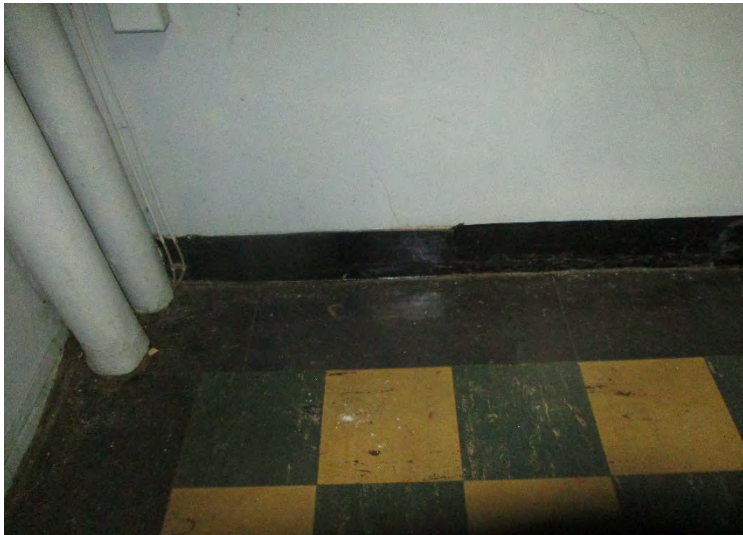
Photo 23. A view of asbestos-containing cove-base in classroom 102

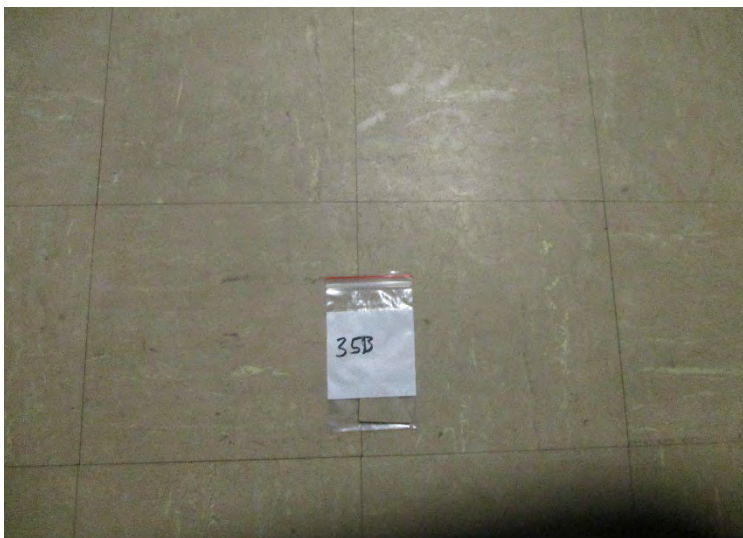
Photo 24. A view of asbestos-containing 9"x9" floor tile in room 112

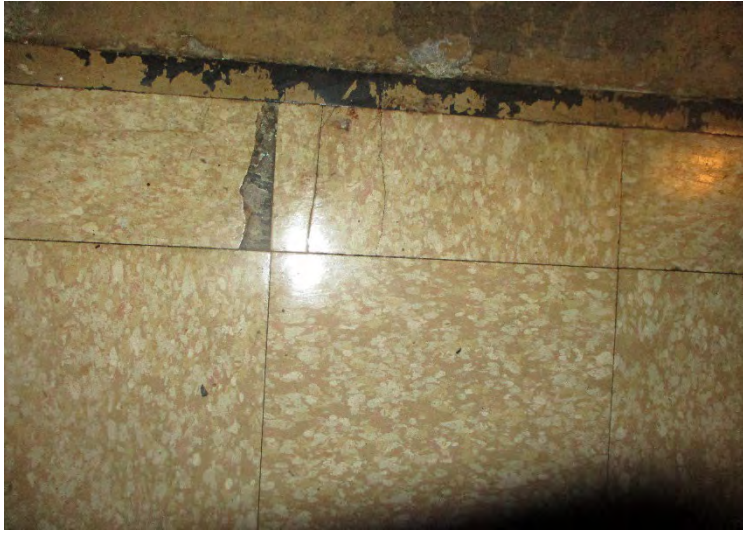
Photo 25. A view of asbestos-containing 9"x9" floor tile in room 104

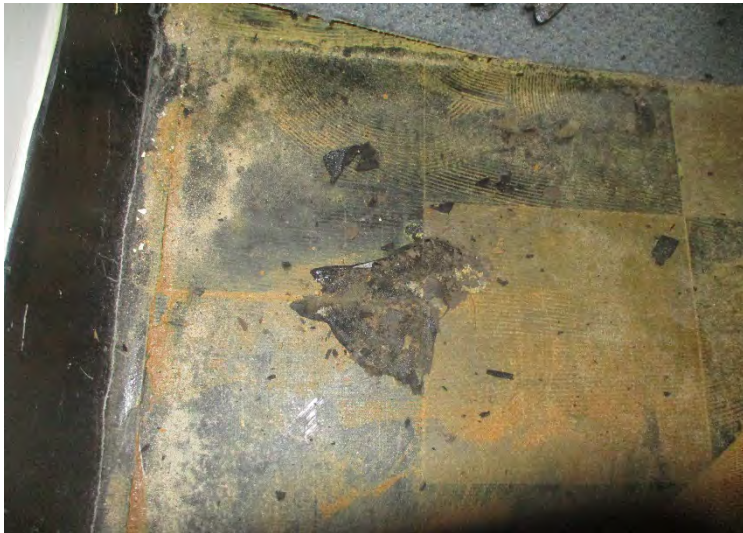
Photo 26. A view of asbestos-containing 9"x9" floor tile beneath carpet in room 105

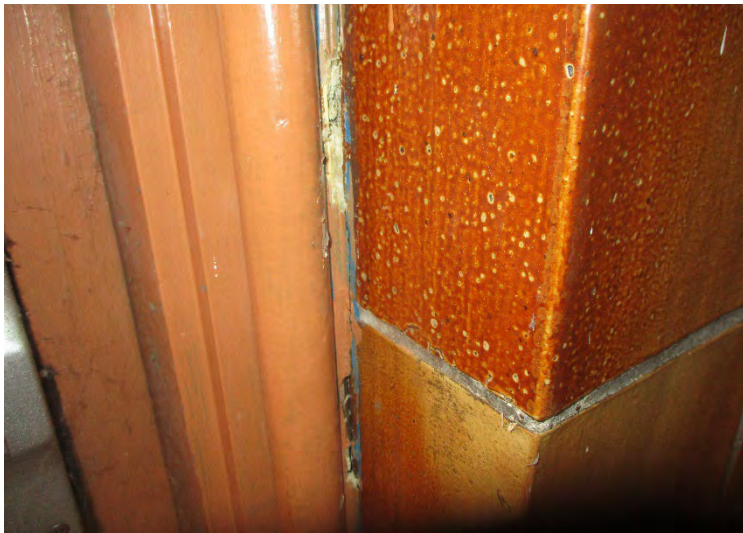
Photo 27. A view of asbestos-containing interior Gym door caulk

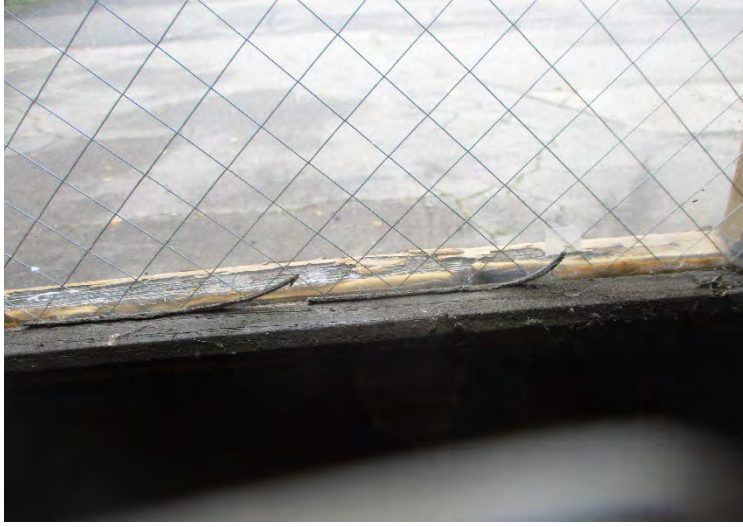
Photo 28. A view of asbestos-containing window glaze on the west stairway door

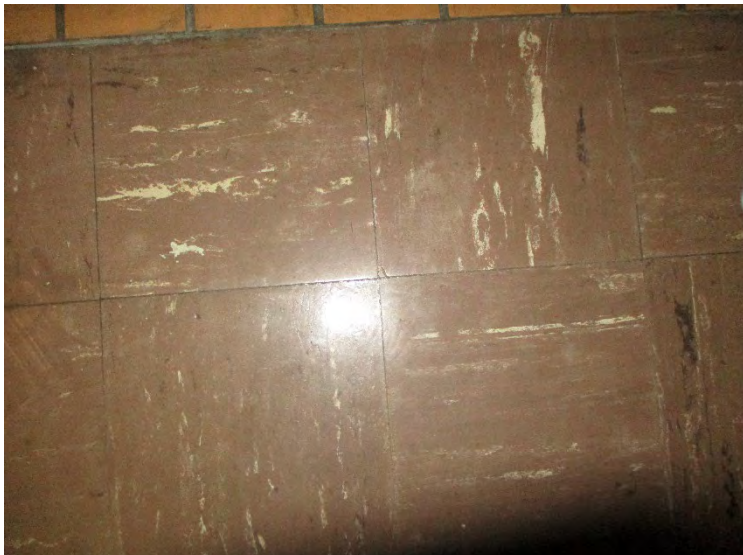
Photo 29. A view of asbestos-containing 9"x9" floor tile in north end hallways

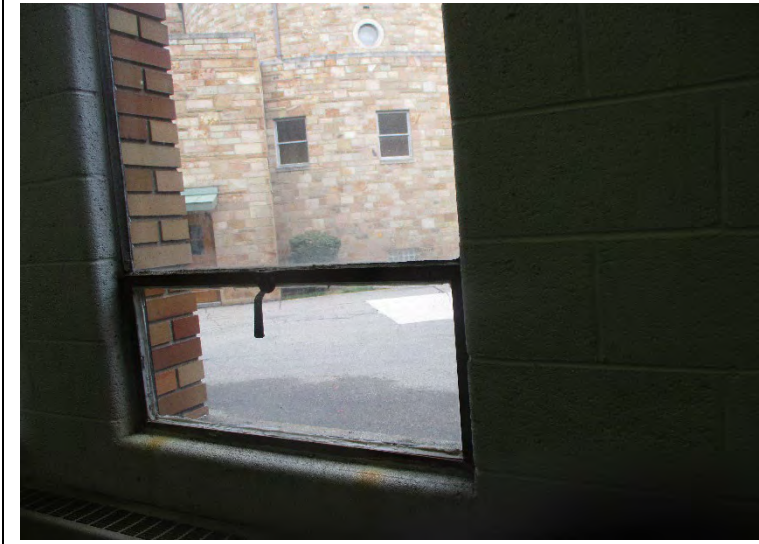
Photo 31. A view of asbestos-containing window glaze

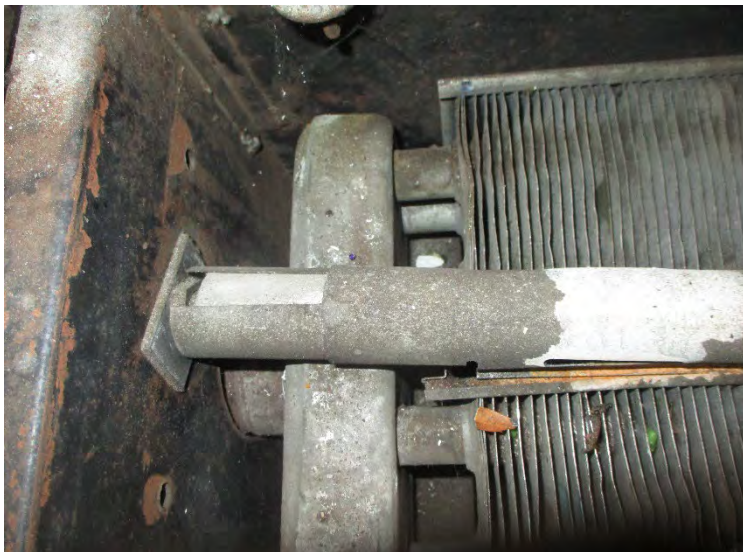
Photo 33. A view of asbestos-containing radiator spacer

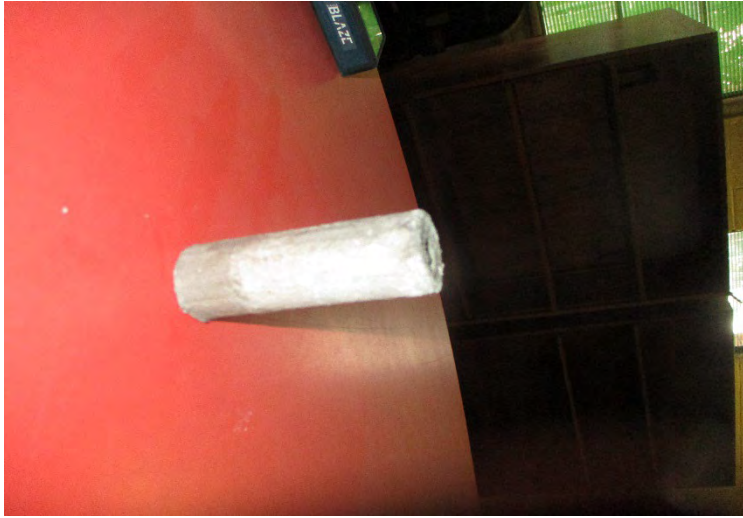
Photo 34. A view of asbestos-containing radiator spacer out of casing and radiator

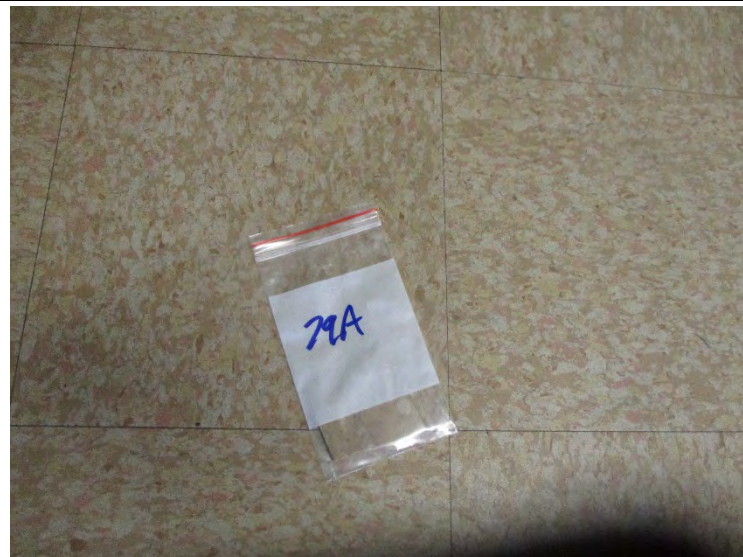
Photo 35. A view of asbestos-containing 9"x9" floor tile in classroom 205

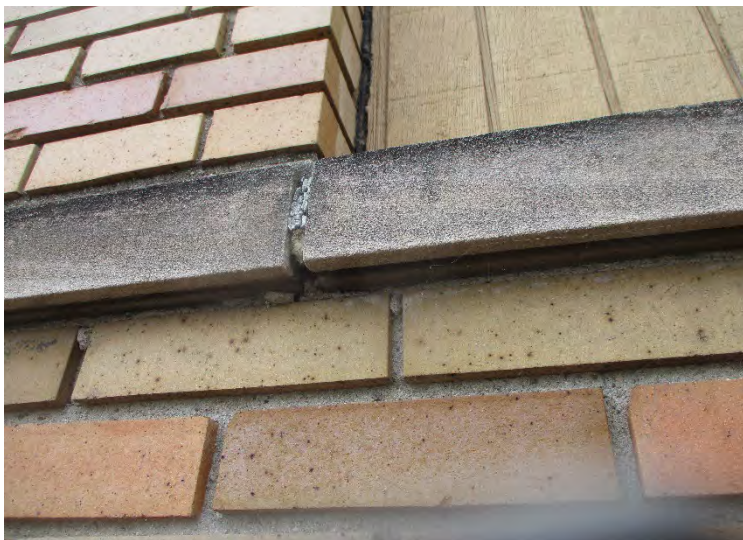
Photo 36. A view of asbestos-containing stone mortar
