# Renovation Environmental Inspection Summary Report

2918 Garland Street, Detroit, MI 48214

Date of Inspection: 06/30/2023

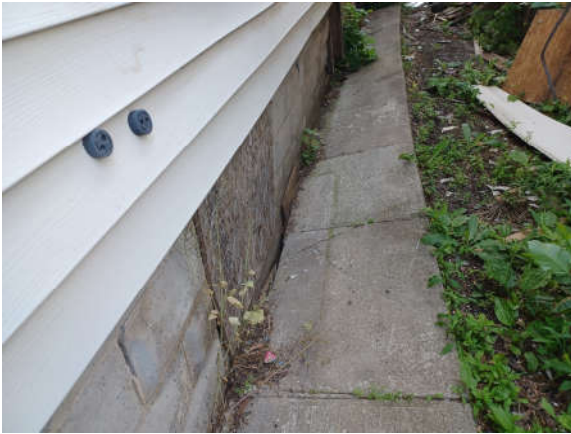
Bowing Foundation

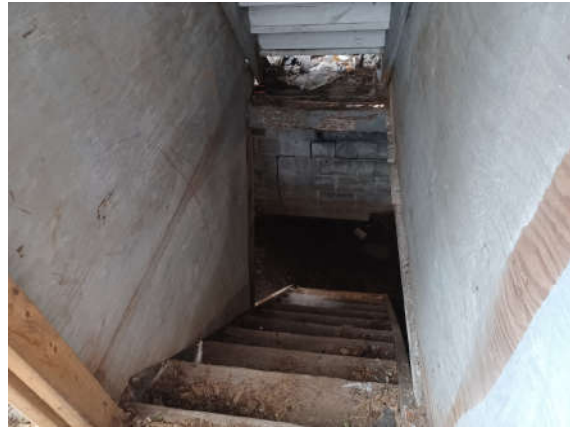
Cracked Foundation and Water Damaged Stairs

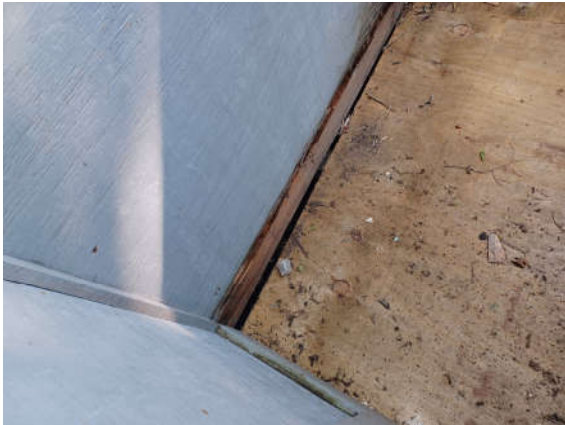
Disconnected and Insecure Landing

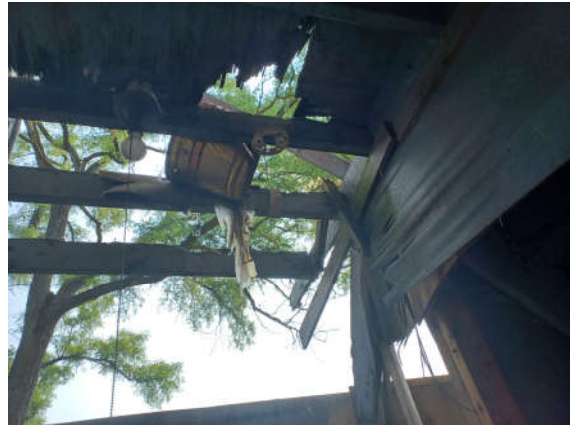
Missing Ceiling

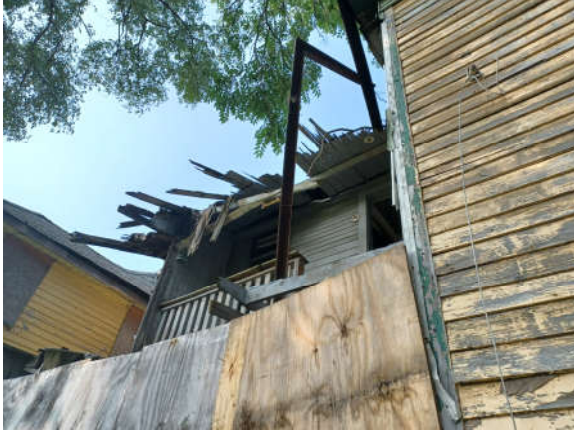
Missing Roof

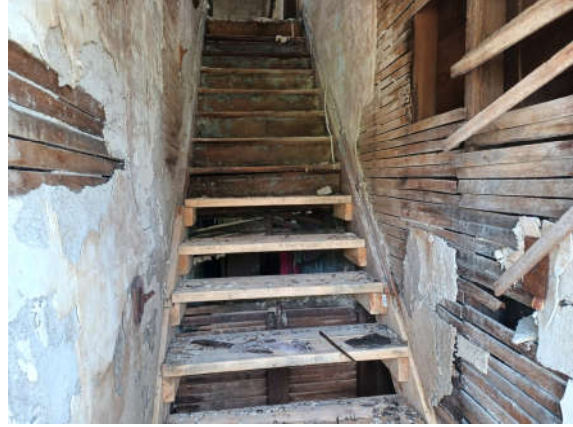
Water damaged and rebuilt stairs

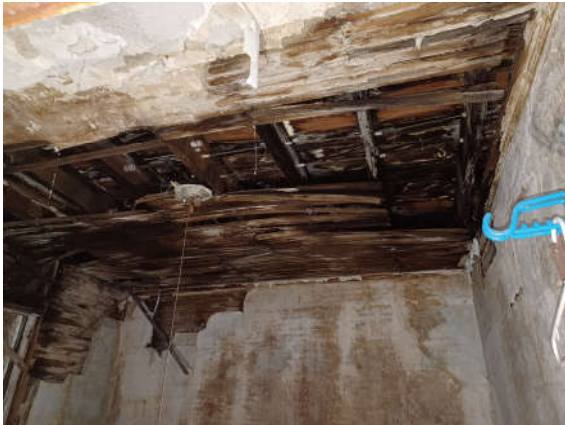
Water Damaged Ceiling

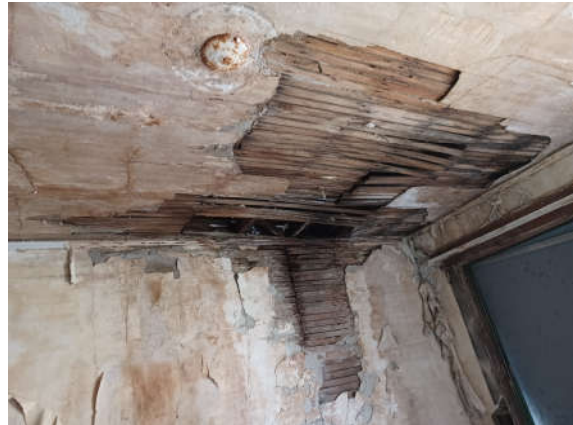
Water Damaged Ceiling

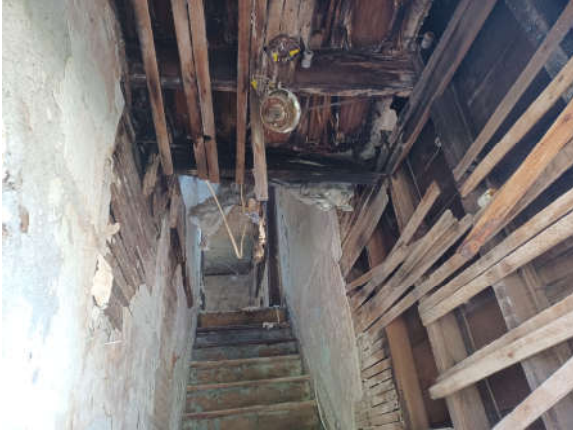
Water Damaged Ceiling and Missing Ceiling

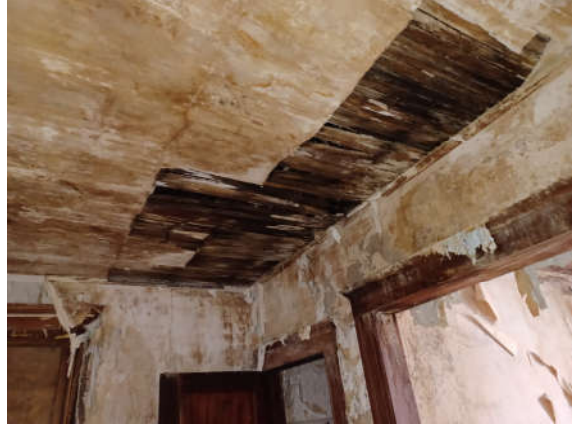
Water Damaged Ceiling

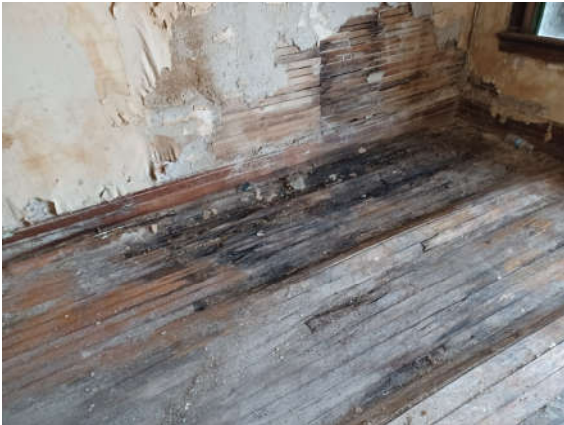
Water Damaged Floor

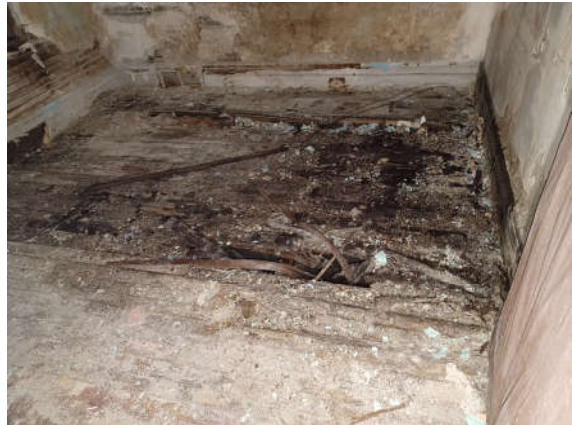
Water Damaged Floor

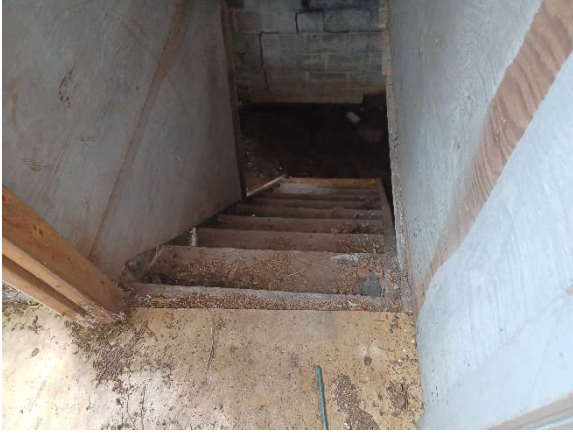
Water damaged Stairs
