STAFF REPORT: 10-9-2019 MEETING
APPLICATION NUMBER: 19-6490
ADDRESS: 791 SEMINOLE
HISTORIC DISTRICT: INDIAN VILLAGE
APPLICANT: YURI DADO
DATE OF COMPLETE APPLICATION: 11/13/2019
DATE OF STAFF SITE VISIT: 12/4/2019

SCOPE: INSTALL NEW WINDOWS

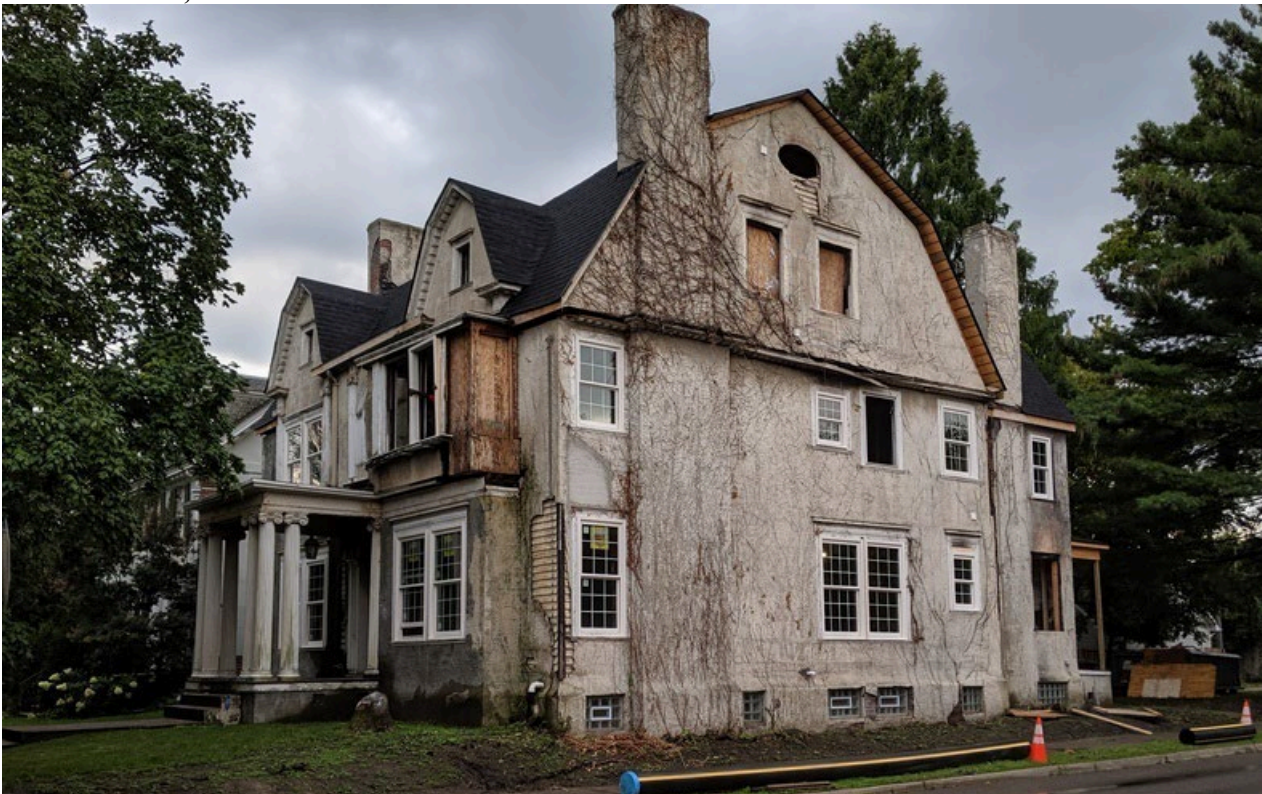
791 Seminole, current conditions

- The light configuration of the new windows do not match the old/original
 - The grids at the new windows are between the glass
 - Many of the windows are improperly fitted within their opening. Plywood has been used to infill the gaps in the opening.

- The new windows are not properly recessed with their openings
 - HDC field investigations revealed that leaded glass windows were removed from the building.

- All existing plywood from the home's exterior walls shall be removed and new stucco added to match the historic appearance
- Replace all existing non-historic wood windows and replace with new wood windows, to match the original in dimension, profile, operation and light configuration. The new windows must be true divided light or simulated divided lite (grid applied to the exterior surface of the glass).
