OLD BUISNESS: 2-12-2020 MEETING  
APPLICATION NUMBER 19-6464  
VIOLATION NUMBER 19-322  
ADDRESS: 4801 STURTEVANT  
HISTORIC DISTRICT: RUSSELL WOODS - SULLIVAN  
APPLICANT: WAYNE GROLEAU  
DATE OF APPLICATION: 9-23-2019  
DATE OF VIOLATION: 9-26-2019

PREPARED BY: B. CAGNEY

STAFF REPORT 11-13-2019 MEETING  
APPLICATION NUMBER 19-6464  
ADDRESS: 4801 STURTEVANT  
HISTORIC DISTRICT: RUSSELL WOODS - SULLIVAN  
APPLICANT: WAYNE GROLEAU  
DATE OF APPLICATION: 9-23-2019  
DATE OF VIOLATION: 9-26-2019  
DATE OF STAFF VISIT: 11-6-2019

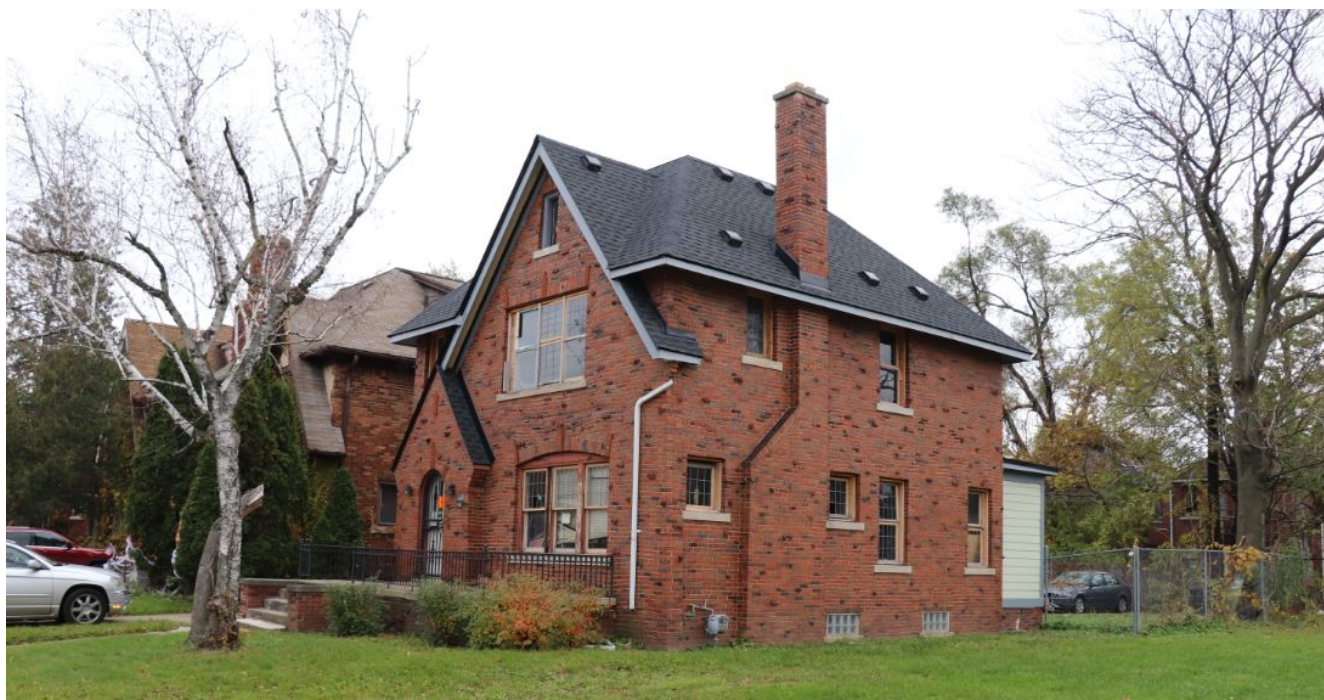
*Staff Photo: 11-6-2019*

On August 23, 2019, the applicant had applied to repair the front porch by “salvaging existing materials.” The violation at this address was discovered when staff reviewed a proposal to rehab the front porch. Upon review of the photos received from the applicant, staff compared the current conditions with a previous proposal to replace the asphalt shingle roof, submitted in October of 2018. From these images, it was determined that significant exterior alterations occurred at the rear of the home. Additionally, upon further inspection of the photos, it was discovered that a majority of the windows had been altered and the window openings at the rear of the home had been reconfigured.

- Removal of wood shakes at rear and replacement with painted horizontal siding at 1<sup>st</sup> story and painted half-timbering / stucco at second story
- Reconfiguration, and elimination of, window openings / door at rear
- Removal of, and alterations to, windows

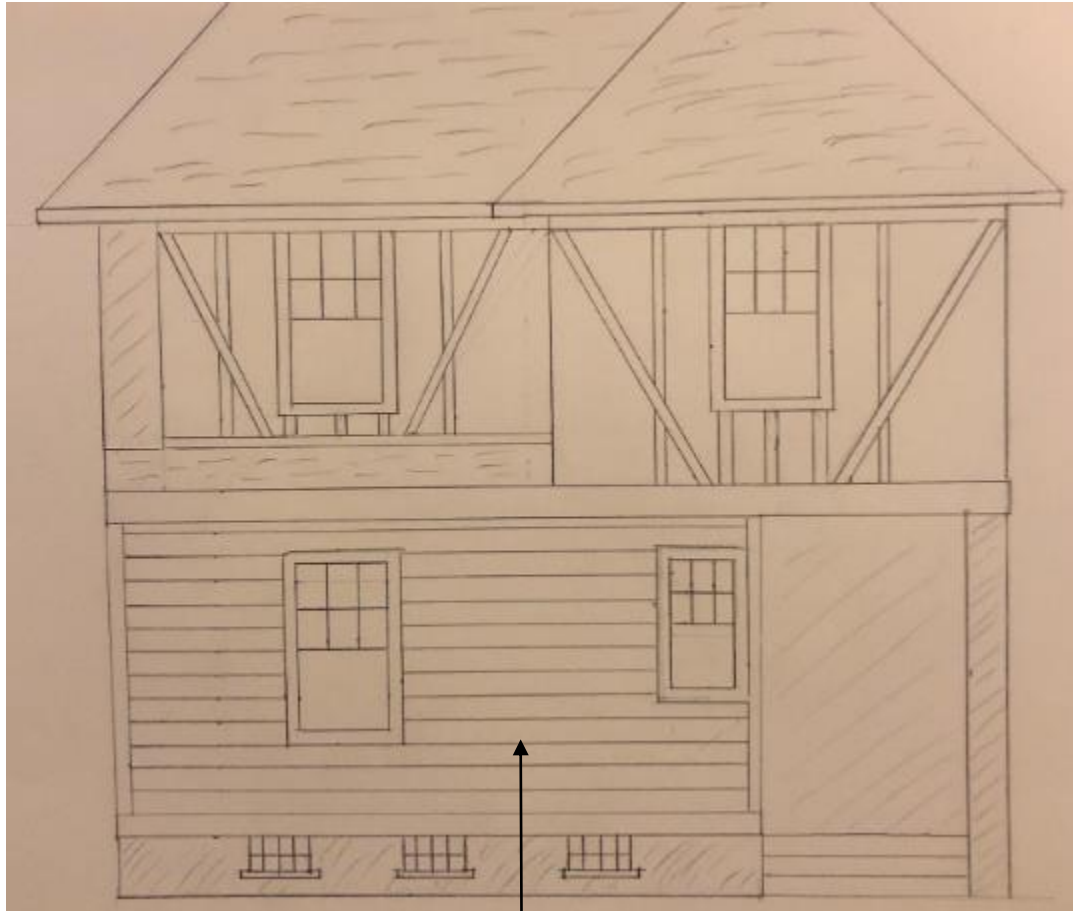
Rear Elevation - Siding at Rear

Applicants put in the application that the lap siding was wood. The staff represented to the commission that applicants had applied “synthetic siding.” If staff is not certain what the siding is, they should just admit it. Applicants’ credibility is maintained because the lap siding is wood and the physical evidence will be brought to the HDC meeting (see below).

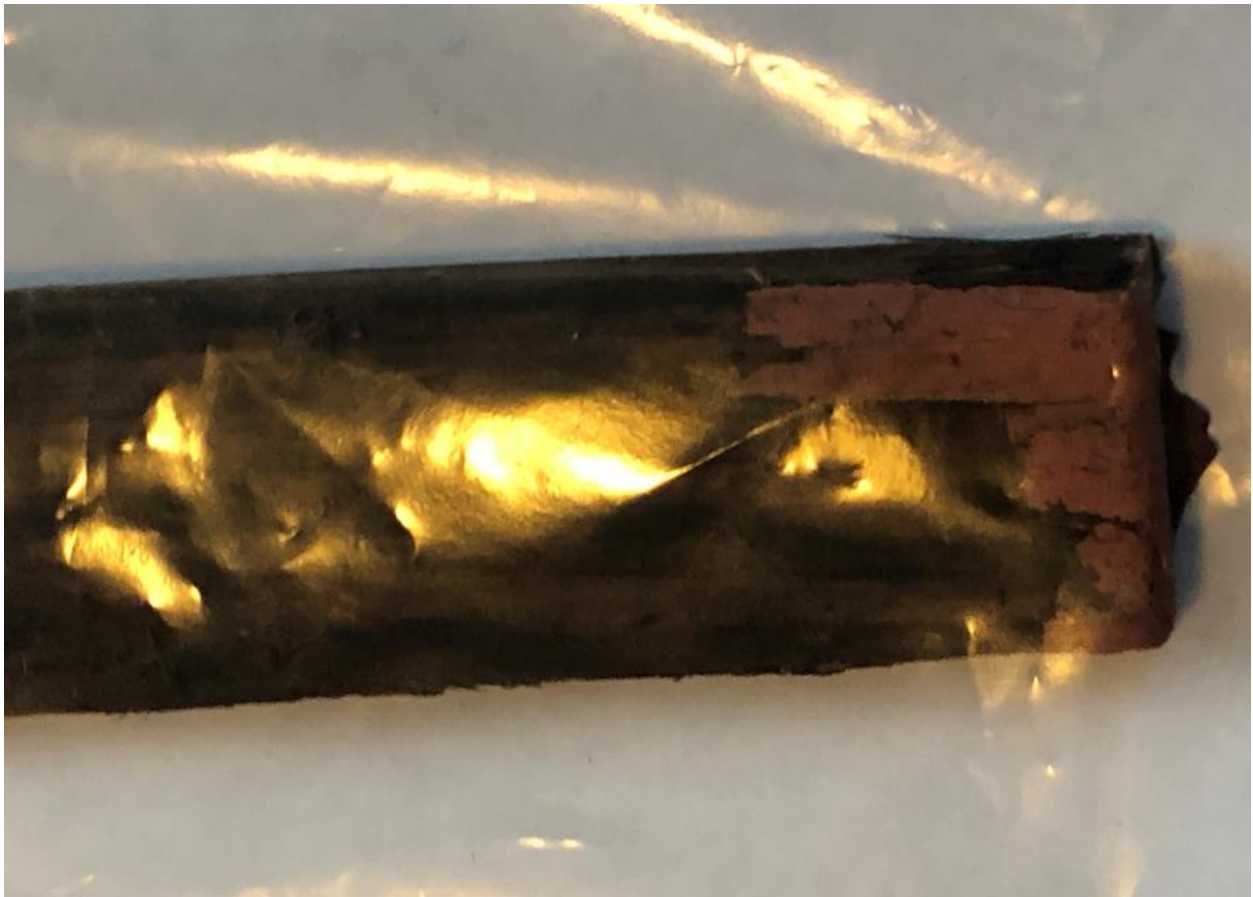
Remaining piece of rotted cottage shake from 4801 Sturtevant. This shows the extent of the rot and the the moulin rouge paint was the only coat of paint ever placed on this cottage shake. This is the sample that had the paint scraped off by Accurate Labs on 12/30/19.

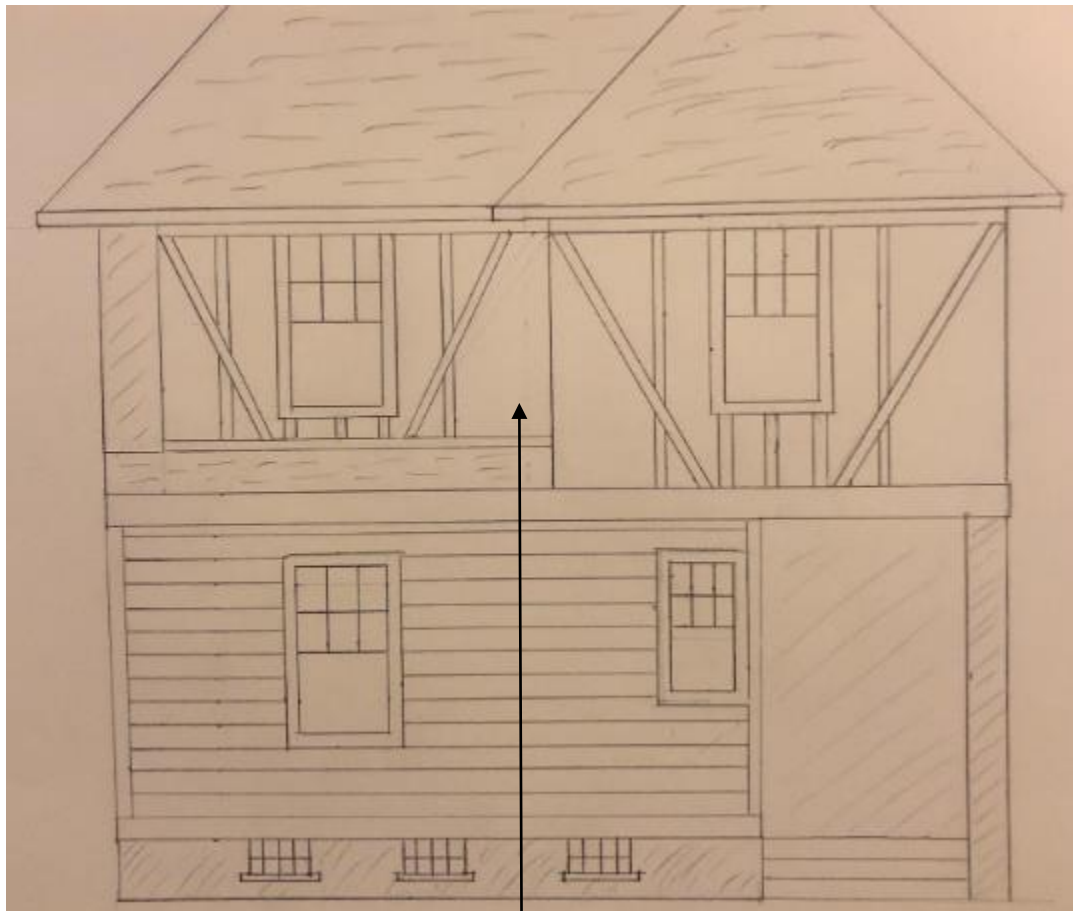
Rear Elevation - Stucco at Rear

Dragomir Cosanici and Nicholas Bozon from the State Historic Preservation Office wrote a paper titled Economic Hardship, Feasibility and Related Standards in Historic Preservation Law. This report happened to talk about stucco and wood siding. “An example of the lack of feasibility would involve a house sided with a unique circa 1920s stucco, when there was no longer any company in the state doing repair work on stucco homes. In such a case, siding the home with another historically correct material, such as wood, might be considered economically and technically feasible, whereas using stucco might not be viewed as feasible.” This shows that both stucco and wood siding are historically correct solutions. We went the extra mile to do the original stucco with half timbering at a greater cost and higher level workmanship. In addition to the previous documentation showing the cottage shakes on upper rear elevation were not original, we have the following additional documentation for the stucco.

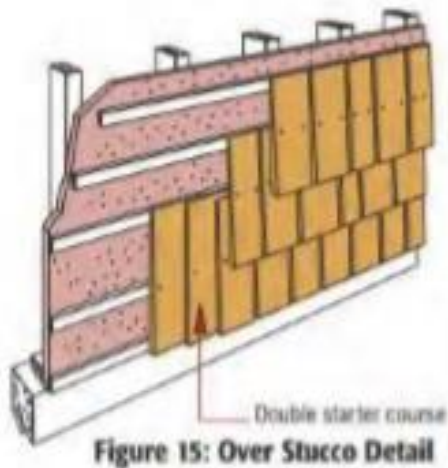
Your applicant found that wood strips were attached to the stucco to nail the shakes to. This is a practice shown below. The bottom shakes were placed directly over the lap. The second floor door was not original.

Additional proof for applicant's position on rear of house.

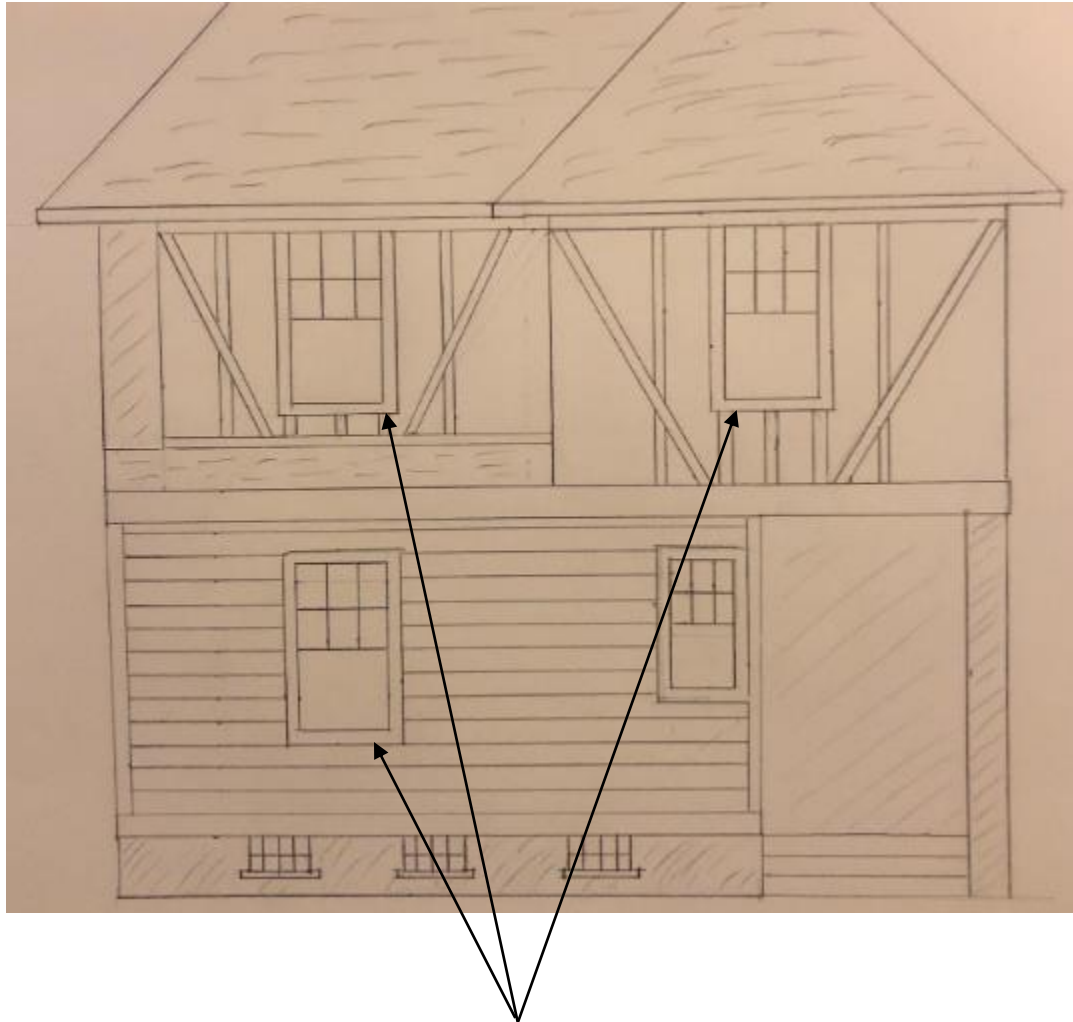
Rear Elevation – Windows and Openings

New Information – Treatment of applicants relative to Window Openings and Windows at Rear

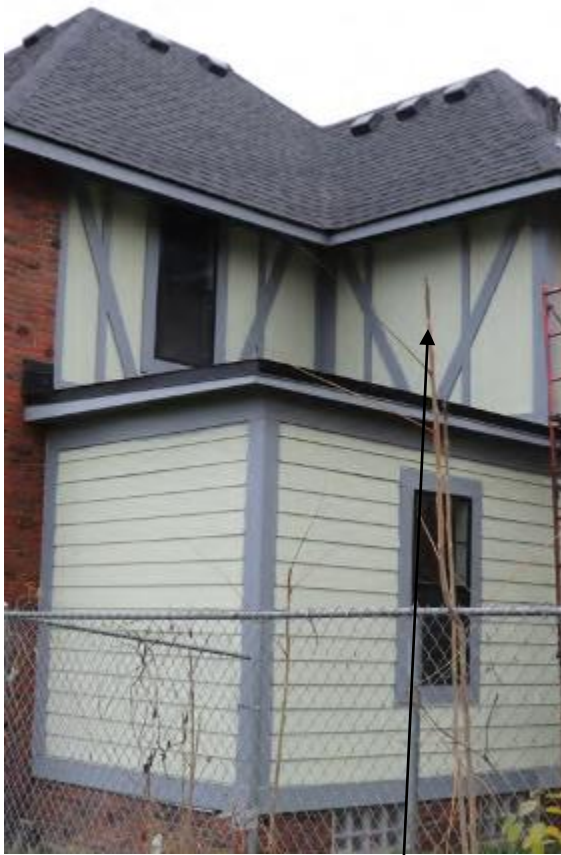
Rear Iso Elevation – Removal of Door

New Information – Treatment of applicants relative to Removal of Door at Rear

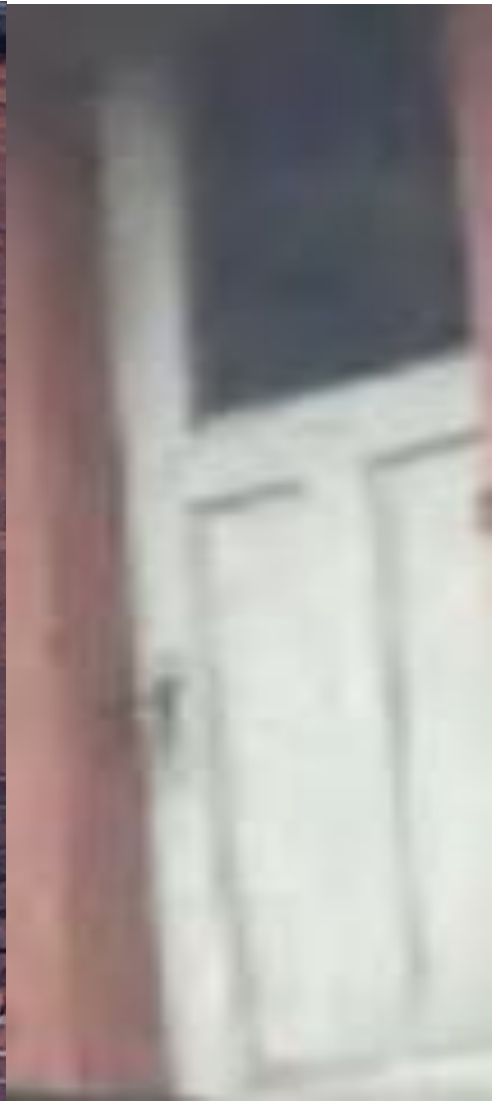
4801 Sturtevant Non Original Door

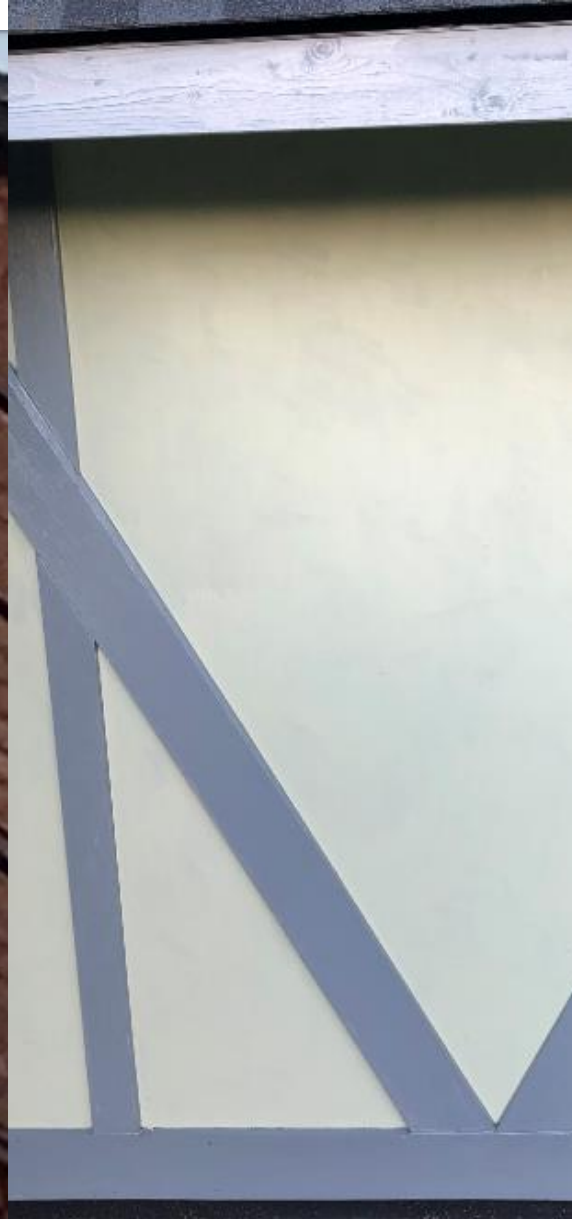
4801 Sturtevant Seamless Fill Solution

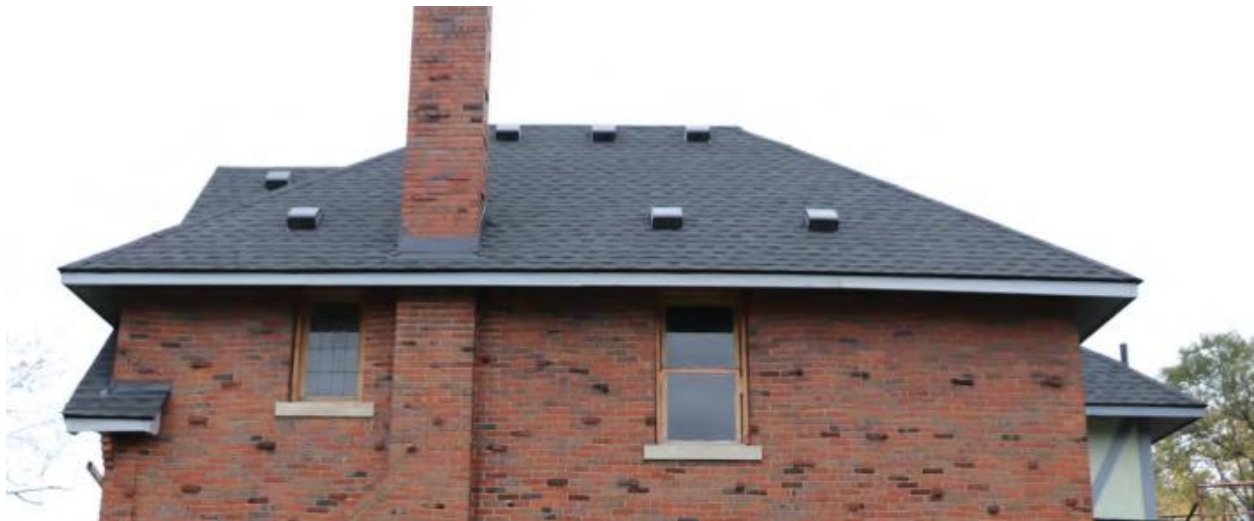
4801 Sturtevant – Applicants demonstrated the finest roofing workmanship in all of Russell Woods. The rotted roof structure was made perfectly flat, roof was properly vented, and chimney protected by cricket. Per color chart, new wood trim (facia) was painted to match the roof. The vents, chimney, flashing, and cricket were chosen to match the roof as well.

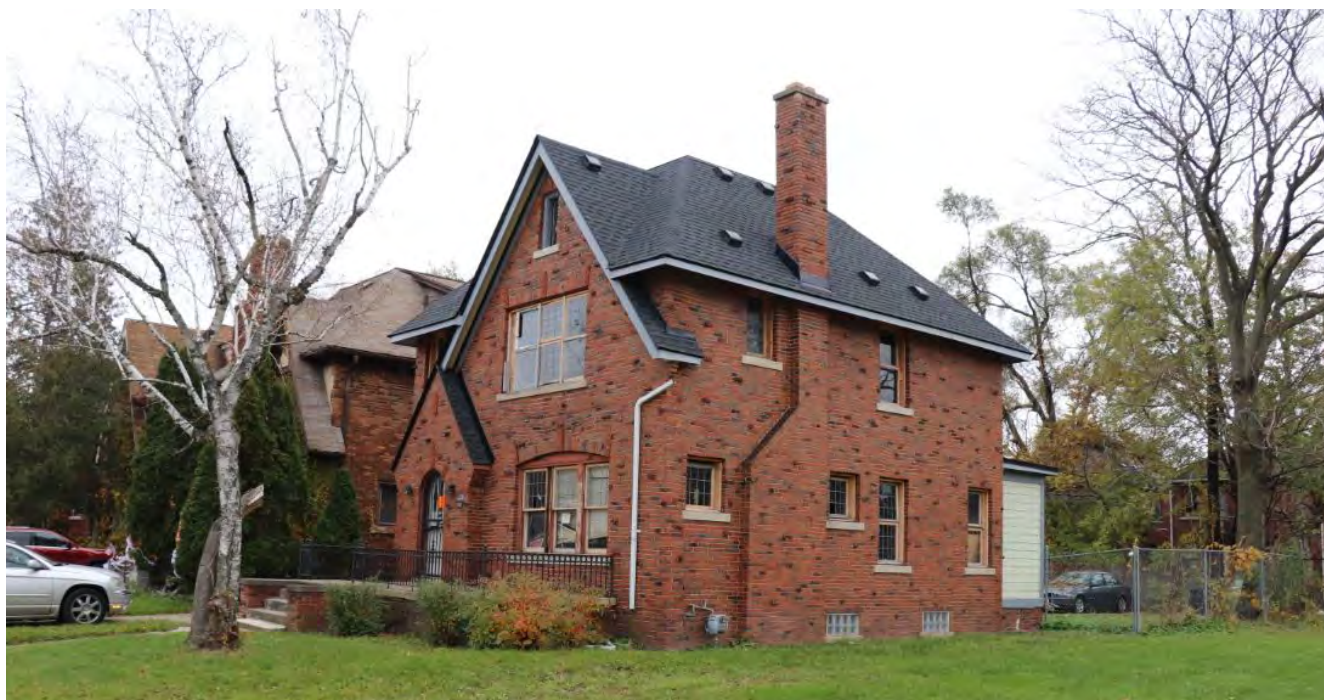
*Staff Photo: 11-6-2019*

The rear of the home features two rooms that project from the main body of the home. The second floor room is asymmetrically balanced on the first floor, creating a void that allows a doorway to a walk-out deck on to the roof of the first floor room. Prior to work completed by the applicant, the rear of the home was clad in wood shake. The shake was installed in such a style that creates a distinctively staggered, “saw-tooth” pattern, observed on several homes on Sturtevant street and throughout the Russell Woods neighborhood.

On September 23, 2019, the applicant had applied to repair the front porch by “salvaging existing materials.” The violation at this address was discovered when staff reviewed a proposal to rehab the front porch. Upon review of the photos received from the applicant, staff compared the current conditions with a previous proposal to replace the asphalt shingle roof, submitted in October of 2018. From these images, it was determined that significant exterior alterations occurred at the rear of the home. Additionally, upon further inspection of the photos, it was discovered that a majority of the windows had been altered and the window openings at the rear of the home had been reconfigured. The building department was notified that work had taken place without a permit and a stop work order was issued for the following violations:

- Removal of wood shakes at rear and replacement with painted horizontal siding at 1<sup>st</sup> story and painted half-timbering / stucco at second story
- Reconfiguration, and elimination of, window openings / door at rear
- Removal of, and alterations to, windows

It is staff's opinion that the shake siding should be restored on the back of the home, in the original "staggered" style that was removed. **This can be achieved by a tradesman experienced in historic home restoration.** Further, should the commission decide the exterior siding be removed or may remain, it should be painted a color appropriate to the architectural style of the home, from **Color Chart: D.**

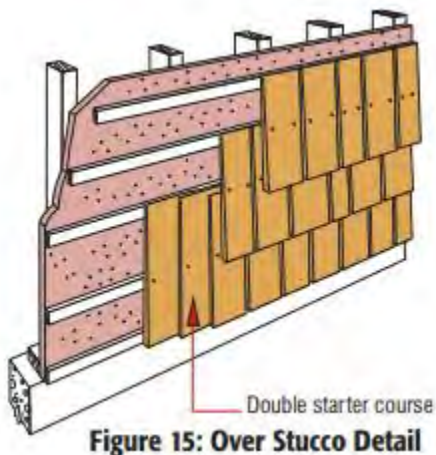
Your applicant found that wood strips were attached to the stucco to nail the shakes to. This is a practice shown below. The bottom shakes were placed directly over the lap. The second floor door was not original.

Additional proof for applicant's position on rear of house.
