STAFF REPORT: 01-22-2020 MEETING

APPLICATION NUMBER: 20-6648

ADDRESS: 8116 - 8130 KERCHEVAL/THE KERCHEVAL 3

HISTORIC DISTRICT: WEST VILLAGE

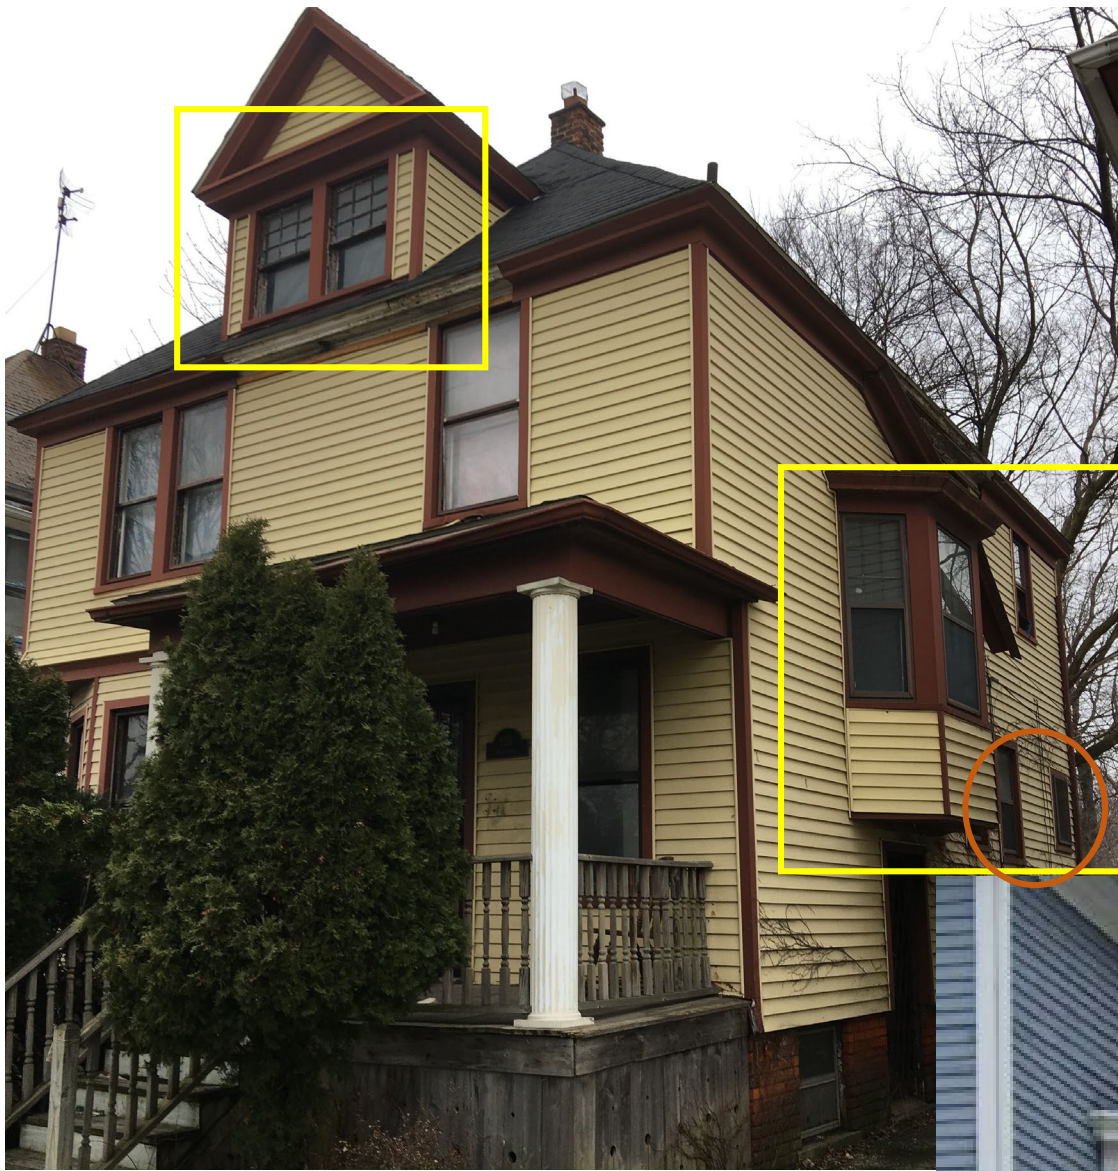
Photo comparison showing window replacements, window removals, window shortening and a new door opening.

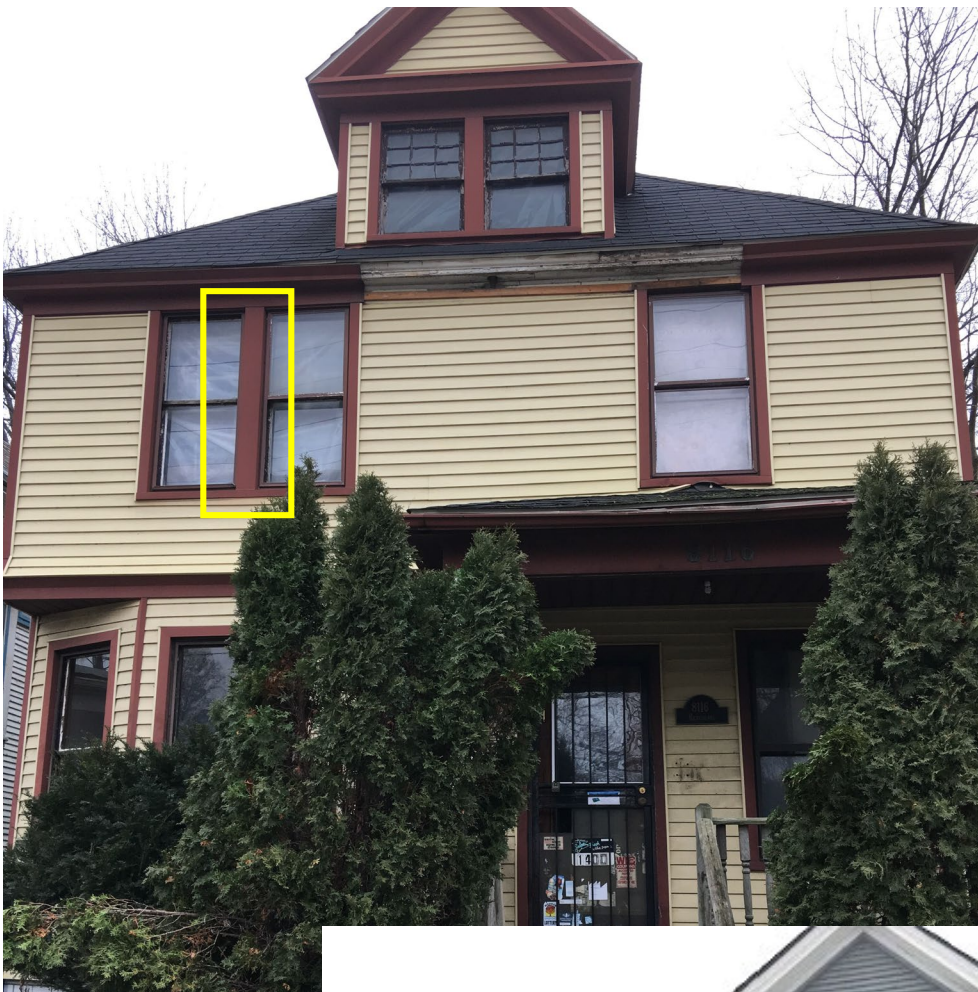
Replacement windows are inserts. It looks like the original wood mullions remained and were possibly covered in aluminum.

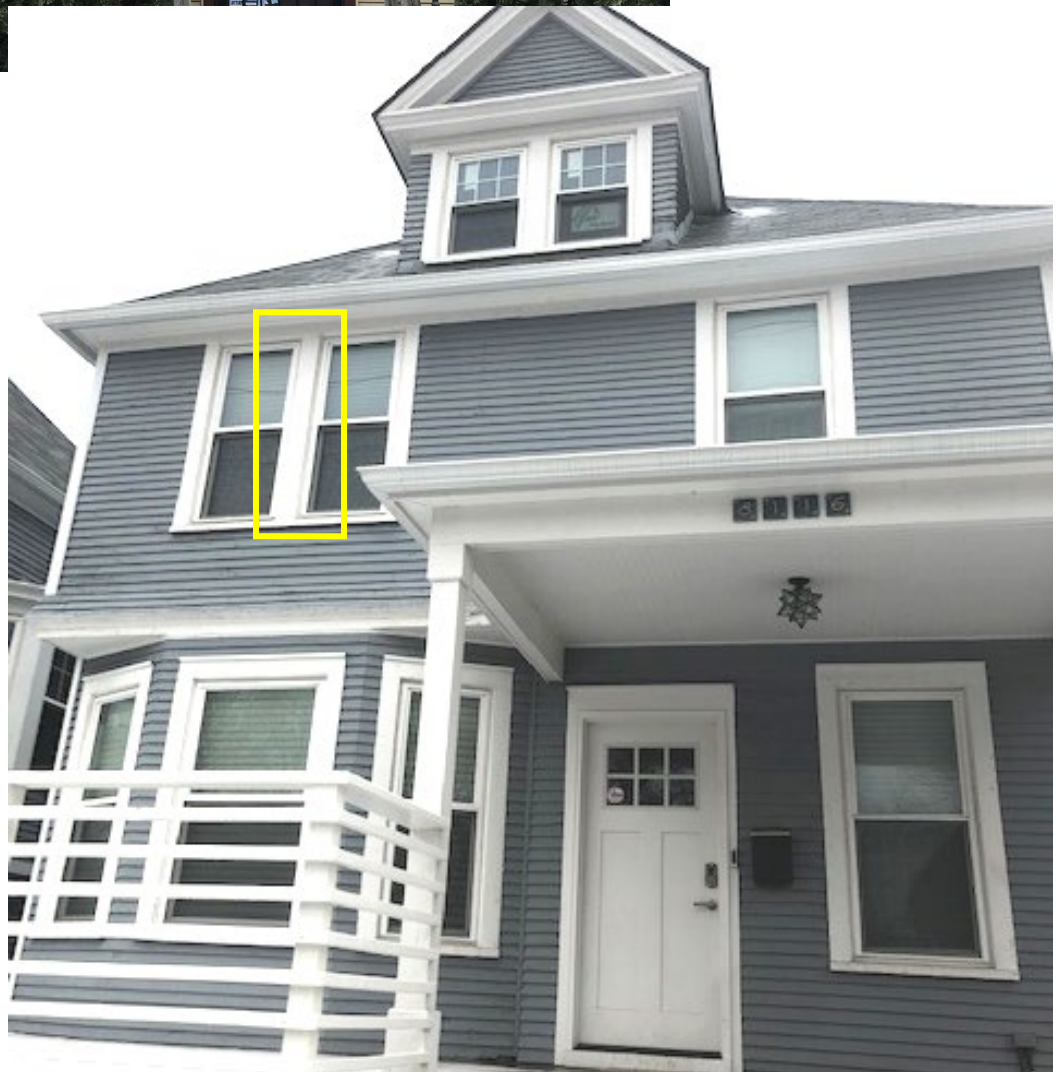
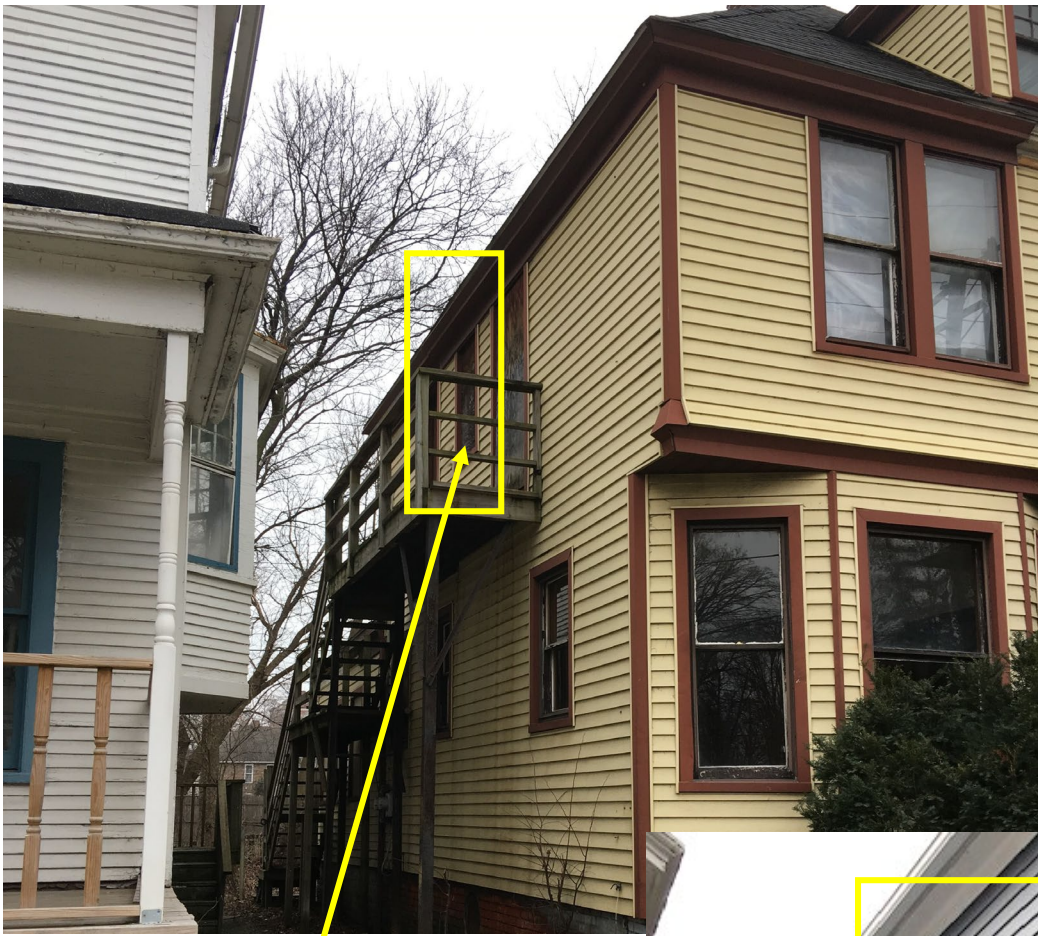
One window on the second floor was to be retained. It was fully removed.

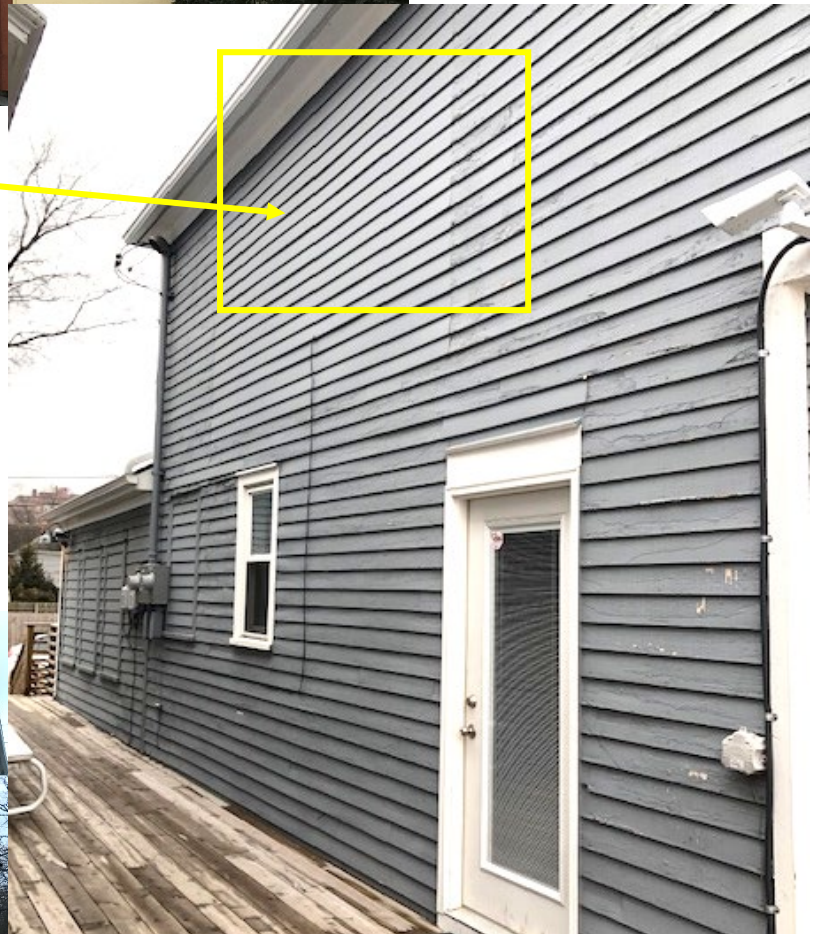
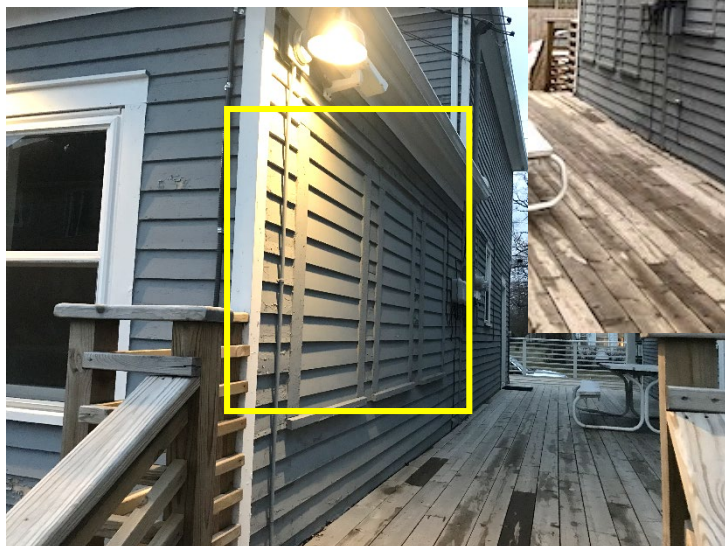
Three windows on the east elevation of 8116 Kercheval were covered with wood siding. Please refer to the plans from the 2017 review for documentation of the windows.

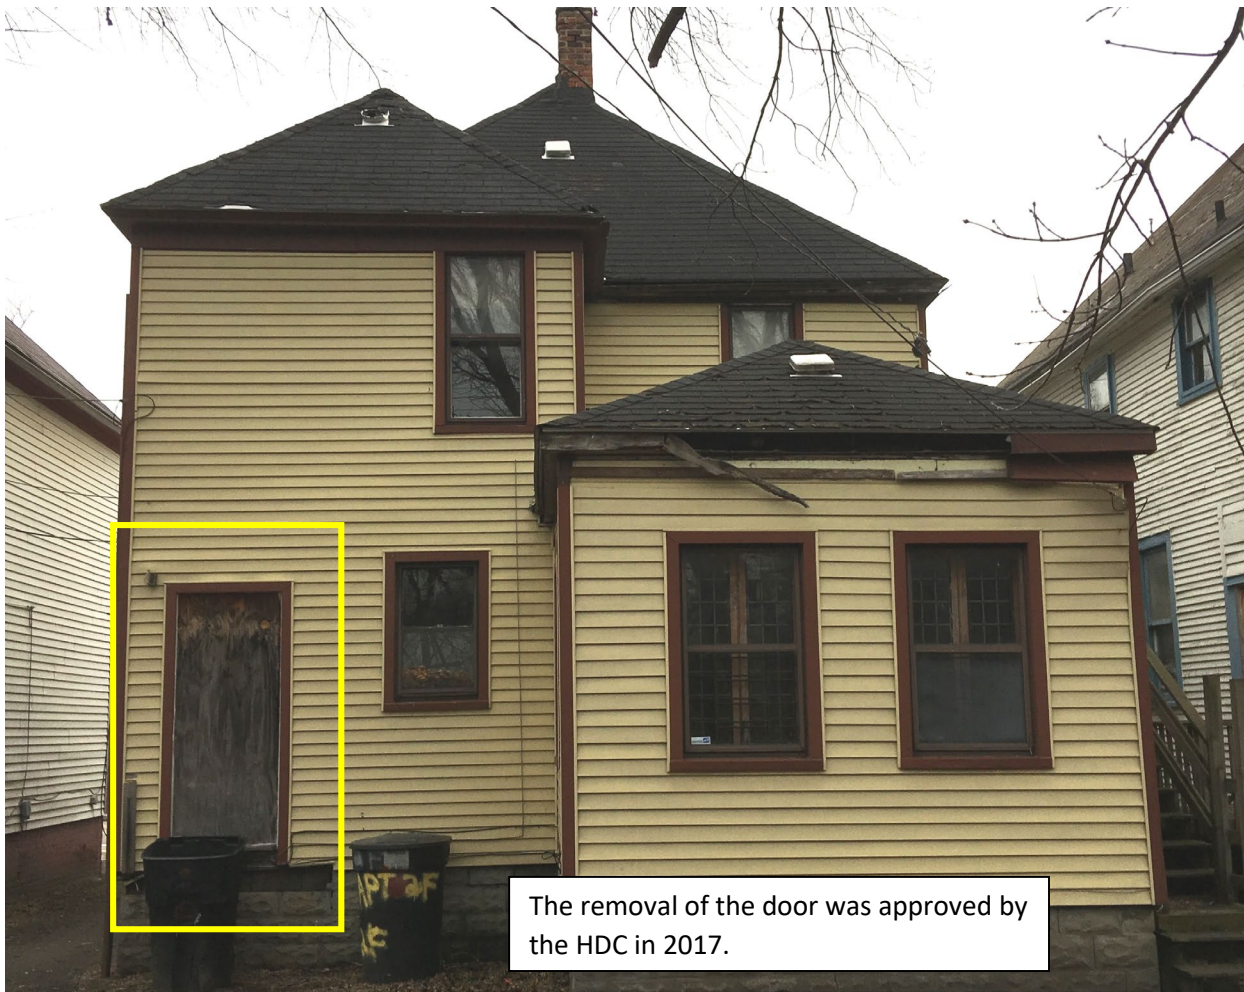
The removal of the door was approved by the HDC in 2017.

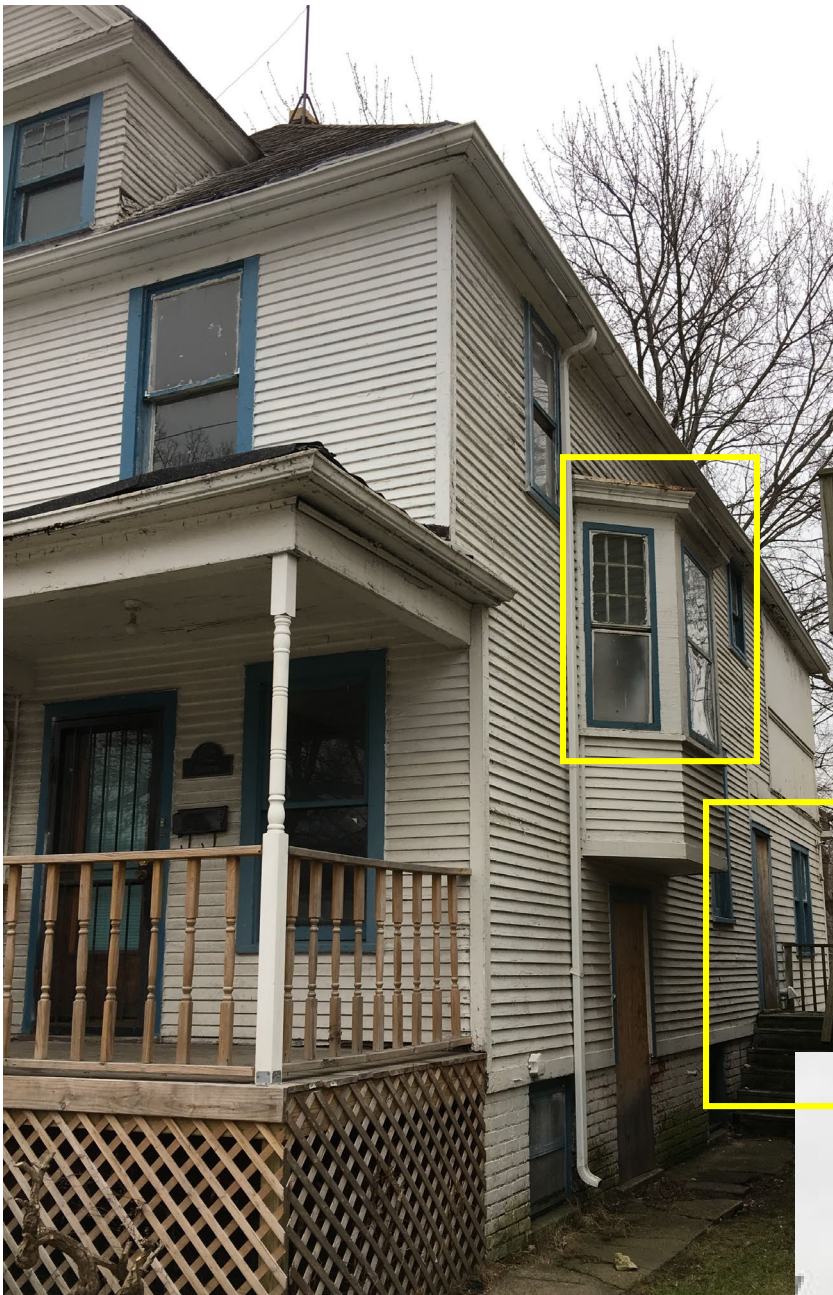
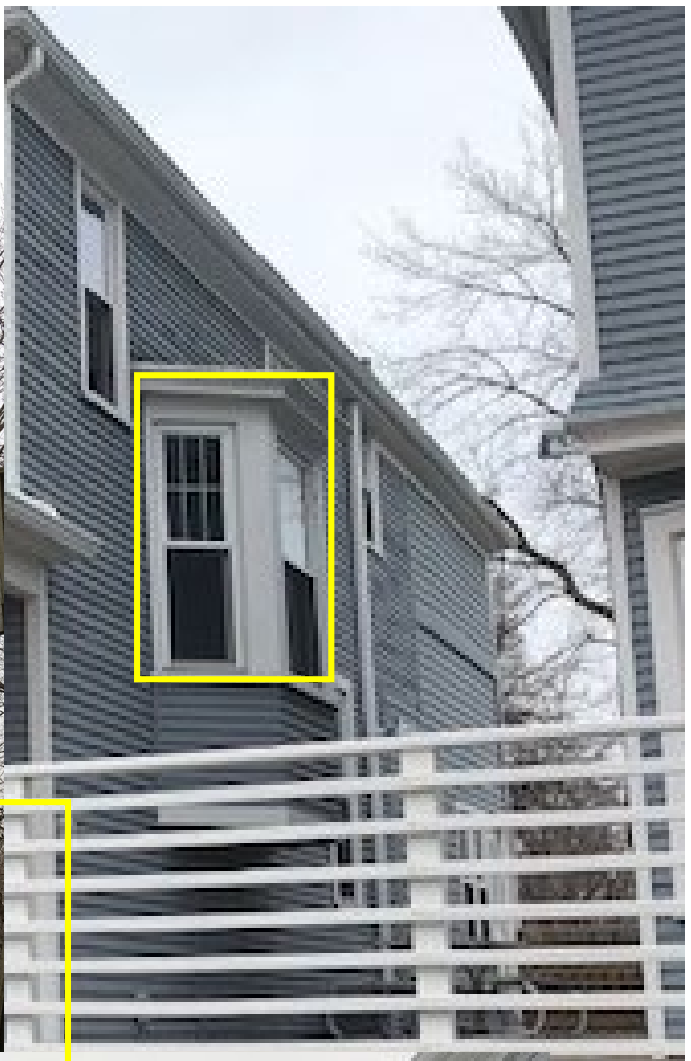
8122 Kercheval – West Elevation

Bay windows: Original vs. new

New door installed next to the side-by-side double-hung windows. Not reviewed by the HDC.

FYI - Existing door removed and covered. This was shown in the 2017 plans, as this is to be the location of the addition joining the two buildings (and ultimately would be interior space).

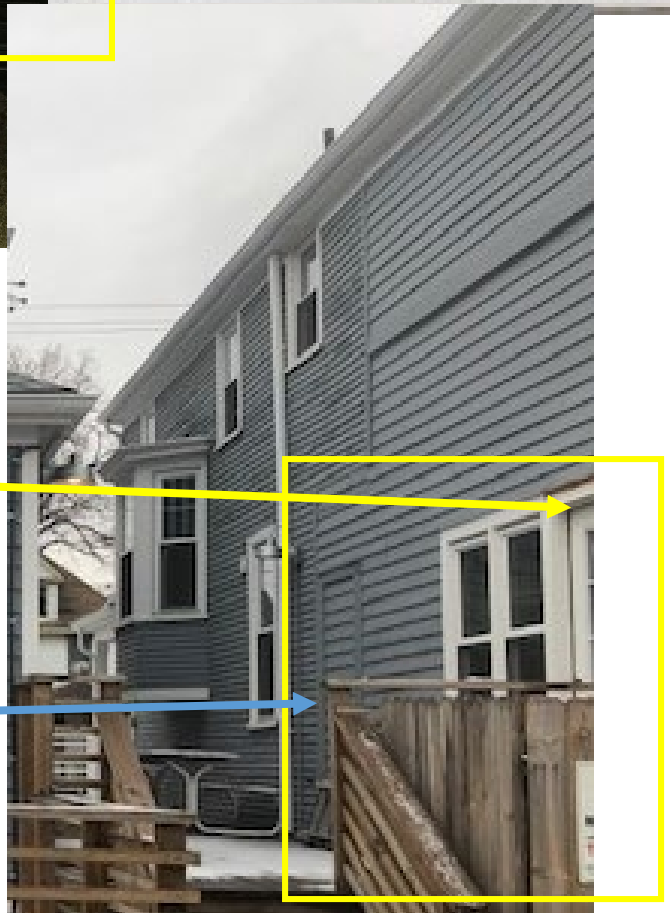
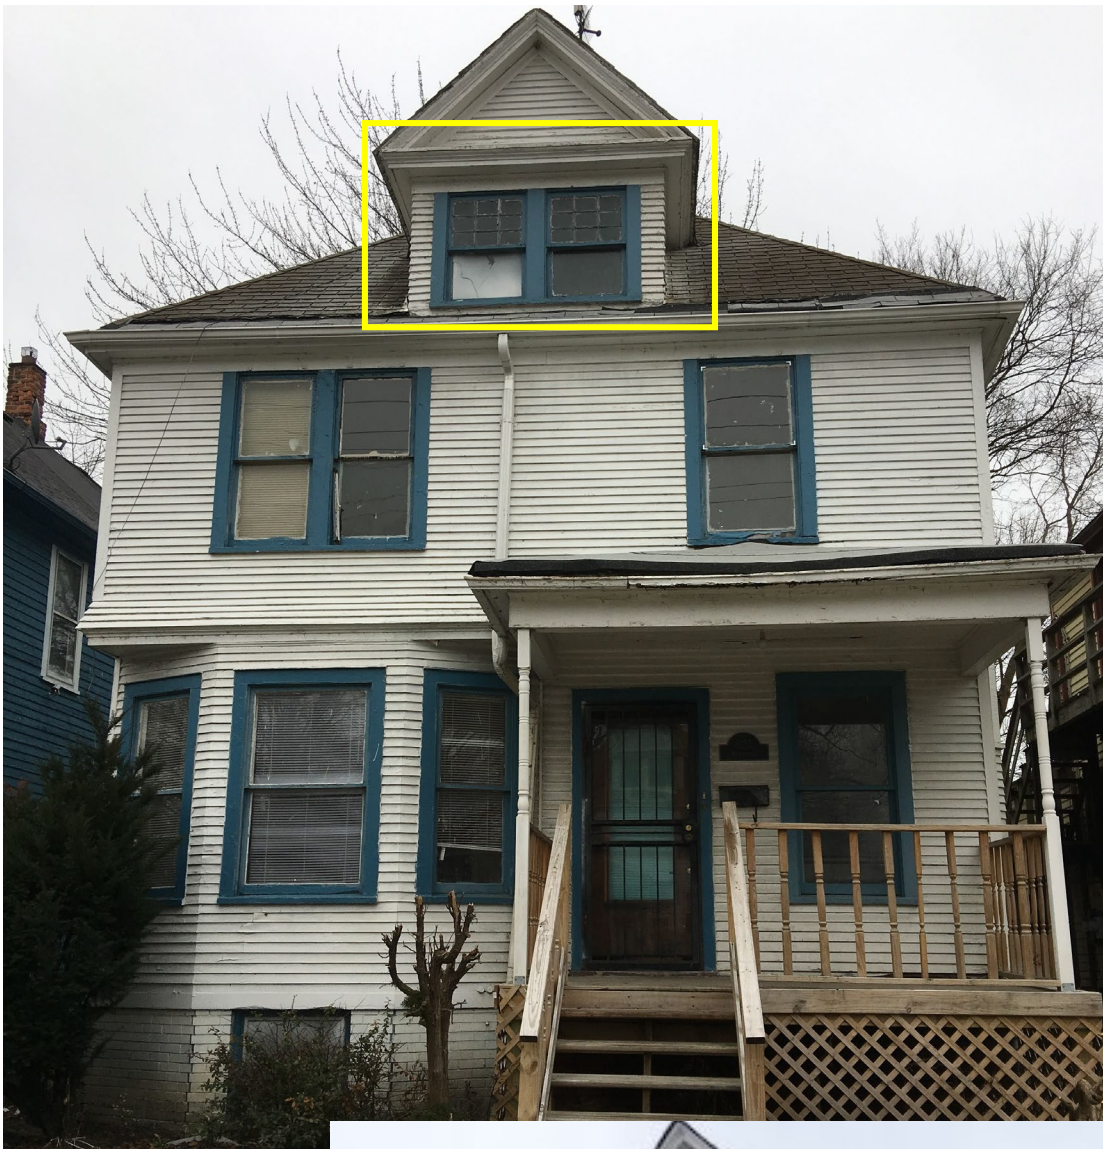
Dormer windows:
Original vs. New

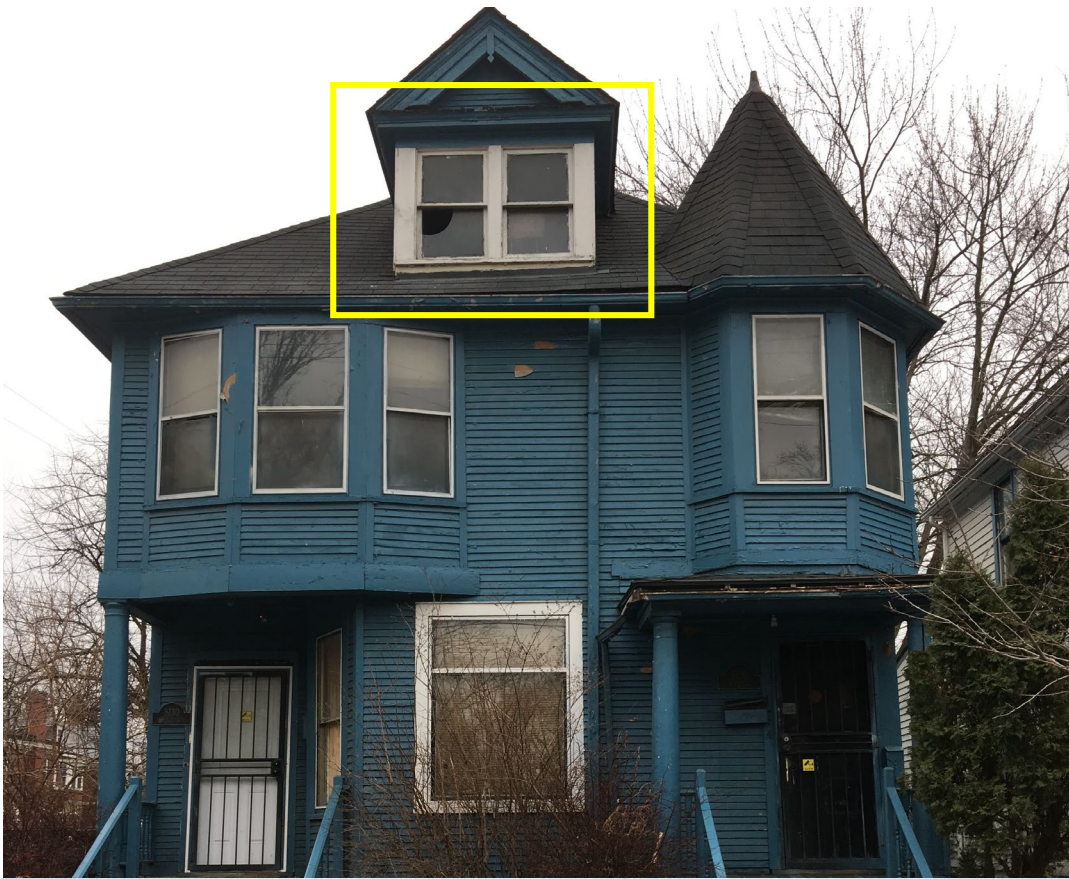
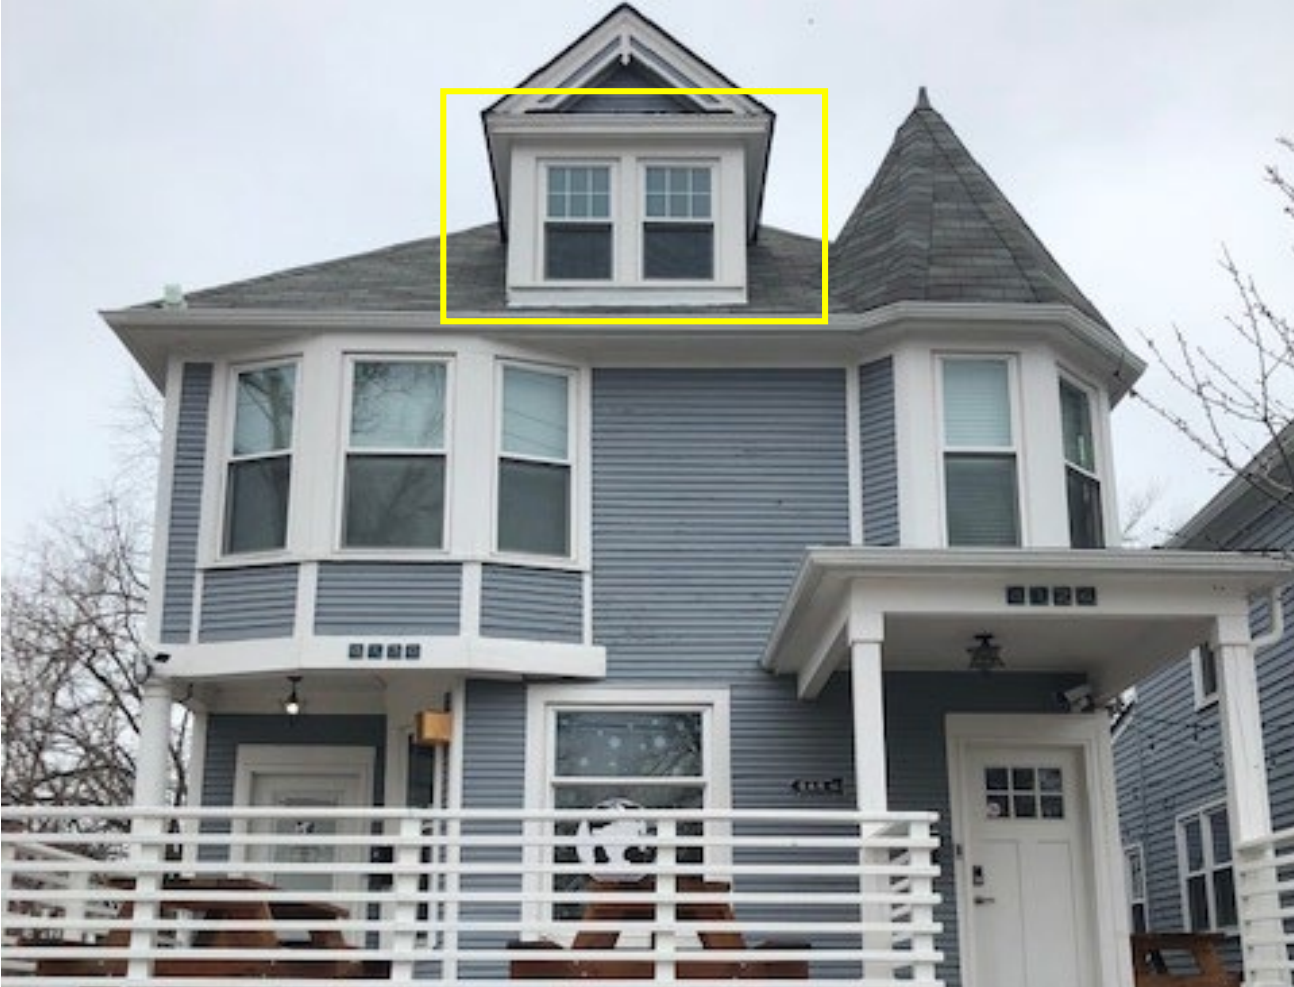
Dormer: Original vs. New

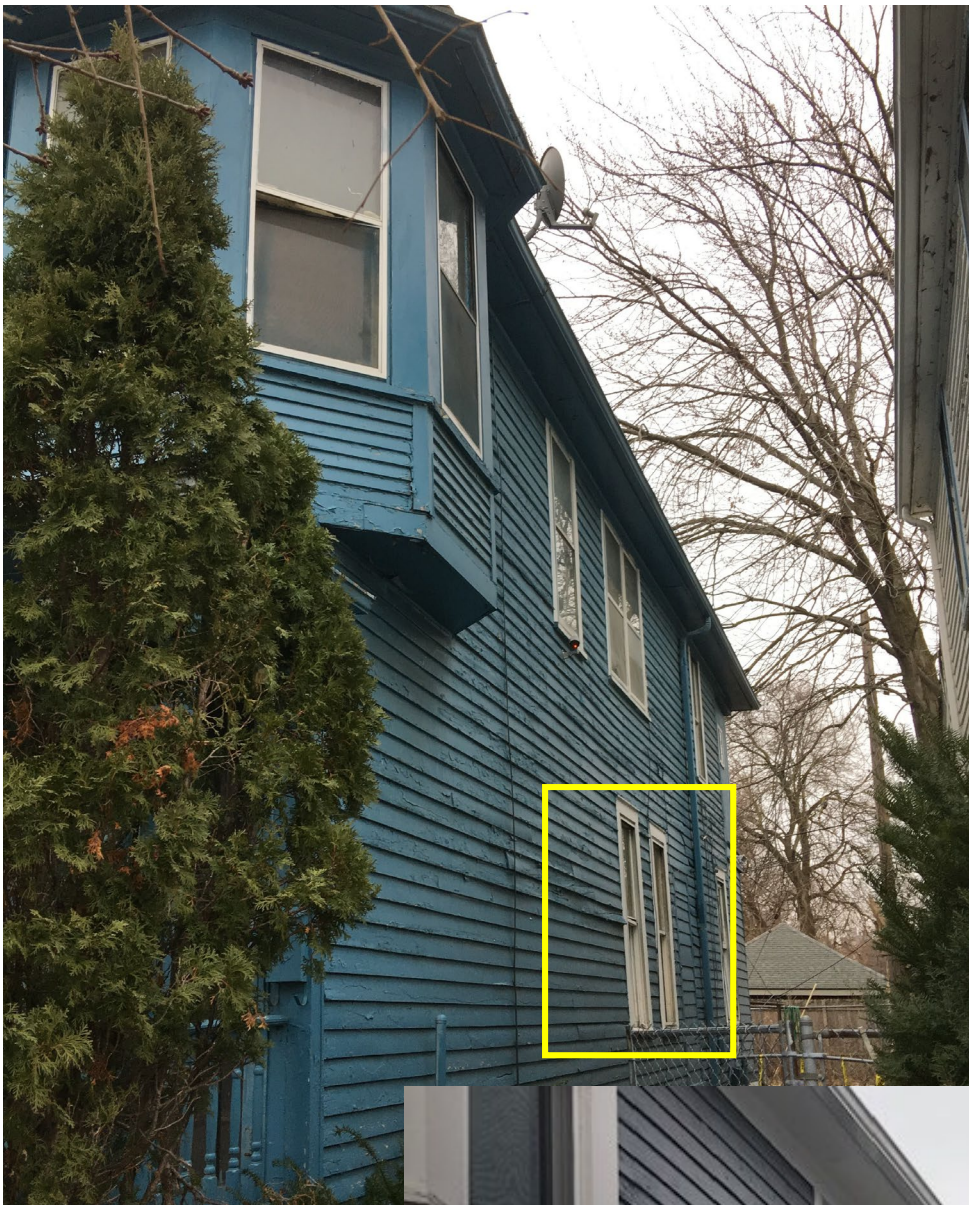
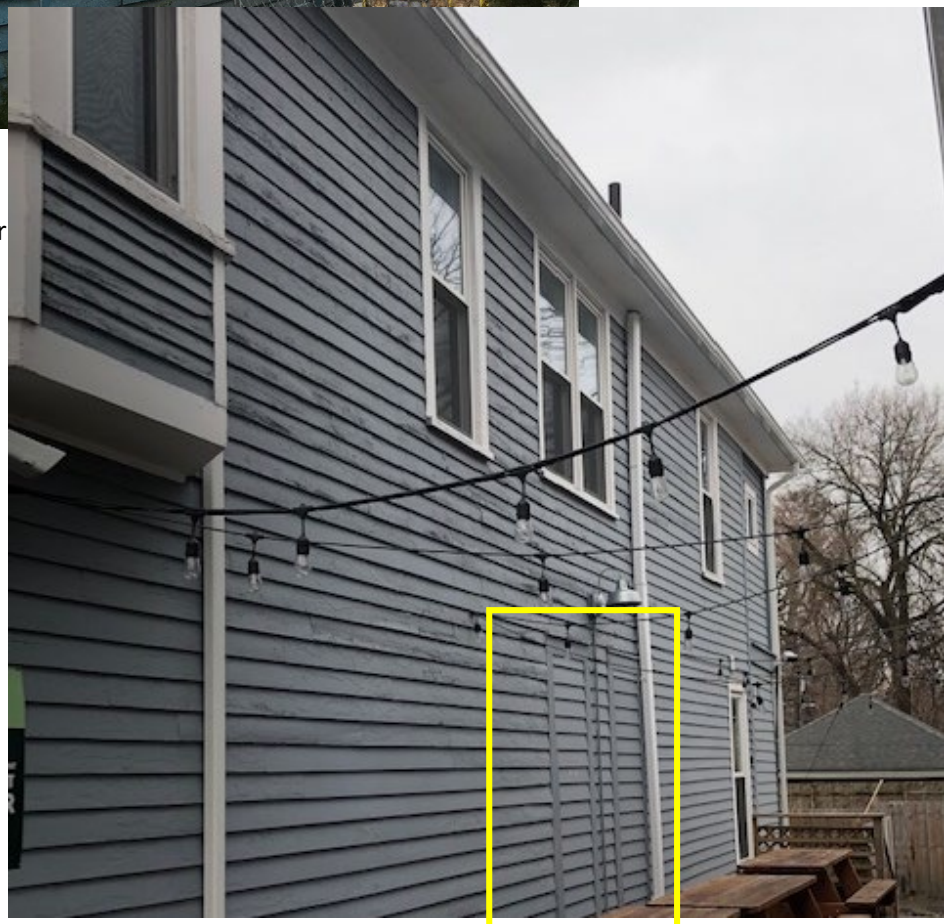
8126-8130 Kercheval

Two windows removed. However these are located where the original addition/connection was to be placed.

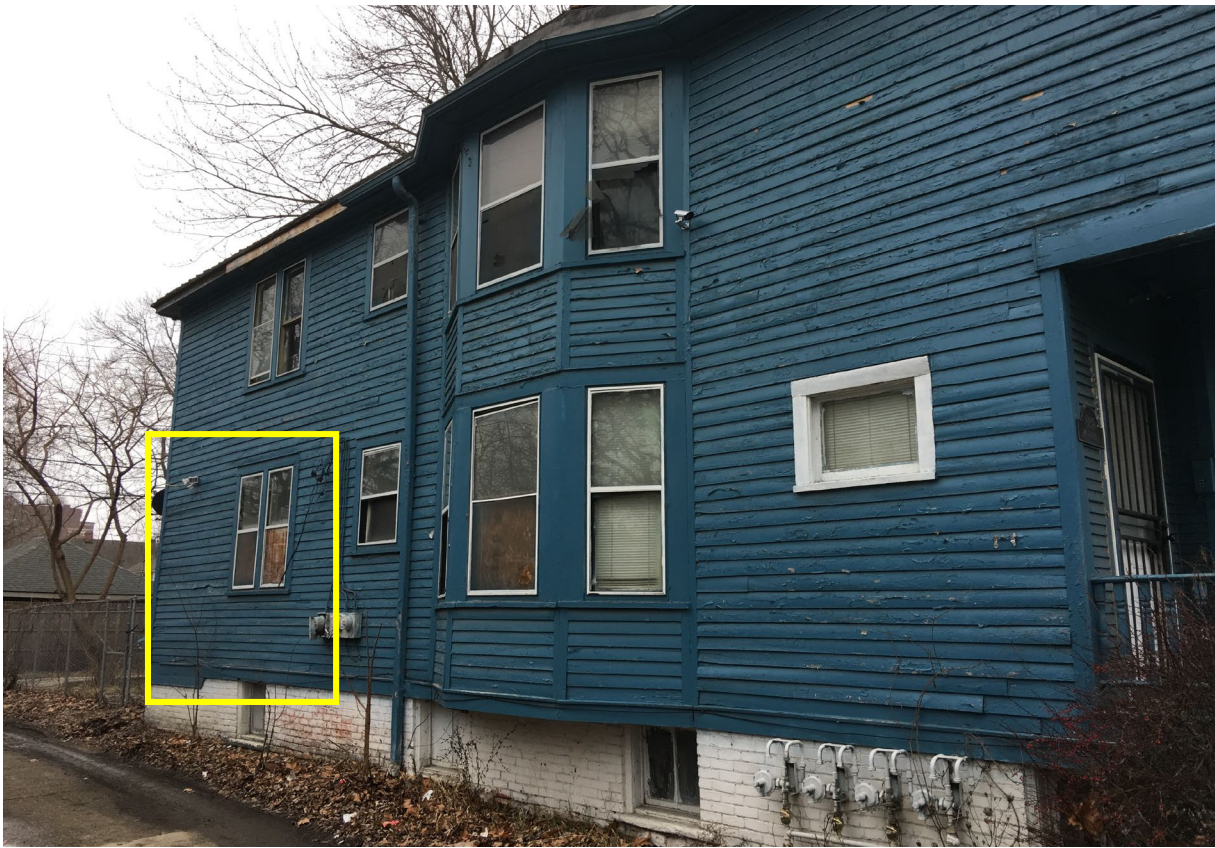
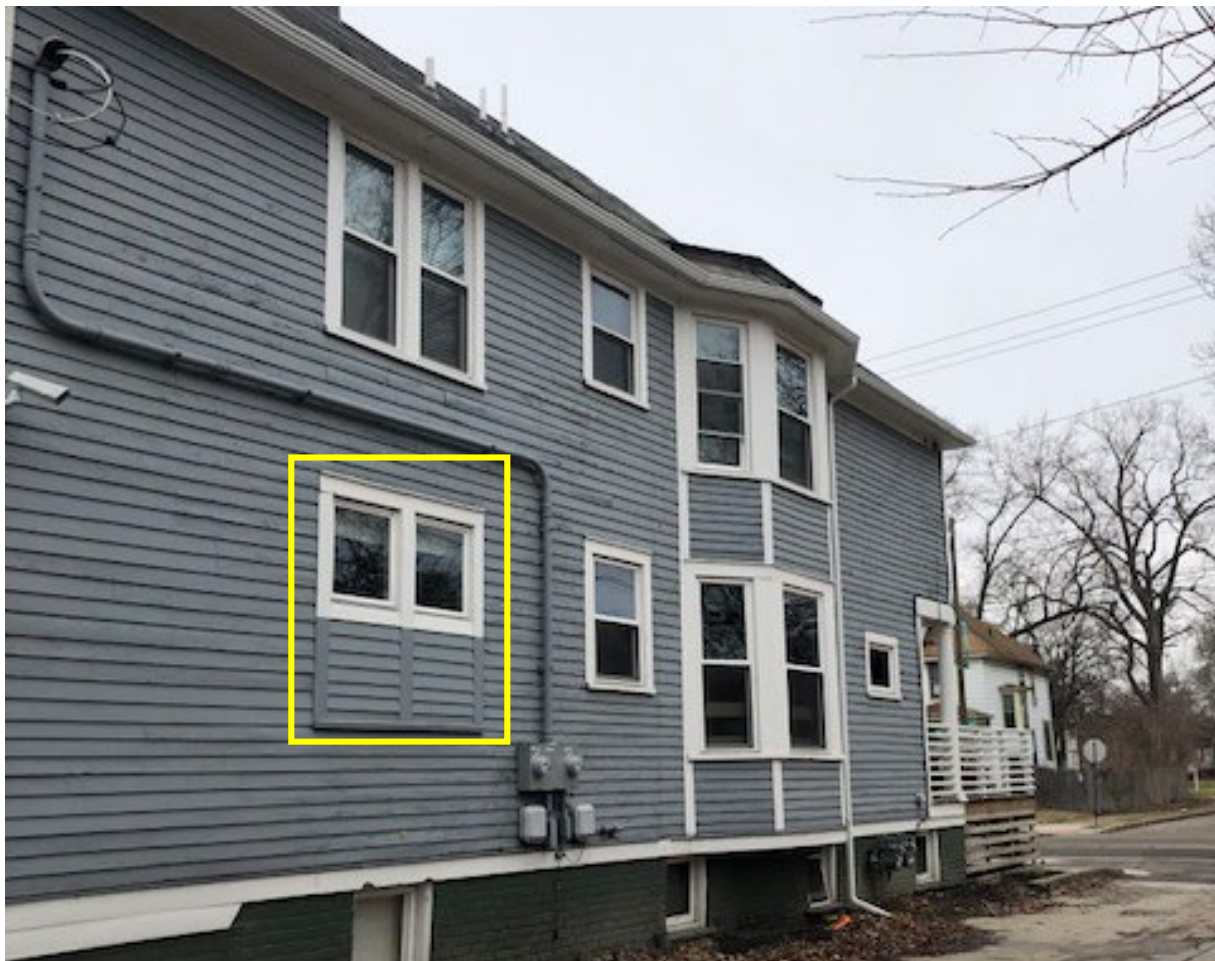
8130 Kercheval

Windows reduced in size.
