**STAFF REPORT:** 03-11-20 MEETING

**APPLICATION NUMBER:** 20-6671

**ADDRESS:** 12146 BROADSTREET

**12146 Broadstreet Avenue Residence**  
**Russell Woods-Sullivan Michigan Local Historic District**  
**Historic Structural Assessment Report**

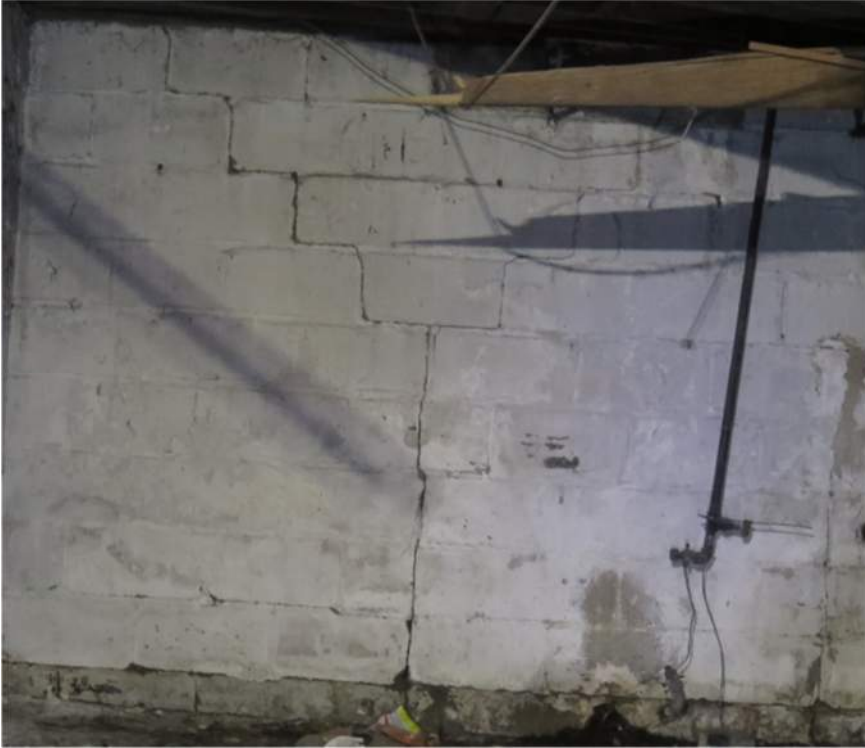
From Silman's limited observations of the foundation walls (due to obstructions from finishes), the walls appeared to be in poor condition. Water was observed to be flowing through the step cracking observed in the interior face of the west foundation wall (Figure 3). Vegetative growth was observed through the walls as well (Figure 4). The slab on grade could not be appropriately assessed due to the large amount of debris and standing water present (Figure 5).

Figure 3 Existing Condition of Foundation CMU Walls With Cracking Observed

- The large cracks in the CMU block walls at the basement need to be repaired to prevent water infiltration into the basement.

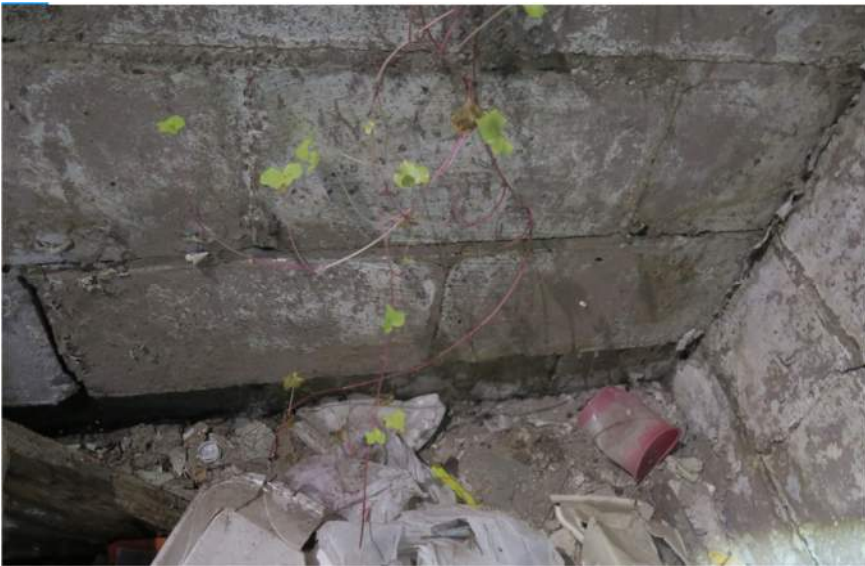
Figure 4 Vegetative Growth Through Foundation Walls

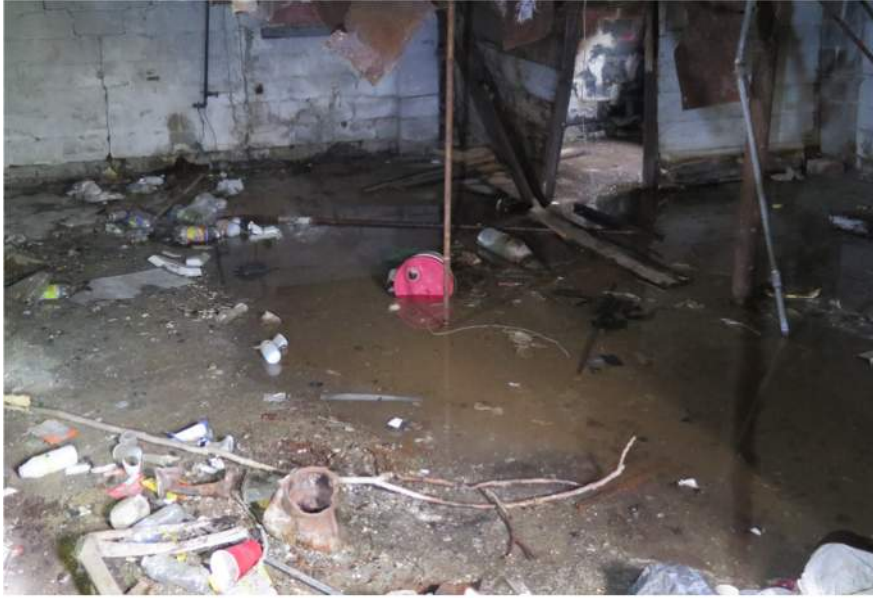
Figure 5 Basement Slab with Standing Water Observed

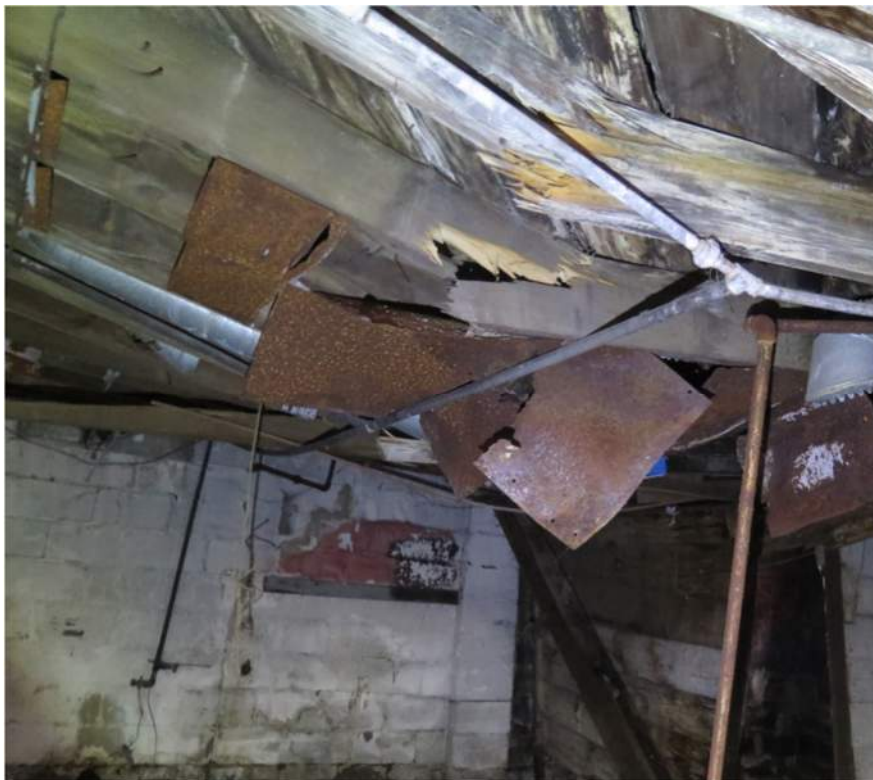
At the first floor, the wood joists within the southernmost bay were observed to have failed where a large section of the floor had collapsed (Figure 6). The central timber supporting the north-south spanning joist had appeared to failed as well, resulting in the collapse in the majority of the first floor (Figure 7). The steel pipe columns supporting the failed timber had visible signs of surface rusting, were out of plumb, and appeared to be punching through the timber (Figure 8).

Figure 6 First Floor Failed Joist Framing

- All the interior framing observed appeared to be collapsing inward, likely due to the failure of the first-floor framing. The interior bearing line at the first floor had failed which compromises the support of the remaining framing above. The entire framing of the first floor, second floor, attic, and likely the roof needs to be replaced. The exterior bearing walls that were visible also exhibited severe fire damage and would need to be replaced. Entrance to the house should be restricted to the unsafe nature of all the framing.
- The front porch should be removed and replaced if desired.

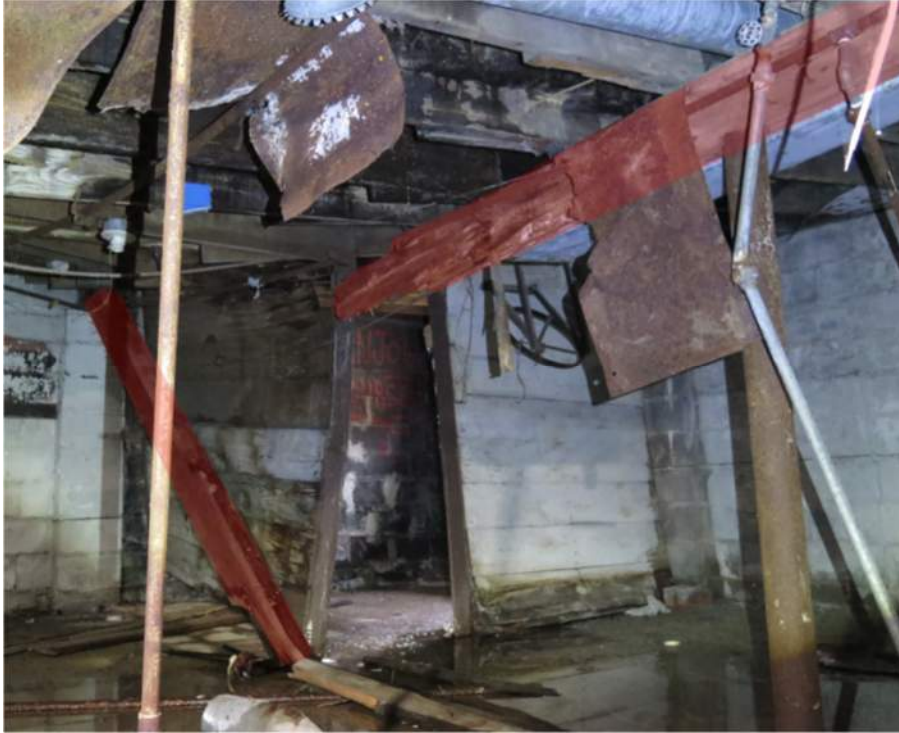
Figure 7 First Floor Failed Central Timber (Red)

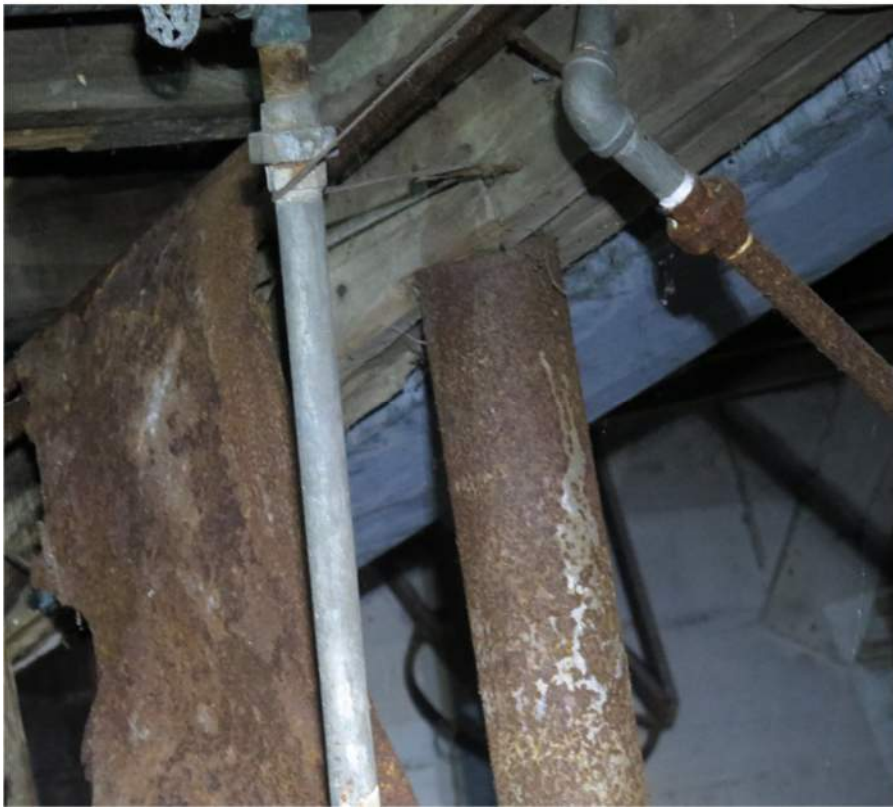
Figure 8 Apparent Punching Failure of Post Through Timber

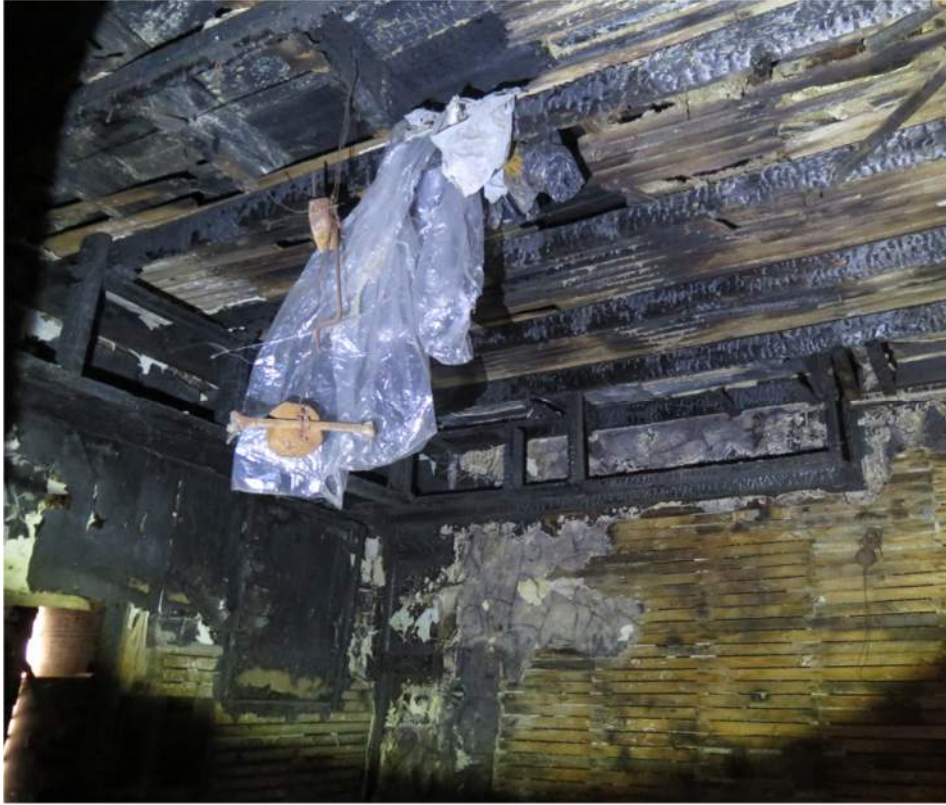
From Silman's limited observation due to the collapse of the first floor, the wood joist and supporting wood stud bearing walls at the second floor appeared to be in poor condition. Extensive fire damage of the joists was observed (Figure 9 to Figure 11). The entire middle portion of the building appeared to be collapsing inward, in the same location of the collapsed first floor below (Figure 10).

Figure 9 Second Floor Framing with Extensive Fire Damage

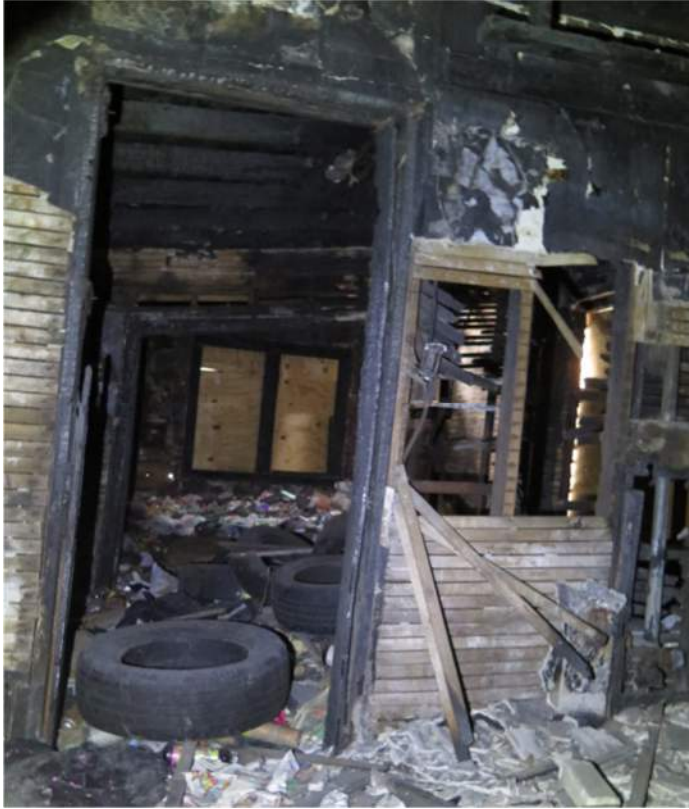
Figure 10 Wood Stud Walls with Extensive Fire Damage

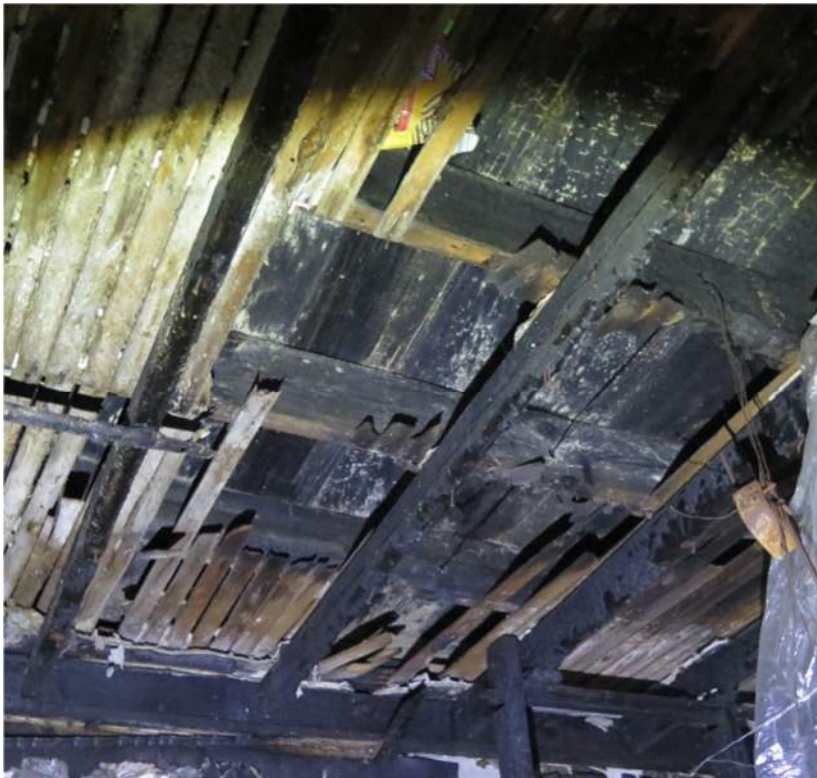
Figure 11 Second Floor Joist Framing with Extensive Fire Damage

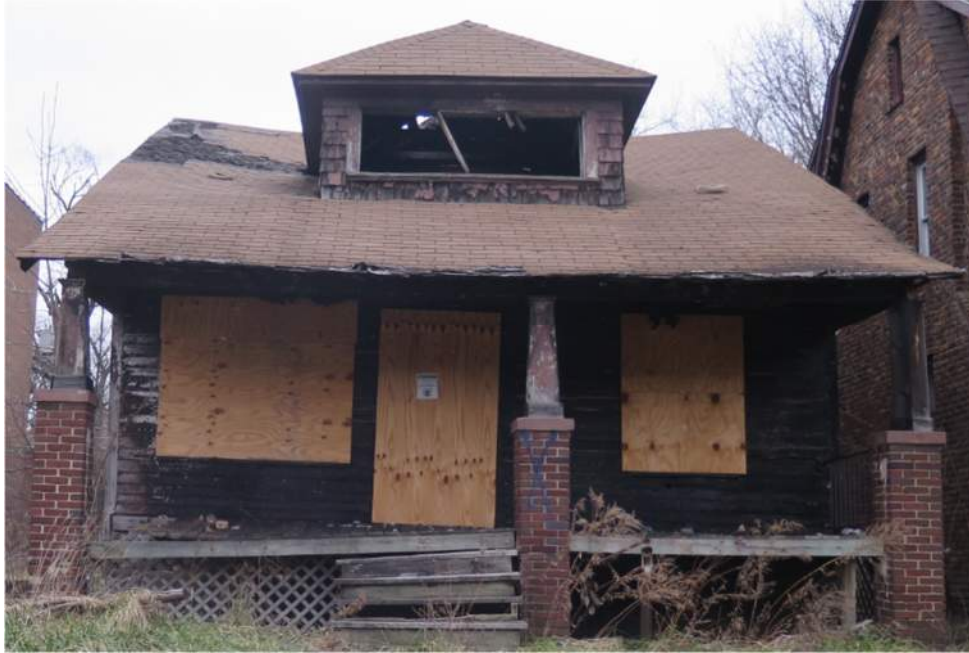
Figure 12 West Facade

Due to the collapse at the first floor, there was no access to the stairway leading to the floor above. As a result, observation of the roof / attic framing from the interior was prohibited. From the exterior, the roof framing was concealed by the roofing assembly but appeared to be sagging inward, likely due to the collapsed framing support found at the interior (Figure 12 & Figure 21).

The wood façade was observed to be in poor condition, typically. Fire damage was observed typically around window/door openings and throughout most of the front porch area (Figure 12, Figure 15, & Figure 18). In areas, where fire damaged was not apparent, extensive weathering was observed indicated by the extensive paint deterioration (Figure 19 & Figure 20). Ivy growth was observed at the north façade (Figure 18).

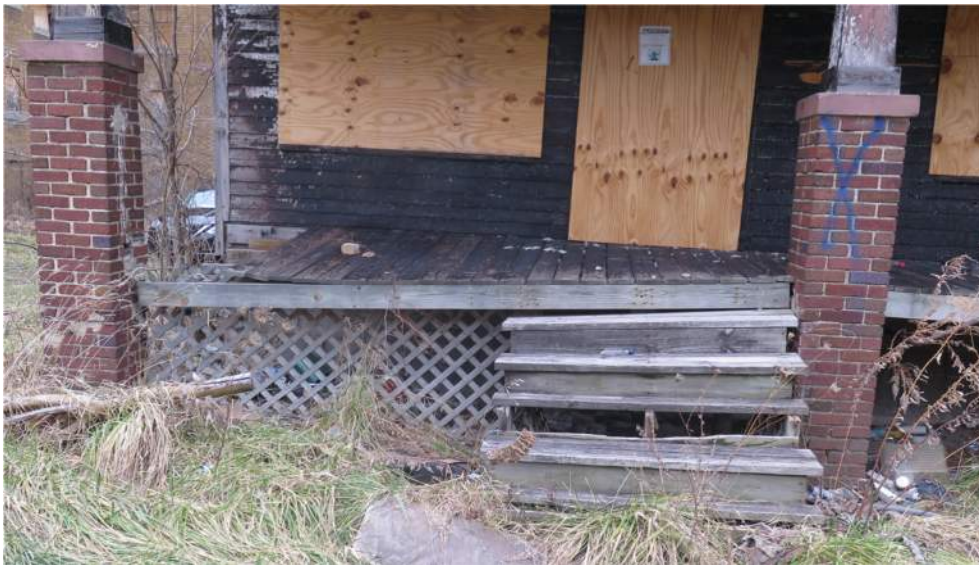
The front porch was observed to be in poor condition as well. Severe warping of the floor was observed (Figure 13). The primary joist supporting the porch were observed to be unsupported at their end conditions (Figure 14). At the upper sections of the porch, the spandrel beam spanning between wood post appeared to be sagging (Figure 16). The southern most wood post appeared to have shifted and is now out of plumb and alignment with the brick masonry pier below (Figure 17).

Figure 13 Front Porch

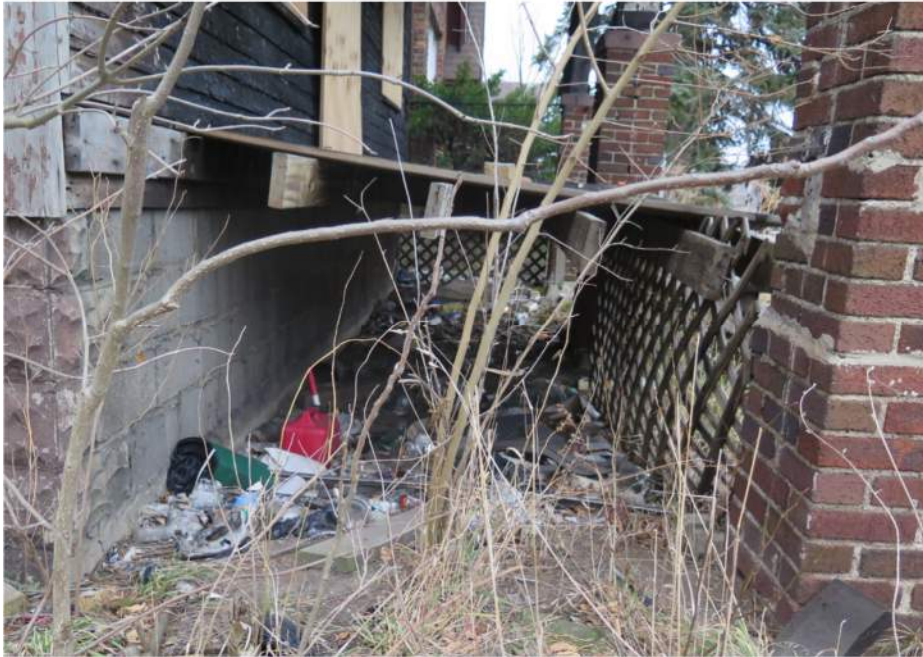
Figure 14 Side View of Front Porch

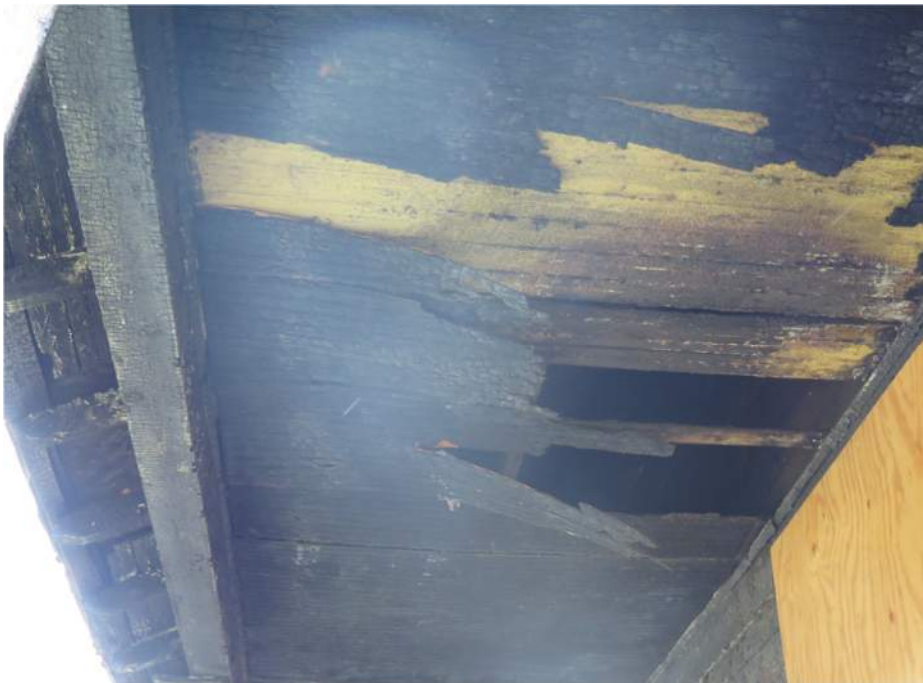
Figure 15 Underside of Porch Framing with Extensive Fire Damage

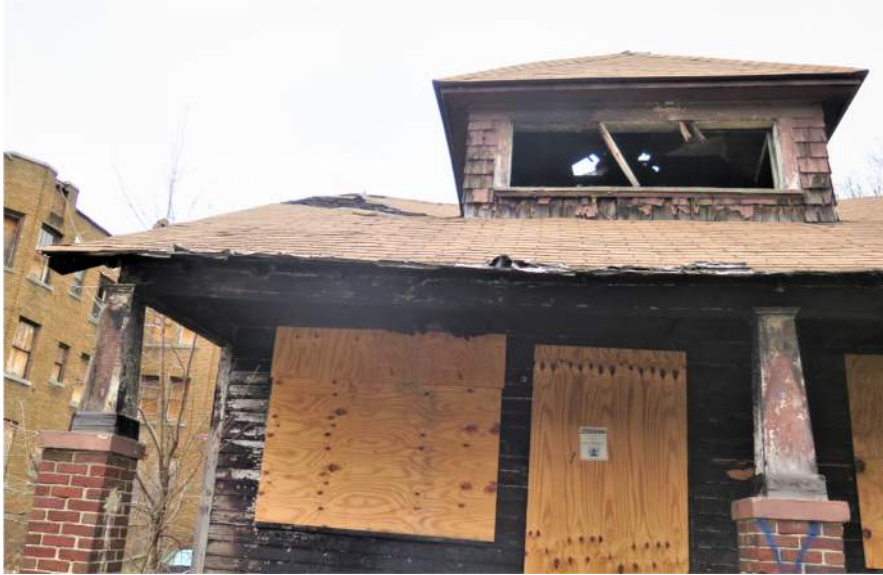
Figure 16 Apparent Sagging of Roof and Spandrel Beam

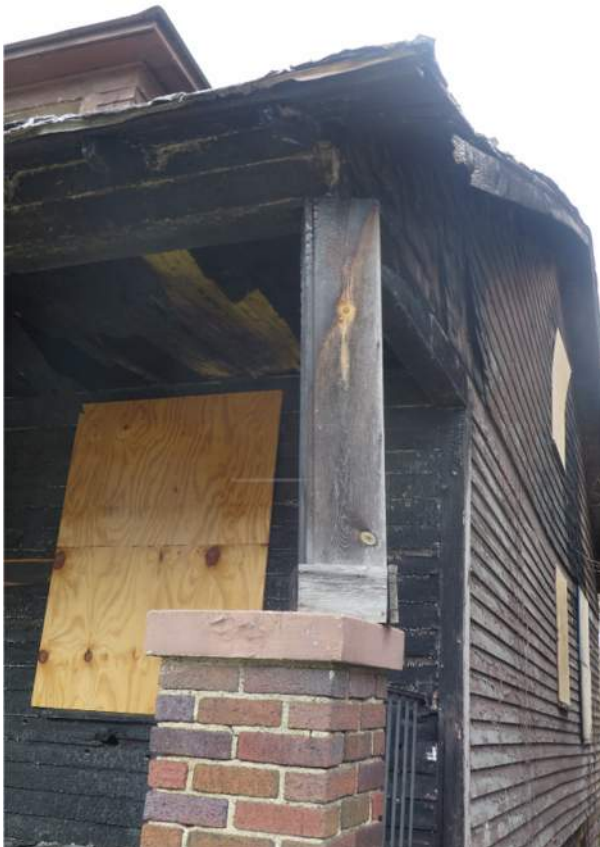
Figure 17 Wood Post Roof Support Out of Alignment

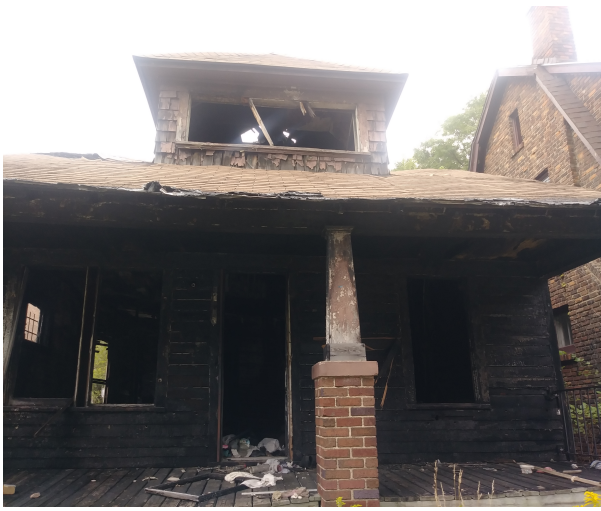
EA A - fire damage/unsafe

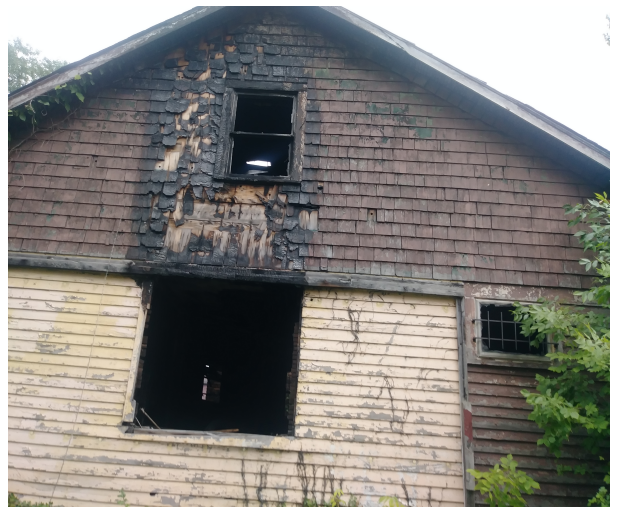
EA B - fire damage/unsafe

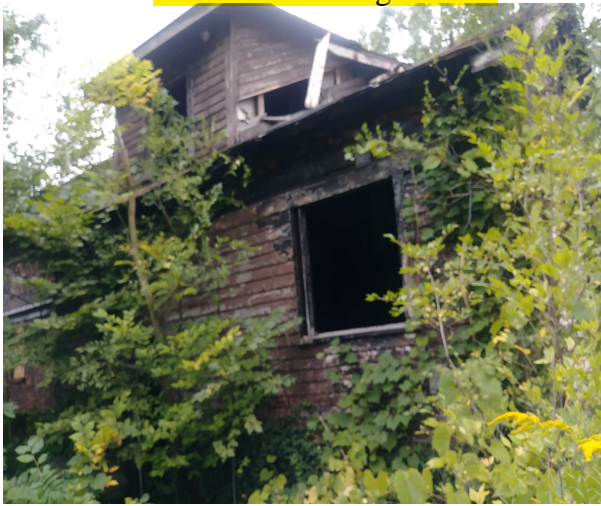
EA C - fire damage/unsafe

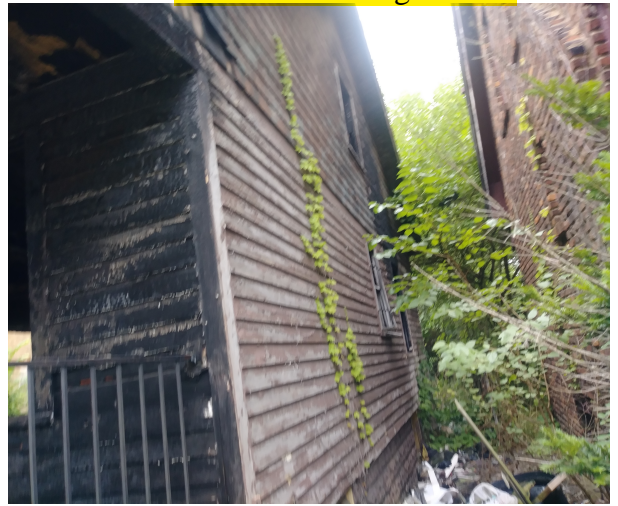
EA D - fire damage/unsafe

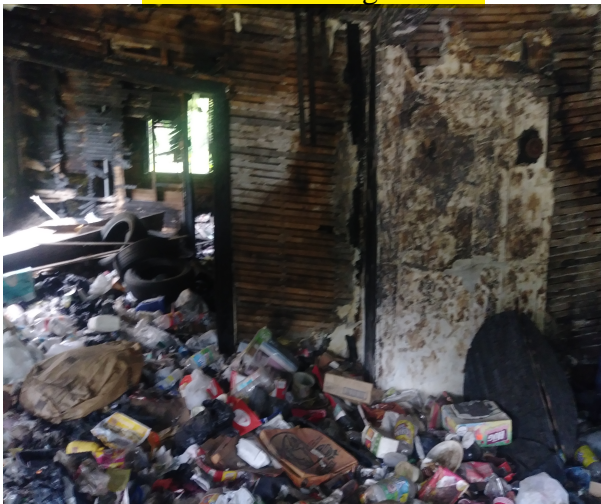
FS 01- fire damage/unsafe
