STAFF REPORT 11-13-2019 MEETING
APPLICATION NUMBER 19-6464
ADDRESS: 4801 STURTEVANT
HISTORIC DISTRICT: RUSSELL WOODS - SULLIVAN
APPLICANT: WAYNE GROLEAU
DATE OF APPLICATION: 9-23-2019
DATE OF VIOLATION: 9-26-2019
DATE OF STAFF VISIT: 11-6-2019

PREPARED BY: B. CAGNEY

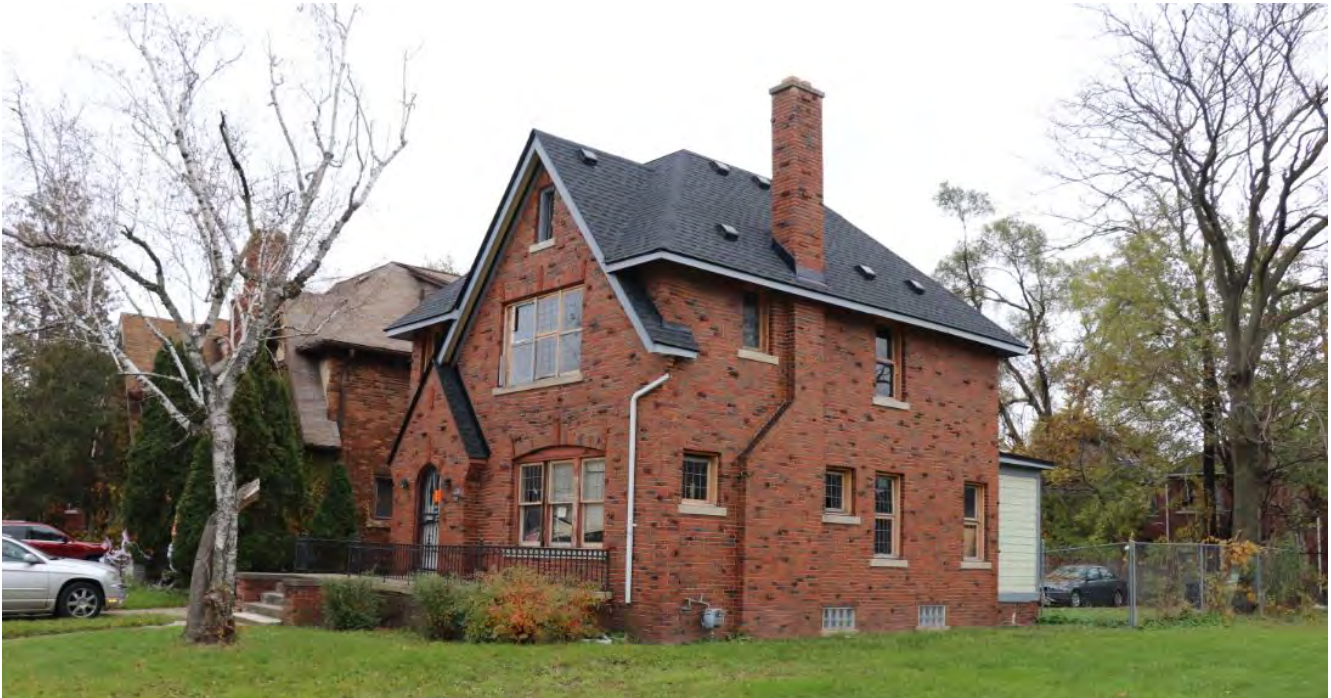
Staff Photo: 11-6-2019

The 2.5-story, single-family home at 4801 Sturtevant was built in 1925. While the home is located midblock on Sturtevant, between Livernois and Broadstreet, the adjacent parcel to the west is vacant, allowing views of the full side of 4801 Sturtevant from the right of way. It is an English Tudor Revival, clad in an orange / brown brick. The brick work is detailed and intricate, featuring **rough bricks dispersed among a “wobbly” stretcher course**. The balanced, asymmetrical front façade is dominated by a steeply pitched gable that extends outward from the hipped roof. A smaller gable that contains the front entrance projects forward from the larger gable. The front door features a rounded arch with ornamental brick trim. A bay of (3) windows with an arched brick lintel looks on to the uncovered front porch at the lower level. The porch is bordered by a decorative, black, metal fence. Photos provided by the applicant **show deterioration to the concrete cap and missing coping around the perimeter of the porch**. Brick wing walls extend down the steps that show **deterioration in the mortar**.

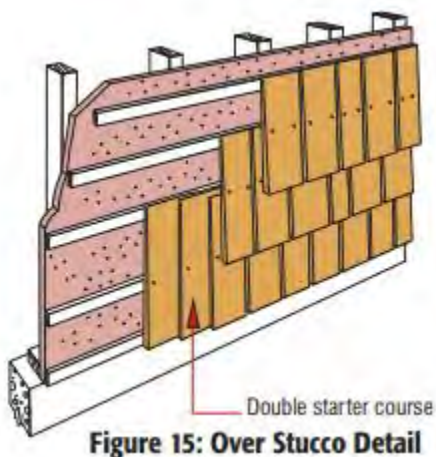
Your applicant found that wood strips were attached to the stucco to nail the shakes to. This is a practice shown below. The bottom shakes were placed directly over the lap. The second floor door was not original.
