CERTIFICATE OF APPROPRIATENESS

Application Number: HDC2026-00018

Project Address: 4324 (4314-4316) W. Vernor

RE: 4314 W Vernor – Structural Evaluation Report
4314 Vernor W
Detroit, MI 48209
Use Group: Commercial
Project No. 25-1086

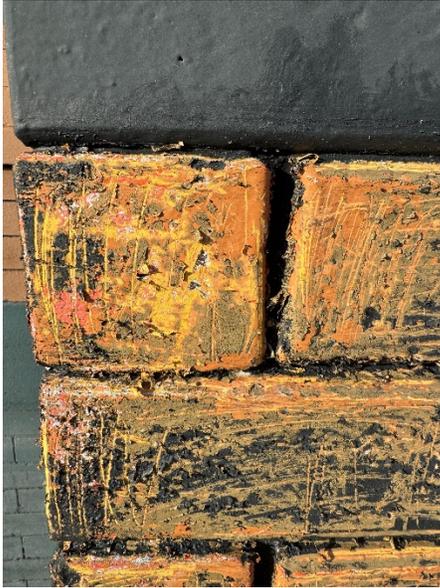
- **Exhibit A – Brick Removal Test Area (Close-Up):** Photograph documents partial paint removal revealing severe surface scarring, loss of fired brick face, pigment ghosting from multiple historic paint layers, and irreversible texture damage.

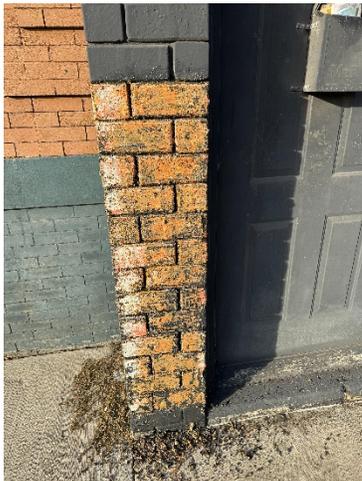
- **Exhibit B – Brick Removal Test Area (Context View):** Photograph shows broader test area adjacent to storefront opening, illustrating inconsistent brick coloration, widespread staining, mortar deterioration, and lack of recoverable original brick appearance.

These photographs represent the best achievable outcome using reasonable, preservation-conscious removal methods and demonstrate that further stripping would exacerbate damage without yielding an authentic historic brick façade.

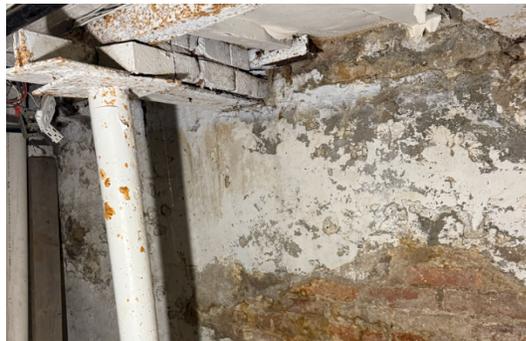
Photograph P2.1.1A

The basement walls are constructed with brick and coated with plaster in some areas. The existing masonry walls along the street side of the building are in poor condition structurally, the brick units have begun to lose their integrity, and their mortar joints have softened. Efflorescence was observed on the surface of the exposed walls in some locations due to prolonged exposure to freeze thaw cycles, deicing salts, and water infiltration due to failing masonry sill joints. The age of the construction and careful inspection of the mortar materials strongly indicate a hydraulic lime type mortar was used in the construction of the original building. Accordingly, Portland cement-based materials must be prohibited from the repair works. Refer to photographs P2.1.1A, P2.1.1B, P2.1.1C.

Note: Retrofit of the basement walls is required for safety and serviceability of the structure. It is recommended that the mortar joints be repaired/ tuckpointed and the damaged brick be replaced/ repaired in kind. It is also recommended to expose the walls and coat them with an approved penetrating sealer that is compatible with hydraulic lime-based mortars and the masonry walls at select locations. Temporary support of the 1st floor structure and existing masonry walls will be required before construction. Lateral support at the top of the existing masonry wall may be necessary

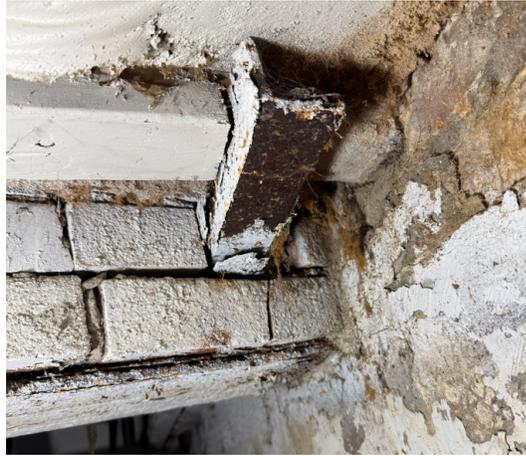
Photograph P2.1.2A

The steel angles in the basement supporting the masonry knee walls underneath the existing storefront and the concrete supported entrance slab are in poor condition structurally. The steel structural members are showing signs of intergranular delamination (pack rust) and surface rust. It is recommended that the members that are showing signs of surface rust be cleaned and painted with a zinc rich primer to prolong their life and prevent further deterioration. The angles that are showing signs of pack rust are in poor condition structurally. It is recommended that these members be removed and replaced in kind. Temporary support of the existing masonry walls and first floor system will be required before construction can begin. The beams bearing pockets are also in poor condition and are required to be restored/ grouted solid to prevent further deterioration/ movement of the beam. Refer to Photographs P2.1.2A, P2.1.2B & P2.1.2C

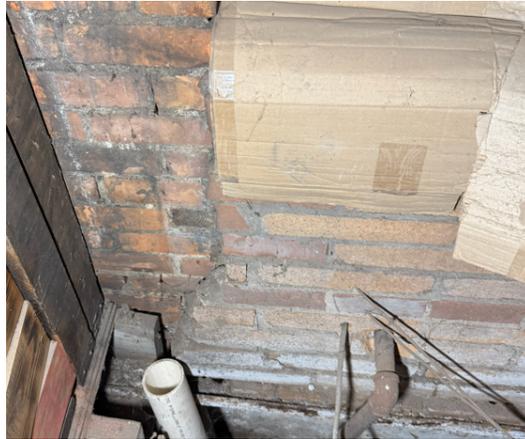
Photograph P2.2.1A

There are several areas where the masonry walls are in poor condition structurally. The brick units have begun to lose their integrity, and their mortar joints have softened. Masonry wall cracks were observed in multiple areas. The existing knee walls supporting the storefront system are in poor condition structurally and need to be removed/ replaced. Refer to photographs P2.2.1A, P2.2.1B, and P2.2.1C.

Note: Retrofit of the masonry brick walls is required for safety and serviceability of the structure. It is recommended that the bricks that have begun to lose their structural integrity be removed and replaced in kind, and mortar joints thought the first floor be tuckpointed. It is also recommended that the cracks observed along the masonry wall be patched/ repaired.

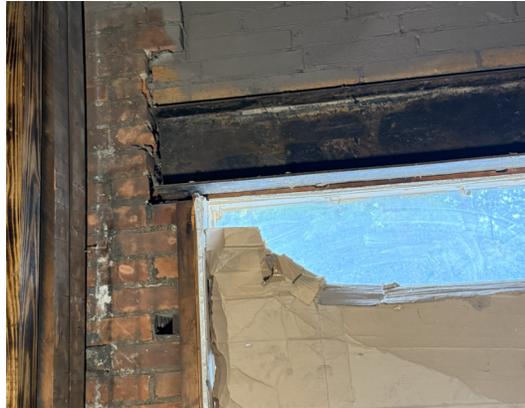
Photograph P2.2.2A

The lintel supporting the masonry above the existing storefront appears to be in good condition overall. The lintel is made up of a steel beam with a steel plate fixed to the bottom flange with steel rivets. The masonry joint above the steel plate is opening up and is in poor condition overall. The plate is also starting to deform/ deflect evidenced by a growing mortar joint and cracks throughout the masonry wall. All of these signs hint that the plate is deteriorating and pack rust is starting to form behind the masonry wall. As the rust forms the plate deteriorates further and starts to deflect. Refer to photographs P2.2.2A, P2.2.2B, and P2.2.2C.

Note: Retrofit of the existing steel lintel is required for the safety and serviceability of the structure. It is recommended that the existing masonry wall and second floor be temporarily supported and the existing deteriorated steel plate be removed and replaced. The existing steel beam is also required to be inspected and restored as needed during this process.

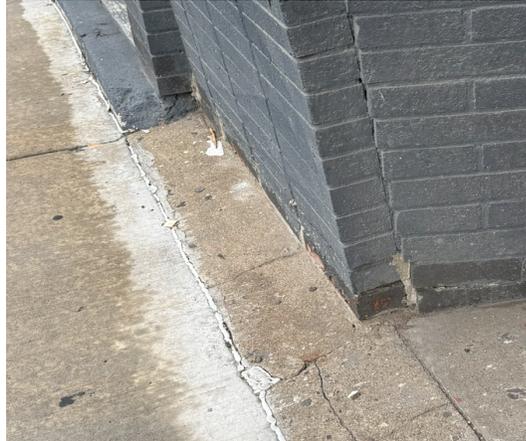
Photograph P2.3.1A

The masonry sill joint around the building is in poor condition and has eroded, spalled, and cracked in many locations. The deterioration of the sill joint is one of the sources of the water observed in the basement. Refer to photograph P2.3.1A

Note: Restoration of masonry sill joints and damaged units is required for the serviceability of the façade system and the overall building envelope.

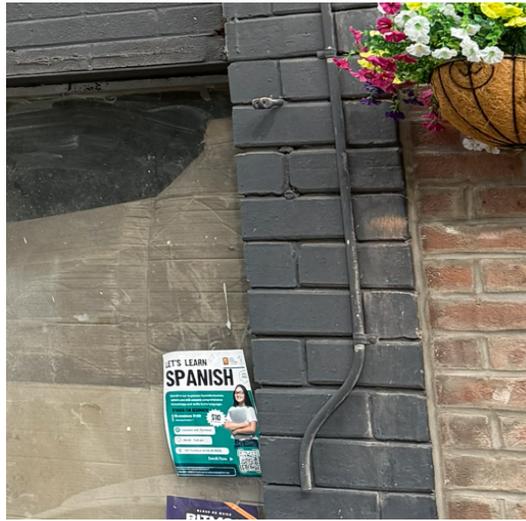
Photograph P2.3.2A

There are multiple areas throughout the Façade where old anchors/ clips and conduit are present. The rusted old inclusions within the building are causing accelerated deterioration of the building's façade. Refer to photograph P2.3.2A

Note: Retrofit of the masonry affected by the rusted clips/anchors is recommended to maintain serviceability of the façade system and the overall building envelope.

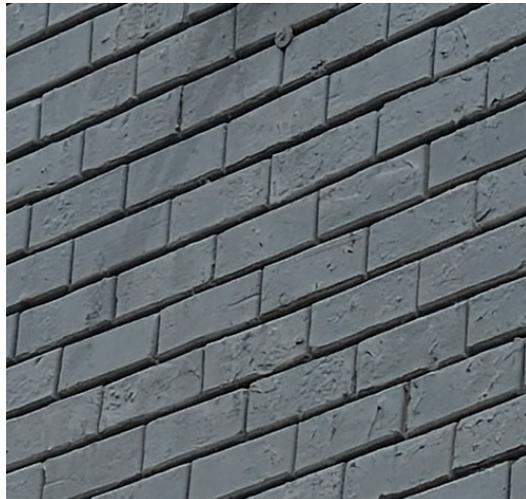
Photograph P2.3.3A

The joints through the masonry wall are in overall poor condition and should be repointed. Refer to photograph P2.3.3A

Note: Retrofit of the masonry joints is required to prolong the serviceability of the façade system and the overall building envelope. It is recommended that the joints be repointed as needed.

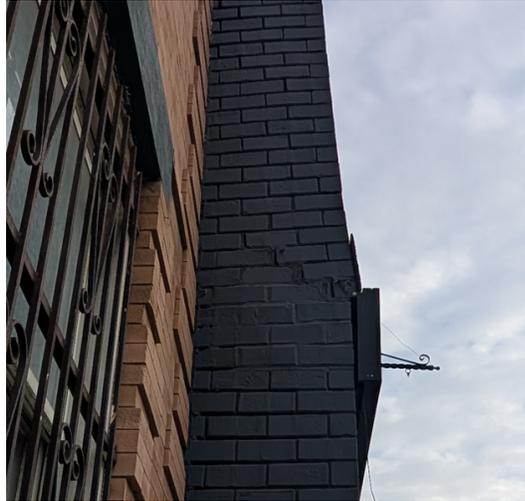
Photograph P2.3.4A

The steel beam supporting the masonry at the second-floor level is concealed by architectural finishes and is required to be exposed for further inspection. Based on the condition of the masonry above the beam and the notable bulge present at the second-floor line, it is likely the steel beam has deteriorated and requires structural restoration. The bulge in the masonry appears to have been stabilized previously via the addition of a through-bolted steel plate. The bulge in the masonry is continuing to grow, indicating that additional restoration is required. The additional restoration can only be determined after exploratory demolition. The nature of the second-floor lintel and its location relative to the sidewalk and main entrance to the building poses an immediate safety concern. Refer to photograph P2.3.4A, P2.3.4B, and P2.3.4C

Note: It is recommended that the beam be uncovered for further inspection. Restoration/ replacement may be required depending on its current condition to maintain the building's overall safety and serviceability
