CERTIFICATE OF APPROPRIATENESS

Application Number: HDC2026-00080

Structural Assessment Report

1436 Edison Street
Detached Garage
Detroit, MI 48206

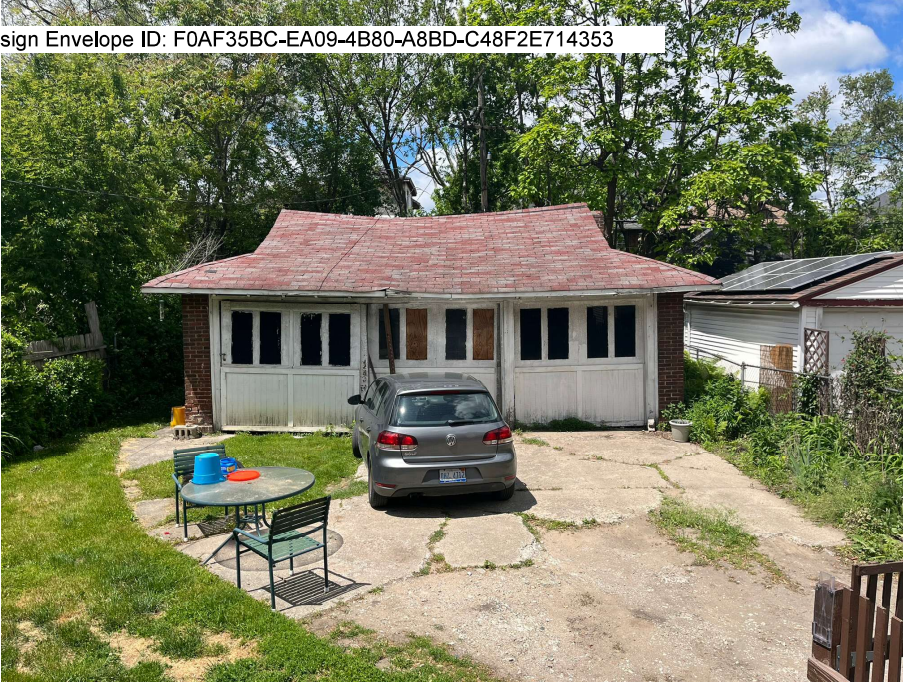
South Wall - Severe

Wall is sagging due to weight of roof and deterioration of wood structural elements. Brick piers have masonry damage at the base of both East and West piers.

**IMAGE 01:
SOUTH ELEVATION**

South Wall - recommend demo and provide new structure as required.

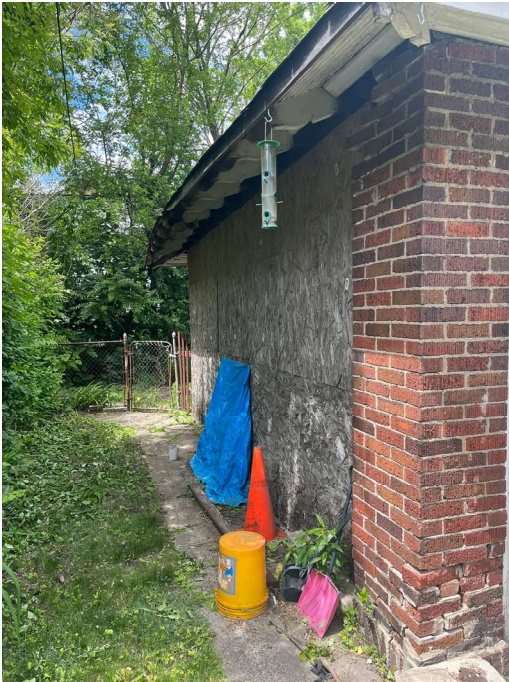
West Wall - Severe

Wood framing and plywood sheathing are severely damaged.

**IMAGE 02:
WEST ELEVATION
SOUTH WEST PIER MISSING MORTAR AT
BASE OF PIER
BRICKS AT TOP OF PIER STARTING TO
SHEAR FROM STRUCTURAL FRAMING**

West Wall - recommend demo and provide new structure as required.

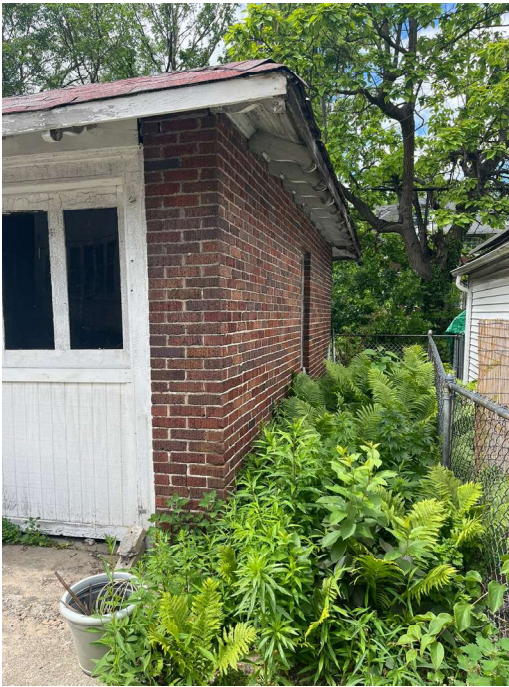
East Wall - Moderate

Wood framing and brick are intact, wall is showing signs of bowing due to structural stresses. Ability to support the wall in its current condition and realign would likely cause further damage to brick masonry.

**IMAGE 03:
EAST ELEVATION**

East Wall - recommend demo and provide new structure as required.

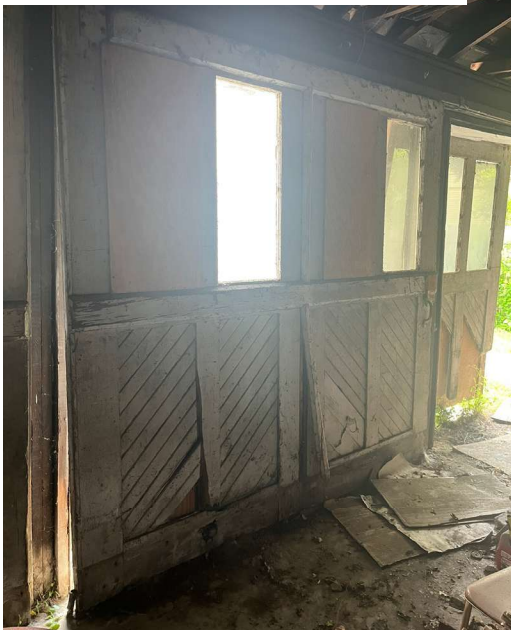
**IMAGE 04:
SLIDING DOORS**

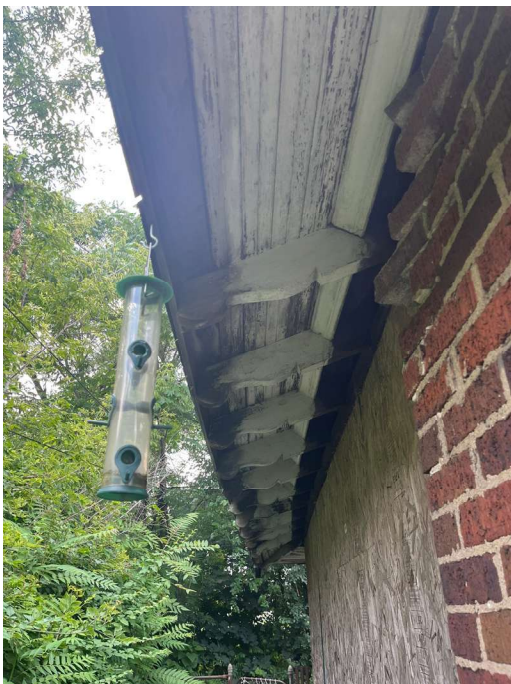
Wood Trim / Eaves - decorative trim detailing exists in some areas, showing deterioration due to age and weather exposure.

**IMAGE 05:
EAVES / BEAD BOARD / RAFTER TAILS**

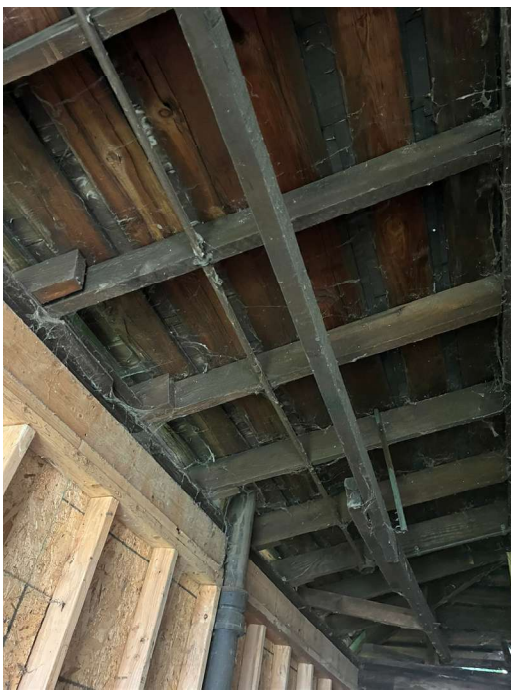
**IMAGE 06:
HIPPED AREA OF WEST ROOF**

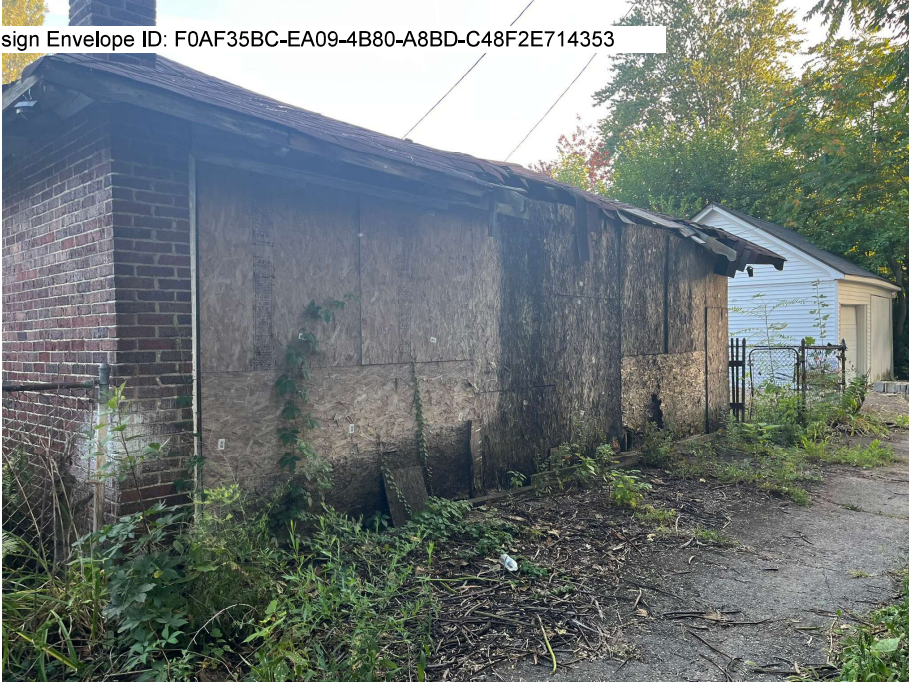
North Wall - Severe

Wood framing is not complete and severely water damaged. Sheathing is severely water damaged and missing in parts.

**IMAGE 07:
NORTH ELEVATION
EVIDENCE OF DOOR ALONG ALLEY SIDE OF
GARAGE**

North Wall - recommend demo and provide new structure as required.

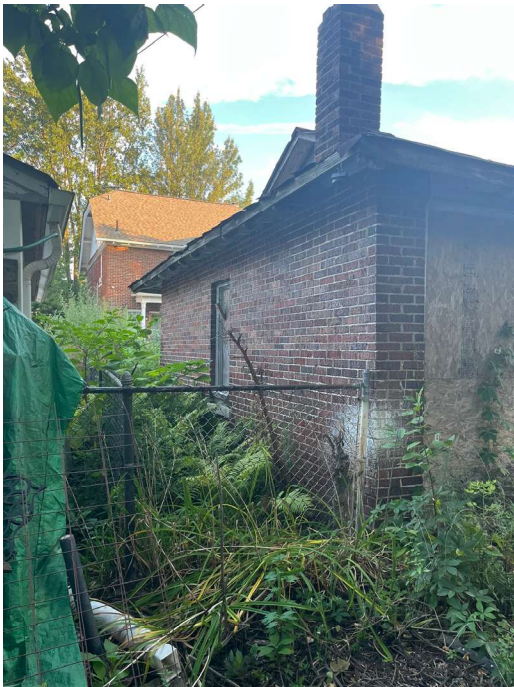
**IMAGE 08:
EAST ELEVATION
EVIDENCE OF DOOR ALONG ALLEY SIDE OF
GARAGE**

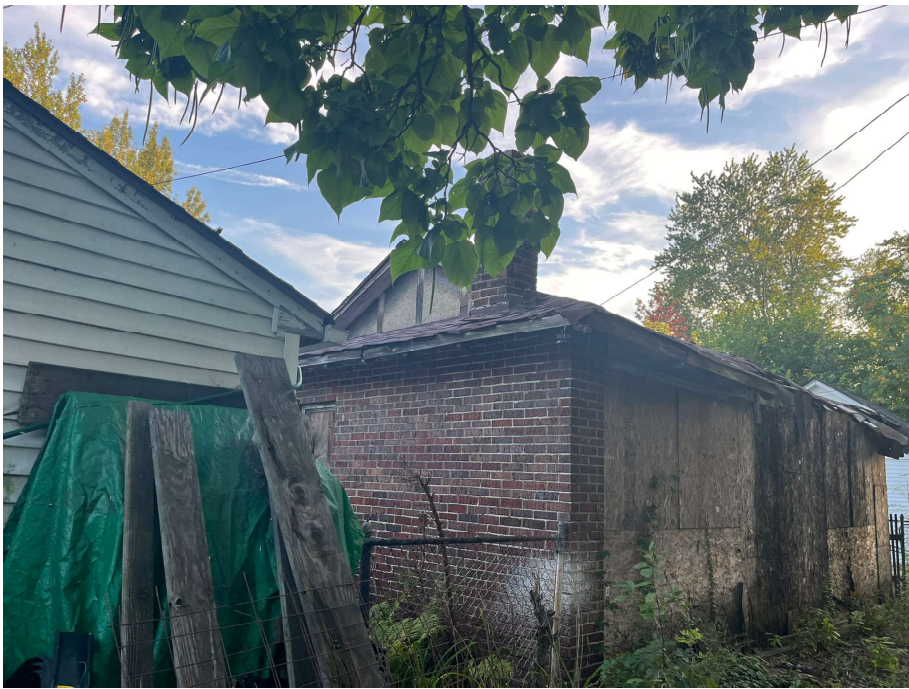
**IMAGE 09:
EAST ELEVATION
SMALL GABLE AT BOTH SIDES WITH
STUCCO AND BEAM DETAILING**

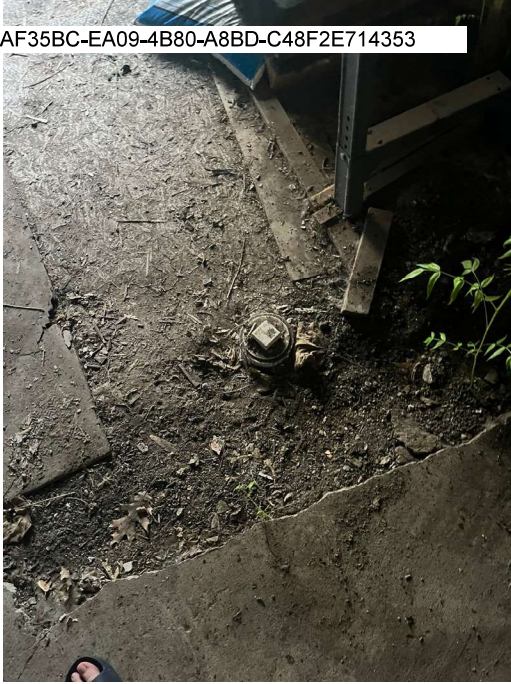
Concrete Slab - Moderate

Approximately 50% of the concrete slab is missing or crumbling. Ability for remaining slab to withstand doweling and adjacent work without further damage is unknown.

**IMAGE 10:
GARAGE SLAB**

Concrete Slab - recommend to demo and pour new to provide proper drainage for the site and underlayment.

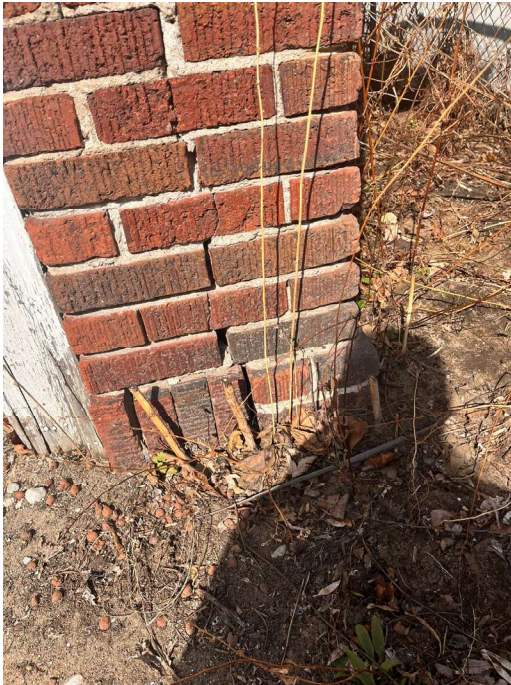
**IMAGE 11:
BASE OF SOUTH EAST MASONRY PIER
MISSING MORTAR AT BASE OF PIER**

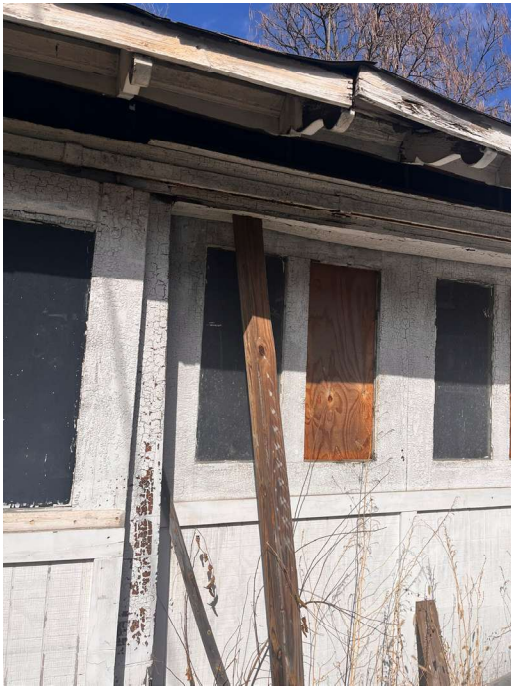
**IMAGE 12:
SUPPORT PROP AT MID SPAN OF SOUTH
WALL
CENTER AND EAST DOORS ARE NOT FUNC-
TIONAL DUE TO SAGGING STRUCTURE +
SLIDING MECHANISM**

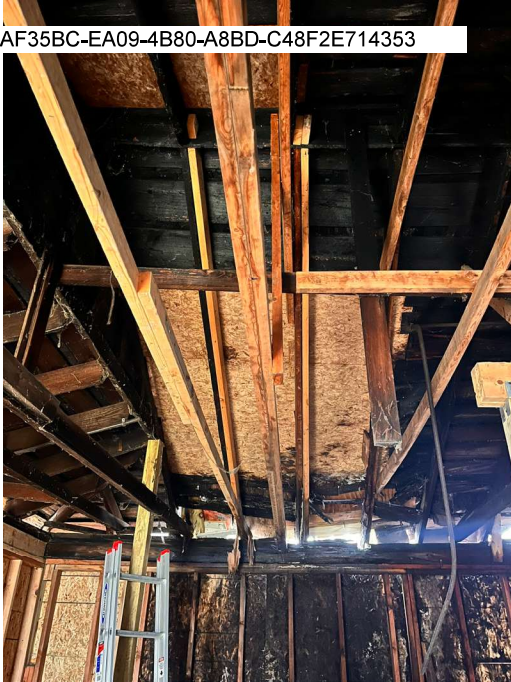
Roof - Severe

Holes in sheathing allow for further water and weather damage to the structure. Asphalt shingles are over cedar shakes in some locations.

**IMAGE 13:
PLYWOOD PATCH AT HOLE IN ROOF
TEMPORARY FRAMING SUPPORTS TO
KEEP STRUCTURE STABLE**

Roof - recommend demo and provide new structure as required.

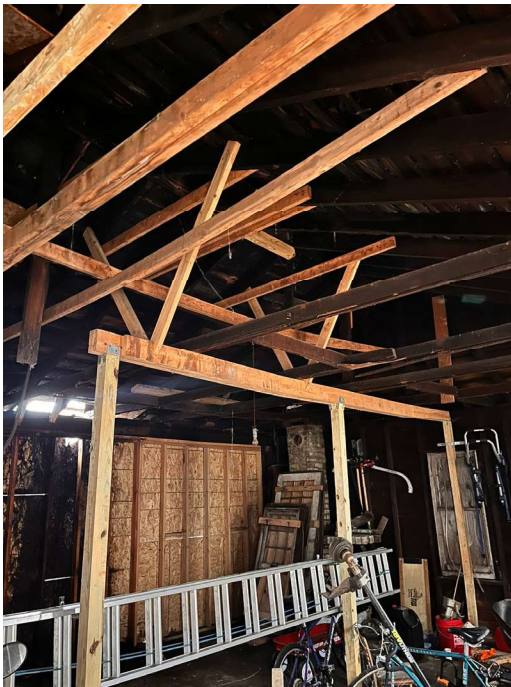
**IMAGE 14:
TEMPORARY CENTER SUPPORT AND
RAFTER SUPPORTS**

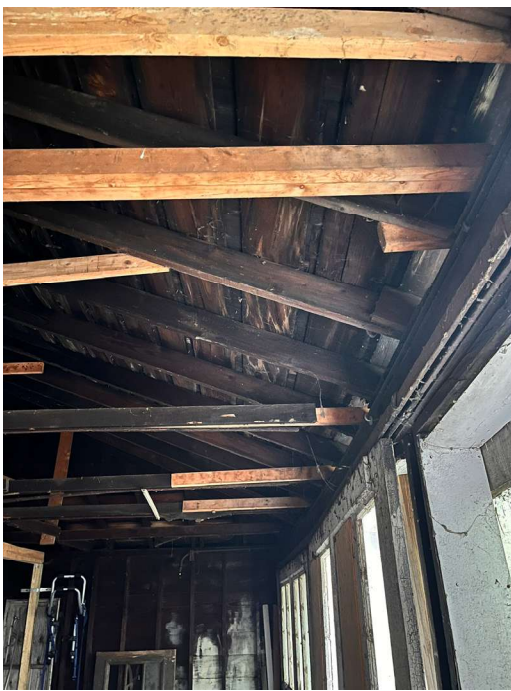
**IMAGE 15:
TEMPORARY CROSS-MEMBER SUPPORTS**

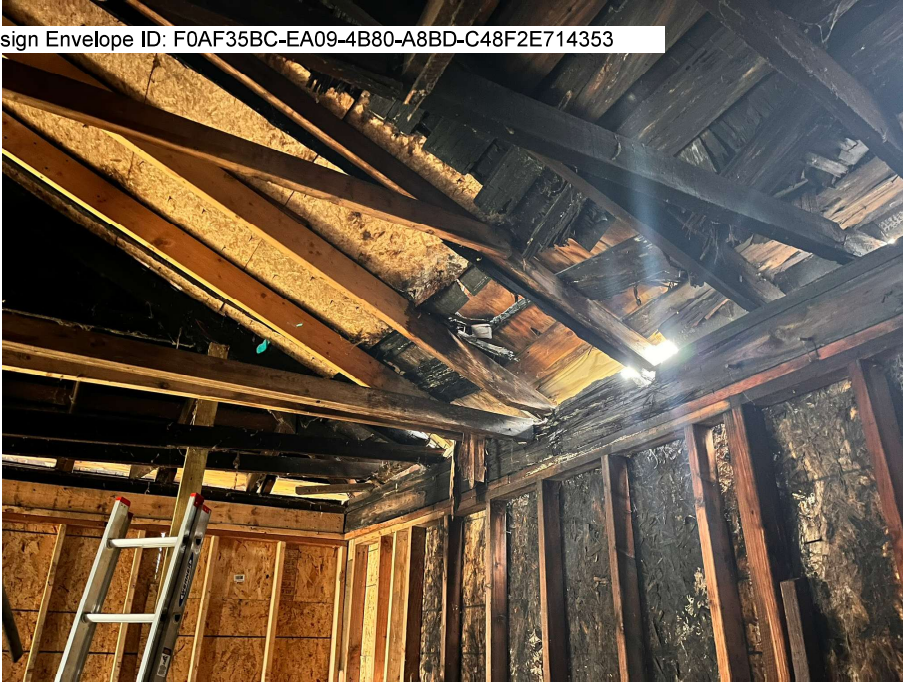
IMAGE 16:
PLYWOOD TO SECURE PROPERTY AND STRUCTURE - WATER DAMAGE ON SOME PLYWOOD ELEMENTS DUE TO HOLE IN ROOF - MULTIPLE UNCONNECTED SUPPORT ELEMENTS

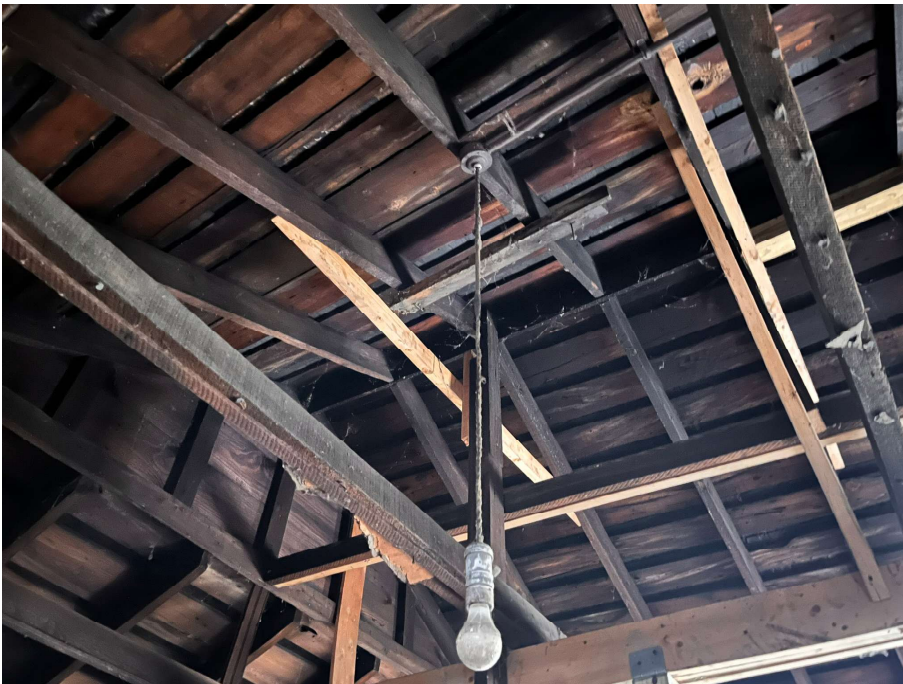
Rafters - Severe

Missing and sagging rafters are not supporting the structure.

IMAGE 17:
RAFTER SHORING IN MULTIPLE LOCATIONS - LIGHT AND CONDUIT ARE NON-FUNCTIONAL

Rafters - recommend demo and provide new structure as required.

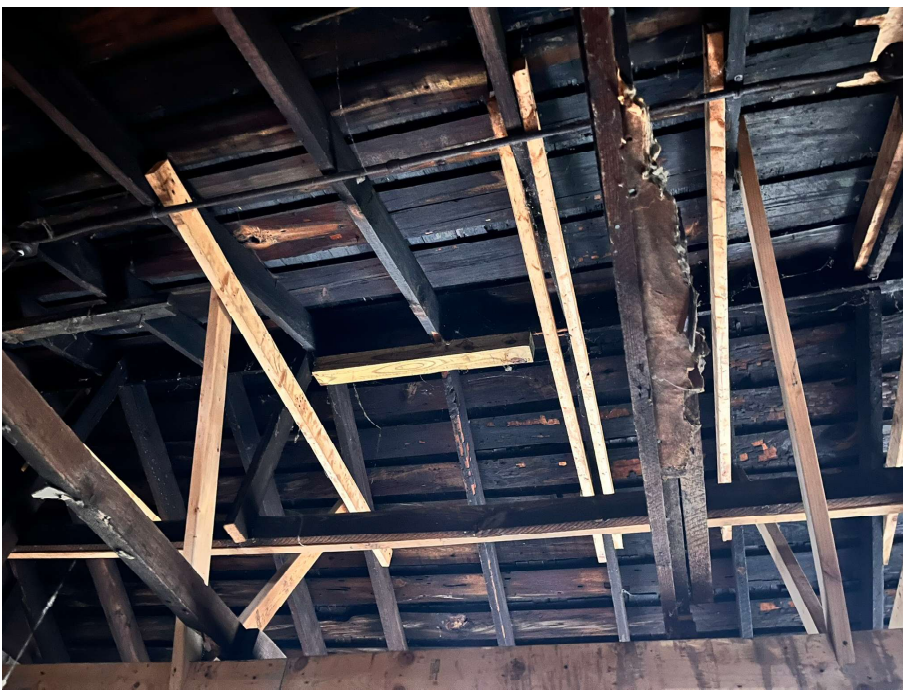
IMAGE 18:
TEMPORARY SISTER SUPPORTS FOR EXISTING RAFTERS - UNKNOWN WOOD CONDITION DUE TO LONGTERM WEATHER EXPOSURE
