**PLANNING AND  
DEVELOPMENT DEPARTMENT**

Coleman A. Young Municipal Center  
2 Woodward Avenue, Suite 808  
Detroit, Michigan 48226

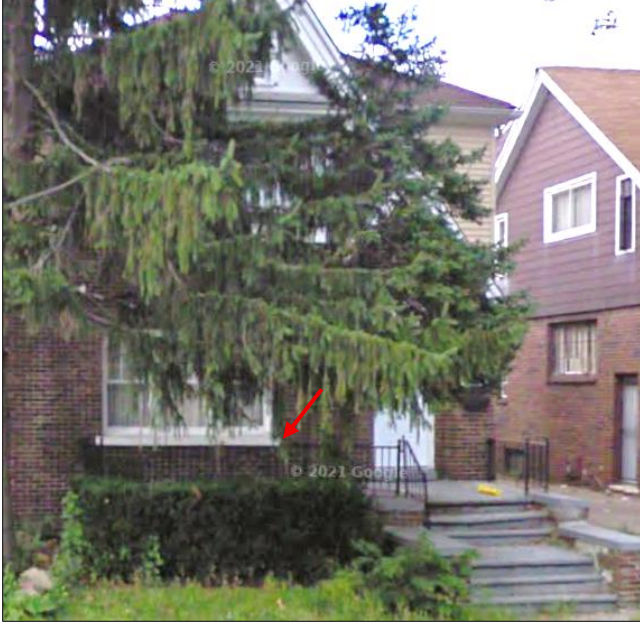
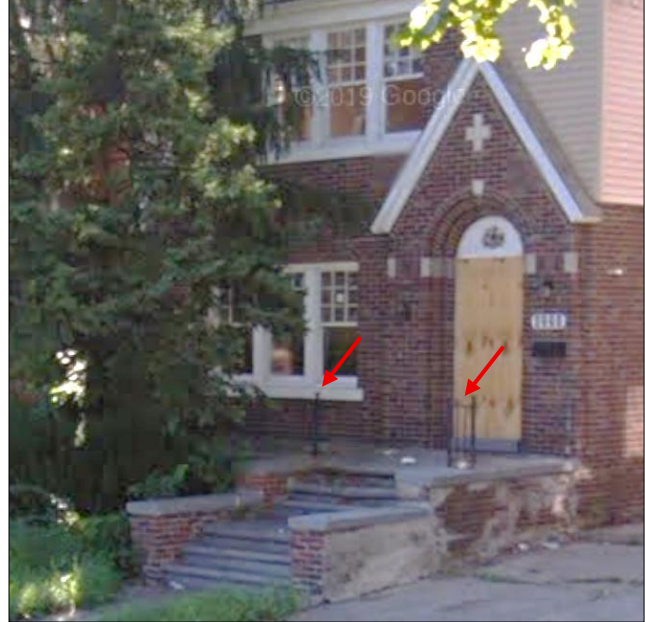
*Google Street View, Left: July 2009 -- Right: August 2011. Although the front of the house is only partially visible due to a pine tree, the 2009 view offers a full view of a low height railing intact at the perimeter of the porch. The 2011 photo shows one small railing remnant and one post remained two years later.*

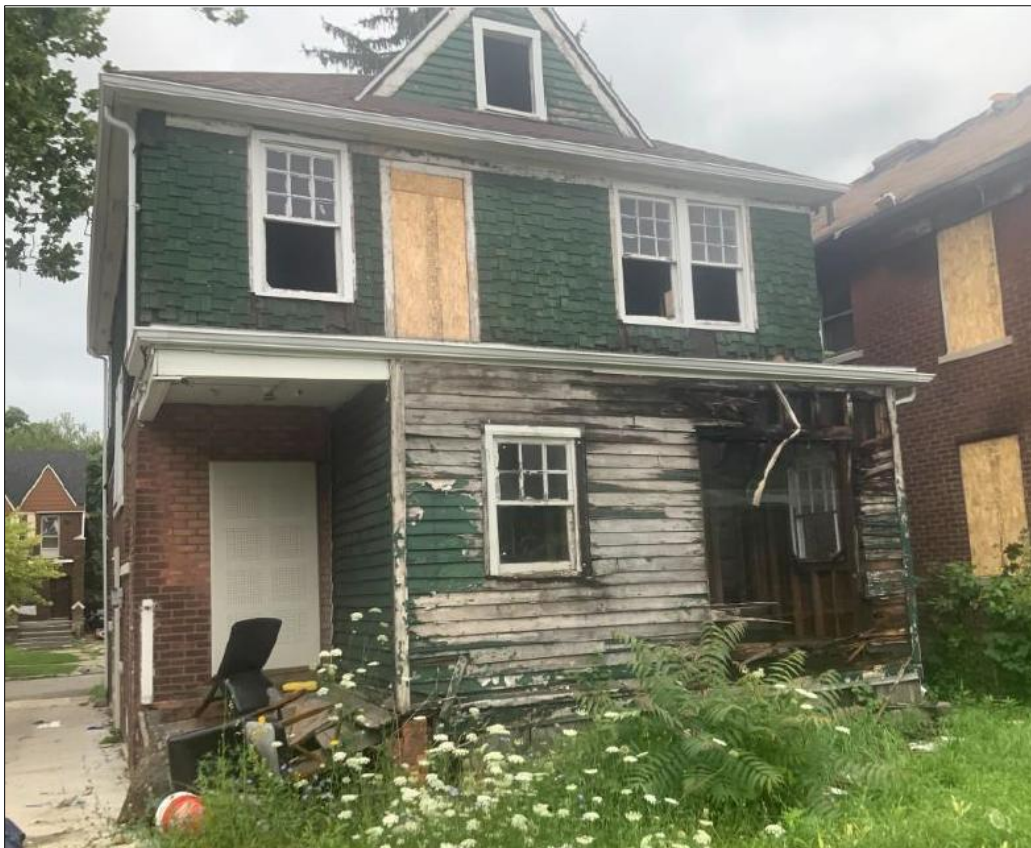
*Applicant photo. With exception of the deteriorated section of the wall, the historic age wood siding on the remaining walls appeared to be intact and in repairable condition.*

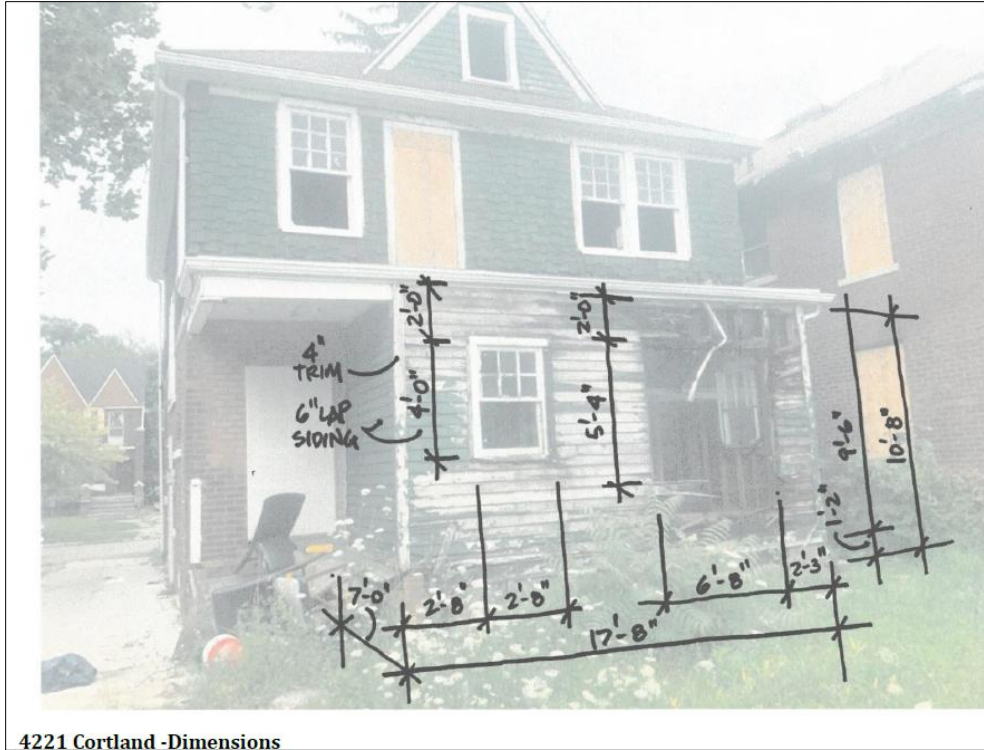
4221 Cortland - Dimensions

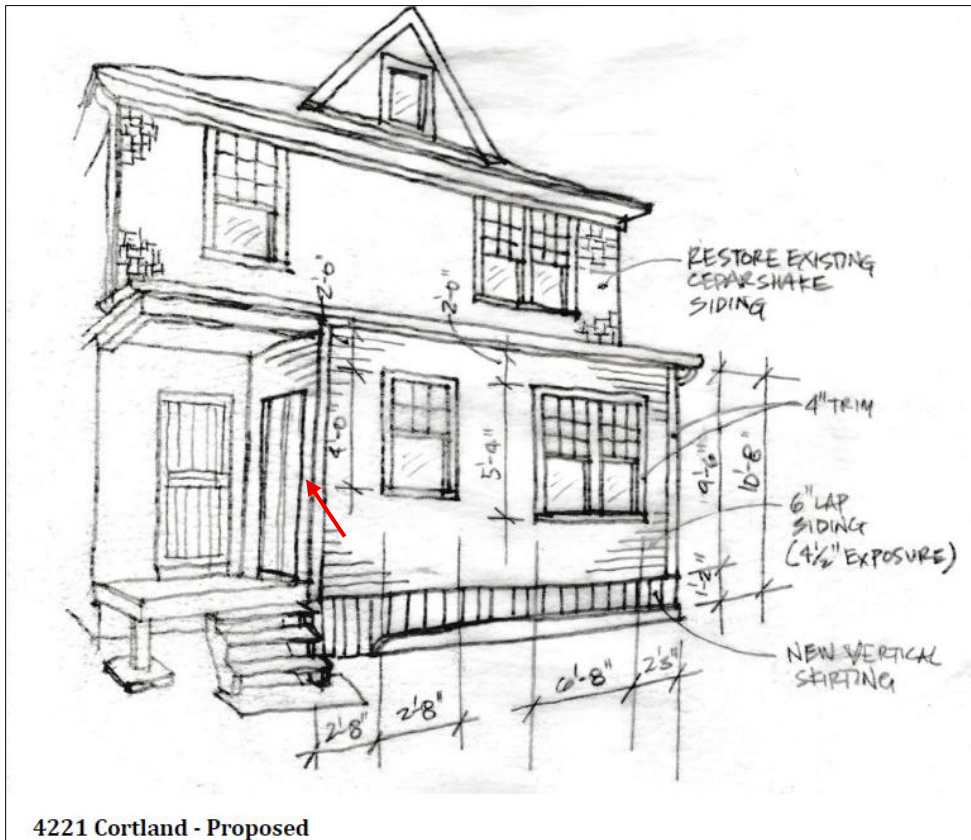
4221 Cortland - Proposed

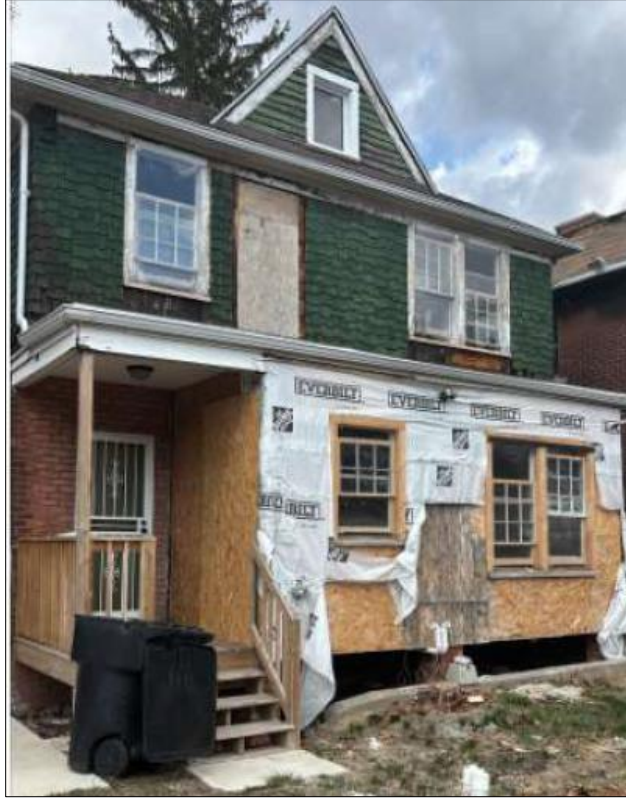
*Applicant photo of existing conditions. The removal of the door at the second floor and installation of matching wood shake siding was approved by staff in 2022 (COA 22-7760).*

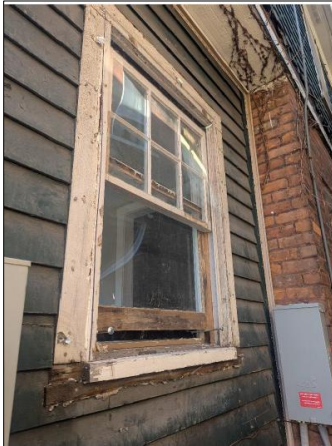
4221 Cortland - Existing 6" Wood Lap Siding (Exposure 4-1/2")

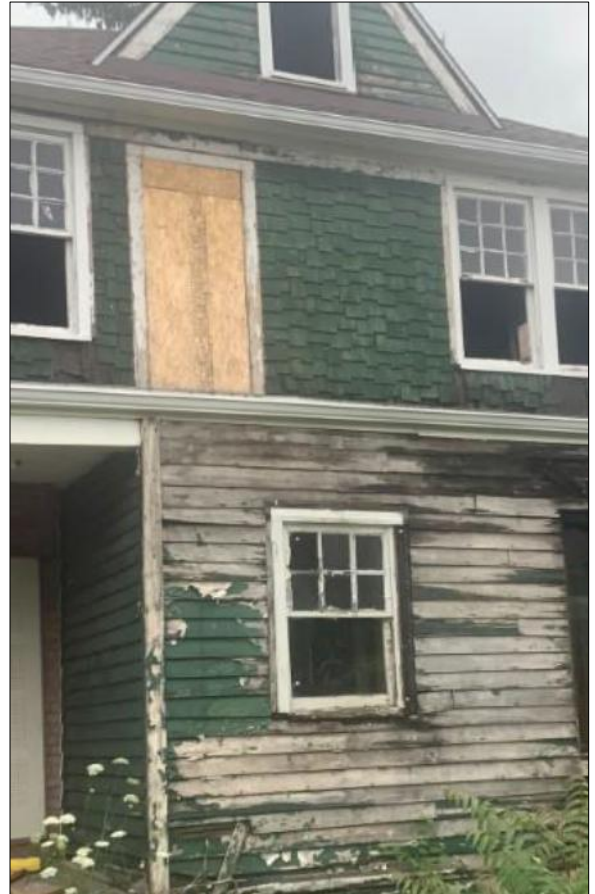
*Close-up of applicant photo prior to wall demolition.*
