**SR-2 – STAFF ADVISORY REPORT (05-08-2026)**

**ADDRESS:** 470 MARTIN LUTHER KING JR. BOULEVARD

**APPLICATION NUMBER:** HDC2026-00162

**SCOPE:** REPLACE WOOD WINDOWS WITH ALUMINUM WINDOWS, BUILD RETAINING WALLS/INSTALL FENCING, INSTALLATION OF CMU BLOCK IN BUILDING’S EXTERIOR WALLS, (WORK STARTED WITHOUT APPROVAL)

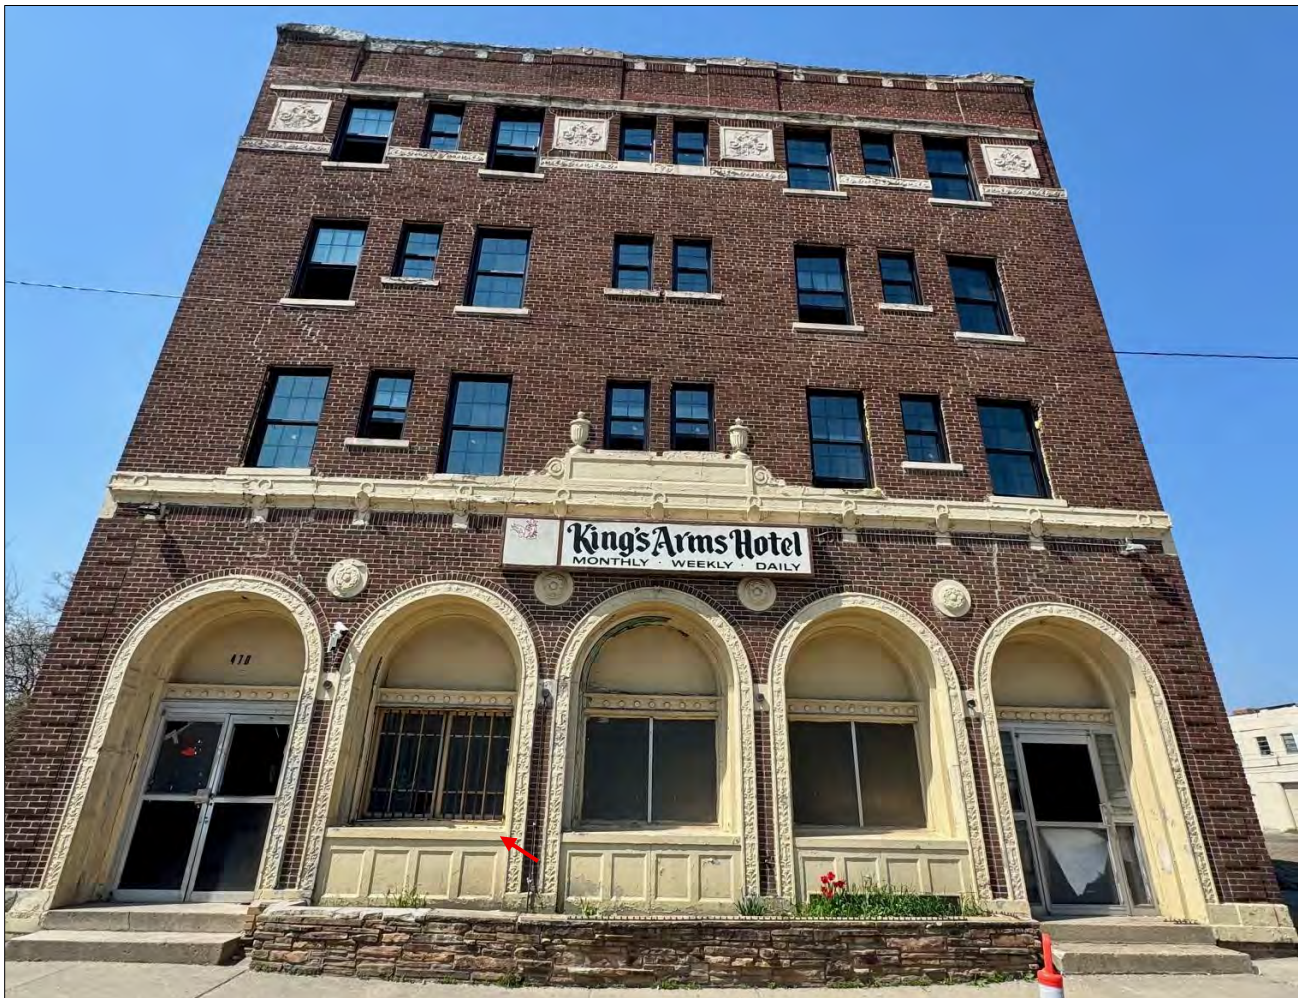
Staff photo, taken on 04/22/2026, shows the replacement of the 2<sup>nd</sup> – 4<sup>th</sup> floor windows is complete. The remaining intact historic-age double casement at the first floor is clearly visible.

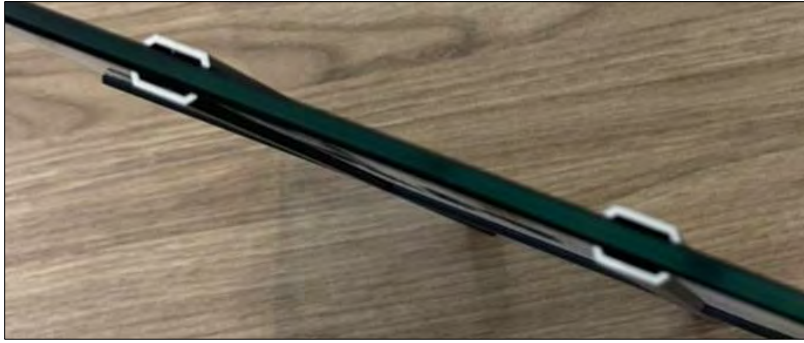
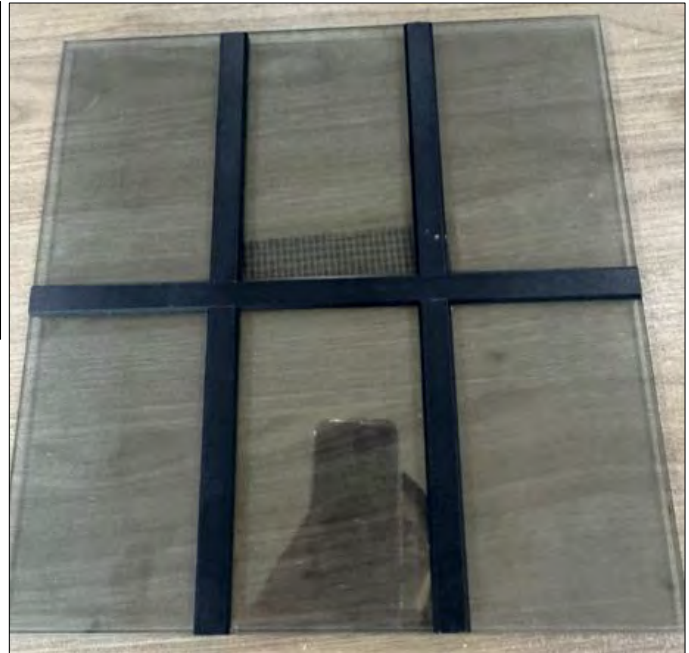
*Above and right: Applicant provided photos, showing the width and profile of the grilles that are to be applied on-site to the exterior panes of glass.*

- Even though this product may be applied to the exterior, it appears to extend from the glass surface about 1/8-of-an-inch and is flat surfaced.
- Pages 11 & 12 from applicant document "Compiled Submittal red" states depths for the grilles at .15" and .45" for different windows. Staff isn't clear why different dimensions are listed; the above sample is likely for the .15" grille.

- The full glass photo also shows a tint which reduces transparency and contrast between the grilles and glass. Staff isn't clear if this glass matches the glass used within the new windows.

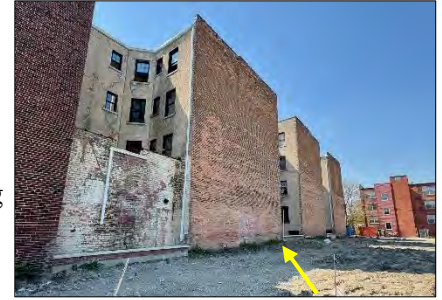
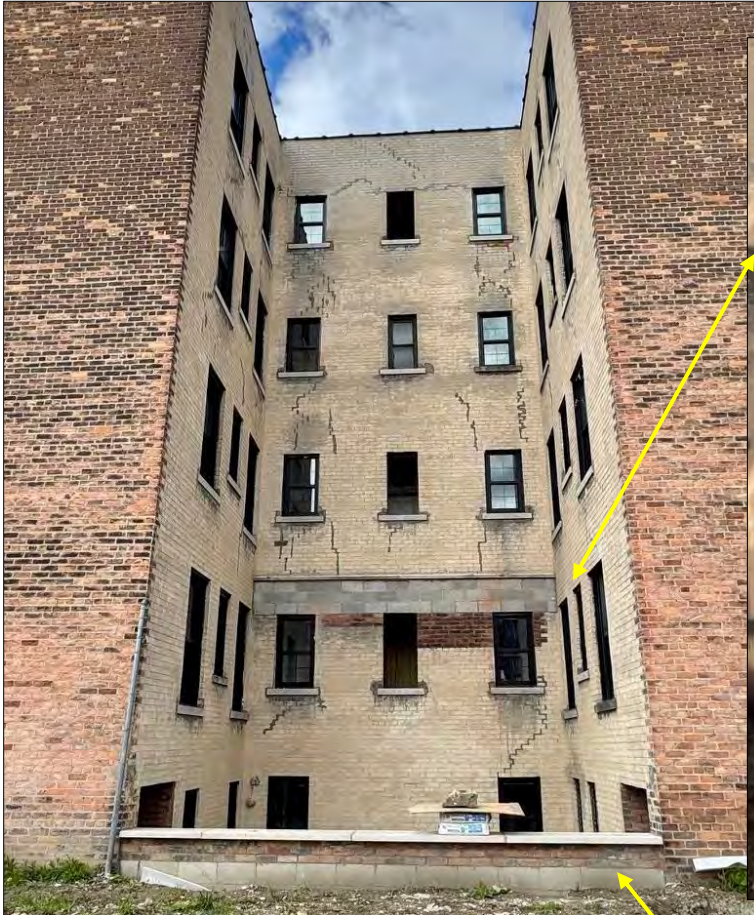
- Using the east wall’s central courtyard/lightwell as an example of work that has been completed in the remaining lightwells: replacement windows fill most of the openings, a portion of an exterior wall was rebuilt using CMU, and a CMU and brick retaining walls topped with cast stone were erected.

*Top and above: East wall, central bay/lightwell. Replacement windows fill most openings. CMU block was installed below a cast stone band on the outward-facing wall. Staff also notes dark colored tuckpointing and use of reclaimed brick below the CMU. A CMU and brick retaining wall, topped with cast stone has been built at five of the six lightwell openings. Staff photo, 04/30/2026*

- The applicant states CMU block was used "for durability"; however, new brick (matching all details of the historic brick, including color) is the correct historic preservation treatment, including the area where red reclaimed brick was used. New brick is generally harder and has a higher compressive strength than early 20<sup>th</sup> century brick due to the use of higher kiln temperatures. Therefore, the new bricks would be denser and less porous than the previous bricks. Using lime mortar (matching the historic mortar) would absorb the surface water more quickly, possibly requiring tuckpointing or repointing more regularly, but new yellow brick would retain a consistent wall cladding and blend into the historic building design, while retaining the historic character of the element.

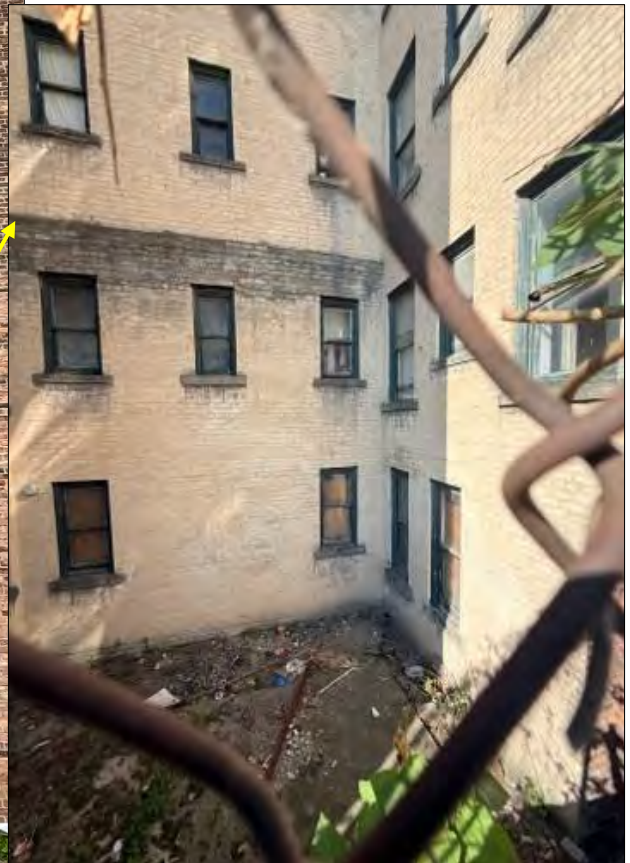
*Undated applicant photo of the east side central lightwell prior to work taking place. The brick that was replaced with CMU is visible, as is the chain link fencing that previously enclosed these recessed openings.*

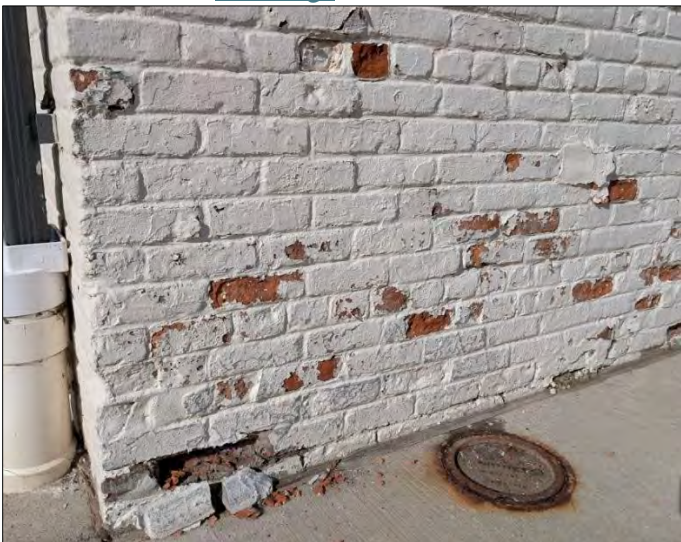
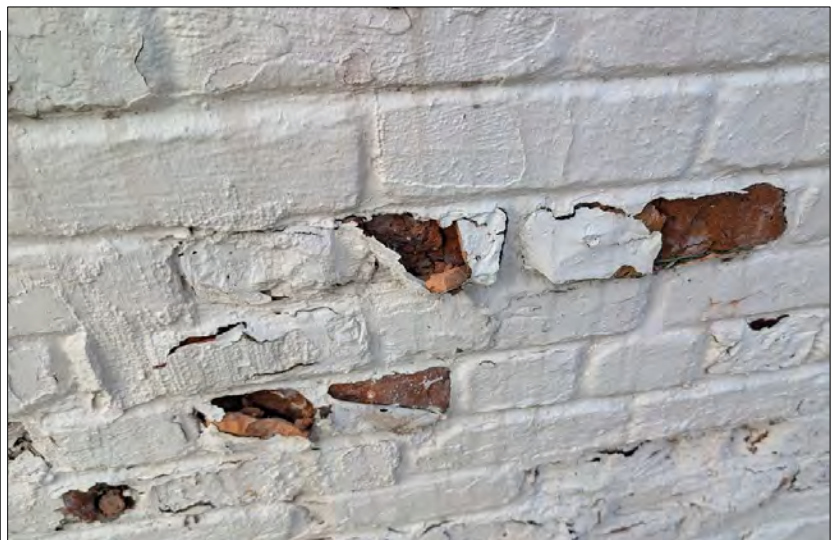
*Historic-age Detroit building exhibiting paint slowly destroying the brick wall through spalling and moisture retention.*

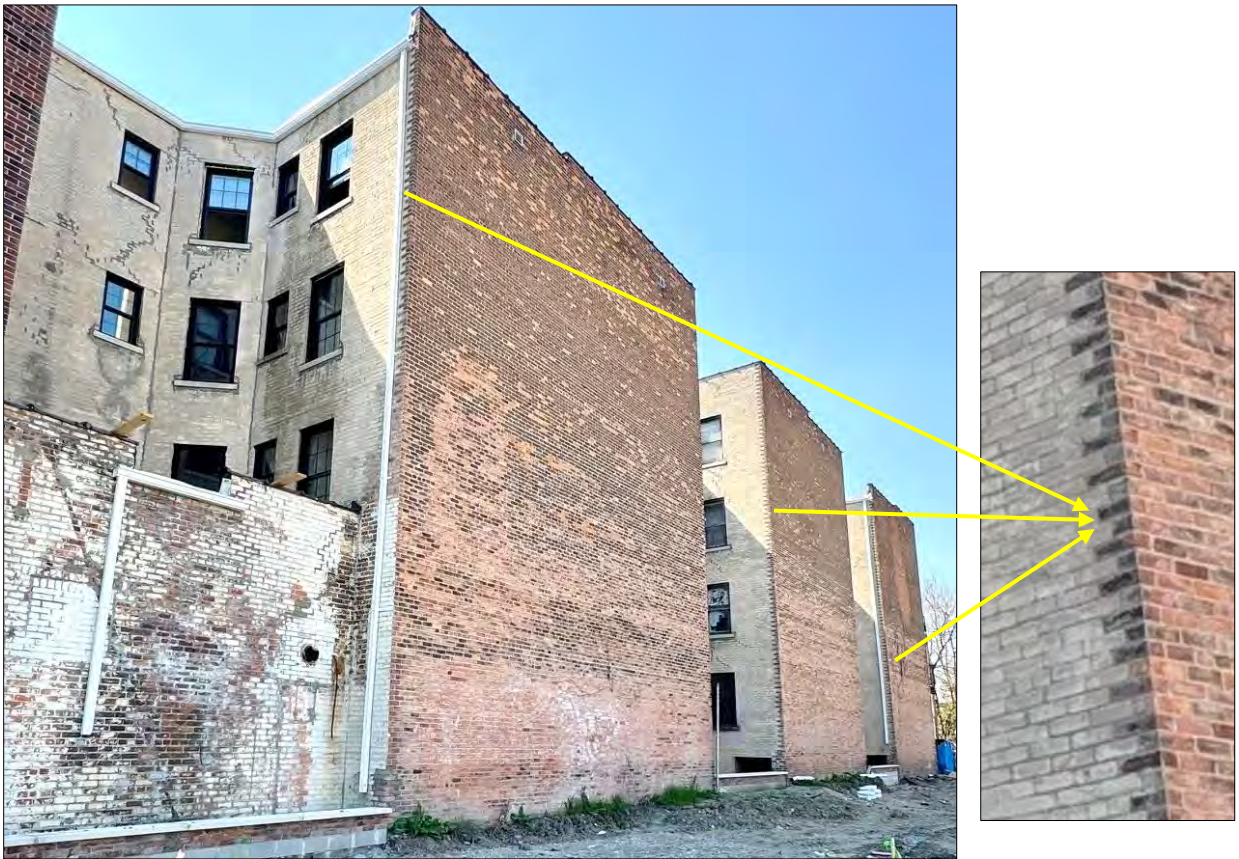
- This contrasting brick was joined to the outer wall's red brick with a course-by-course staggered brick pattern, creating a distinctive feature of the building. Painting the interior courtyard/lightwell wall surfaces would also likely cause the loss of this feature.

*The stepped brick pattern occurs at the interior edge of each corner of the courtyards/lightwells (east and west sides). Staff photo, 04/22/2026.*

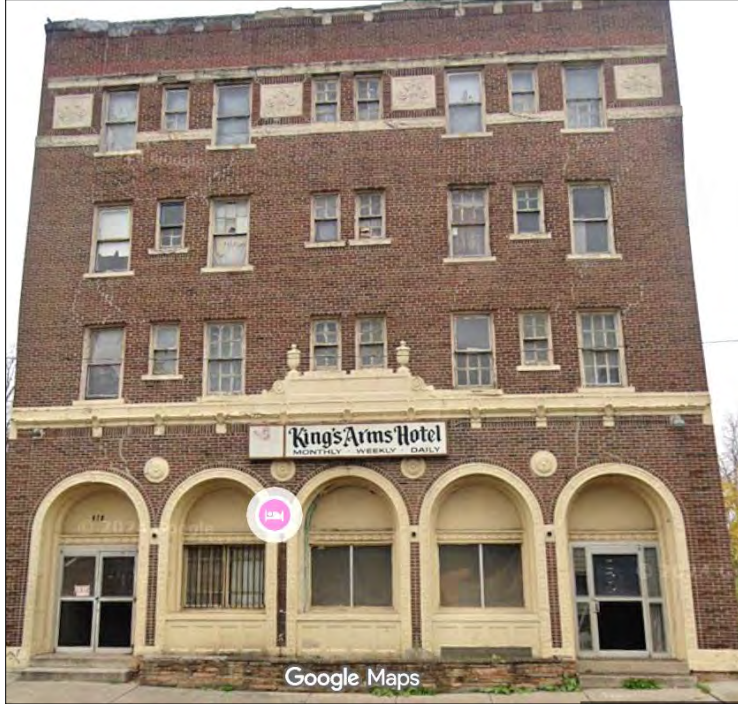
*Above: Condition of façade windows, November 2024. Google Streetview.*

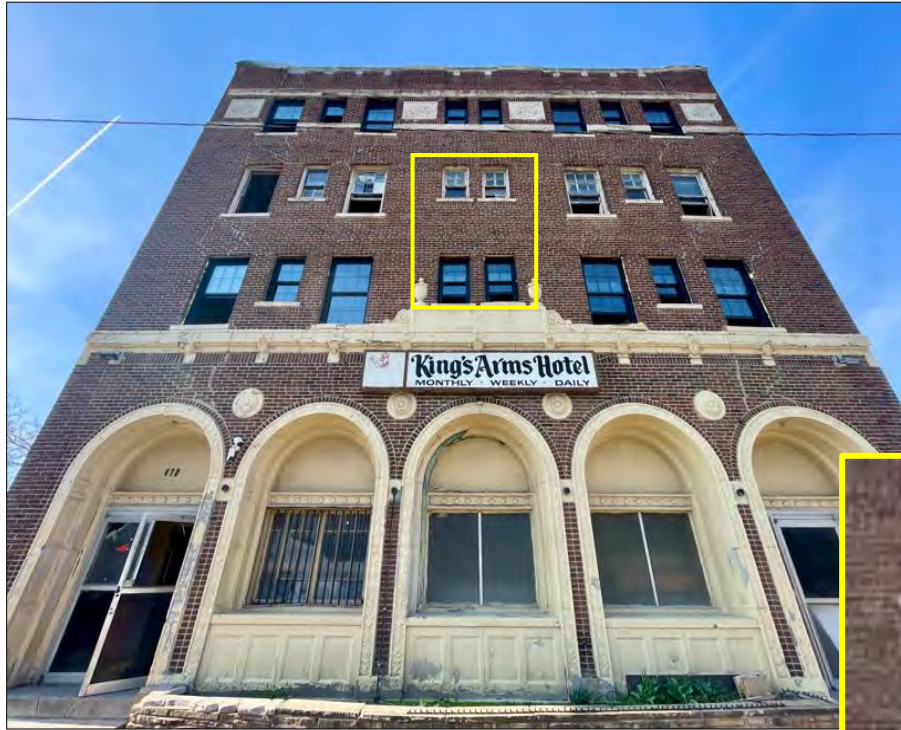
- The replacement of the building’s windows was noticed in early April and continued later in the month after BSEED had issued a stop work order. Now, only a few original wood windows remain.
- It is staff’s opinion that the windows did not appear to be deteriorated beyond repair. The undivided glass on the façade removed without HDC approval between time of district designation and May 2026 could have been replaced with fabricated true-divided light sash.

*Condition of façade, April 9, 2026. Staff photo.*

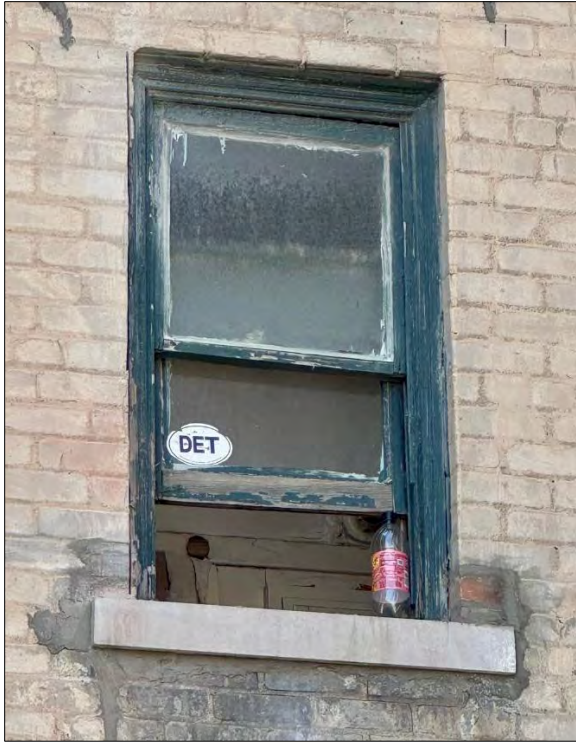
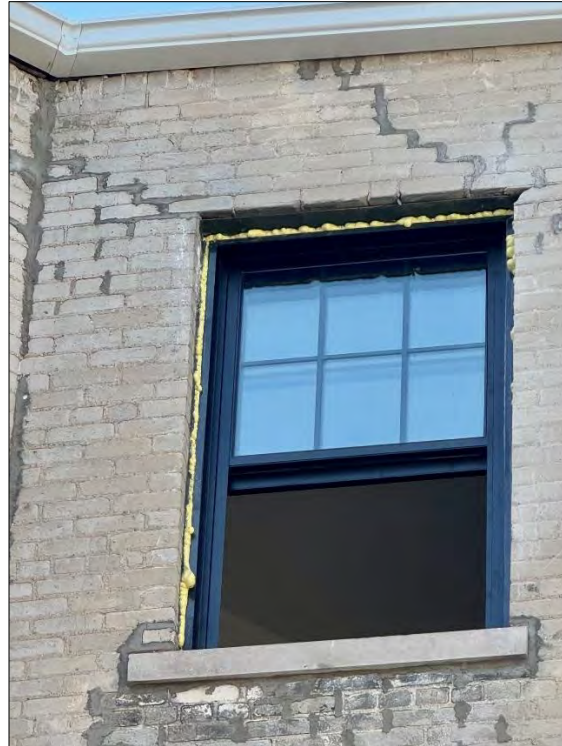
- The applicant submitted a measurement comparison in the “*Compiled Submittal Red*” document, and it states there is no visible difference in sash dimensions. However, the photo comparisons on this and the following page attest to a noticeable change in appearance due to the profiled dimensional loss.

*Staff photos of wood and replacement windows on the east side, central courtyard/lightwell. The dimensionality of the historic brickmold is visible, in comparison to the flat, thin trim installed against the replacement window. The importance of wood brickmold is clear: the window retains a highly dimensional appearance (even with a 1-over-1 pattern) in comparison with the 6-over-6 internal grid replacement window. 04/22/2026*

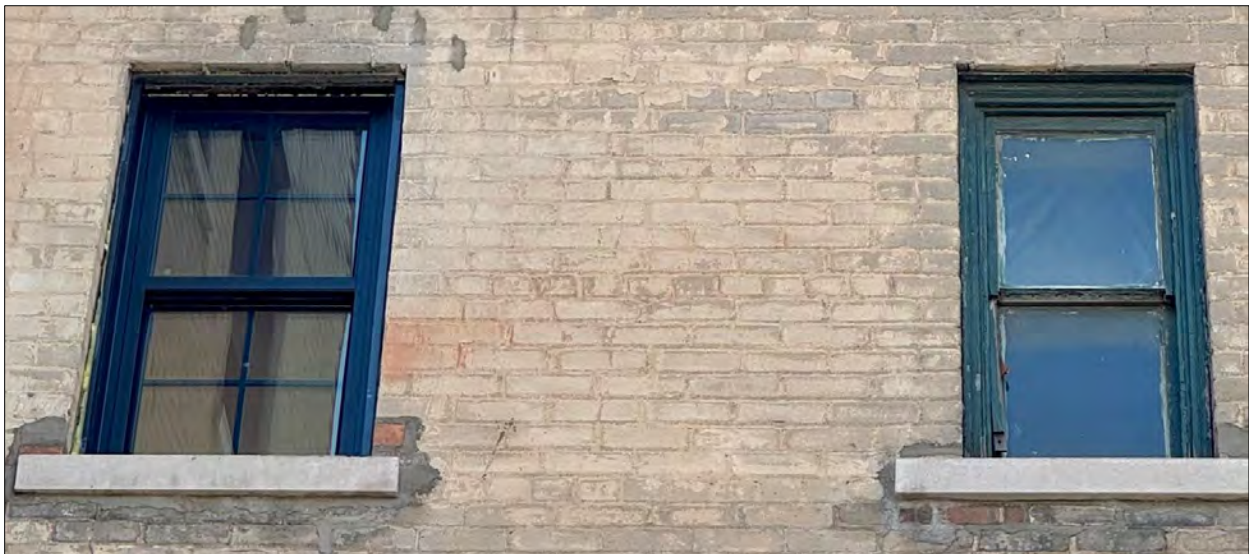
- The above photos show that traditional lime mortar was likely not used to repair areas of the interior courtyard/lightwell walls. It also appears some portions of the wall has been previously painted, but the flaking paint reveals the original brick color to be a similar light color.

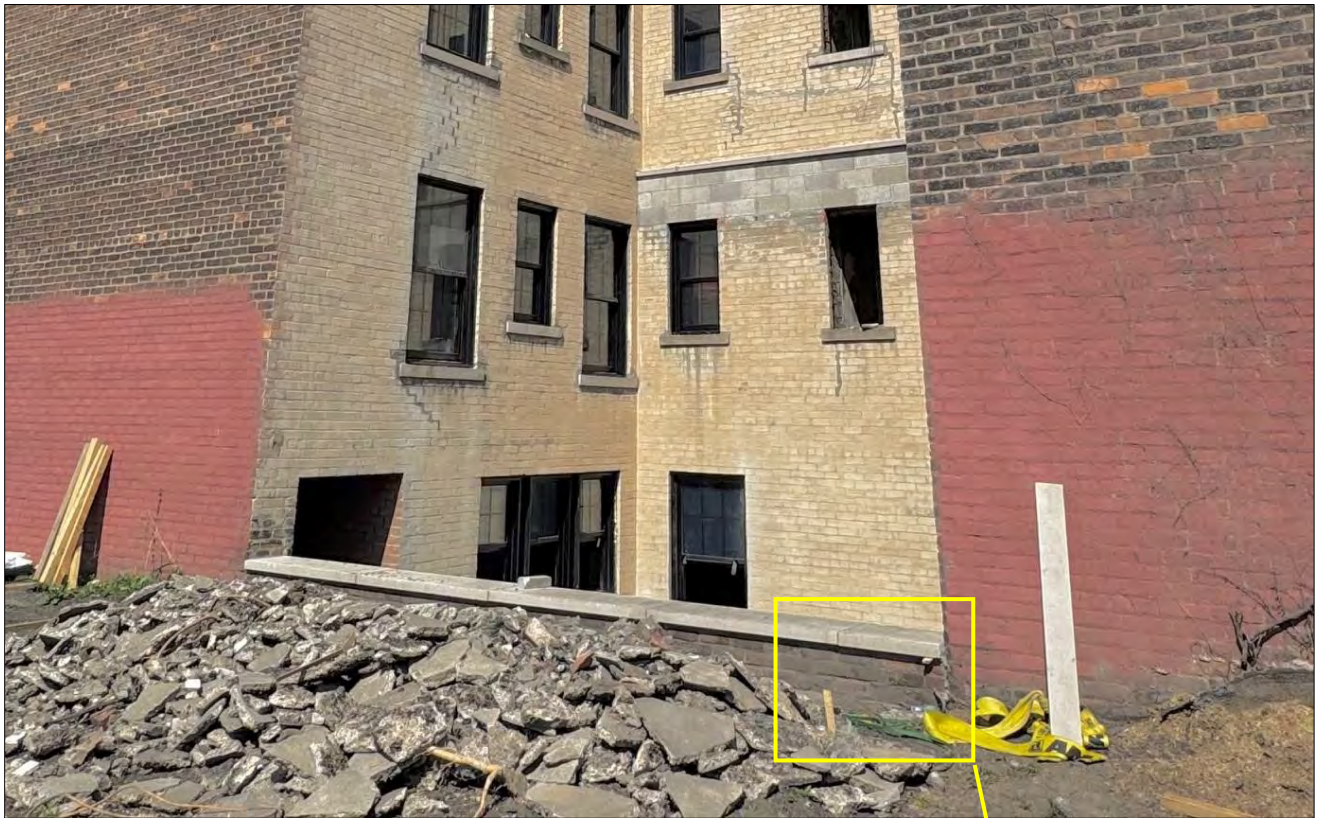
Central lightwell. The new retaining wall is clad with at least four courses of brick. Staff photo, 04/22/2026.

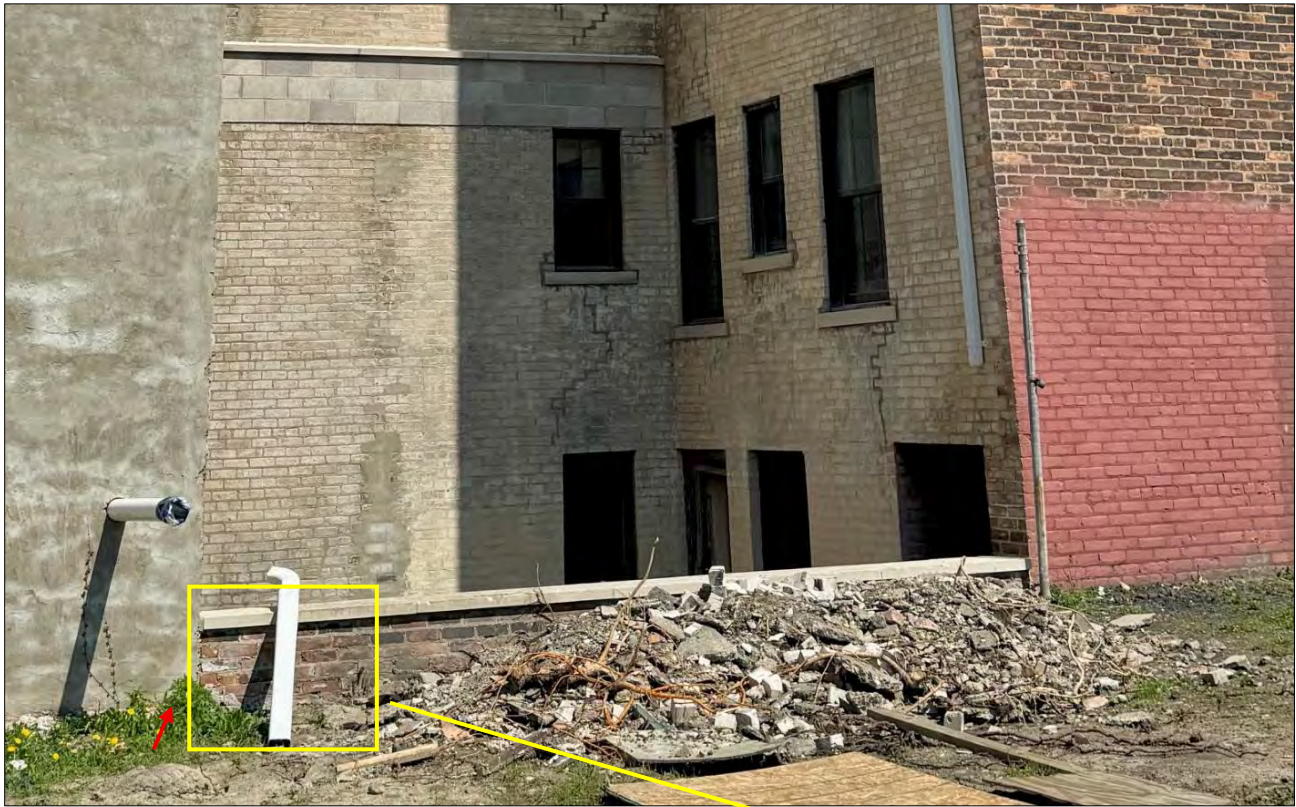
*Rear lightwell. The new retaining wall is clad with five-to-six courses of brick. Current grade is substantiated by the remaining grass at the base of the outer building walls. Staff photo, 04/22/2026.*

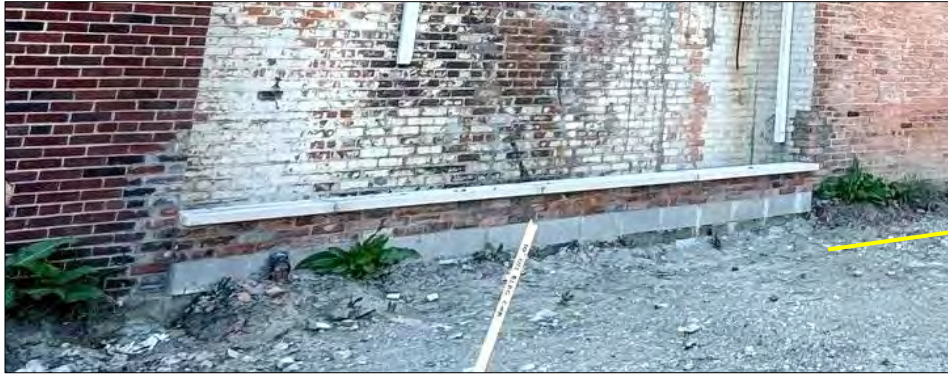
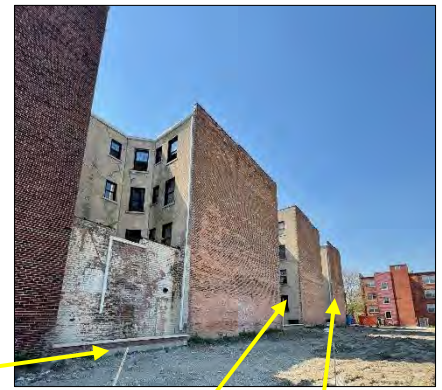
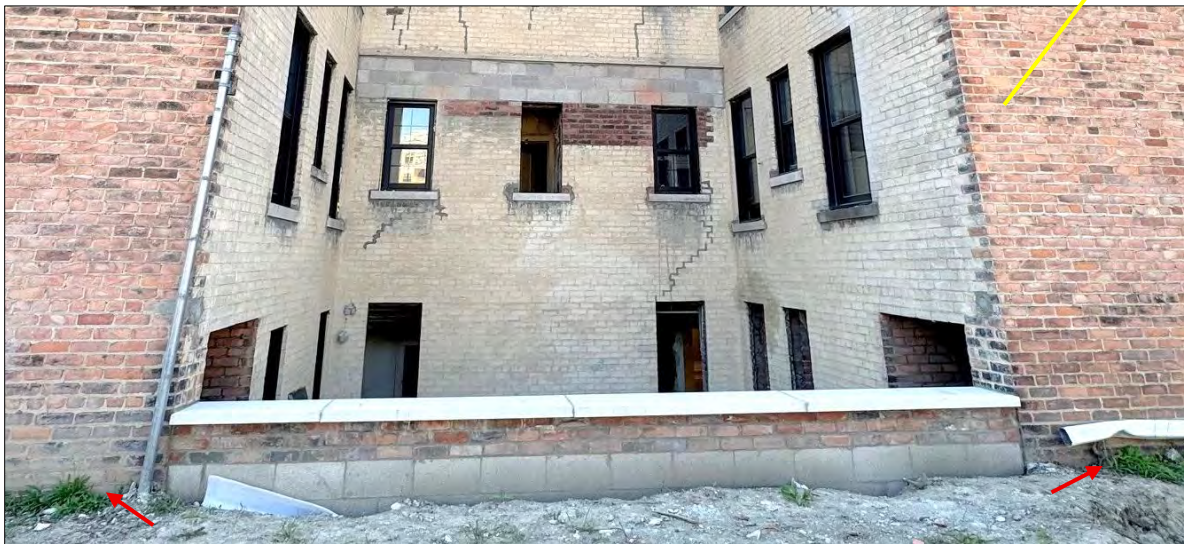
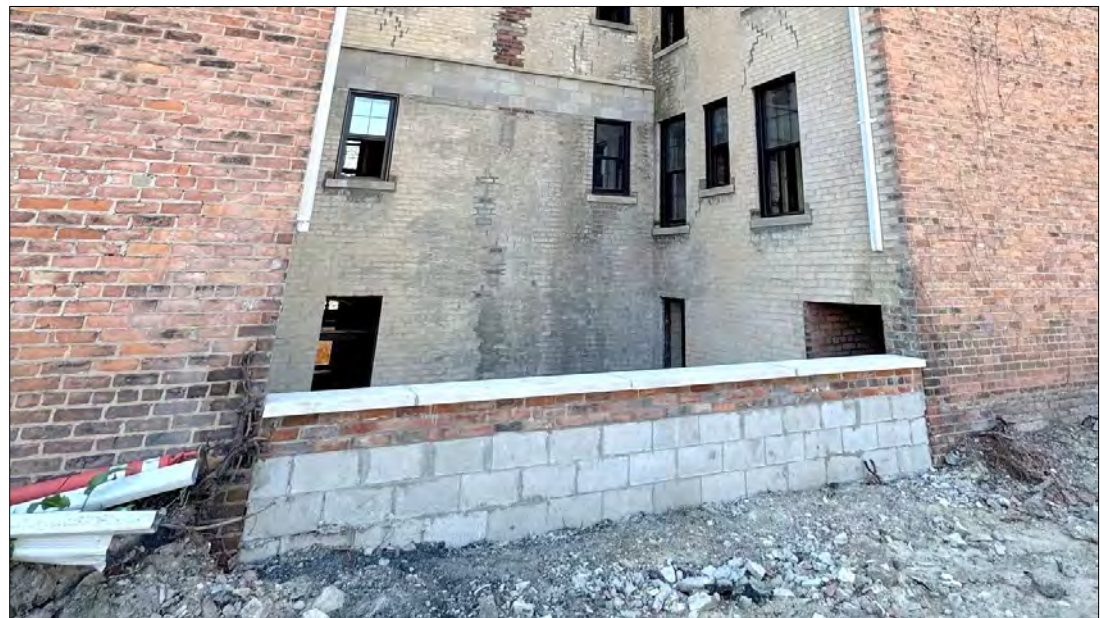
*Top right: View of east side of building. Staff photo, 04/30/2026.*  
*Top: Retaining wall at front lightwell, between the front and center-front bays.*  
*Middle: Retaining wall at center lightwell.*  
*Bottom: Retaining wall at rear lightwell. Staff photos, 04/22/2026.*

- In the close-up photos of the five retaining walls (evident by the remaining weeds in the mostly undisturbed surrounding ground visible in the photo on page 12 and the middle photo on this page), the current ground surface appears to be below the top three courses of brick.

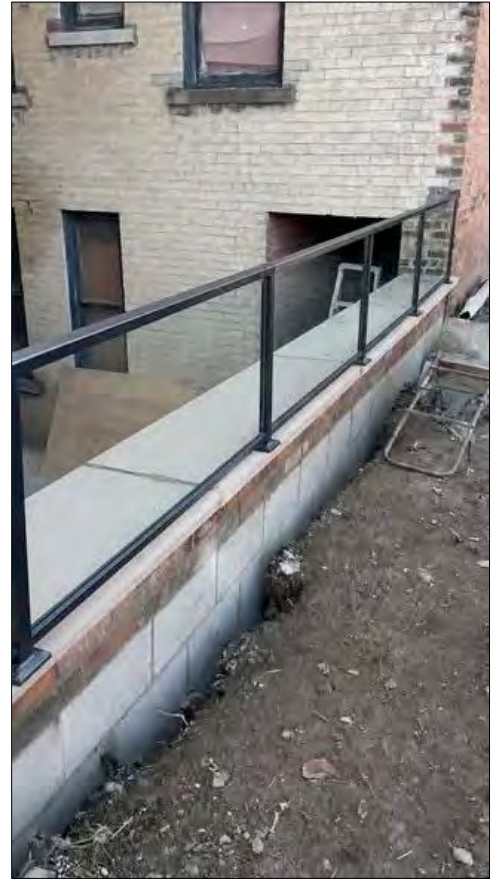
- The use of CMU block on these walls, however, is not compatible material for use at a historic location spanning the walls of an early 20<sup>th</sup> century building.

*Above and below: Undated applicant photos. Below is an interior wall view of a newly constructed wall, extending into a retaining wall of a lightwell prior to the installation of cast stone.*

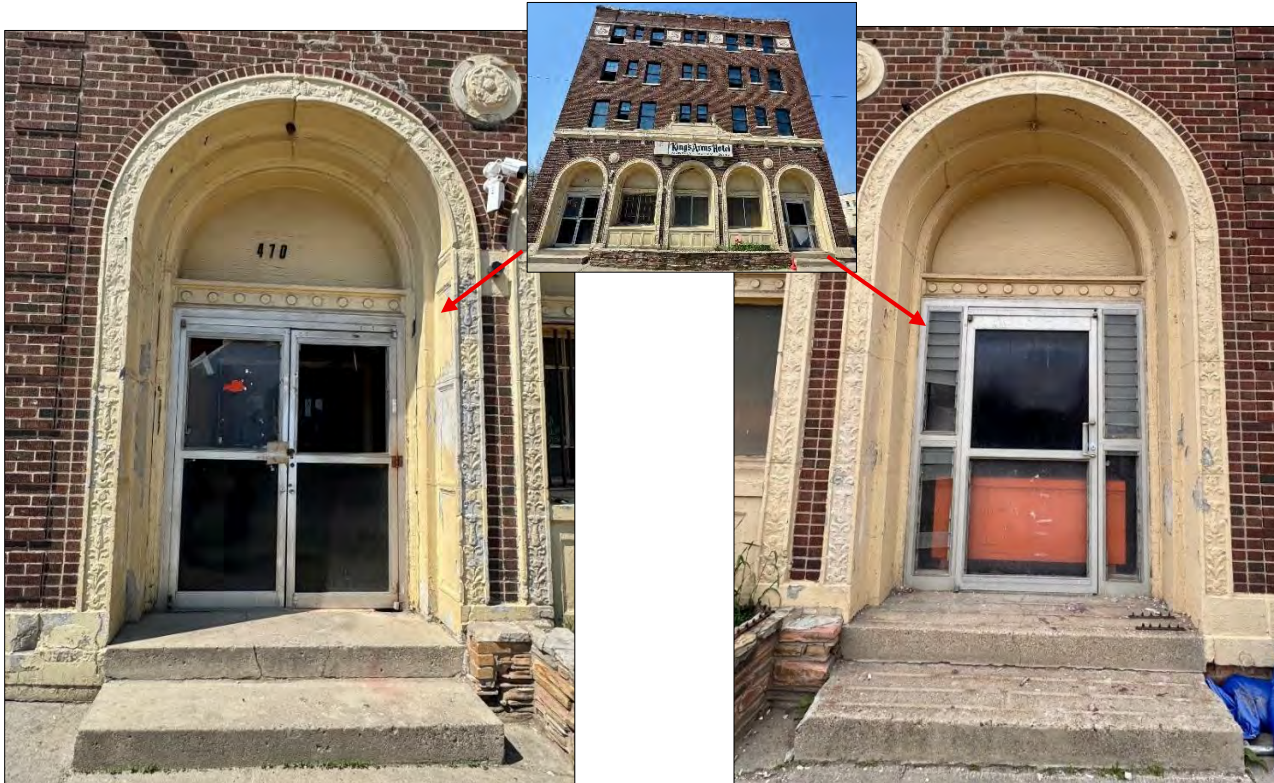
- Currently aluminum storm doors (one with partially missing Jalousie sidelights) fill the building’s outer door openings.

Above: Staff photos of façade and west and east existing exterior entrance doors

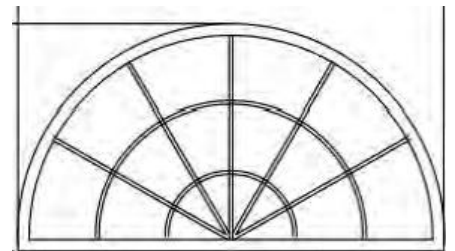
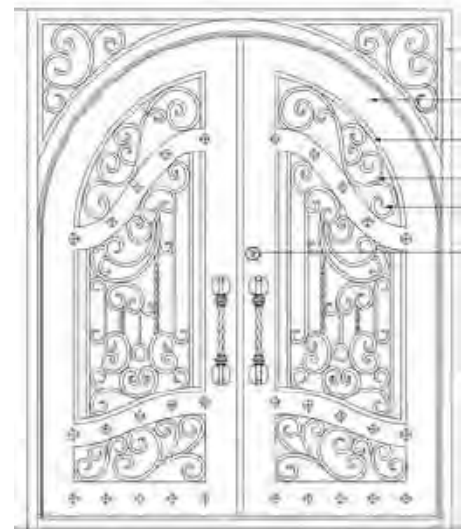
Right: Applicant drawings for half-round transom window openings and outer door openings.

- The adjacent drawings were copied from the applicant’s document “*Compiled Submittal Red*”.
- It is staff’s opinion the ornately designed doors are not appropriate for the Colonial Revival style building as the doors would impart a level of detail not found on the building. The arched windows above each door/window opening at the first floor is a historic component and should not be mimicked in any other opening. The highly decorative, dimensional doors would become focal points, rather than compatible elements deferring to the authentic historic character of the building.
