SR-2 – ADVISORY STAFF REPORT (06-05-2026)

ADDRESS: 4254 TYLER

APPLICATION NUMBER: HDC2026-00252

SCOPE: REHABILITATE DWELLING (SOME WORK COMPLETED WITHOUT APPROVAL),
REPLACE WOOD WINDOWS WITH VINYL WINDOWS

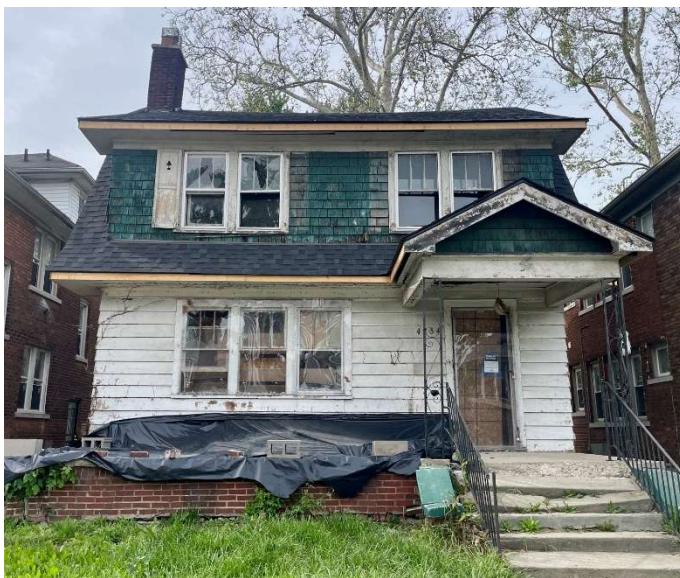
- The applicant stated that “The existing historic wood windows at the property are currently in deteriorated condition due to prolonged exposure, deferred maintenance, and water intrusion. Several windows show signs of rot, damaged glazing, broken panes, failing sash components, and deterioration of surrounding trim and framing materials.”

Staff photo, 05-26-2026, showing existing conditions

- The Elements of Design (Sec. 21-2-168) mention “wood is almost universally used for window frames and other functional trim.” And “windows are commonly either metal casements or wooden sash.” In this case, the wood windows provide important character that contributes to the building’s historic appearance.
- The wood windows are distinctive, character-defining historic features that mostly have not proven to be beyond feasible repair.
- Some of the conditions described, such as damaged glazing and broken panes, will impair their operation, but are reasonably repairable.

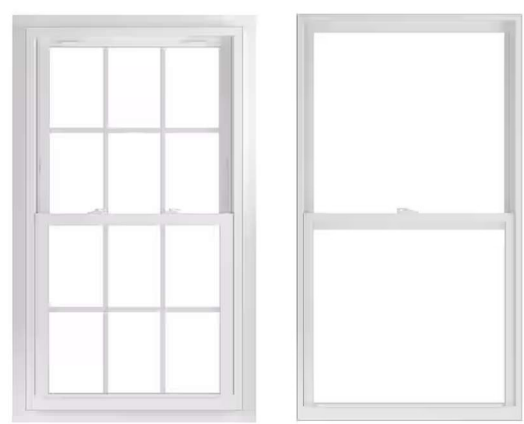
Location: façade

Location: sides & rear

*American Craftsman
Double-Hung
Grids between the glass*

*American Craftsman
Single-Hung*

- Even if the historic window repair is found infeasible, the installation of the vinyl windows does not follow the [Historic District Commission’s ‘Historic Wood Window Guidelines’](#) or the [NPS ‘Replacement Windows that Meet the Standards.’](#) As stated in the NPS’ guidelines for replacement windows, “When historic windows exist, they should be repaired when possible. When they are too deteriorated to repair, selection of the replacement windows must be guided by Standard 6. Design, visual qualities, and materials are specific criteria provided by the Standard that are pertinent to evaluating the match of a replacement window. Evaluating the adequacy of the match of the replacement window involves the consideration of multiple issues.” Specifically, referencing the factors to consider in evaluating the match of a window:

1. The historic wood windows are distinctive, character-defining features that were not proven to be beyond repair.
2. The proposed windows do not match the old in design, texture, materials, and other visual qualities.
3. Due to their plasticity, flatness, detracting color/sheen, component profiles, and poor material quality, consumer-grade vinyl windows are incompatible with the building's overall historic character and do not exhibit an appearance consistent with the general characteristics of a historic window of the same type and period, as required by National Park Service Guidance.

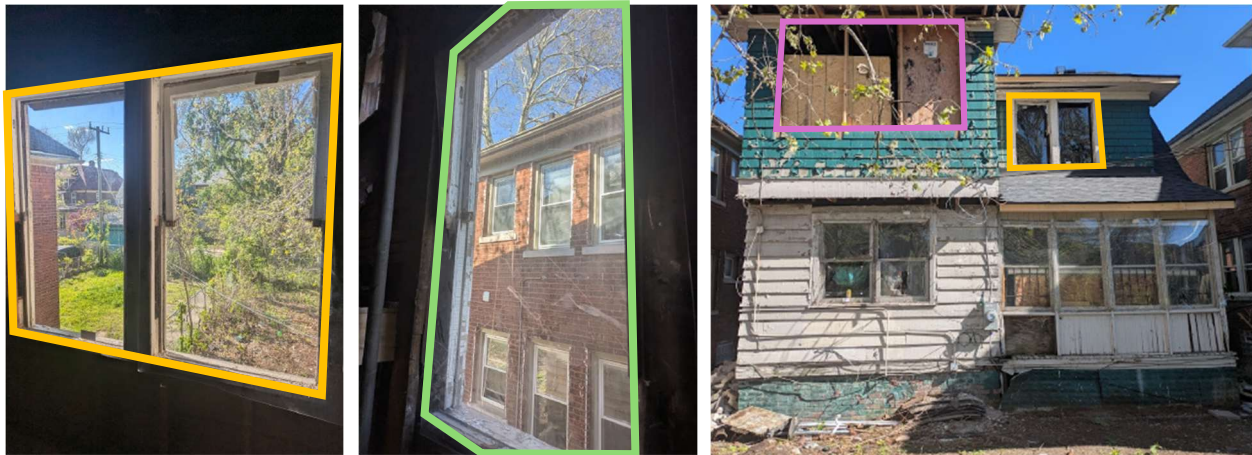
Photos from application, outlines by staff

- It is staff’s opinion that the windows shown are beyond repair or missing altogether. Where the existing window is beyond repair or missing, the replacement should be compatible with the architectural design of the structure. Staff has the authority to approve of the installation of historically appropriate replacements in original historic openings, where windows are missing entirely.

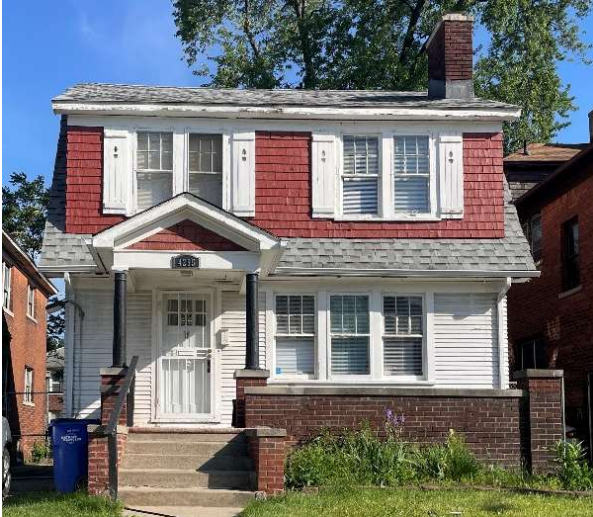
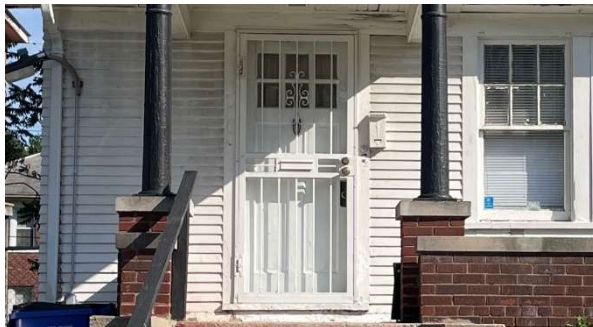
4255 Tyler, 6-lite over 2-panel wood door

- Staff has the authority to approve of the installation of historically appropriate replacements in original historic openings, where doors are missing entirely.
- It is staff's opinion that the proposed front door is inappropriate, especially given its reference to contemporary style doors with the 6-panel style.
- During field observations for the Russell Woods-Sullivan Historic District, staff identified houses of a similar architectural style with historic front doors: multi-lite over 2-panel wood doors.

1. The proposed paint, window, and gutter/downspout colors are to follow the Historic District Commission Color System C.
2. A new design for the replacement wood door incorporating 6-lite over 2-panels shall be selected and submitted to staff for review and approval.
3. Dimensioned drawings for front porch railing will be submitted to Staff for approval.

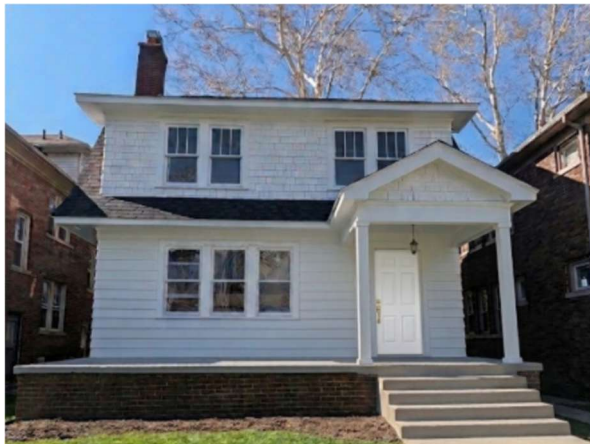
- The proposed paint color, in addition to the proposed white vinyl windows and gutters/downspouts, include A:1 Yellowish Gray.

Photo from application of proposed paint color

- As described in the Historic District Commission Color System C, “For the stucco or clapboard, frame colonial, yellow was the most popular body color, although gray or blue was used. Normally these were then trimmed with white or ivory on the cornice, cornerboards, window frames, sash, etc., depending on which gave the lesser contrast.” Although the colors leaned toward pastels and low-contrast, houses of this style and era weren’t typically one color throughout.
