STAFF REPORT: JULY 8, 2020 MEETING

APPLICATION NUMBER: 19-6733

ADDRESS: 677 W. CANFIELD

SCOPE OF WORK: REHAB BUILDING, REPLACE SIDING AND TRIM, REBUILD FRONT PORCH

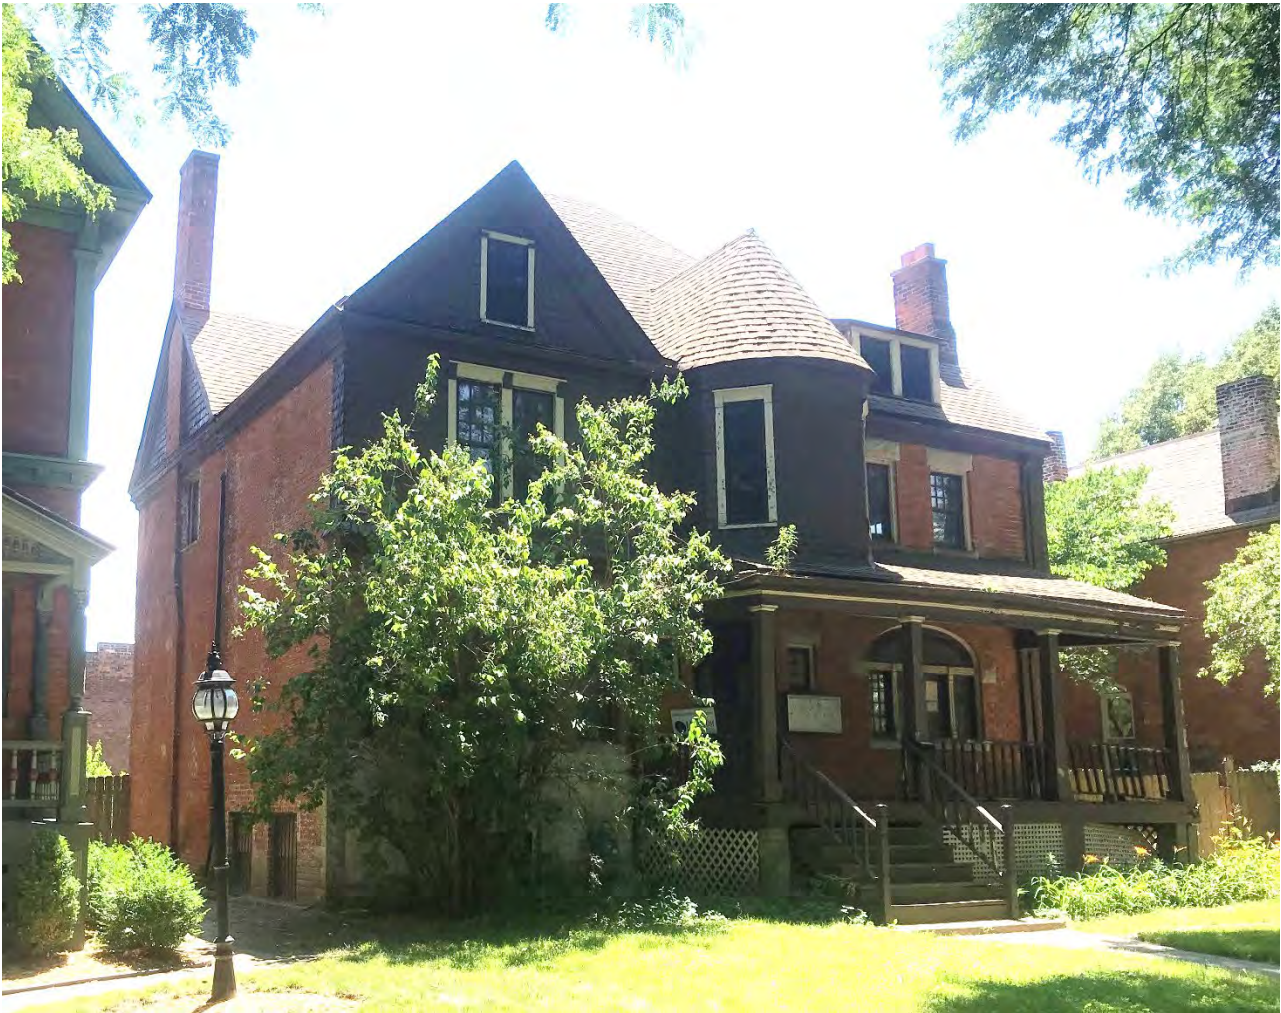
Staff Photo, 7-1-2020

The 2-1/2 story home at 677 West Canfield was built in 1875. It is located on the south side of the residential street, midblock. The home is primarily composed of red brick and features many character defining features that were popular in the late 19th century, including a centrally located bay window designed to give the appearance of a turret, true divided light windows with stone sills and headers, stained glass windows, ornate trim and scalloped wood shingle siding. The front façade also features a heavier stone application at the lower part of the façade that is not covered by the porch.

The applicant has indicated that the existing exterior wood material shows significant signs of rot and damage, and is showing water infiltration. Exterior photos submitted indicate that some **areas of the trim and siding have experienced significant deterioration**. Note that there are **variations in style, dimension and profile in the trim and siding from previous repairs**. Additionally, the applicant is concerned that the painted areas contain lead, **as testing results indicate**. The applicant is also concerned that the existing paint application has been **excessively applied and poorly maintained**, “giving the shingles and trim a less than desirable look and creates difficulty when matching repaired surfaces.” The applicant has also **submitted interior photos that shows deterioration of interior wood framing as a result of water damage**.

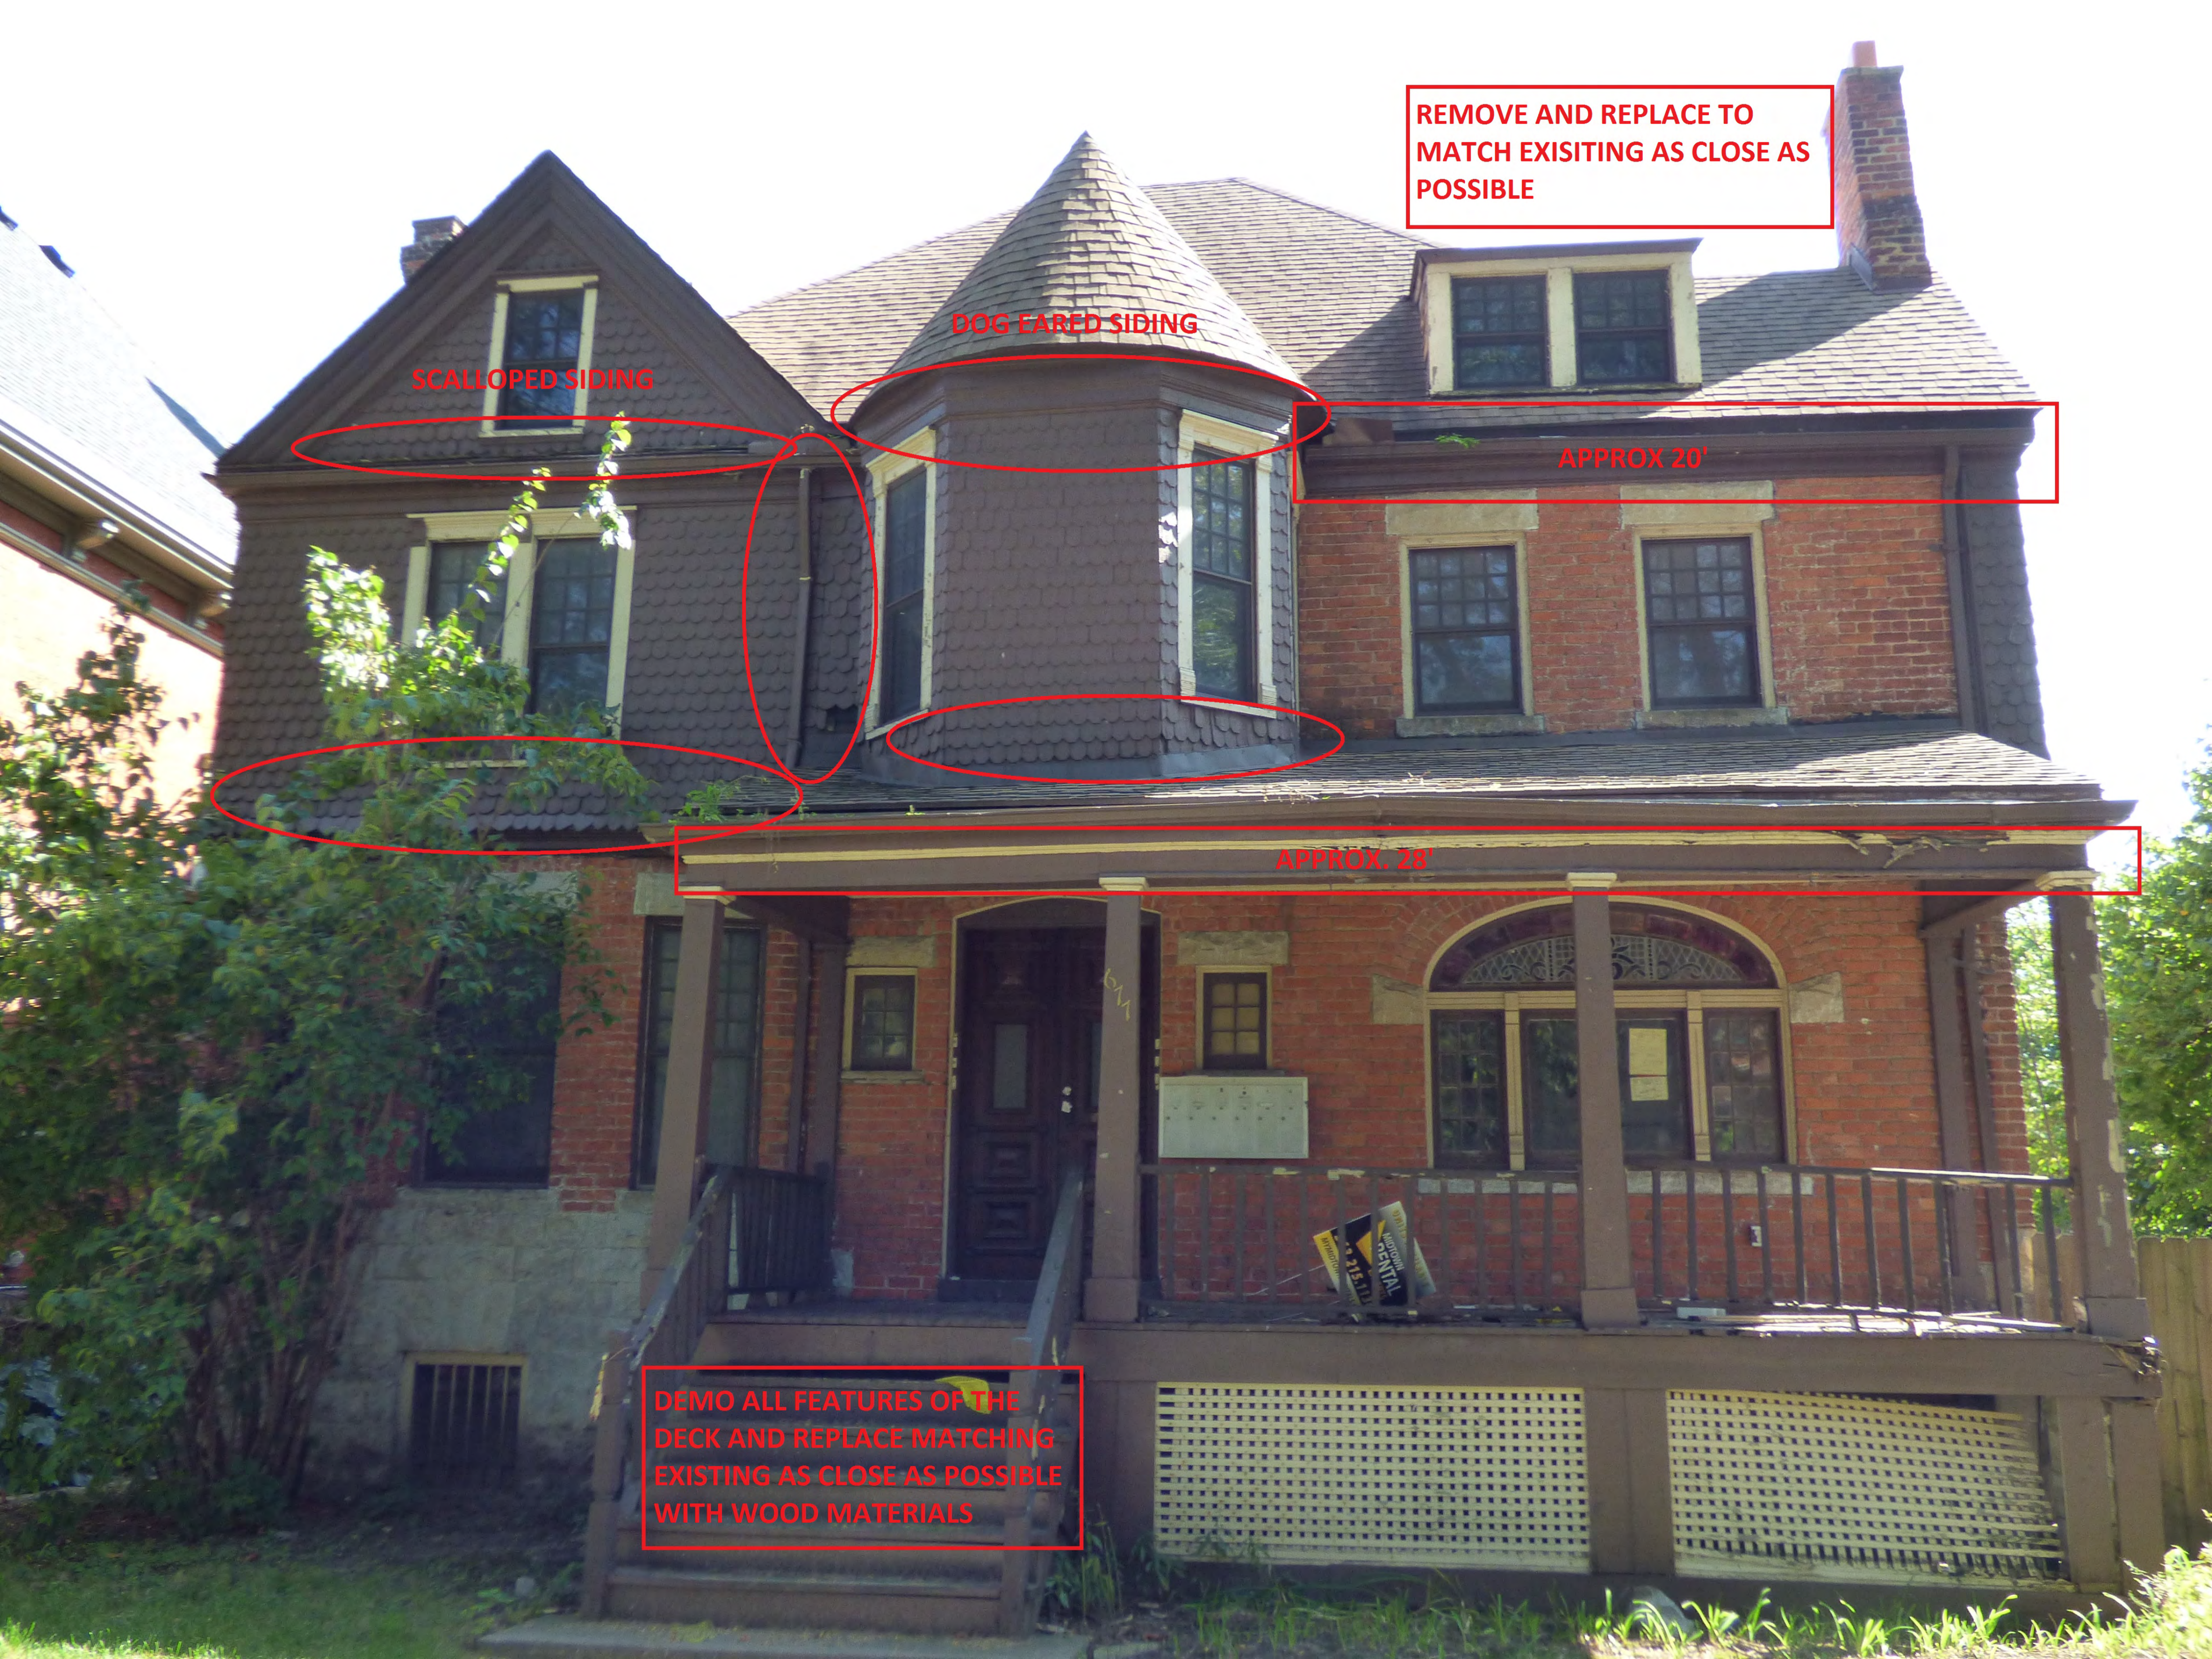
SCALLOPED
WOOD SIDING →
↓

REMOVE AND REPLACE
WITH NEW MATCHING
EXISTING AS CLOSE AS
POSSIBLE

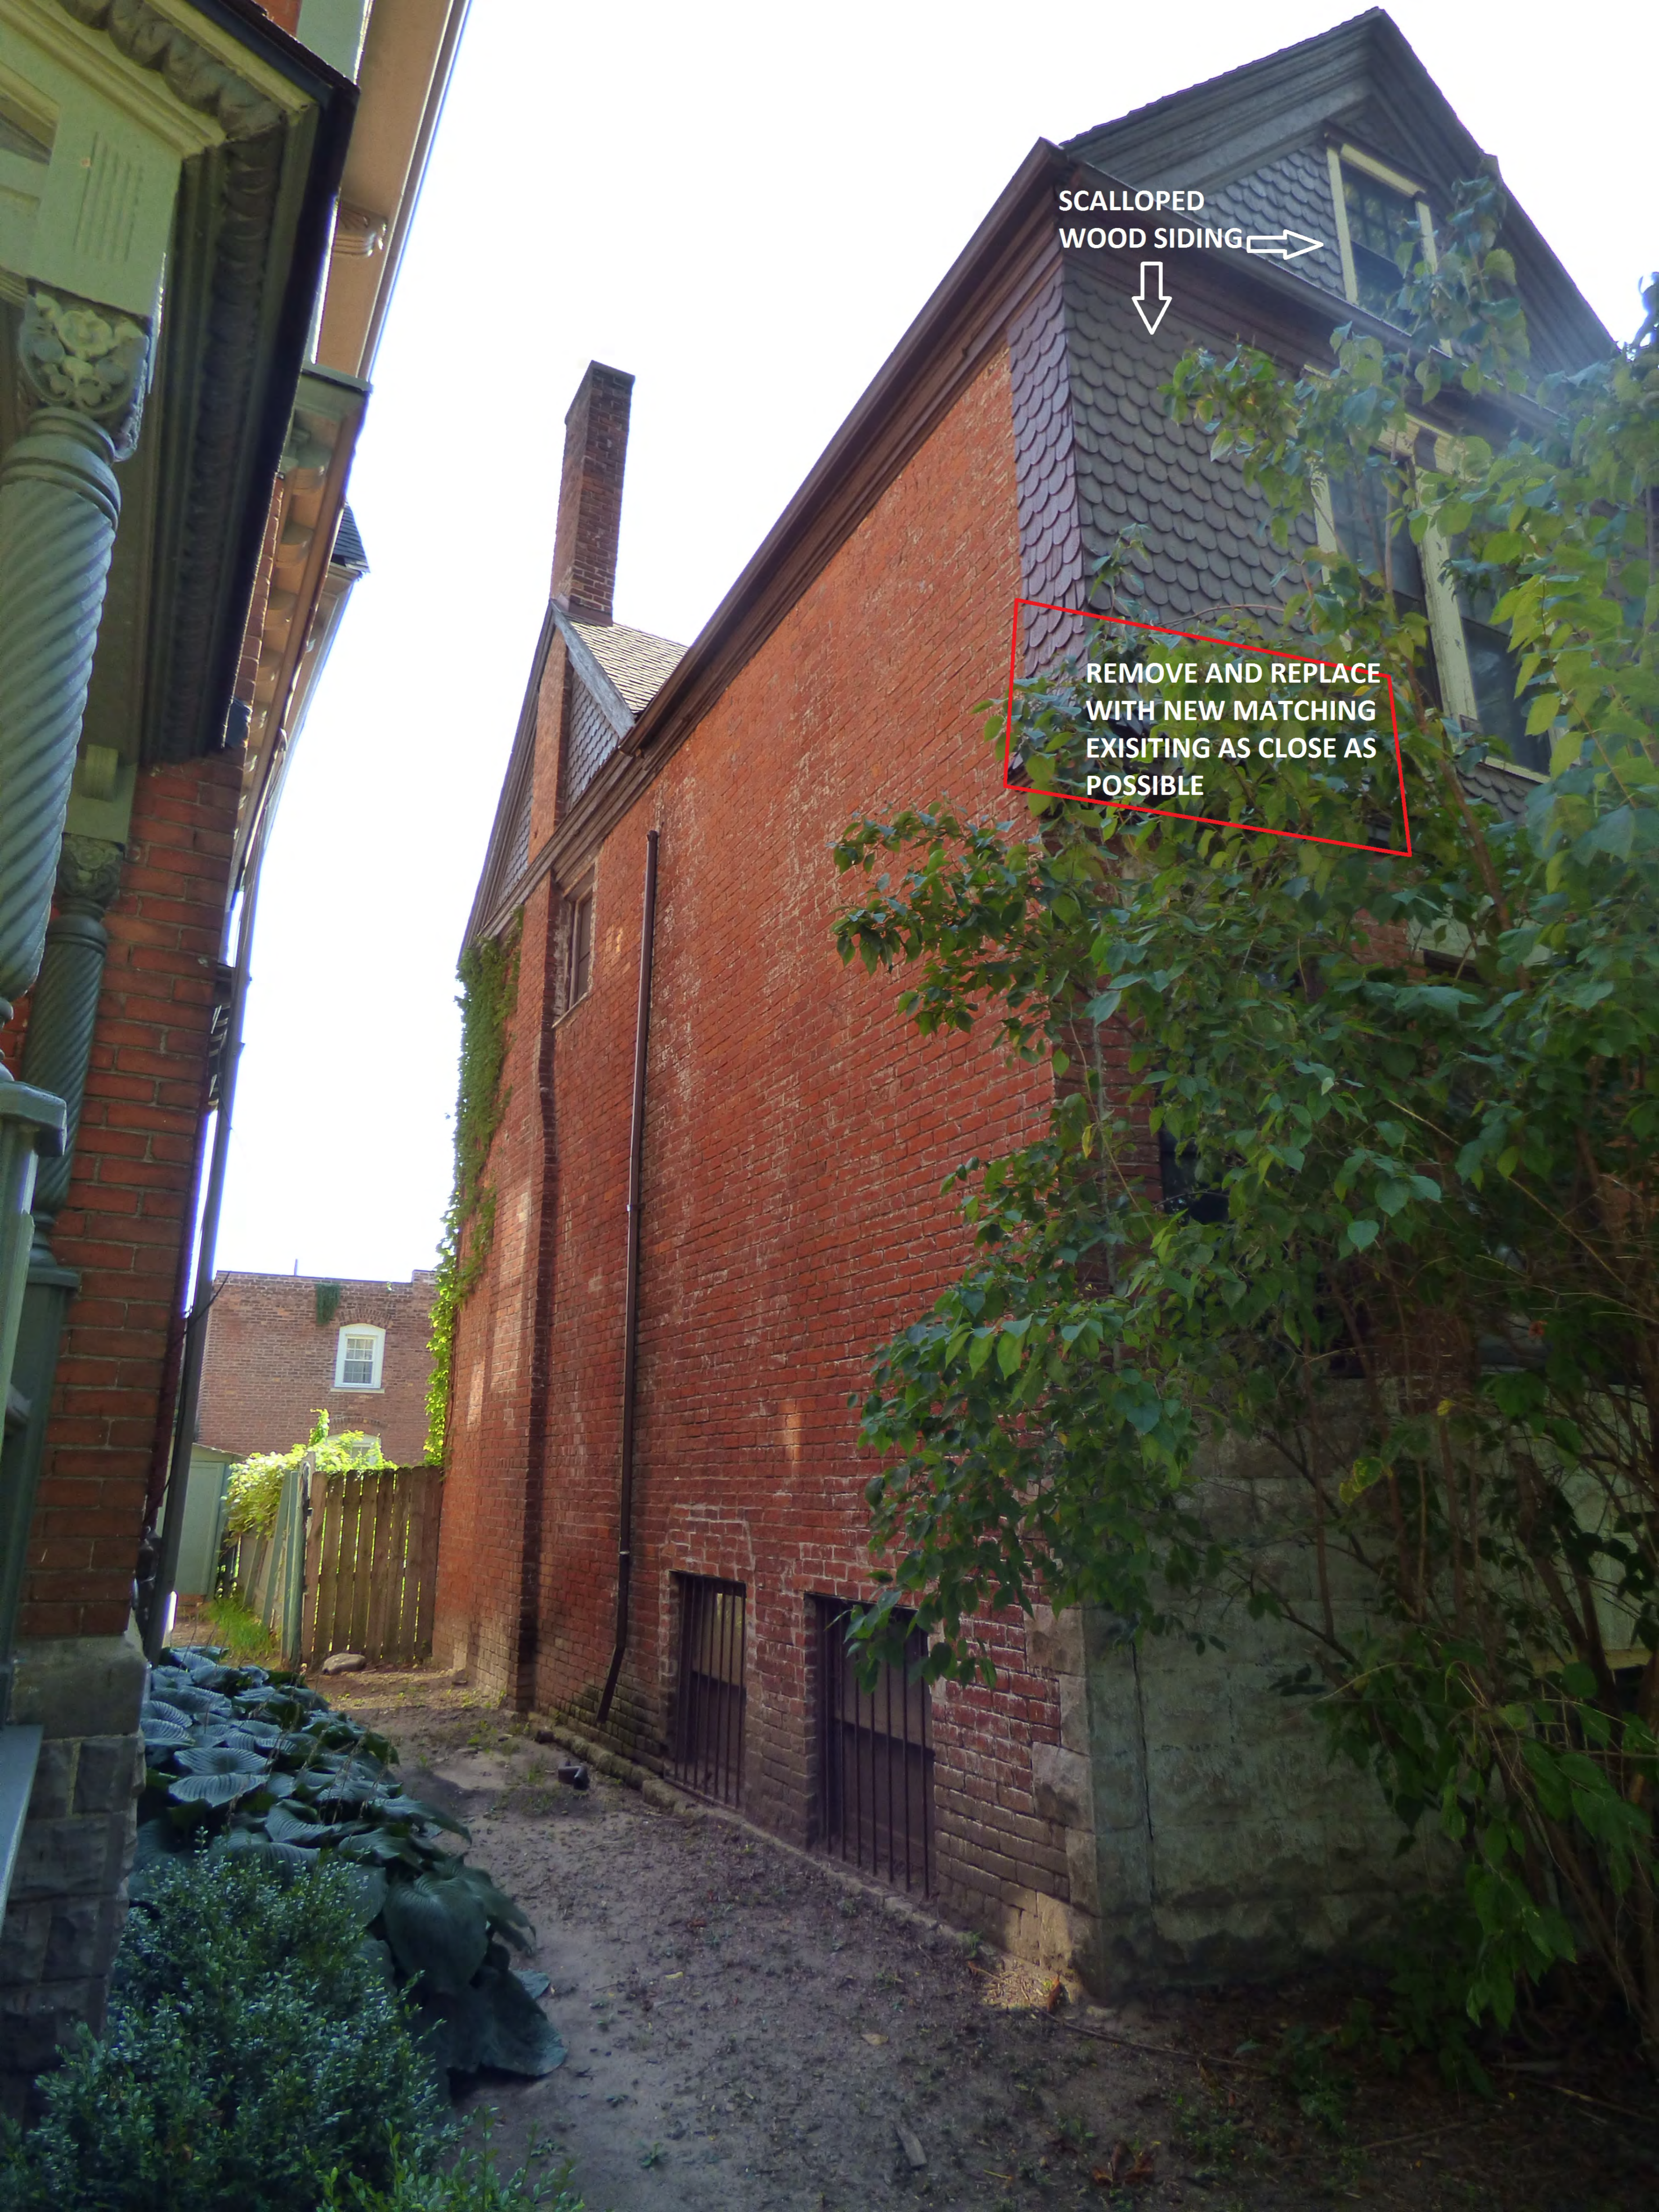
← REPLACE ALUMINUM WITH
WOOD PRODUCT TO MATCH
THE REST OF THE TRIM

REMOVE SIDING AND TRIM
ELEMENTS AND REPLACE WITH
NEW TO MATCH EXISTING AS
CLOSE AS POSSIBLE →

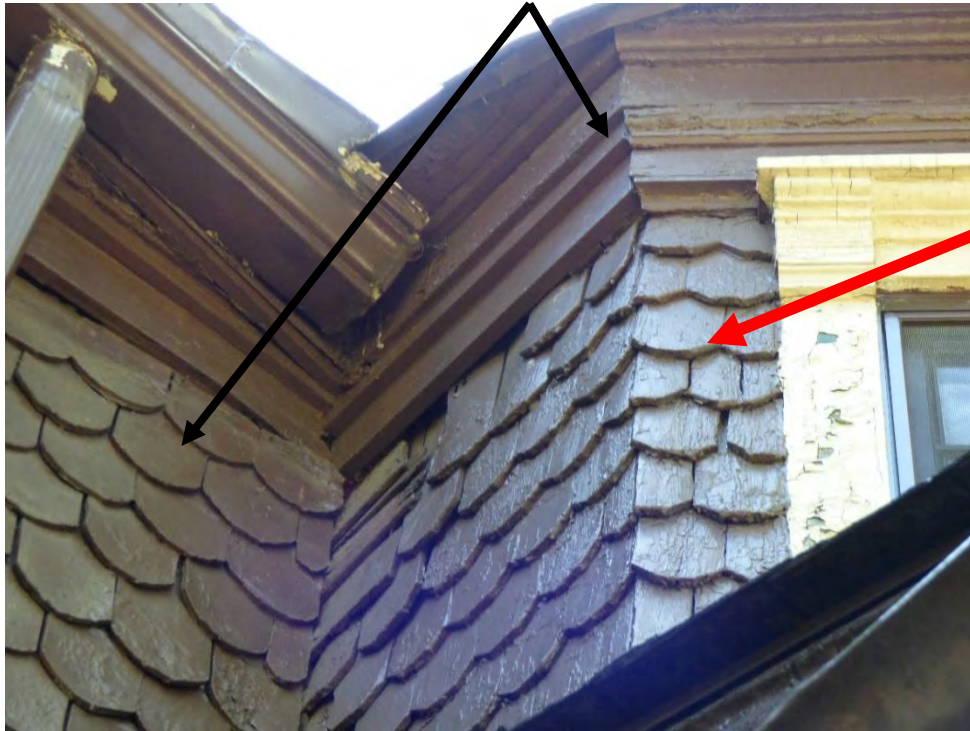
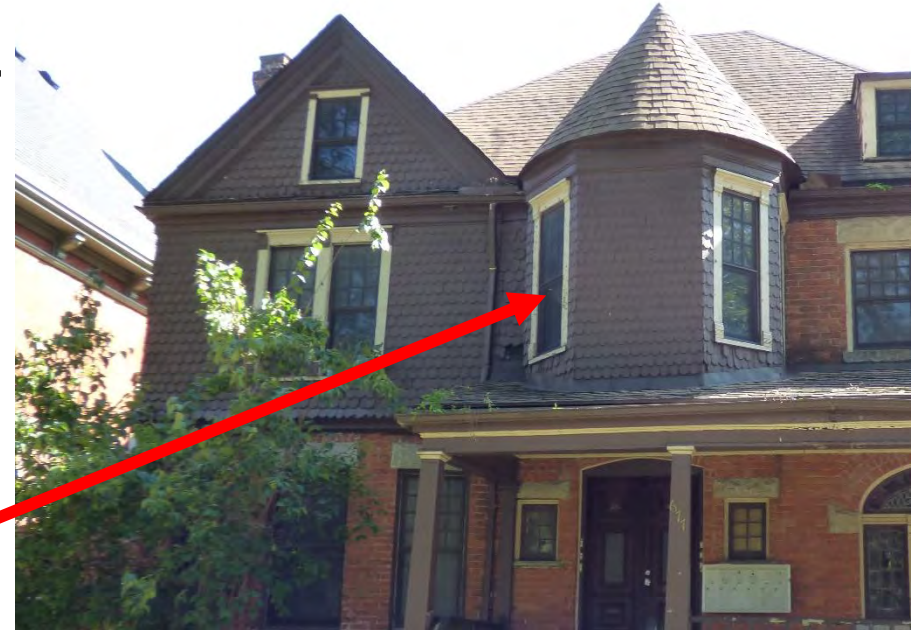
A mismatched repair made with wider scallops between corner and downspout (this will be fixed with new siding) as well as this mismatched trim (about 3ft) to be repaired with salvaged trim materials

Scallop siding at front bay is different than rest of home. It is a straight bottom with angle cut corners with the same exposure and dimensions as the rest of the shingles. We are proposing to use the same scallop siding on the front bay to keep all the siding consistent.

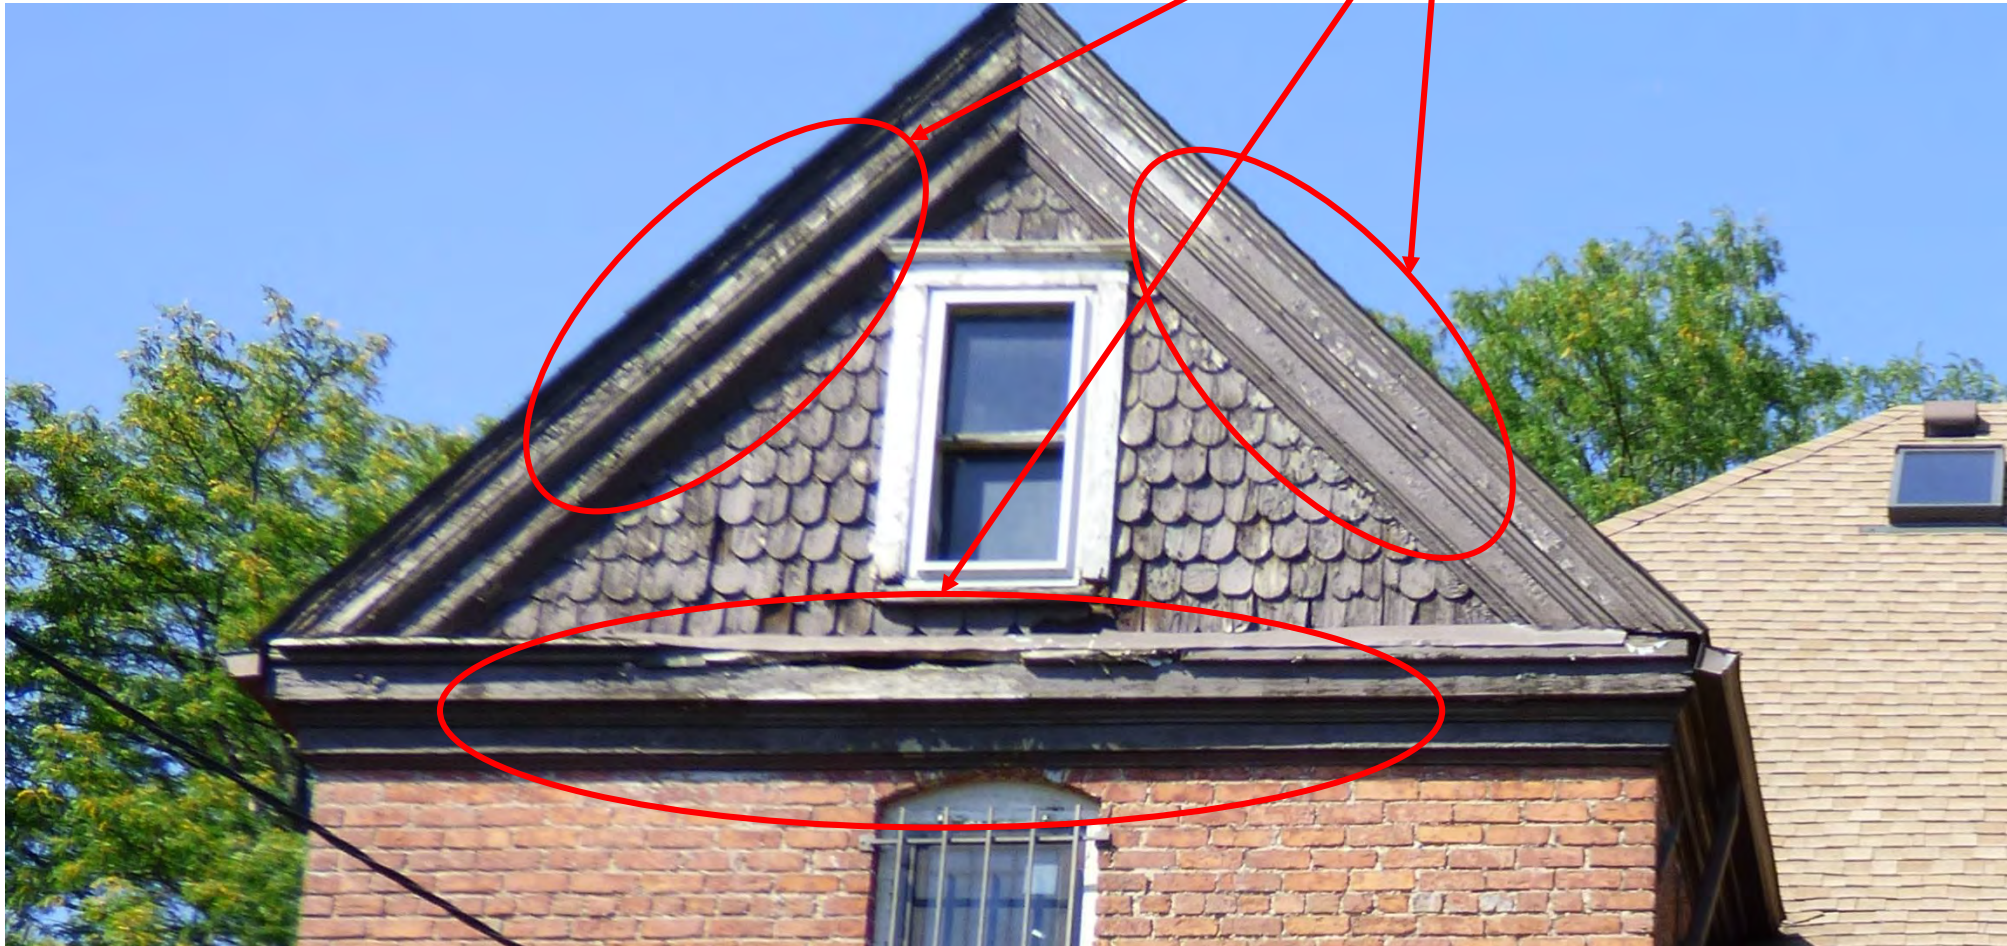
Rear Elevation (3 of 7) :

Remove and rebuilt entire gable trim and fascia that are split, rotten or damaged (about 45 lf) see next page for replica detail

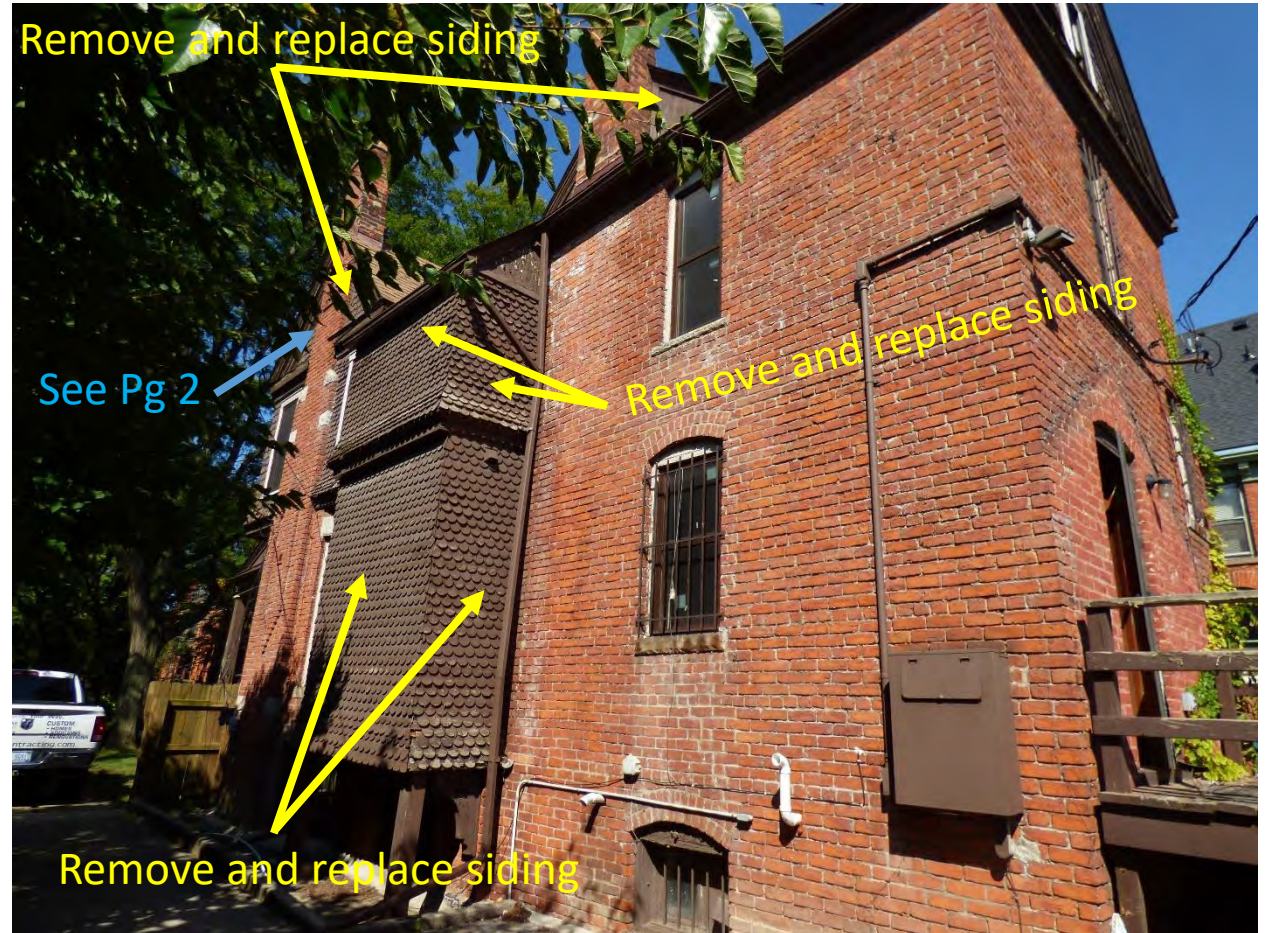
Right Elevation (2 of 4):

Remove and replace with new trim gable trim, approx. 11ft long on each side of chimney and siding (some rot and splitting)

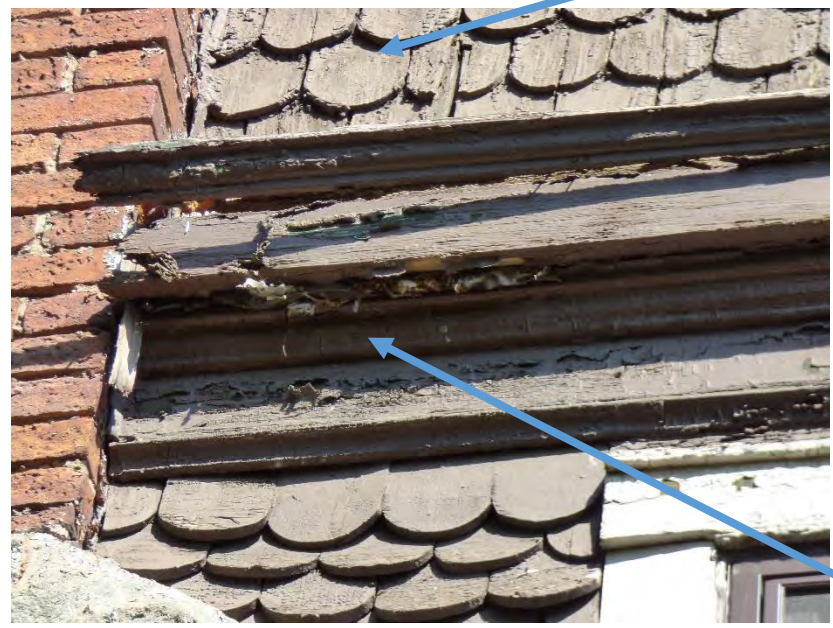
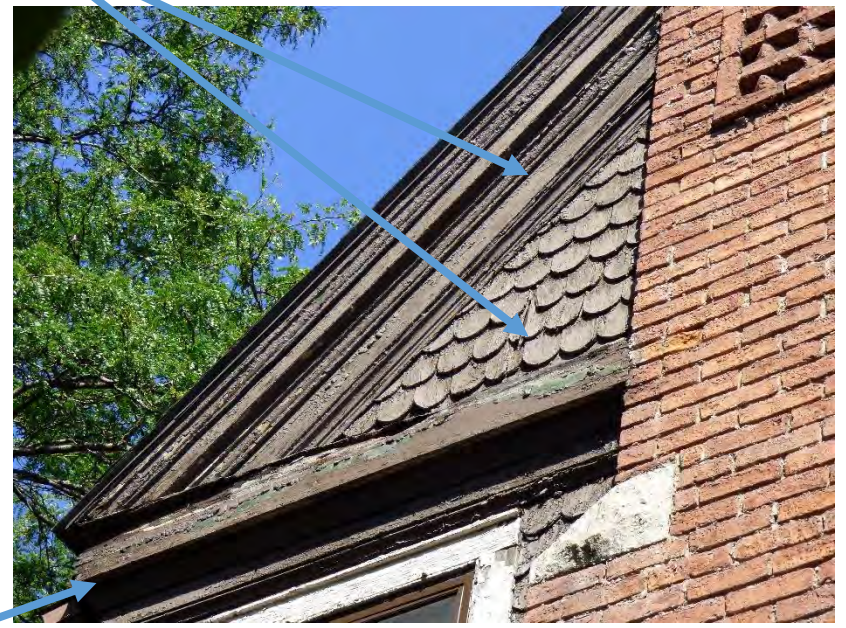
Remove and replace with new trim approx. 8ft long on each side of chimney (rotten and deteriorated)
