STAFF REPORT: 09-08-2021 MEETING

APPLICATION NUMBER: 21-7400

ADDRESS: 630 VIRGINIA PARK

SCOPE OF WORK: REPLACEMENT OF HISTORIC WINDOWS* (WORK COMPLETED WITHOUT APPROVAL)

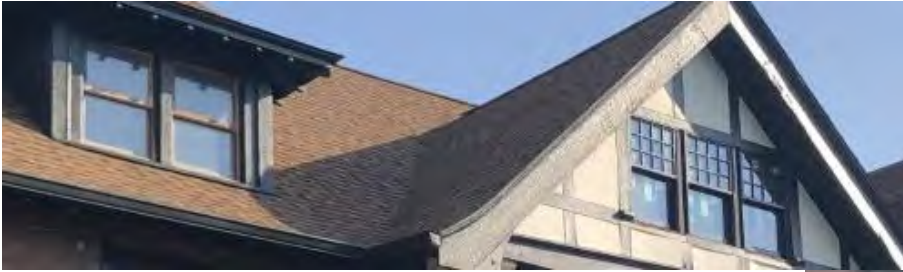
HDC staff photo

- The 1982 HDAB designation photograph shows the double-hung windows on the front elevation, third floor, as having diamond patterned upper sash. The windows in place at the time of the April 2020 review (per the applicant's photo) were one-over-one double-hung wood sash, and have been in place since at least 2007, based on Google street view. *There is no record on file with the city of the HDC reviewing the removal of the diamond paned windows.*

- While drafting this report, HDC staff contacted the applicant and offered the opportunity to include the removal of the diamond paned windows within this application, however the applicant has not responded.
- The recently installed replacement windows within the gable have a twelve-over-one pattern. HDC staff is not clear on the applicant’s reasoning for selecting this muntin pattern. This window pattern alteration does not meet Standards #2 and #5. HDC staff confirmed the selected Pella line offers a diamond muntin pattern.

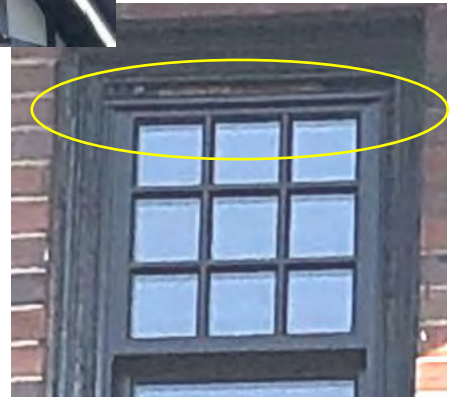
- The two small nine-over-one double-hung windows at the second floor do not fit the existing openings. Infill material has improperly filled the gap between the top sash and window frame.

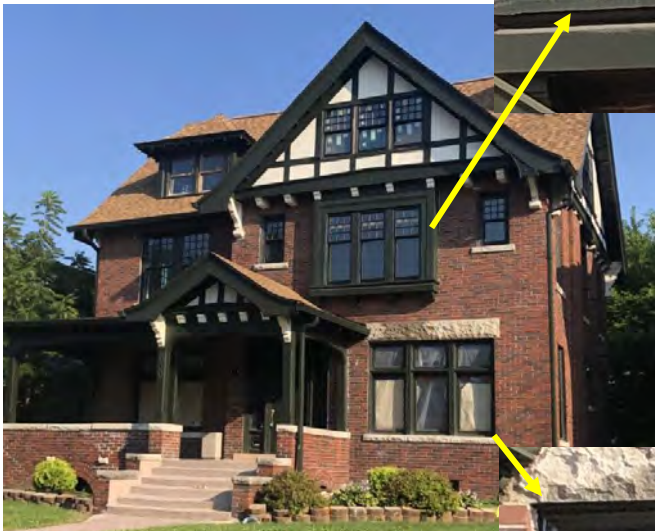
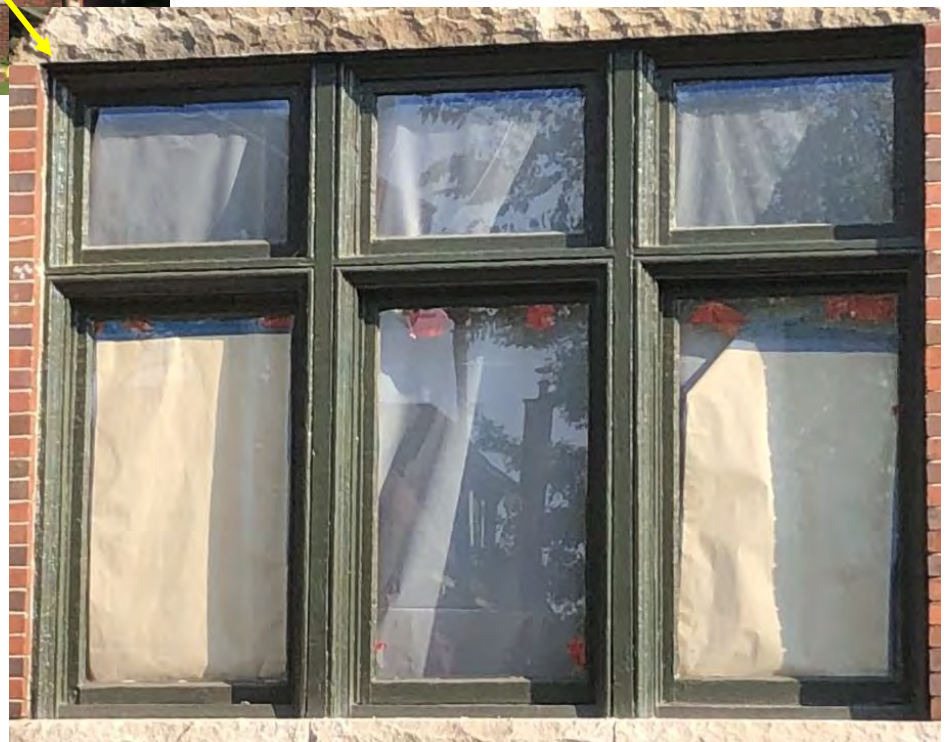
*Front elevation, HDC staff photo
Close-ups show replacement windows
in second floor box bay, and historic
sash remaining in first floor openings.*

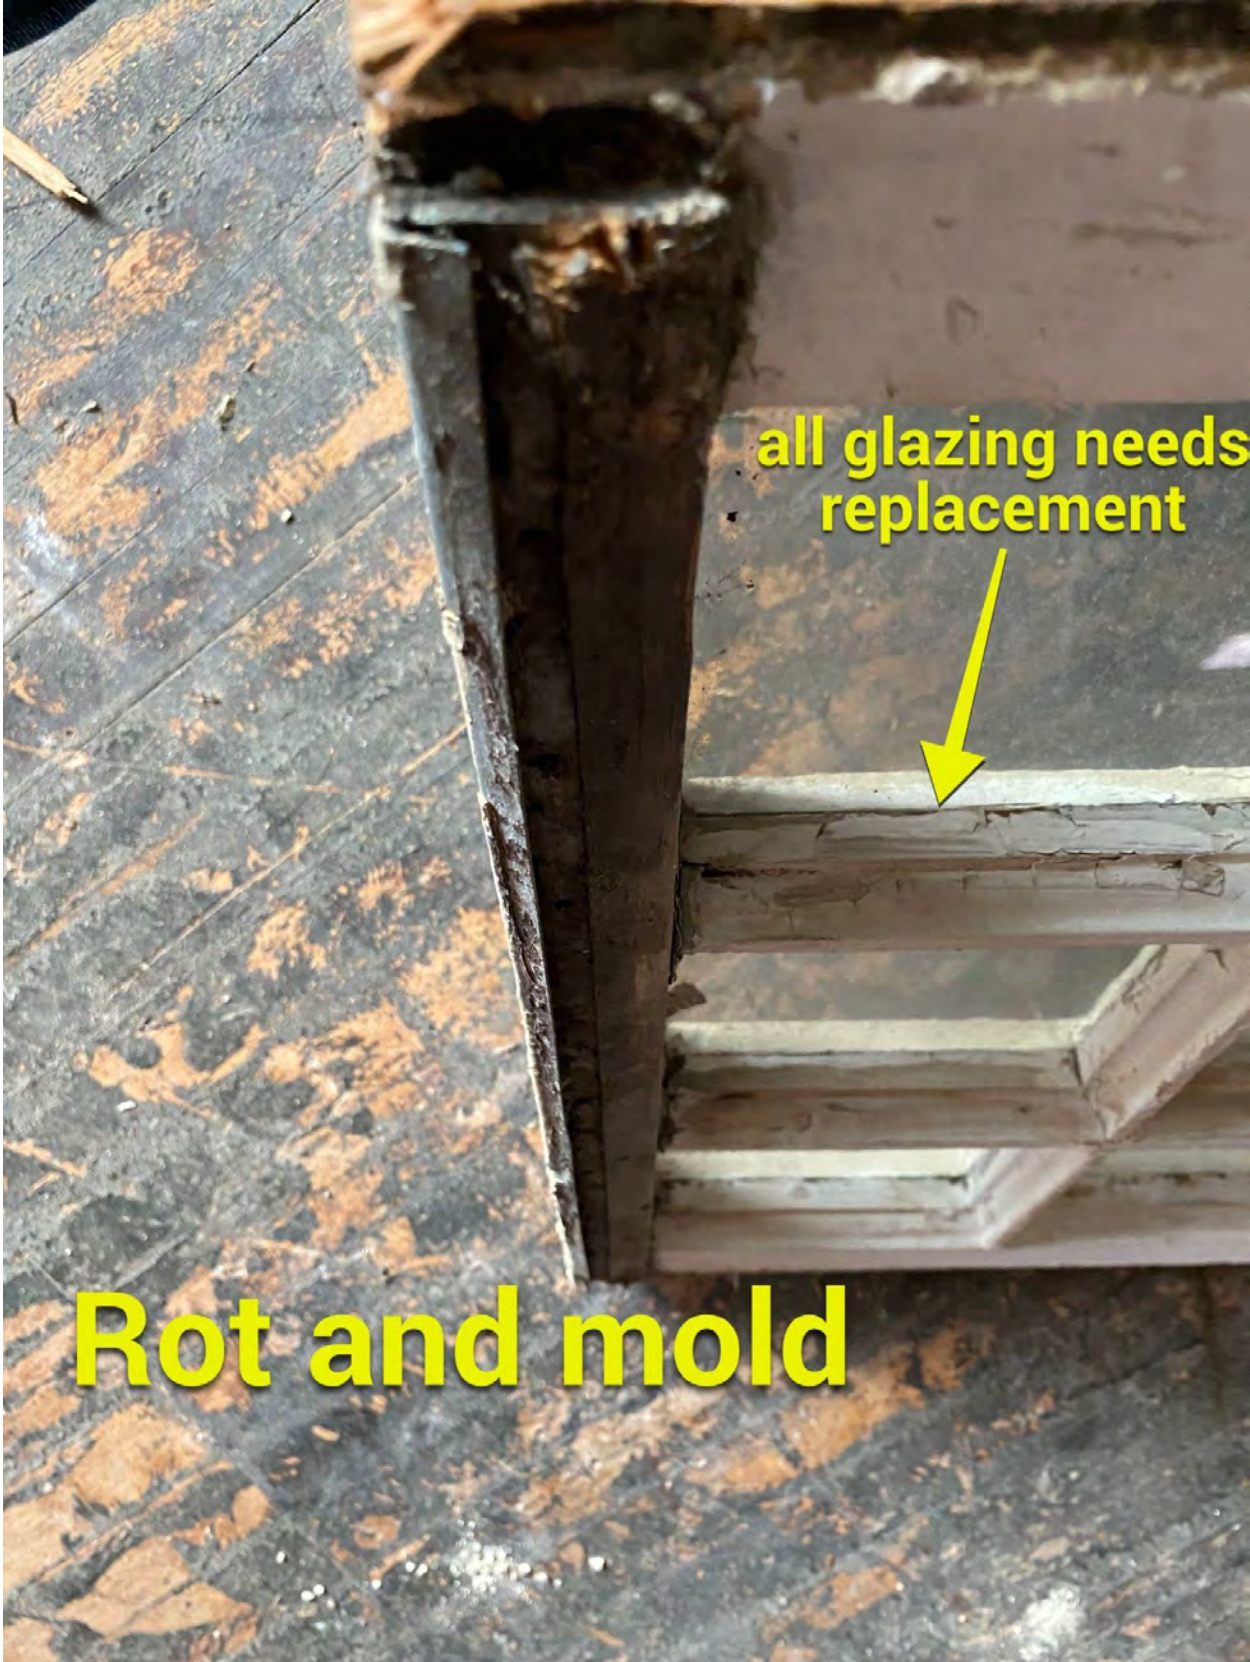
Window 5, 9/1divided light South Elevation

all glazing needs replacement

Rot and mold

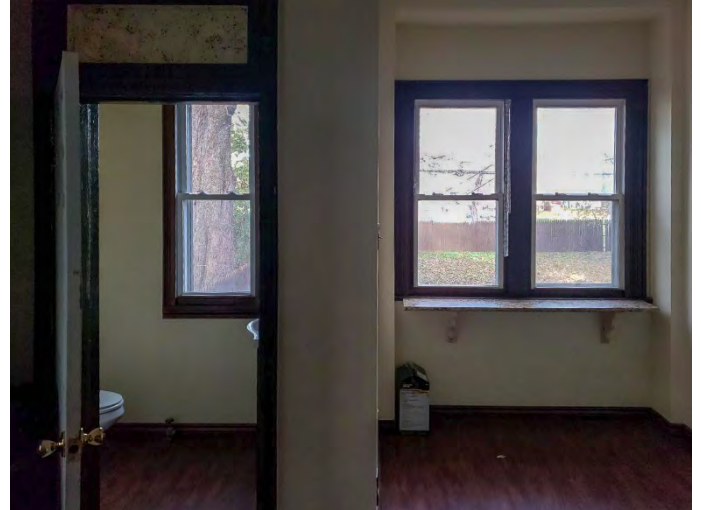
Window 1-03-05 (First Floor, North Elevation, Kitchen)

- Vinyl Replacement Windows

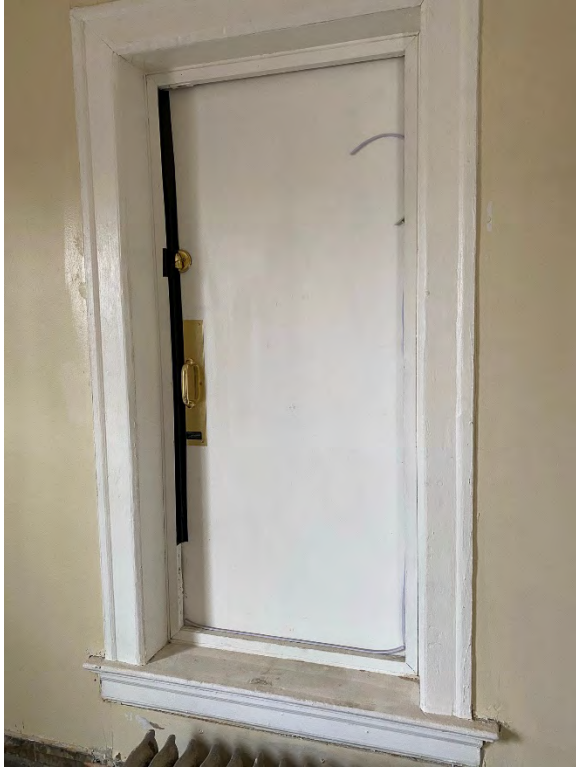
Window 2-10 (Second Floor, East Elevation)

- Currently door to fire escape that will be removed.
- Will be replaced with double-hung window

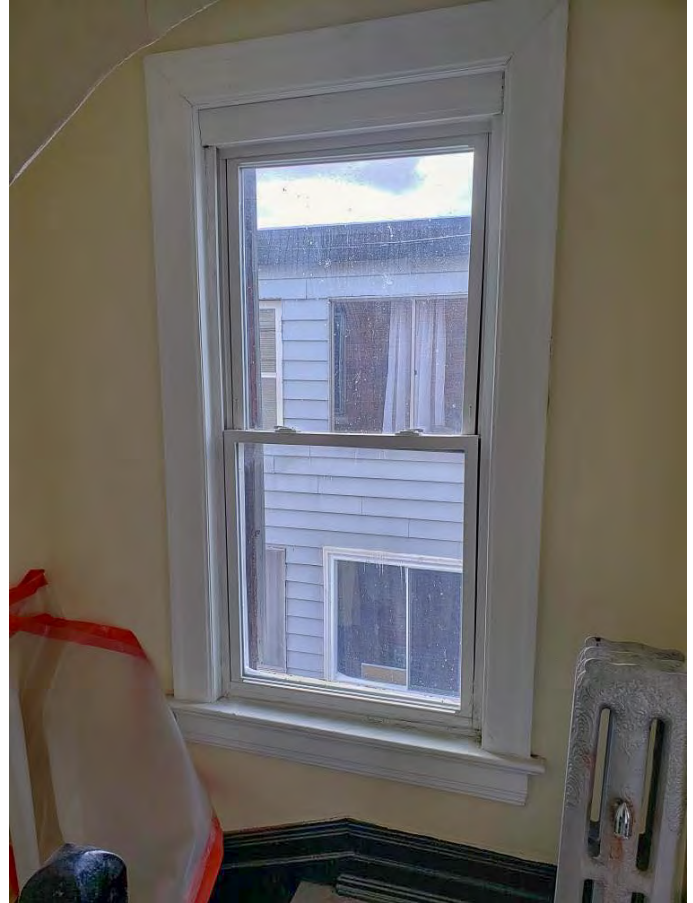
Window 2-11 (Second Floor, East Elevation)

- Double Hung, 1 over 1
- Vinyl Window

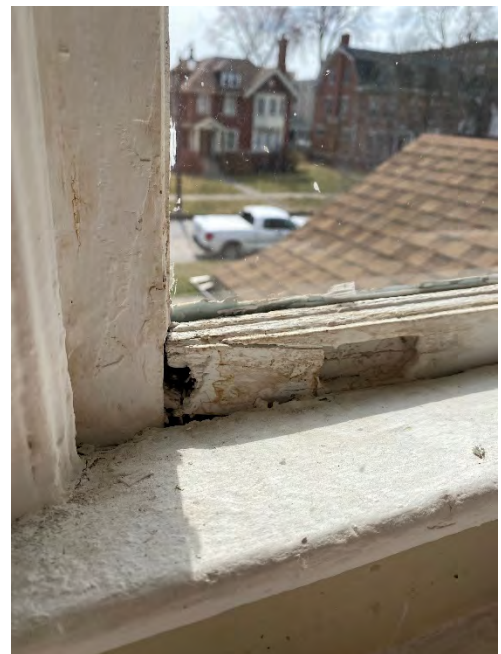
Rot at window sashes
