STAFF REPORT: FEBRUARY 9, 2022 MEEETING

ADDRESS: 1356-1368 LABROSSE

APPLICATION NO: #22-7666

SCOPE: INSTALL TWO NEW DORMERS, REPLACE WINDOWS, REHABILITATE DWELLING AND REMOVE TREES

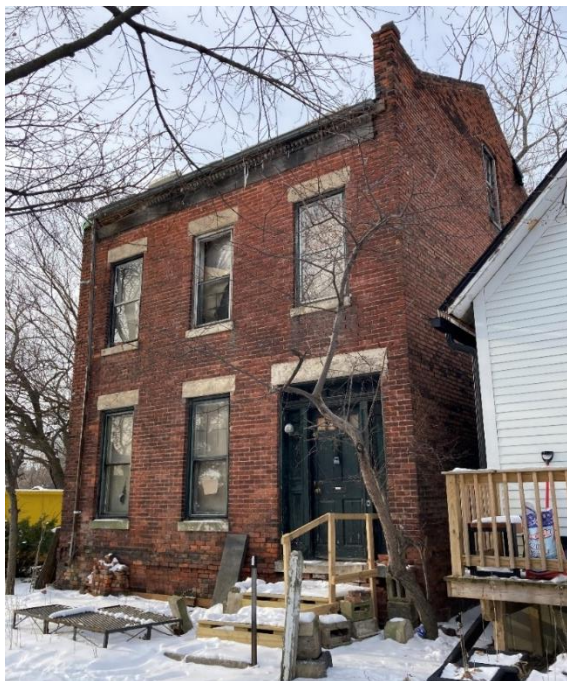
1356 Labrosse, current appearance

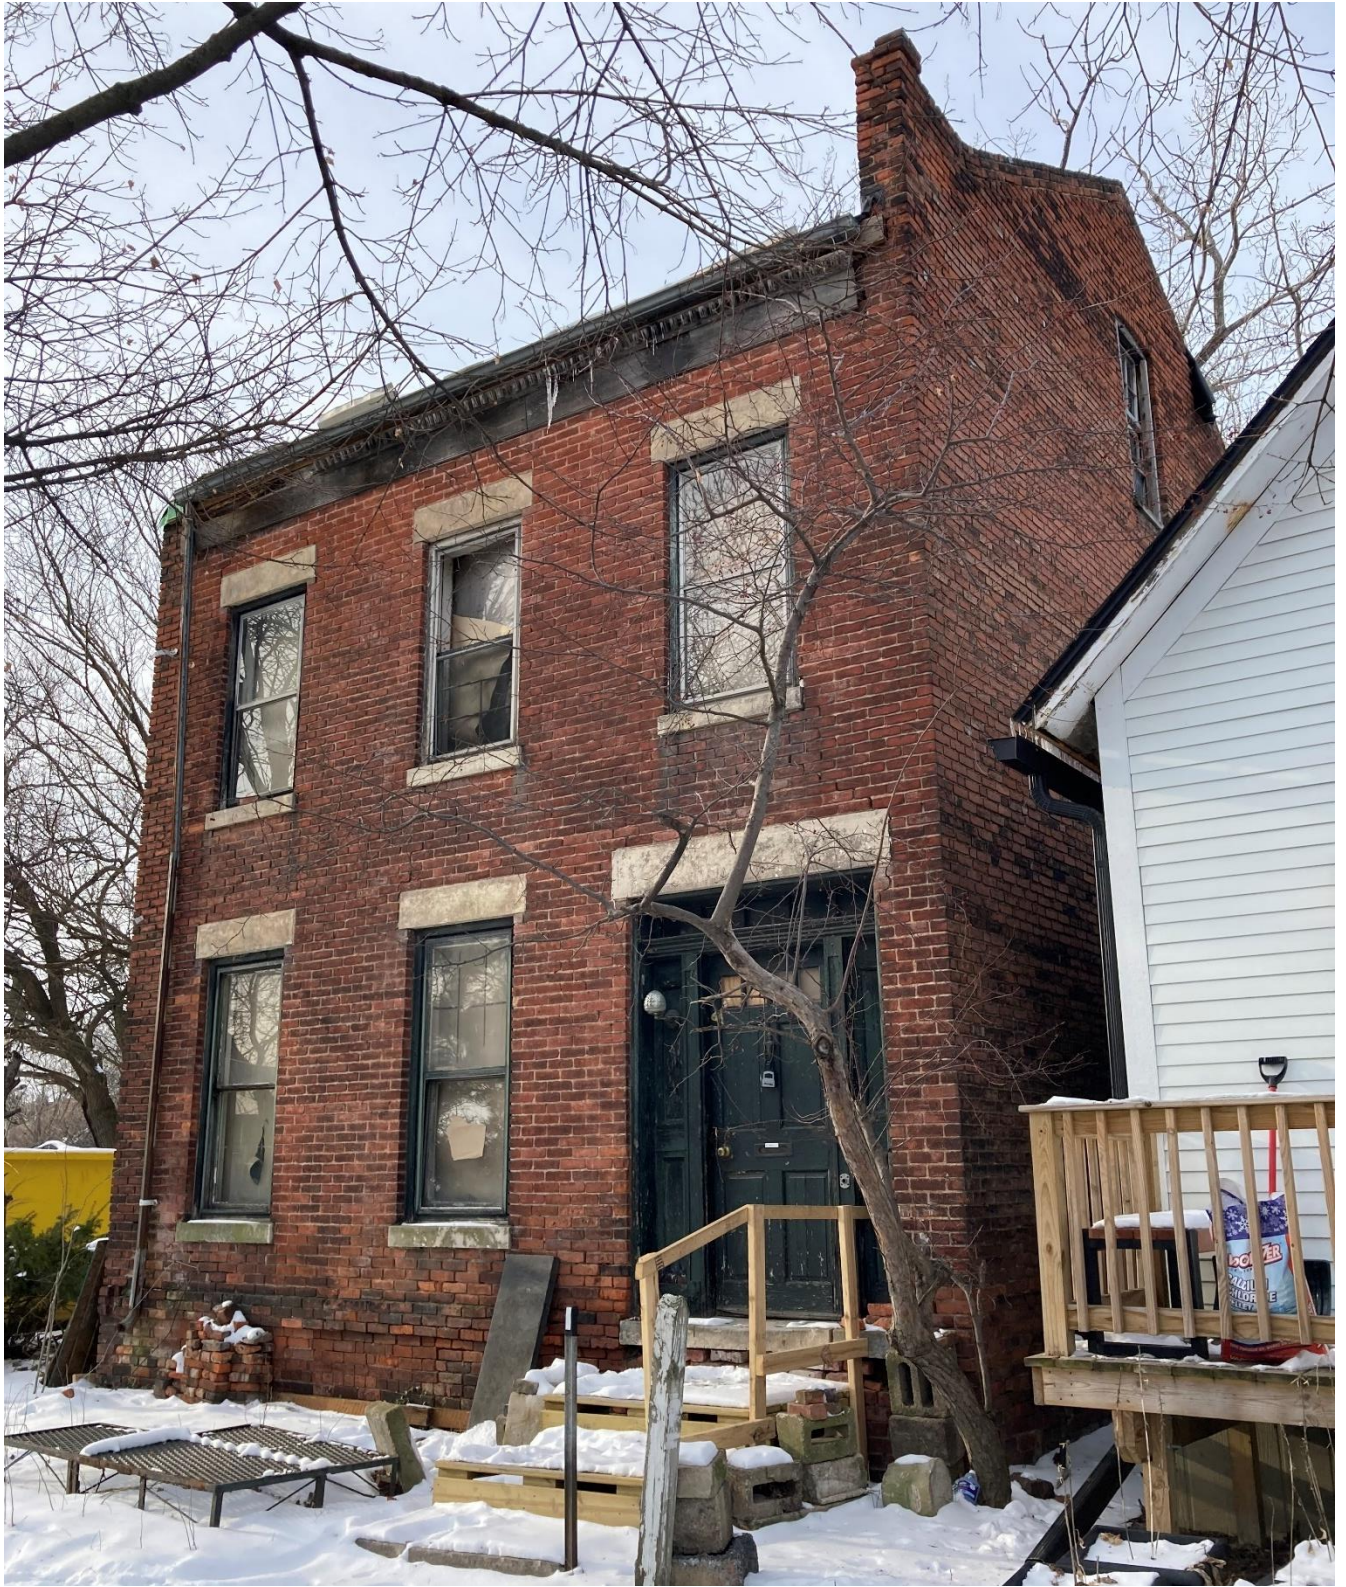
- The application does not include a landscape site plan nor does it indicate the location of any new fencing or HVAC/mechanical equipment
- The recently added front and rear porch structures were not approved by HDC prior to their installation. The applicant has indicated that these structures are temporary and that the rear structure was added to enable to project’s mason to undertake the approved brick repairs. He further stated that the front porch was installed in order to enable the project’s contractors to access the home’s interior space.

1356 Labrosse, current appearance (front elevation) showing unapproved temporary front porch deck

- The existing, newly-installed front porch/railing and rear wood enclosure shall be removed on or before December 31, 2022.

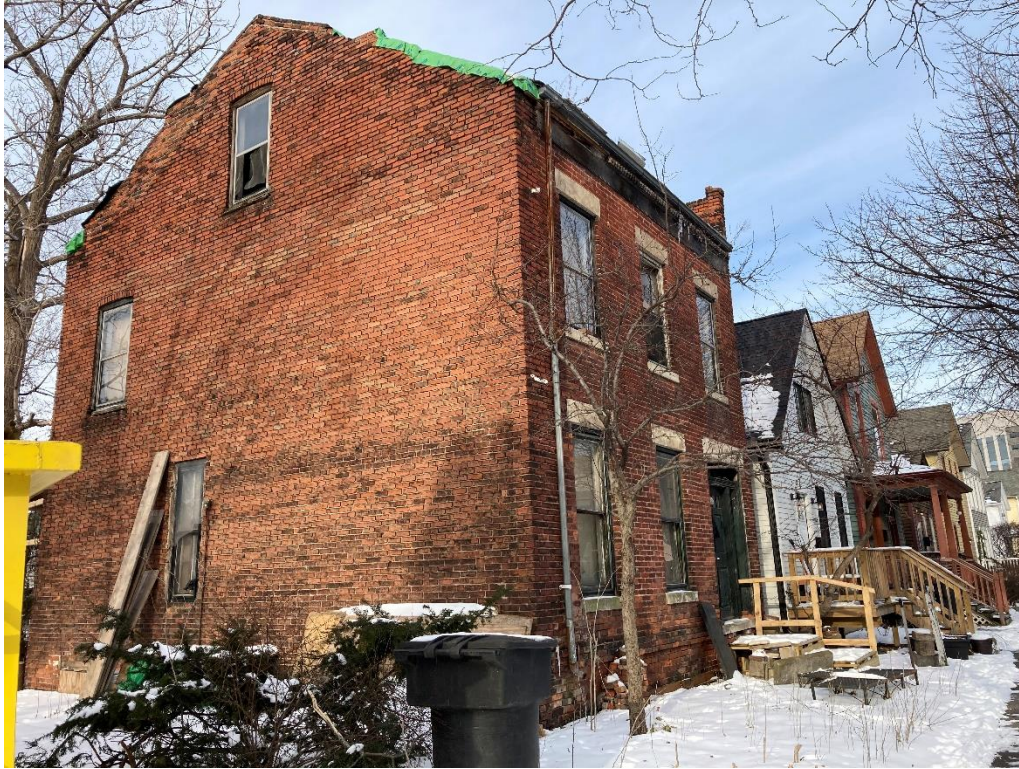
1356 Labrosse, current appearance (side/west elevation)

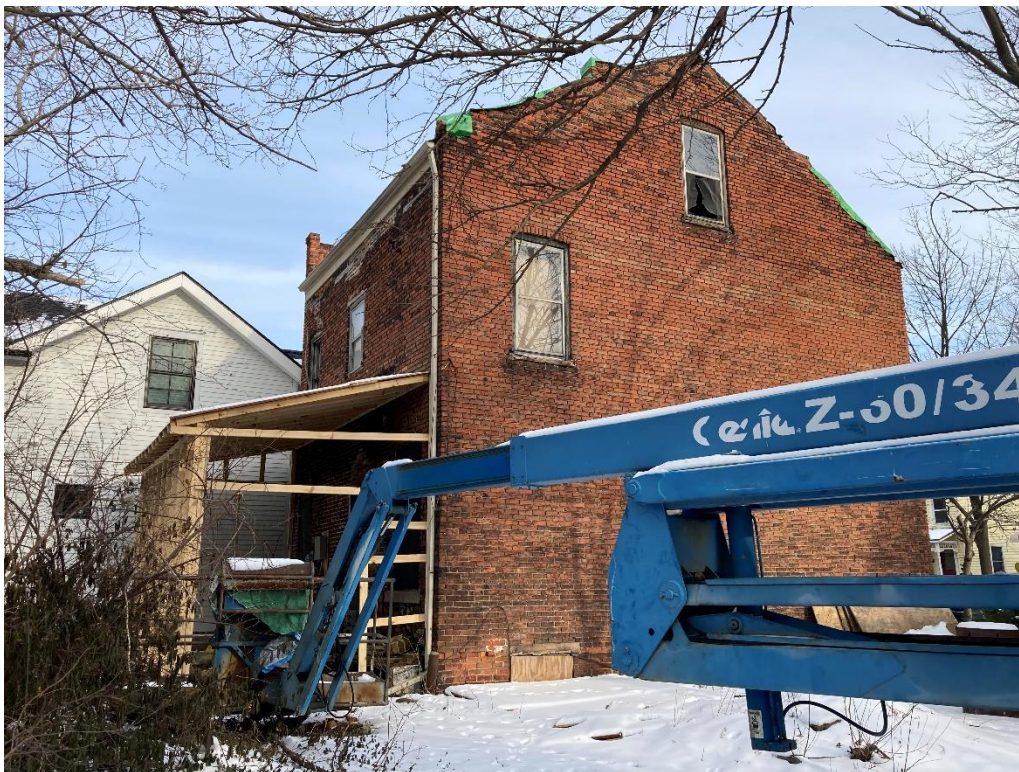
1356 Labrosse, current appearance (west elevation, showing unapproved temporary shelter at rear)

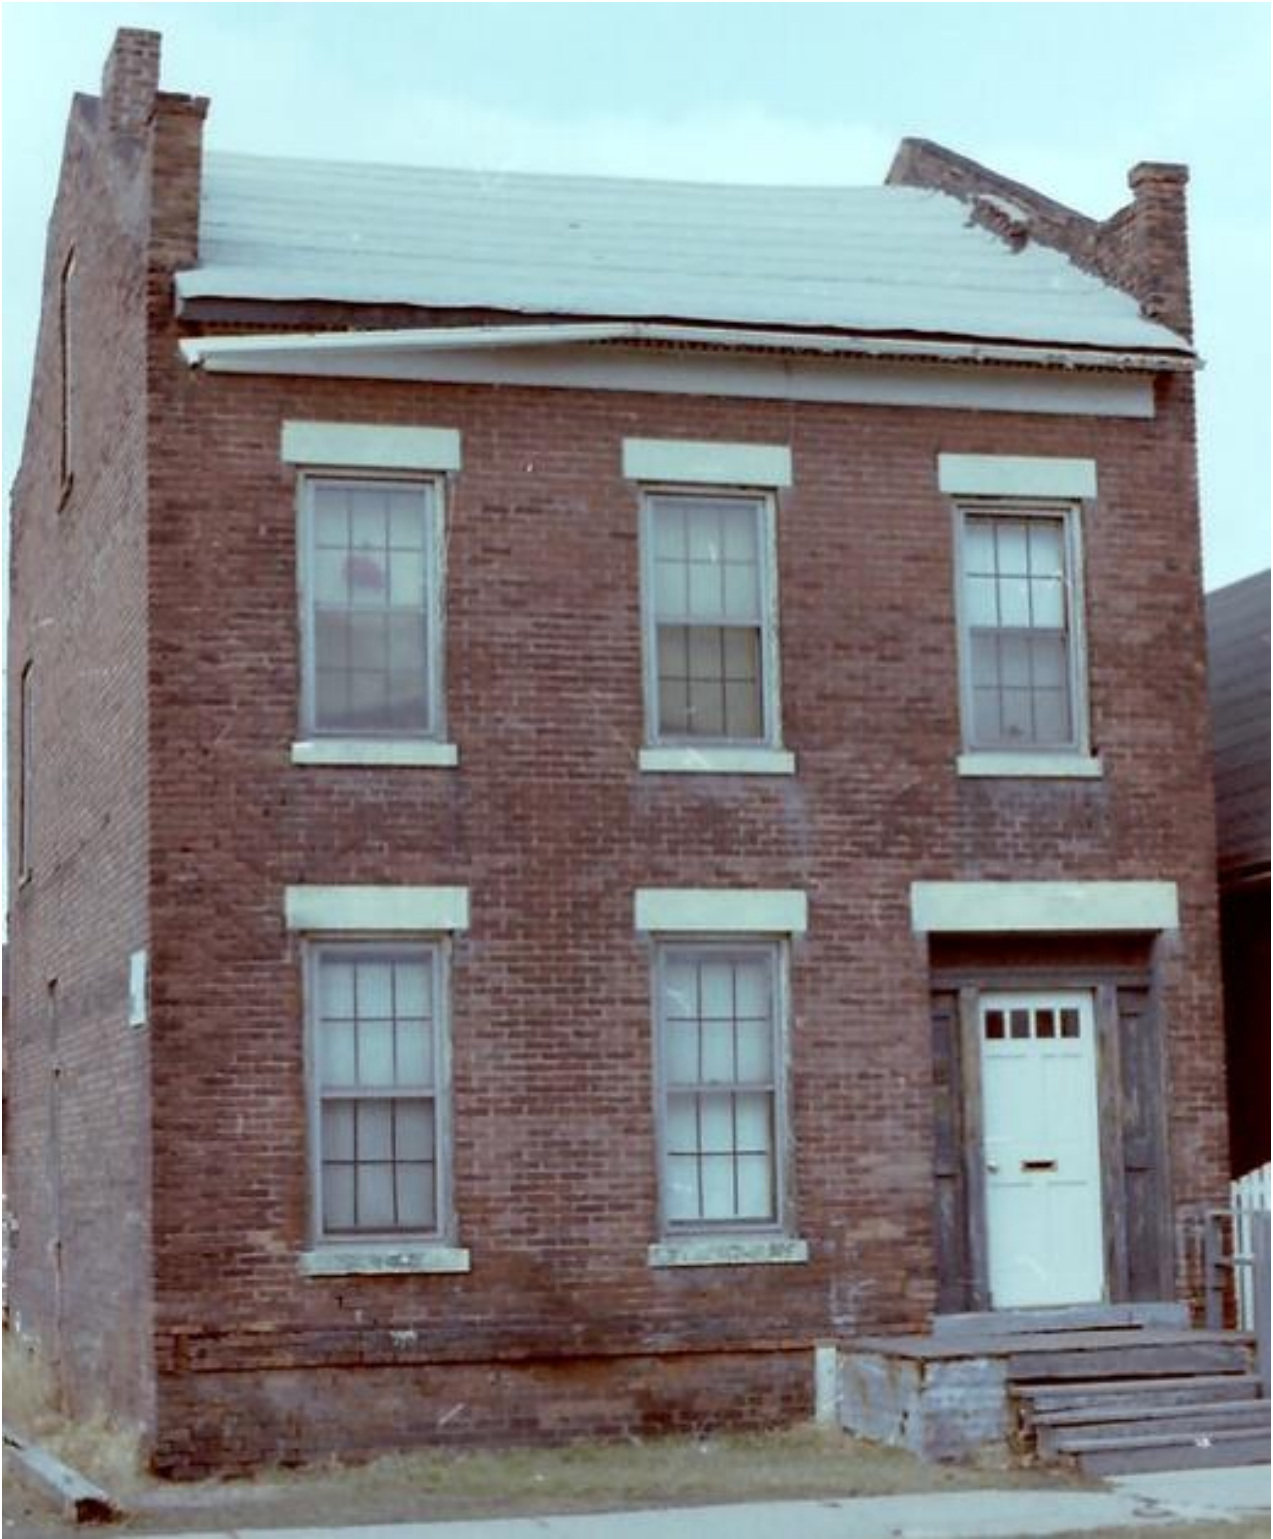
1356 Labrosse, appearance ca. 1979

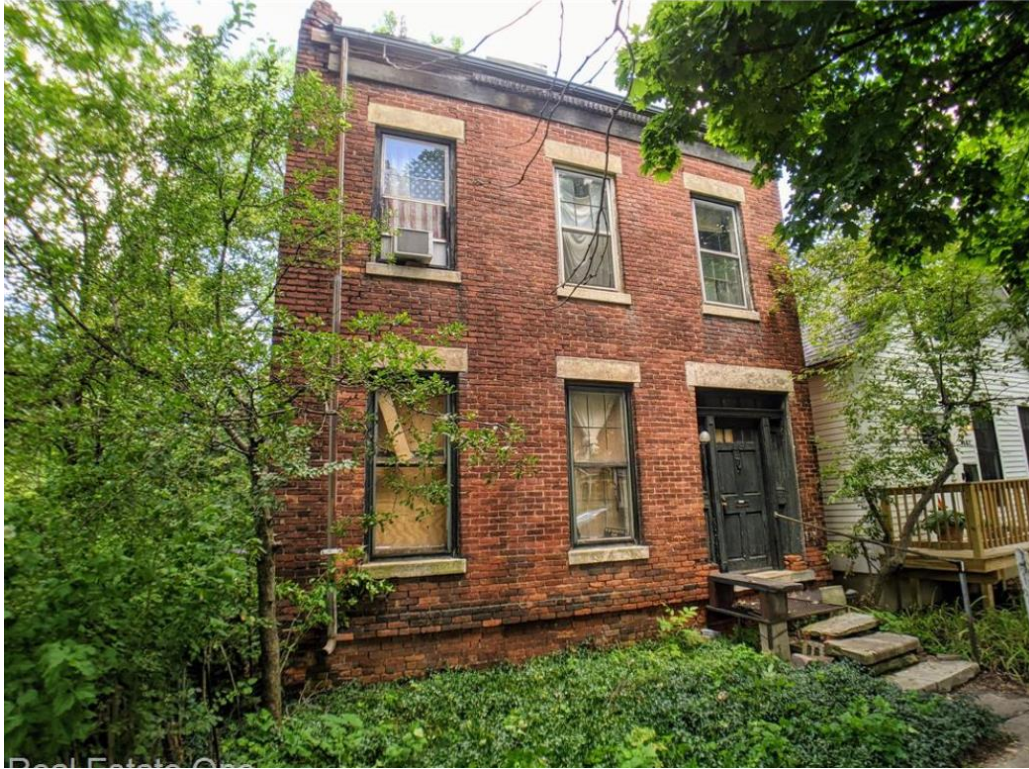
1356 Labrosse, appearance in 2020 prior to current brickwork

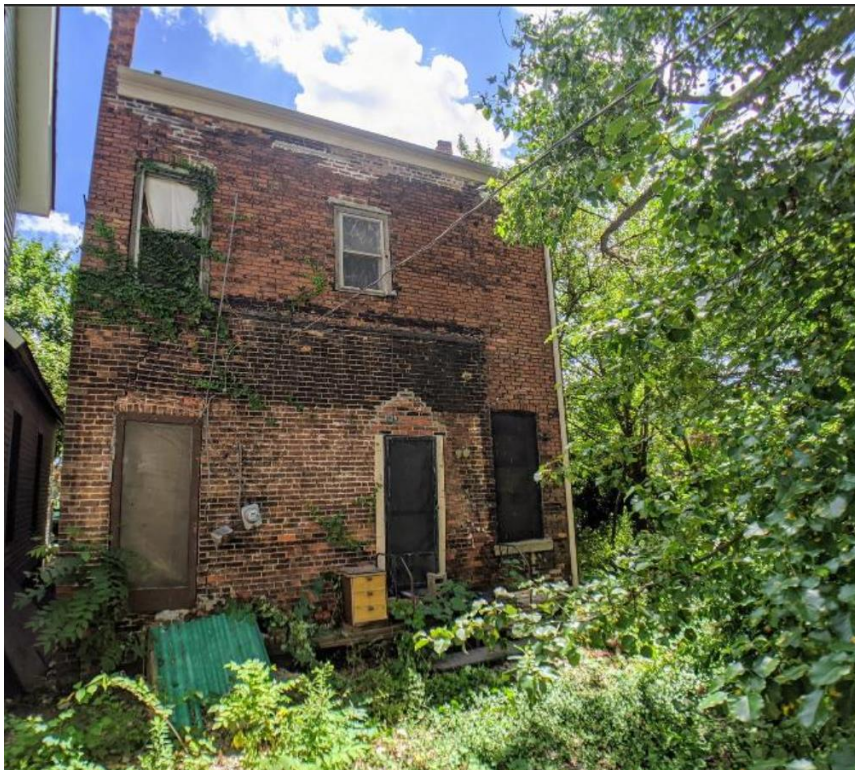
1356 Labrosse, appearance in 2020 prior to current brickwork

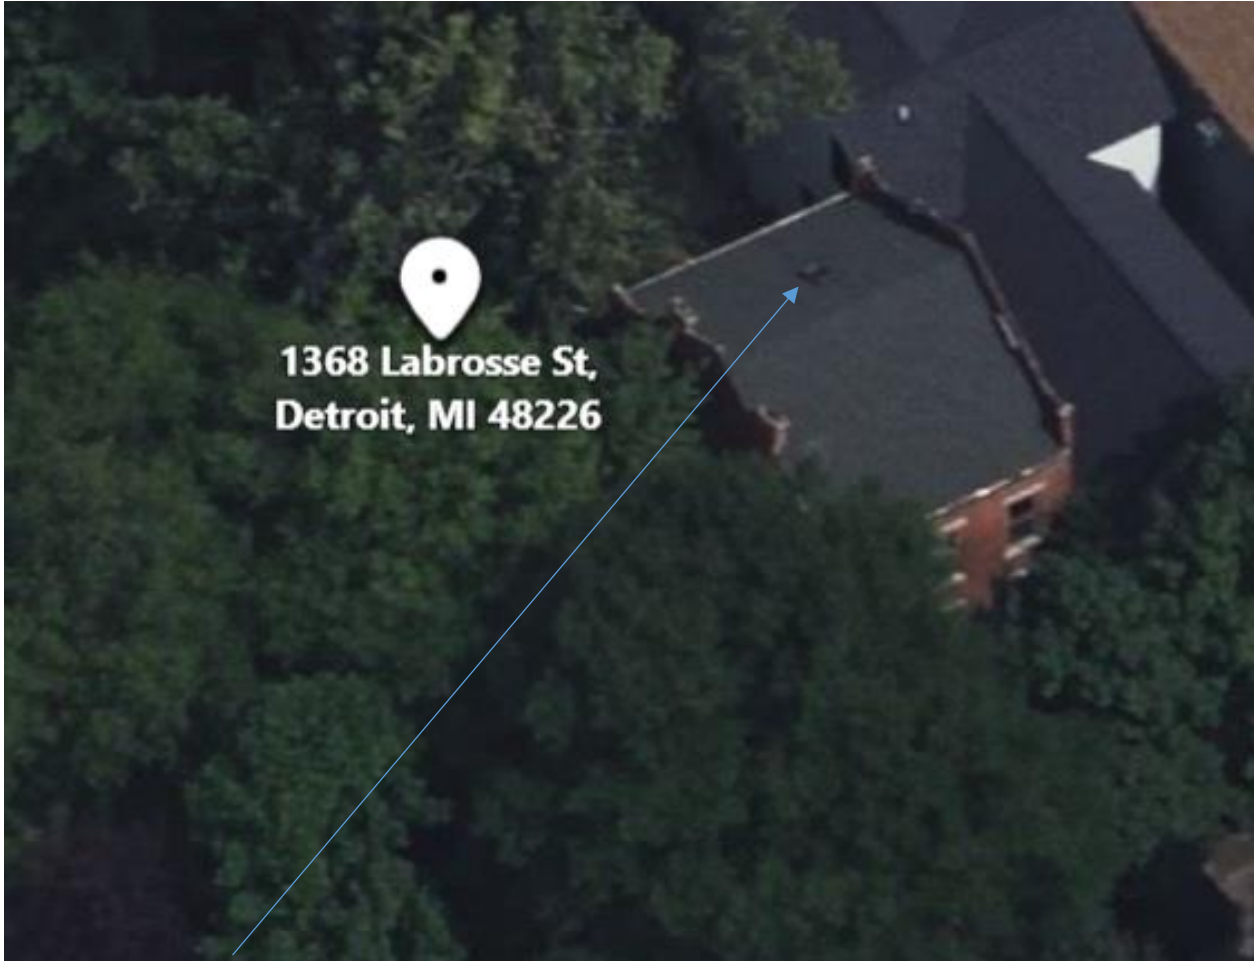
1368 Labrosse, showing existing rooftop skylight
