STAFF REPORT: 7/13/2022 REGULAR MEETING

APPLICATION NUMBER: #22-7908

ADDRESS: 1620 ATKINSON

SCOPE: DEMOLISH GARAGE, FENCE, REAR BALCONY AND DECK, (WORK COMPLETED WITHOUT APPROVAL), ERECT NEW GARAGE

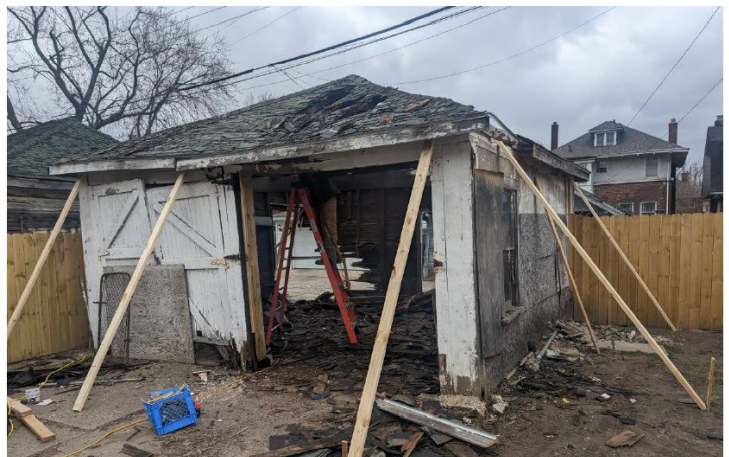
Site Photo 2 by Applicant: (North) rear yard, showing condition of garage before it was demolished and rear privacy fence, constructed without approval.

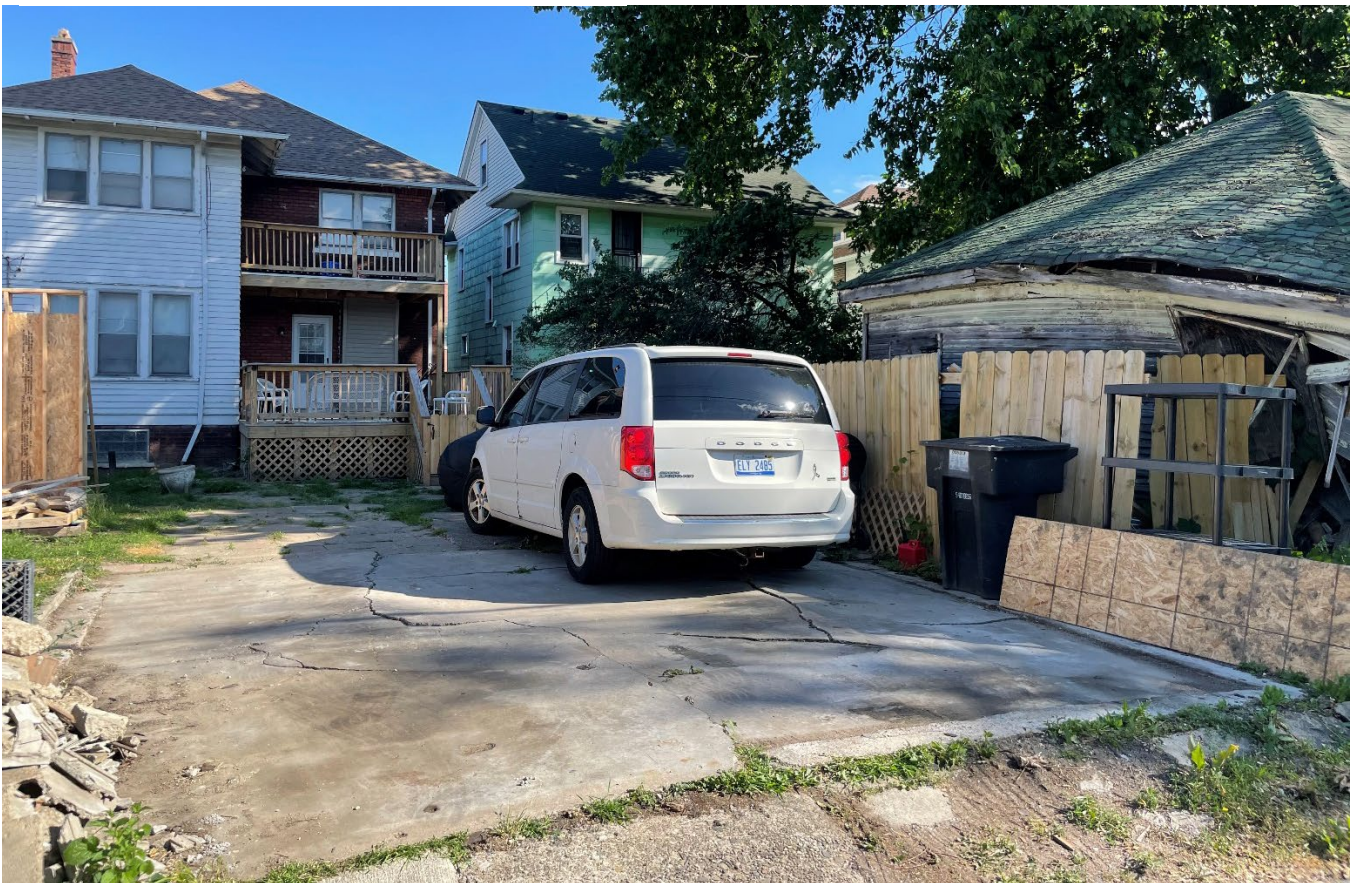
Site Photo 3, by Staff June 23, 2022: (North) Rear elevation, showing current conditions of the rear yard visible from the alley. This shows the site of the proposed new garage, reconstructed privacy fence, rear balcony and rear deck, constructed without approval.

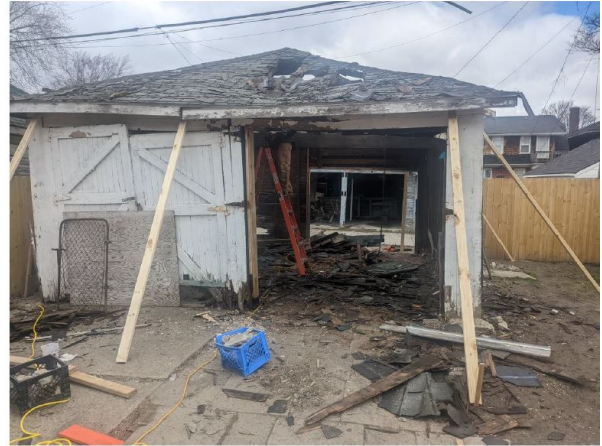
- The garage was already in disrepair before the current owner acquired the property and before the garage was struck by a car that did damage to the garage, the fence and neighboring garage.
- The floor slab is cracked in several places.
- Following the accident, the garage was shored up and evaluated for damages (see photos and attached estimate) by McGrath Restoration Corporation Inc, who is the current applicant.
- Photos show significant damage to the roof, framing, and wall systems to the front, side and rear of the garage, and appeared to suffer significant lean and subsidence (foundation failure) to the southeast (see photo 2 and attached). Significant bracing was temporarily installed before demolition.
- The roof shingles and exterior siding are in need of repair. Gutters are missing.

Site Photo 5, by Applicant prior to demolition of garage showing damage and bracing.

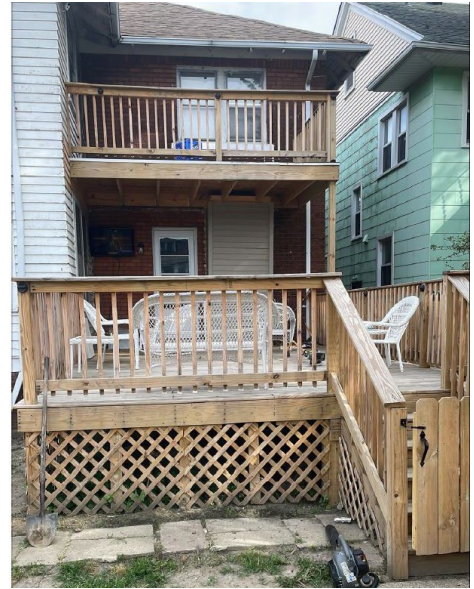
- Staff recommends that the fence be treated with an appropriate stain or paint.
- Staff offers the opinion that the crisscross pattern of the deck skirting introduces a new pattern to the architecture of this historic home and would not be appropriate design. Staff offers the opinion that a vertical or horizontal board would be more appropriate for this application.

Site photo 6, by Staff, (rear, north-facing elevation), showing built balcony and deck.

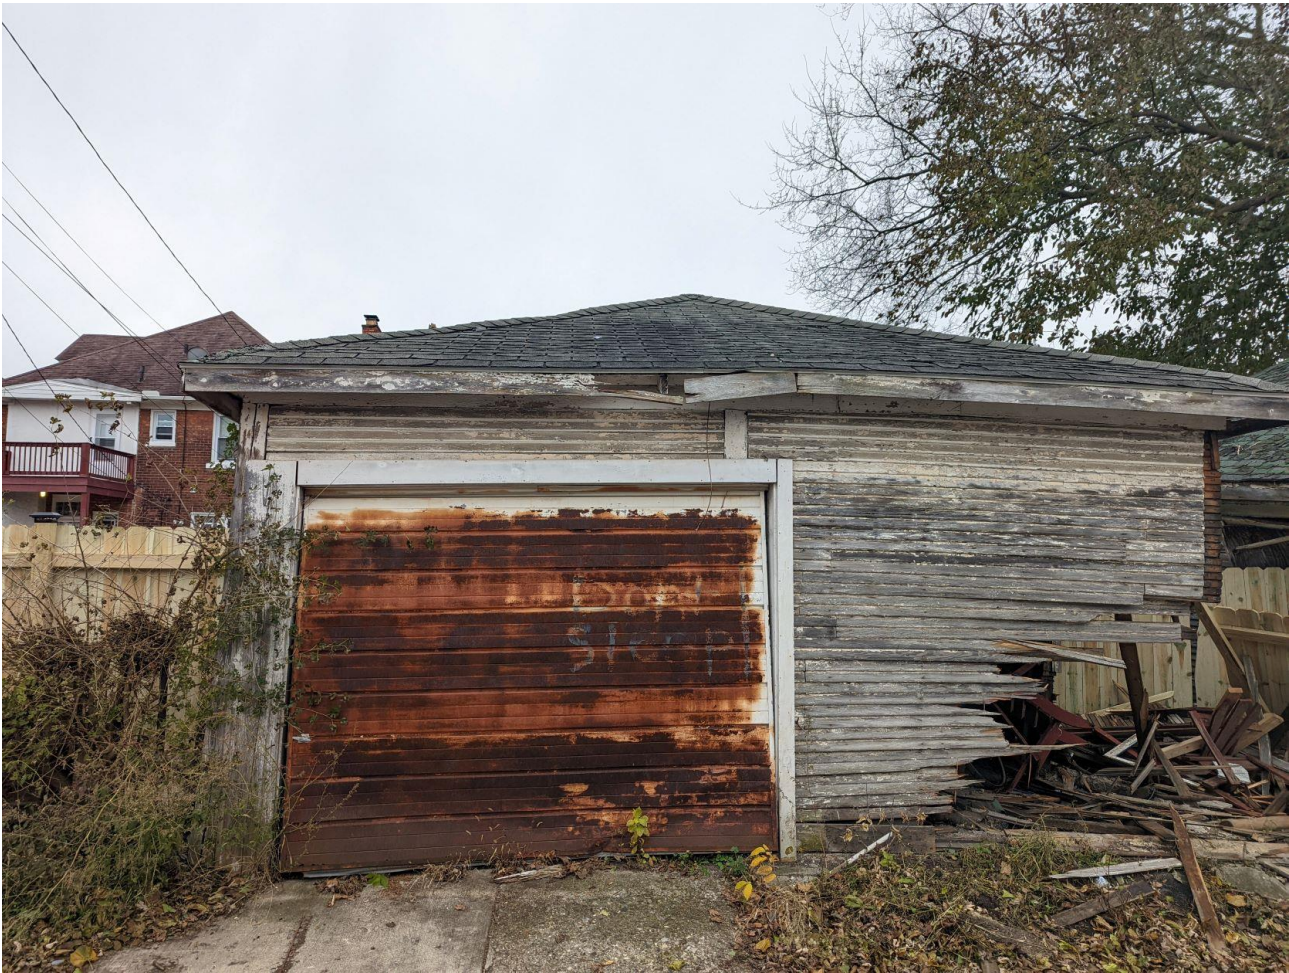
Figure 3 - Back of Garage (alley side) - see corner

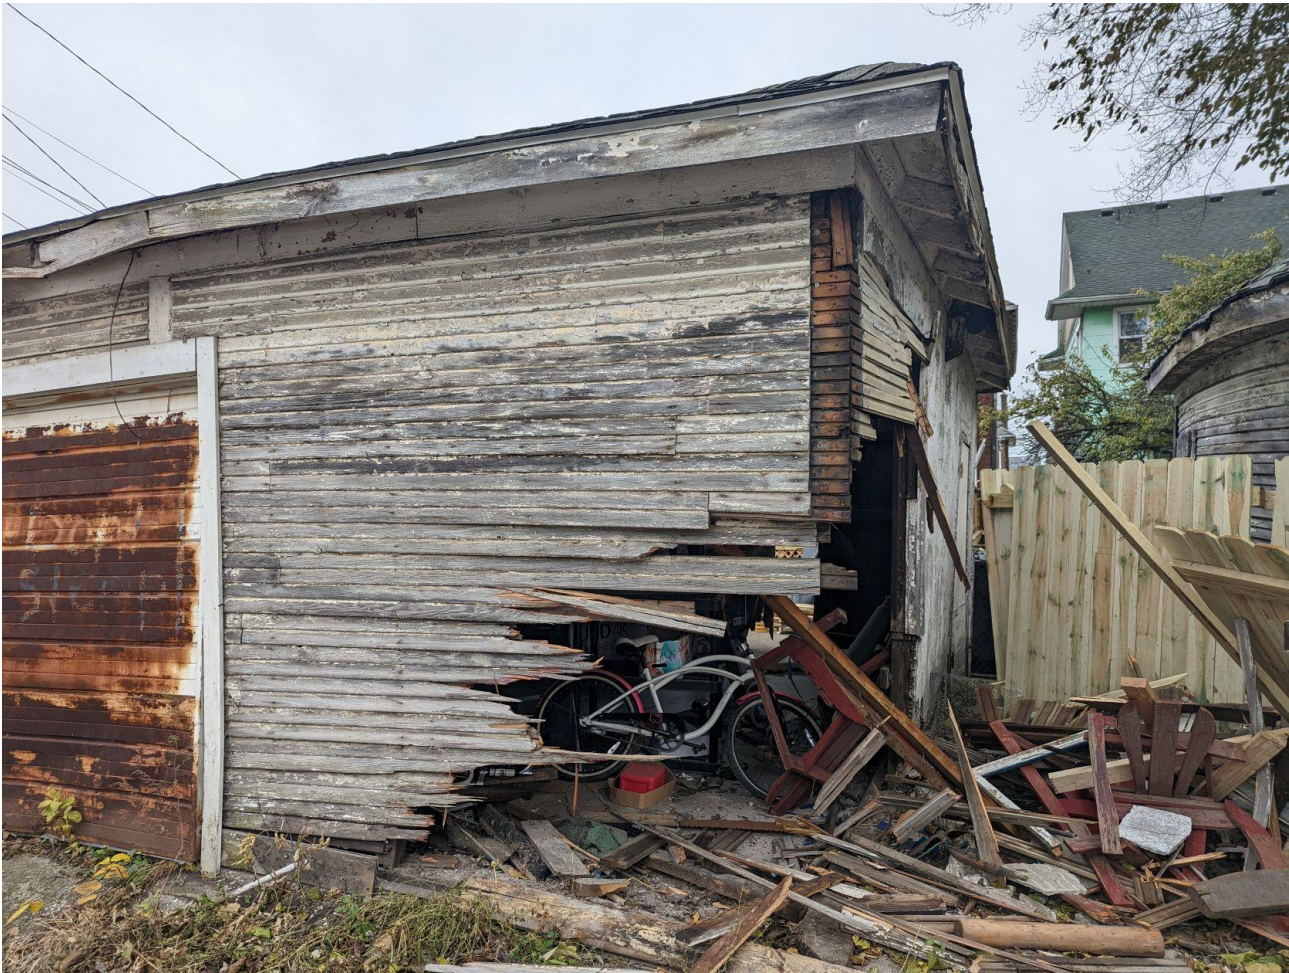
Figure 4 - Back of garage, corner hit by car

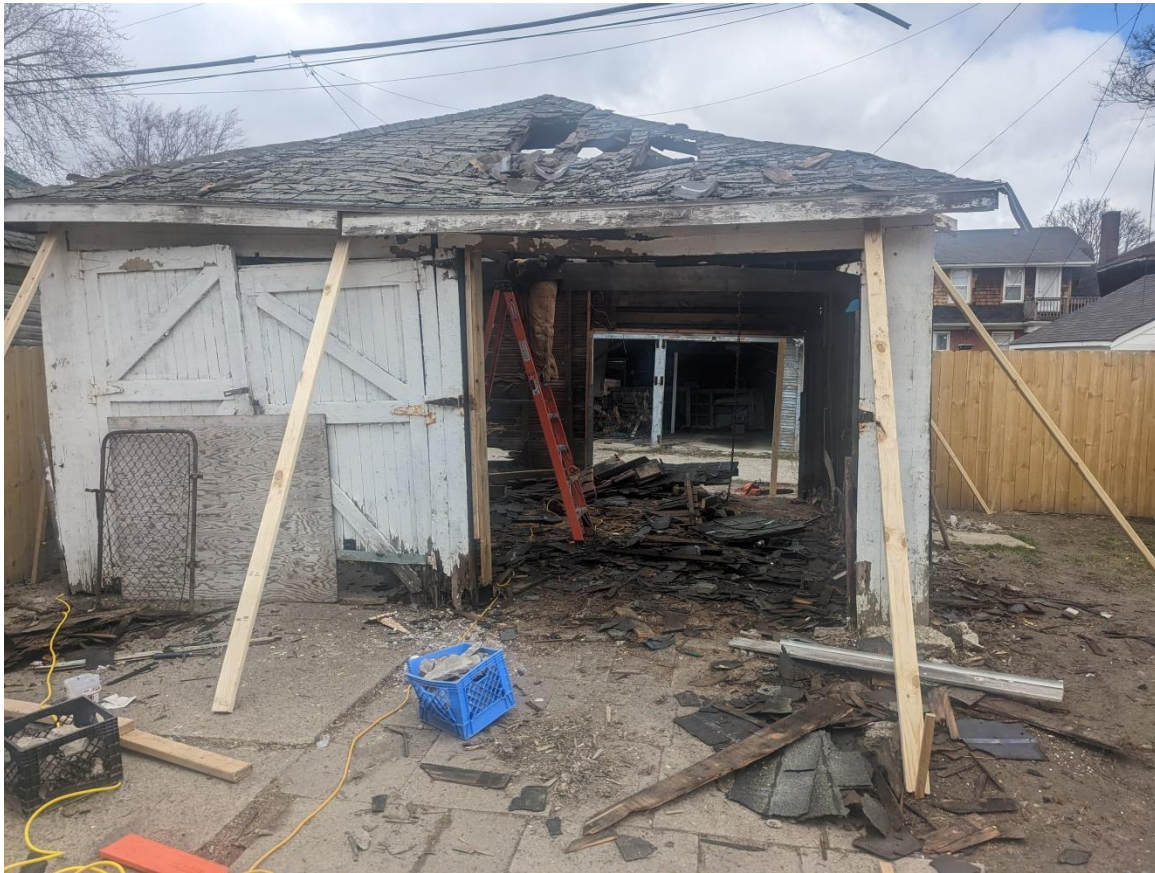
Figure 5 - Front of Damaged Garage (after having been shored up)

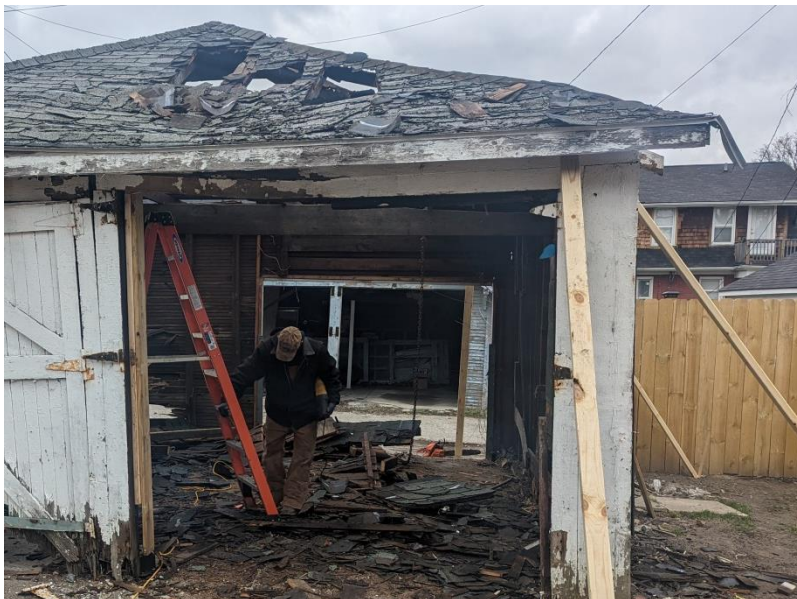
Figure 6 - See through, shored up dangerous/hazardous garage structure (note condition of roof)

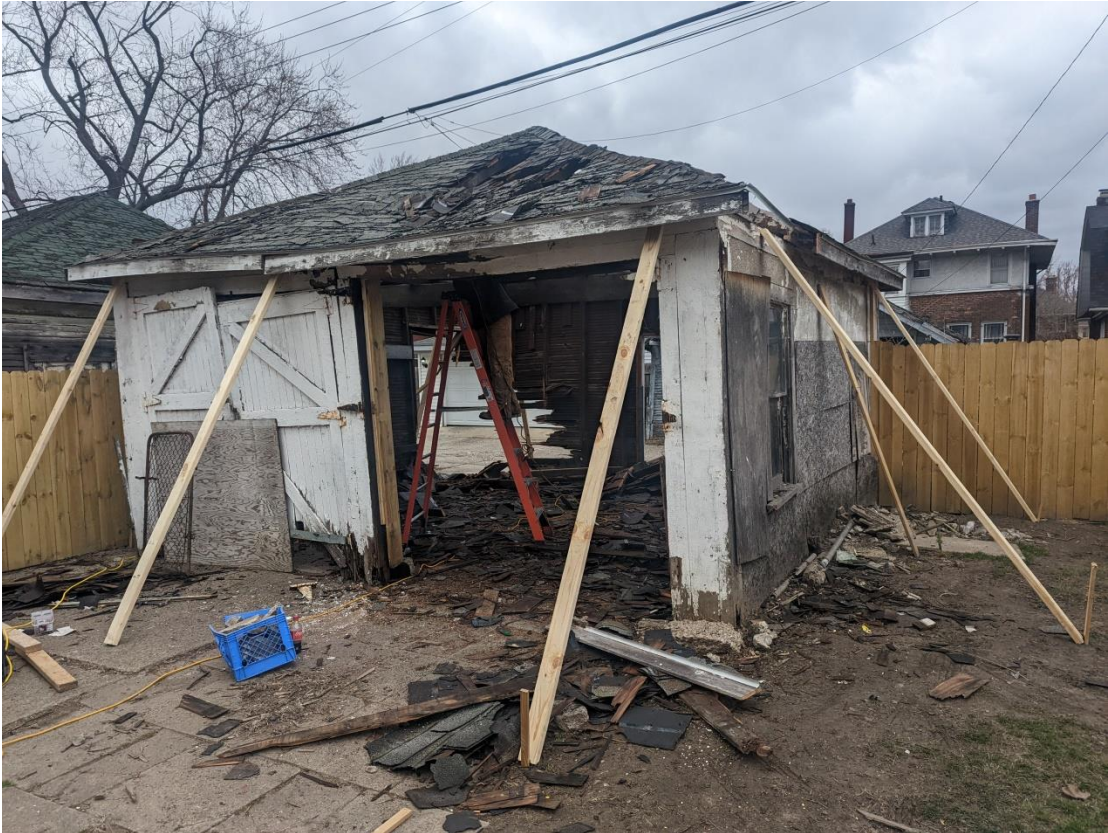
Figure 7 - Full through view (front, side, & through back) of damaged garage

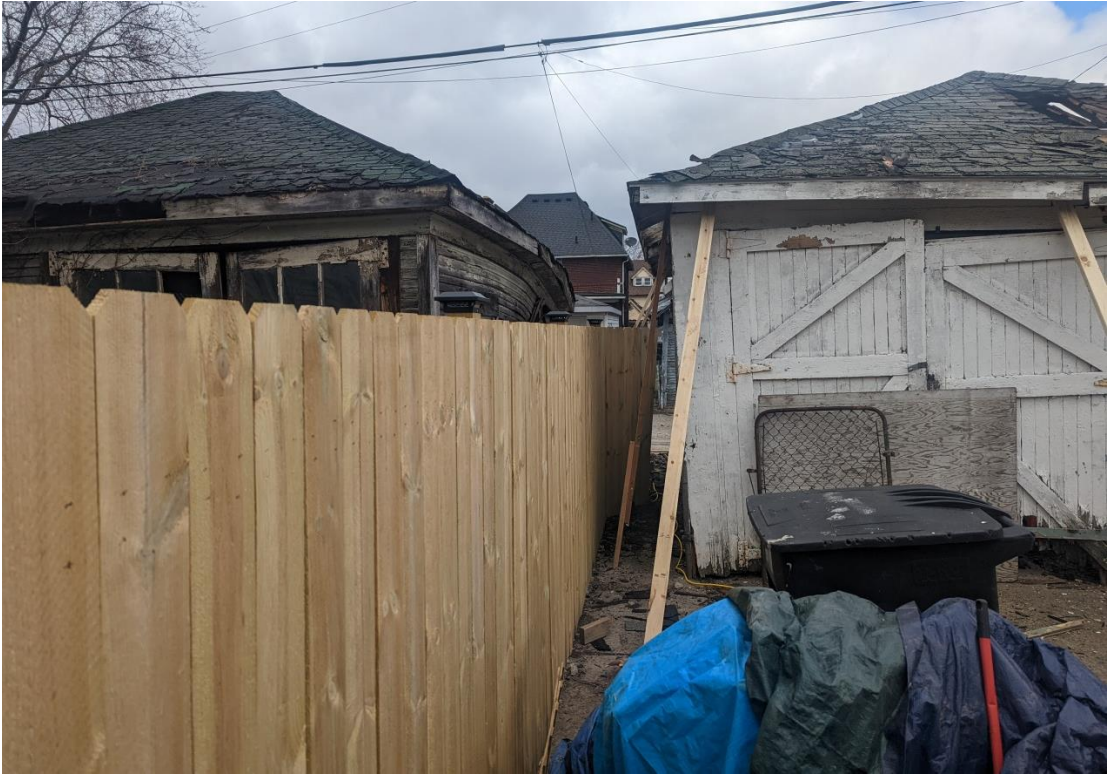
Figure 8 - Left side, near fence, of damaged garage

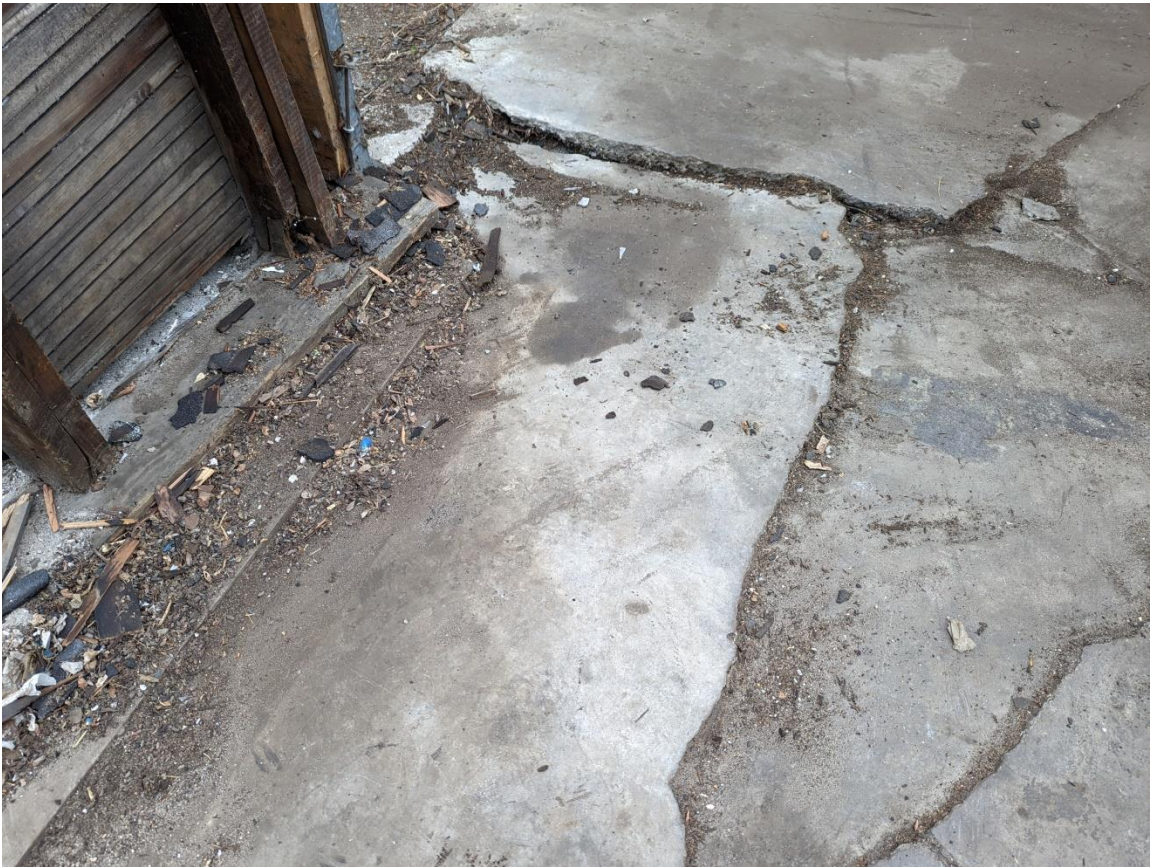
Figure 9 - Concrete slab damaged, needs to be leveled
