STAFF REPORT: 2/9/2022 MEETING

APPLICATION NUMBER: #22-7664

ADDRESS: 2485 BURNS

SCOPE: ALTER FRONT PORCH; ALTERATIONS AT REAR PORCH AND SECOND FLOOR SLEEPING PORCH COMPLETED WITHOUT APPROVAL

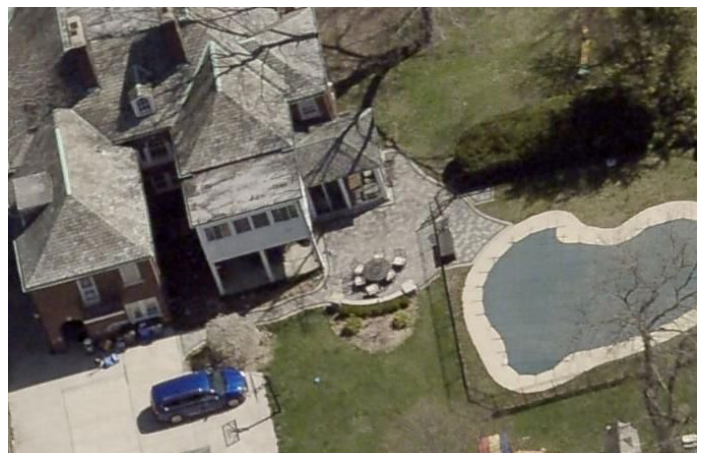
Aerial 3, by All Pictometry April 2020: (Southeast) rear elevation showing replaced windows of sleeping porch and screen-in porch.

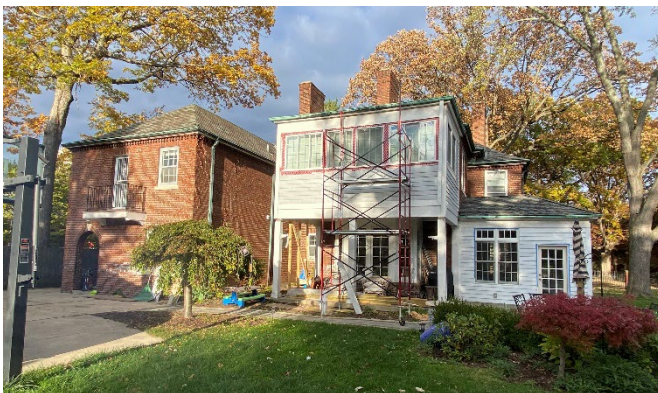
Site Photo 3, by Applicant: (Southeast) rear elevation showing new windows and siding of upper "sleeping porch" and former screened porch.

- It is staff's opinion that the replacement of wood siding to Hardie Board and the replacement of casement windows with vinyl sliders that do not match in design, configuration, material or operation has destroyed the original *scale*, *design*, and *materiality* of this historic property, and therefore does not meet the Secretary of the Interior's Standards for Rehabilitation.

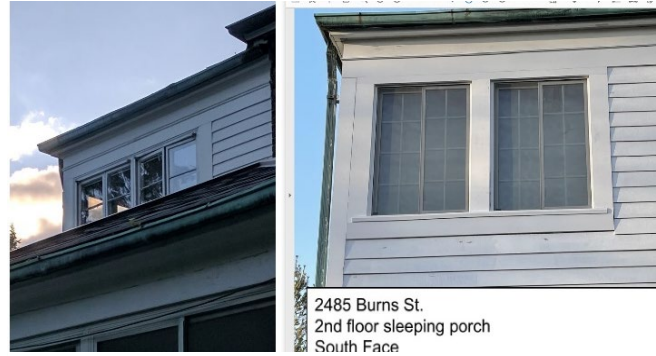
Site Photos 5 and 6, by Applicant: (Southeast) rear elevation showing before and after conditions of the sleeping porch siding and windows: metal casements replaced with vinyl sliders; mitered, wood clapboard replaced with trim board and Hardie board.

- Staff confirmed with the owner that the original metal casements of the sleeping porch are in storage.
- Staff has the opinion that the rear sleeping porch's wood clap board siding with the mitered corners and the operation of the casement windows with true-divided light were distinctive, character-defining features. The mitered edge of the clapboard has been replaced with trim board, the casement windows with vinyl sliders with between-the-glass grids that do not match the configuration, design, material or operation of the original windows. Although this location is not within prime public view, it is staff's opinion that the loss of the casement windows reduces the open-air quality of the sleeping porch and replacement of the mitered edge clapboard with board trim reduces the craftsmanship of the siding. Vinyl windows of this type and quality are inappropriate.

Staff finds that the replacement of wood siding with Hardie board, the replacement of casement windows of the rear sleeping porch with vinyl slider windows, the modification of the rear screen-in porch to an enclosed room, the proposal to replace the front porch cast stone with cement pavers, the redesign of the front porch from rectangular to circular form, and the installation of wingwalls destroys the historic character of this property and removes distinctive, character-defining features.

Staff therefore recommends that the Commission issue a Denial for the above work items, as it does not meet the Secretary of the Interior's Standards for Rehabilitation, specifically Standards:

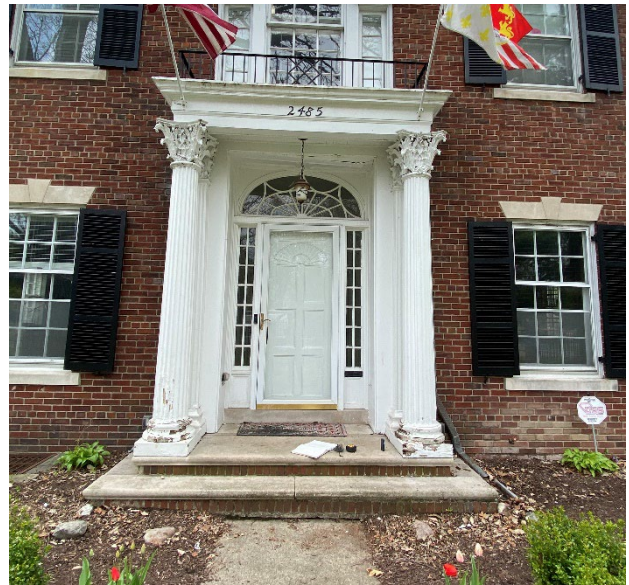
- Staff observed that the existing front porch features cast stone capping and matching brick underlay detailing that matches the material, scale and color of the house (See photo 8). Staff offers the opinion that the rectangular shape and material of the porch, especially the top step that supports the columns, is a character defining feature that supports the symmetry and geometry of this Georgian Revival architecture.

Site Photo 8, by Applicant: (Northeast) front elevation showing current conditions of the front porch.

- Staff offers the opinion that the proposed front porch repair and gutter replacement is consistent with the scale, design, and material of the historic character of the property.

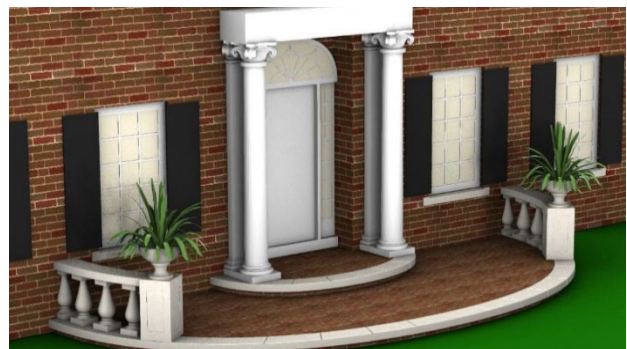
- It is staff's opinion that the introduction of 4x8 cement pavers, replacement of the square form with circular forms, and the introduction of wingwalls destroys the character defining features of the front elevation critical to an understanding of the building's style by obscuring the front elevation windows and introducing a new style and historically anachronistic material, scale and design that is not appropriate.

Conceptual image, by Applicant: (Northeast) front elevation showing proposed new patio and "wingwalls".

- It is staff's opinion that the proposal to change the front porch's material from cast stone and limestone to cement block that does not match the house's material nor scale, changing the shape of the front porch to a circular form and introducing "wing walls" that obscure's the front elevation the house's Georgian Revival architecture would destroy the original *scale*, *design*, and *materiality* of this historic property, and therefore does not meet the Secretary of the Interior's Standards for Rehabilitation.

- Staff does offer the observation that retaining the original material of the porch, its rectangular form and scale of the top step supporting the columns, and the potential expansion of the porch floor minus the balustrade ("wingwall") could be an appropriate solution that would meet the Standards.

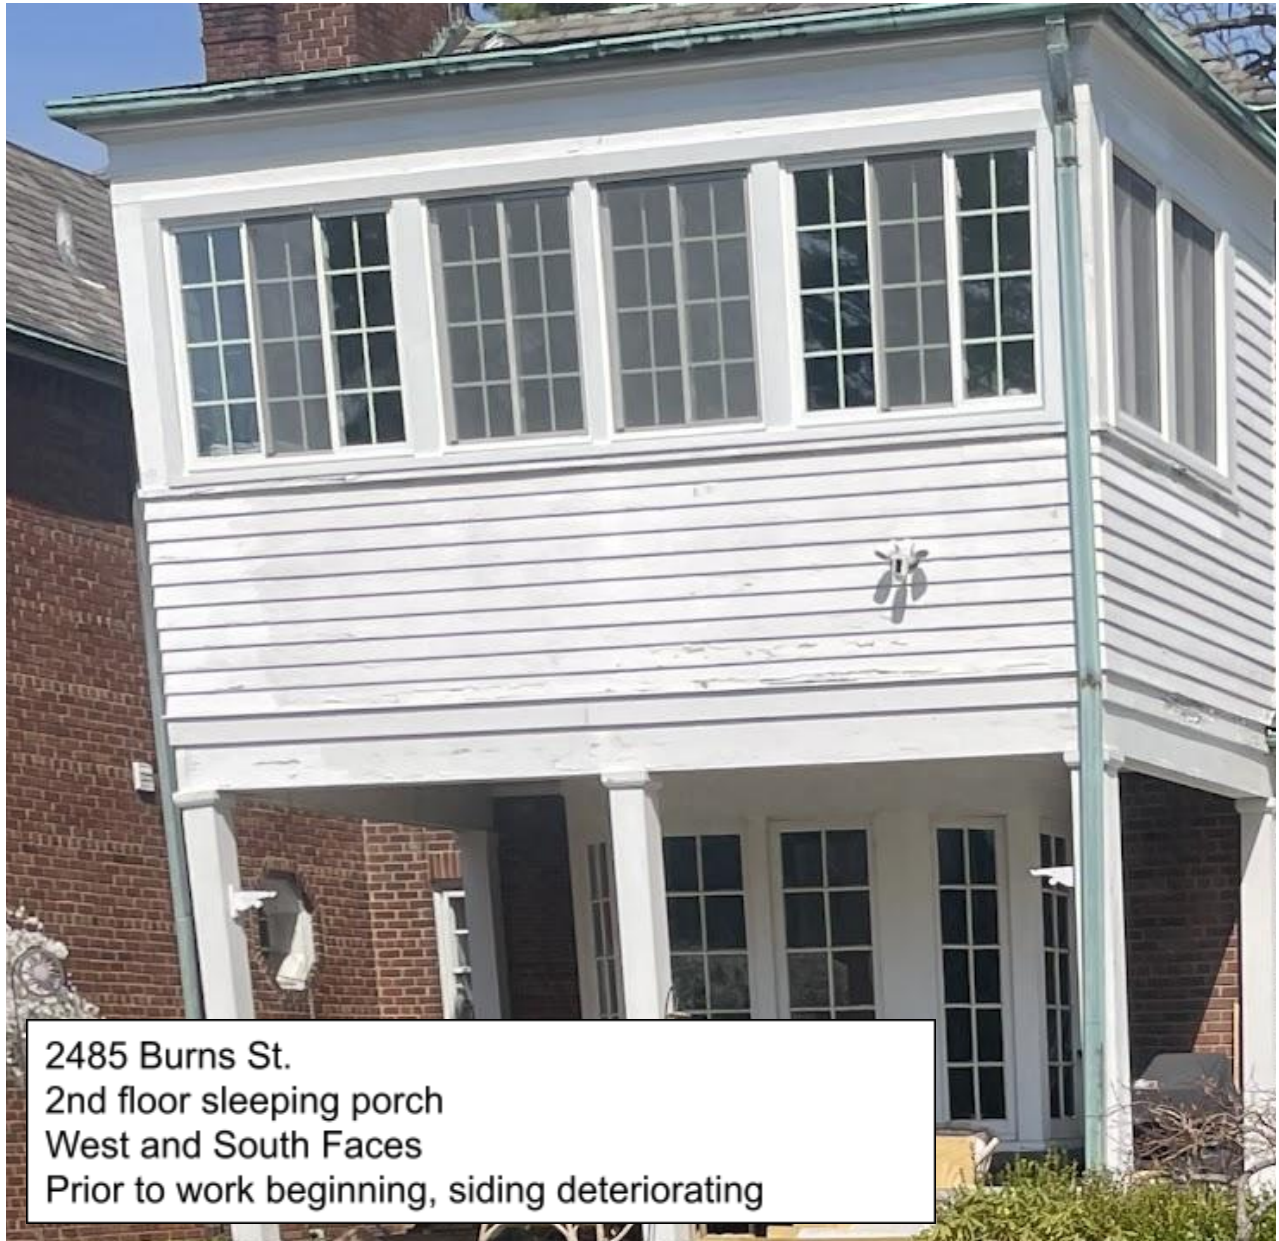
2485 Burns St.
2nd floor sleeping porch
West and South Faces
Prior to work beginning, siding deteriorating

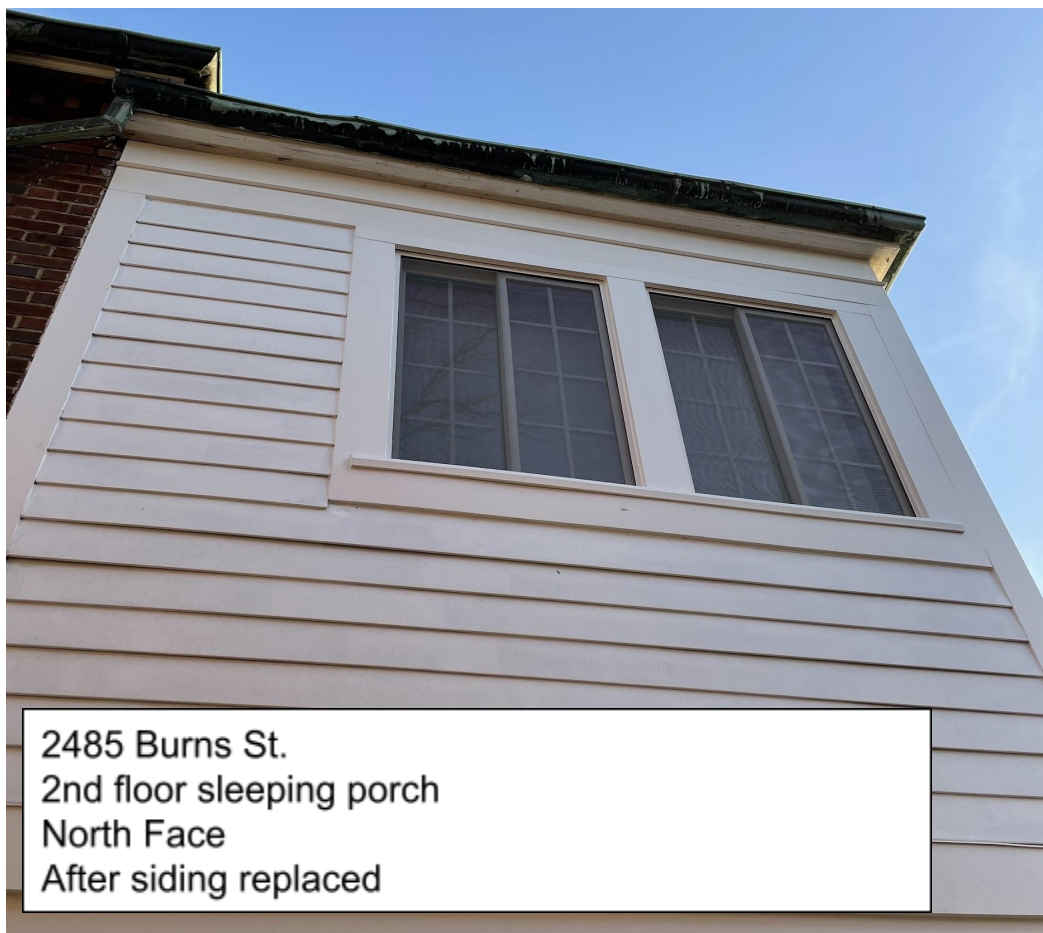
2485 Burns St.
2nd floor sleeping porch
North Face
After siding replaced

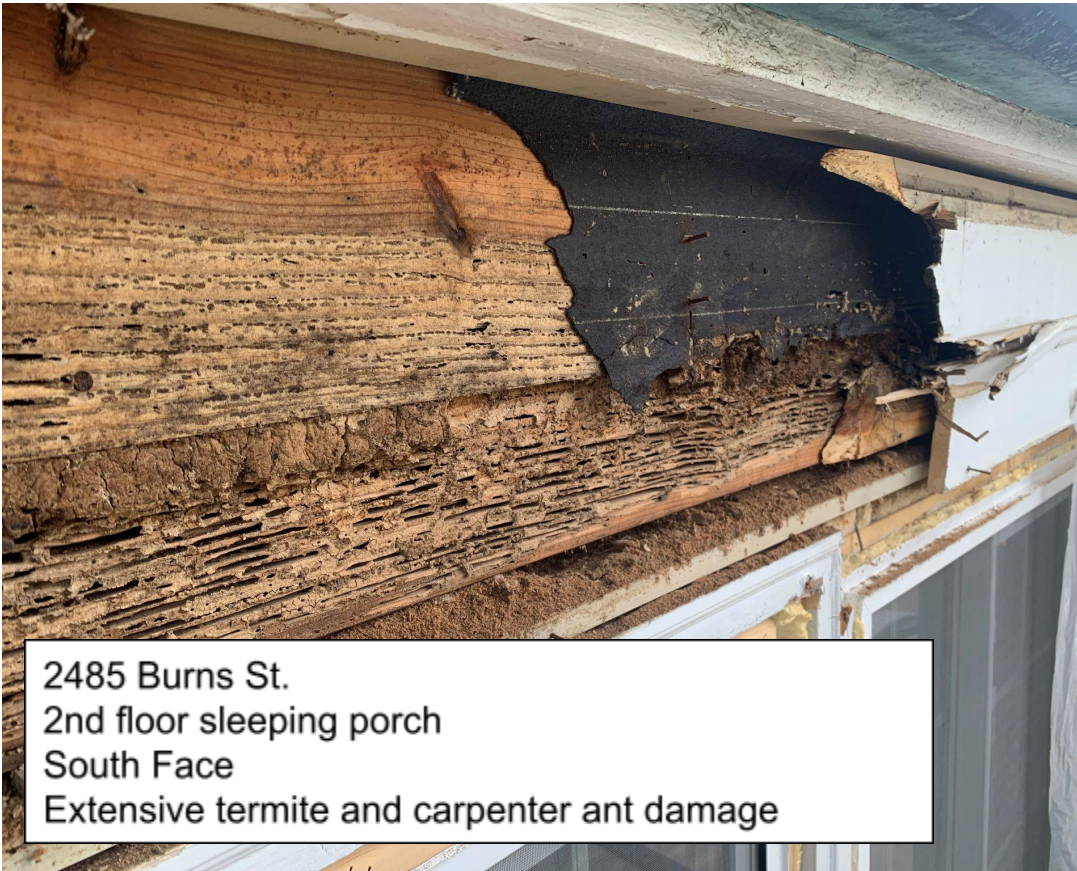
The existing 7" wood clapboard siding was deteriorating (see attached photos). Upon removing the siding, there was also extensive damage from termites and carpenter ants. I replaced the damaged wood behind the siding with pressure-treated wood, added a house-wrap substrate, and installed 7" cement board siding. The siding is painted white to match the look of the previous wood siding, and the overlapping pattern is similar to the previous siding.

2485 Burns St.
2nd floor sleeping porch
South Face
Extensive termite and carpenter ant damage

- Remove deteriorated 7" wood clapboard siding and damaged wood behind siding
- Replace damaged wood with pressure treated lumber (termite resistant)
- Add house-wrap to prevent further damage from moisture
- Add 7" Hardie Board siding (termite resistant) in same overlapping pattern as previous wood siding
- Paint siding white to match all other wood on house exterior

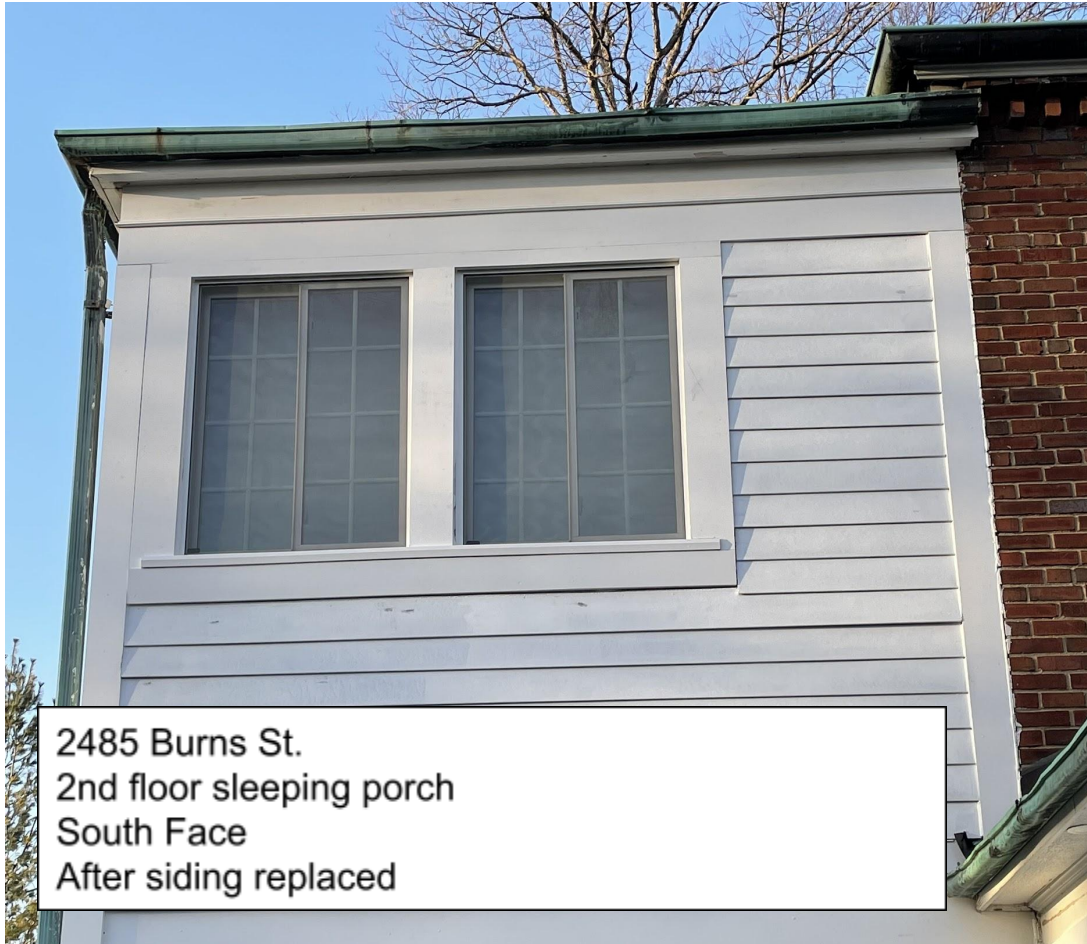
2485 Burns St.
2nd floor sleeping porch
South Face
After siding replaced

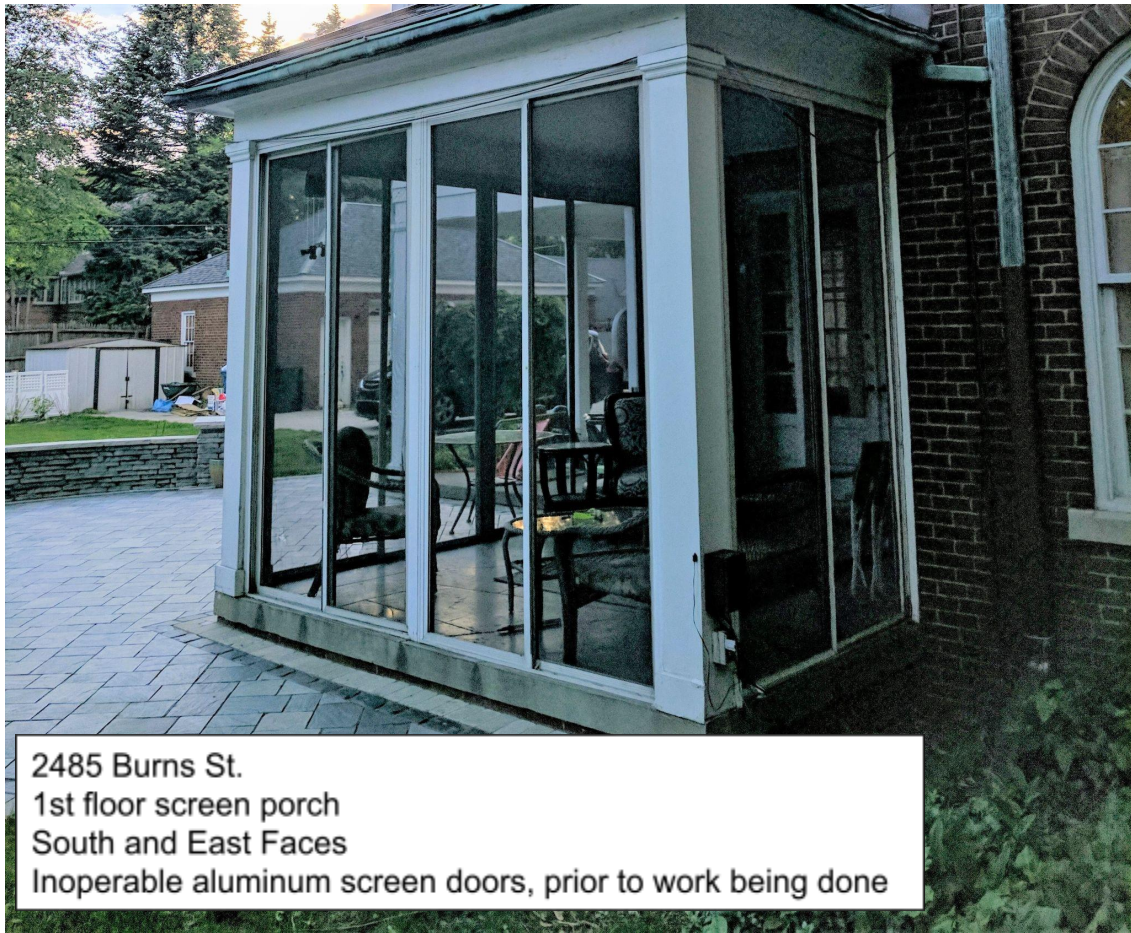
2485 Burns St.
1st floor screen porch
South and East Faces
Inoperable aluminum screen doors, prior to work being done

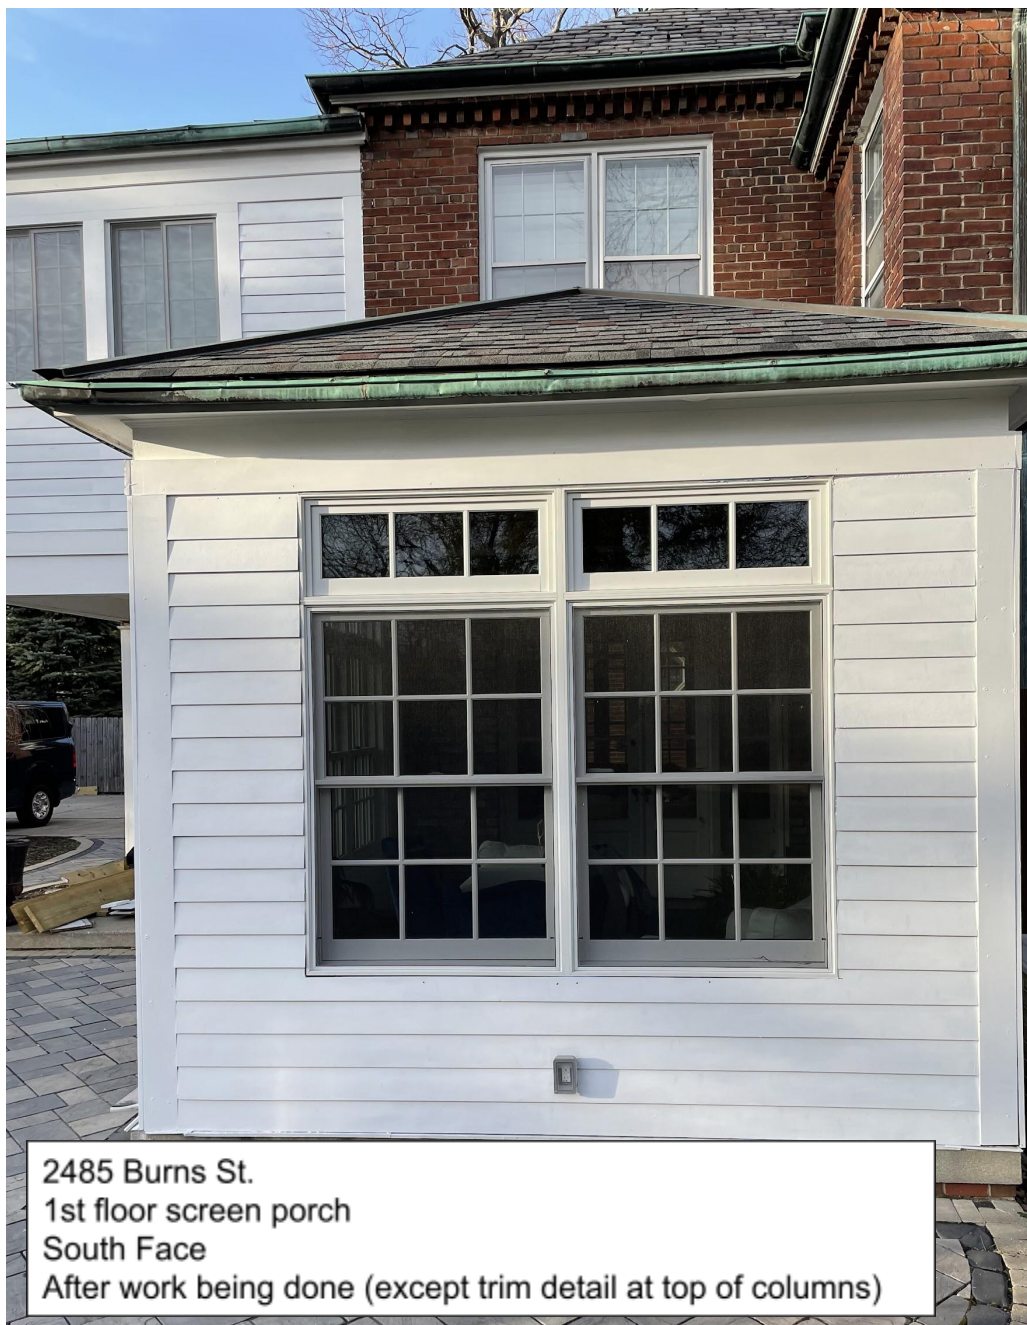
- It is staff's opinion that the full replacement of the rear screened in porch, which is publicly in view from the front yard with a design that did not conform to the HDC's COA, changes the character from an open air porch to a enclosed room with window and transom configurations that do not match the house has destroyed the original *scale*, *design*, and *materiality* of this historic property, and therefore does not meet the Secretary of the Interior's Standards for Rehabilitation.

2485 Burns St.
1st floor screen porch
South Face
After work being done (except trim detail at top of columns)

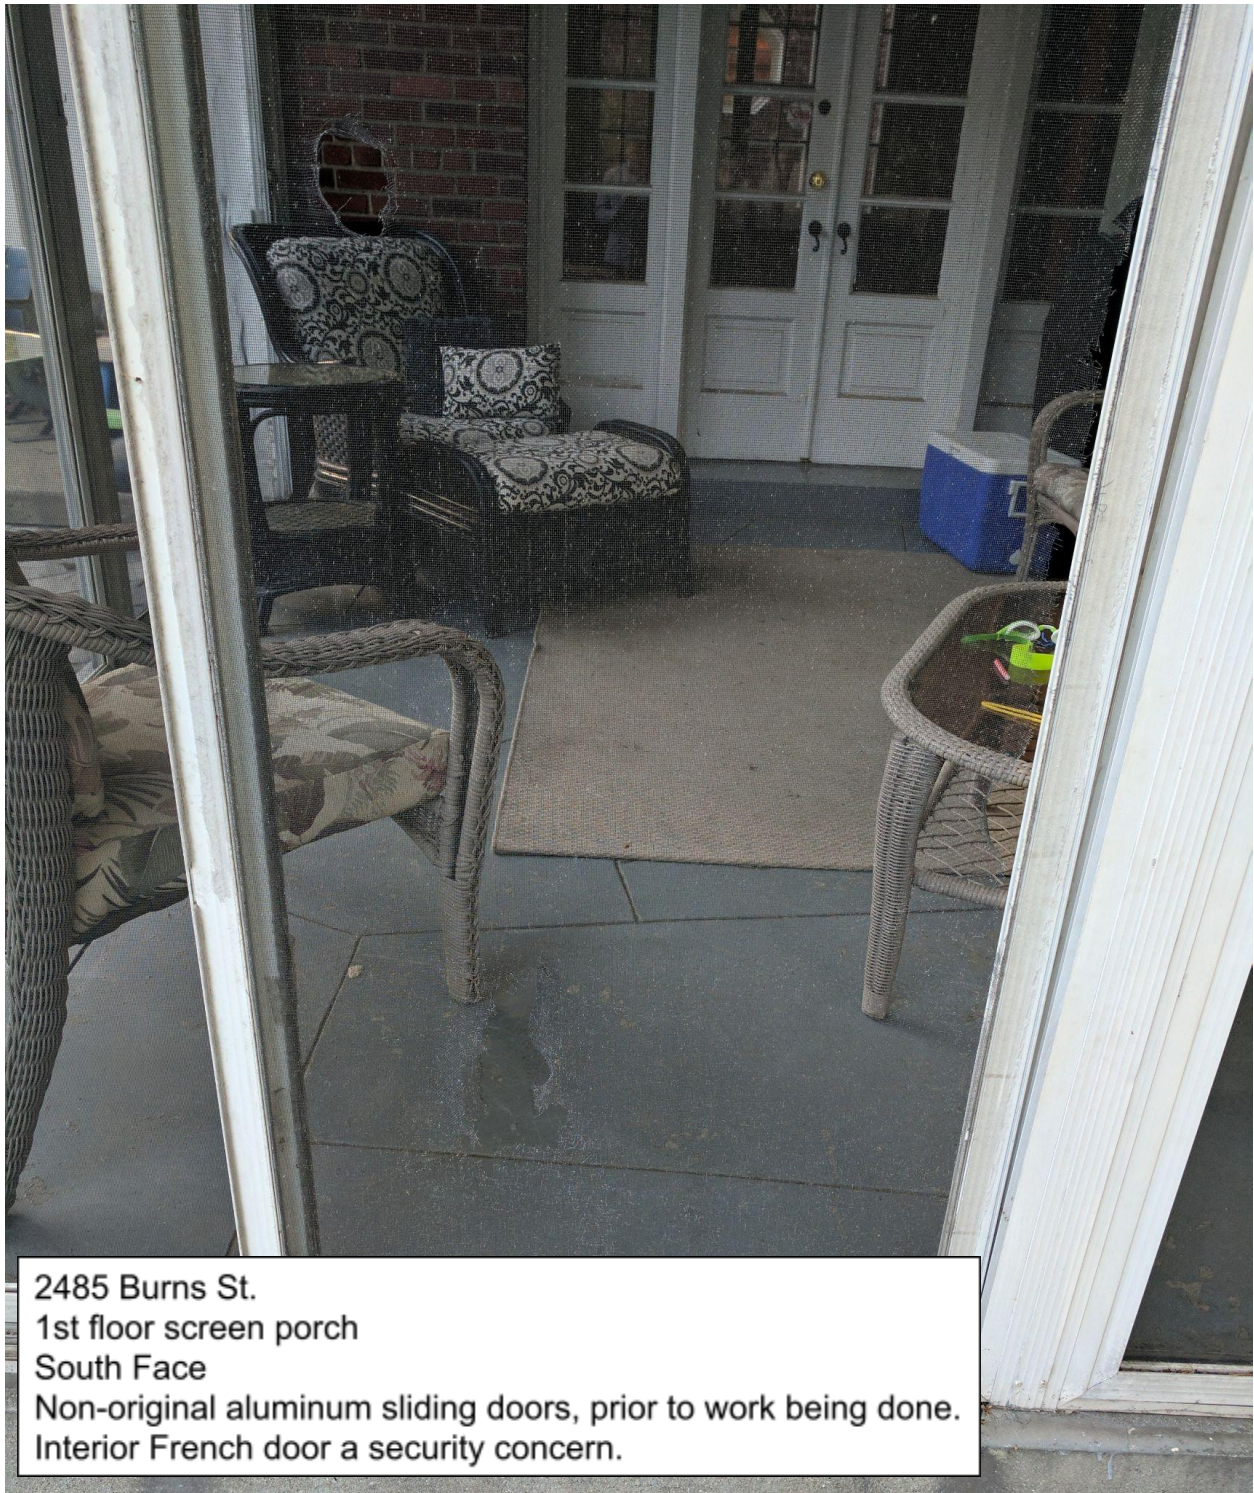
After receiving that approval, we ultimately decided not to go ahead with that work as depicted because we felt the need to increase the security of the room. The screen porch has a french door that opens to the main structure of the house. We installed an additional deadbolt to the door, and had a locksmith repair the security bolts above and below the door. Despite those improvements, the french door was still an easy break-in point with just a screen porch around it.

2485 Burns St.
1st floor screen porch
South Face
Non-original aluminum sliding doors, prior to work being done.
Interior French door a security concern.
