STAFF REPORT: SEPTEMBER 14, 2022 MEETING PREPARED BY: J. ROSS

**APPLICATION NUMBER: #22-8002**

**ADDRESS: 1830 CHURCH**

**SCOPE OF WORK:** DEMOLISH GARAGE

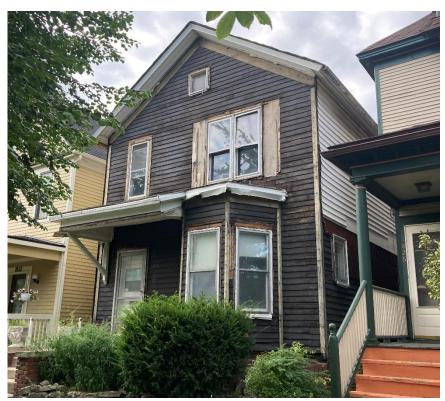
1830 Church, 9/1/2022 staff photo

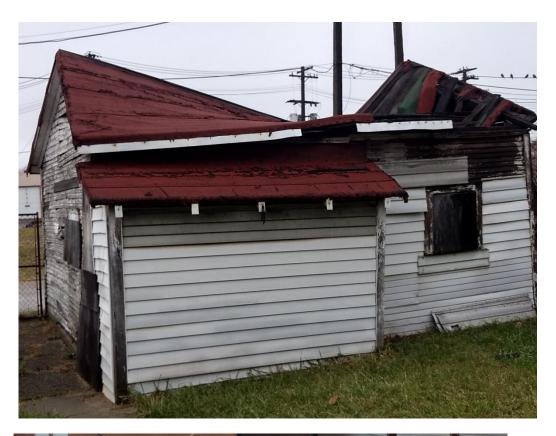
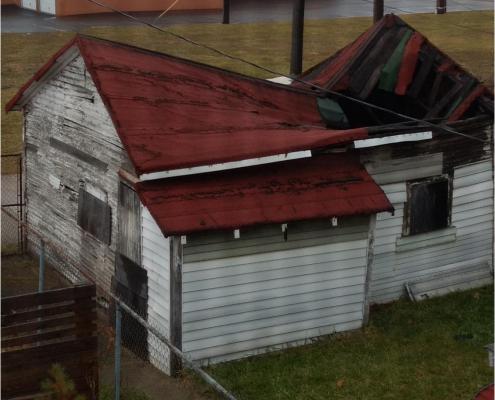
- Please see the below photos of the historic-age garage which were taken prior to its unapproved demolition. Note that the roof had caved in and the walls appear to have been bowing inwards. Although the building was of historic age, it staff's opinion that it lacked the integrity necessary to contribute to the site's and/or the district's historic significance due to its poor condition.
- The applicant has noted that they also see the Commission's approval to install a new airconditioning condenser unit within the property's rear yard. However, the proposal does not indicate the specific location of the unit.

1830 Church, garage prior to unapproved demolition

As noted above, it is staff's opinion that the garage was not a contributing property within the district due to its poor condition. Staff therefore recommends that the Commission issue a Certificate of Appropriateness (COA) for the work as proposed because it conforms to the district's Elements of Design and meets the Secretary of the Interior's (SOI) Standards for Rehabilitation. However, staff does recommend that the Commission issue this COA with the condition that the applicant allow HDC staff the opportunity to review and approve the location of the proposed new air-conditioning condenser unit prior to the issuance of the project permit. Should staff determine that the work does not meet the SOI Standards, the work will be added to the next available commission meeting agenda for consideration/review.

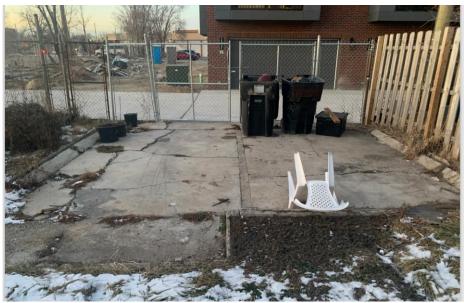
1830 Church, rear yard slab after garage demolition
