**STAFF REPORT:** 10/12/2022 REGULAR MEETING

**APPLICATION NUMBER:** #22-8055

**ADDRESS:** 2801 OAKMAN

**SCOPE:** INSTALL VINYL WINDOWS (WORK COMPLETE WITHOUT APPROVAL), REPLACE EXISTING VINYL WINDOWS WITH NEW VINYL WINDOWS

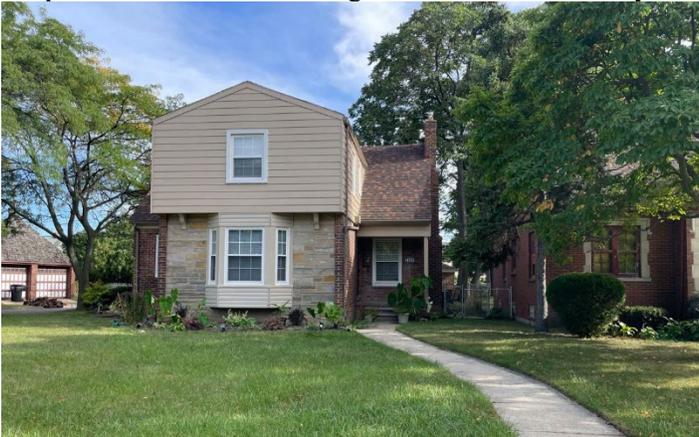
*Site Photo 1, by staff Sept.23, 2022: (Northwest) front elevation.*

- The front elevation shutters were removed
  - The aluminum siding was painted
  - The front bay window wood paneling has been covered with vinyl siding

- The front foundation shrubs were removed and replaced with a garden bed.
- Staff has identified that the original, divided-light double-hung windows on the front elevation were distinctive character-defining features that have been removed without approval, and therefore substantially detracts from and destroys the historic appearance of the building.

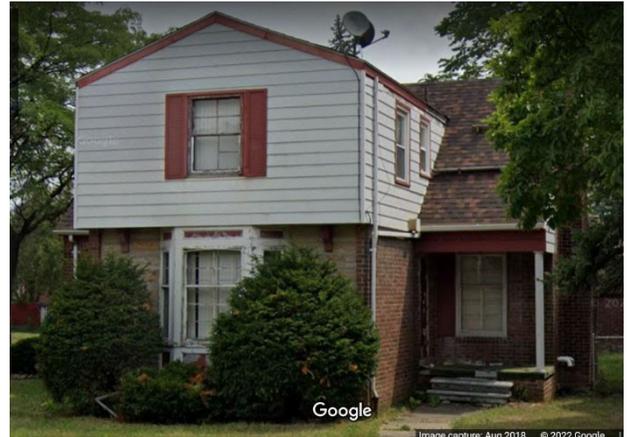
*Site Photo2, by Google Streetview 2018: (Northwest) front elevation showing original casement and double-hung windows.*

- The replacement of the front bay casements with double hung vinyl windows, changes the operation, design and scale and therefore is inappropriate.
- No documentation establishing that the original wood windows were beyond repair was recorded or submitted.

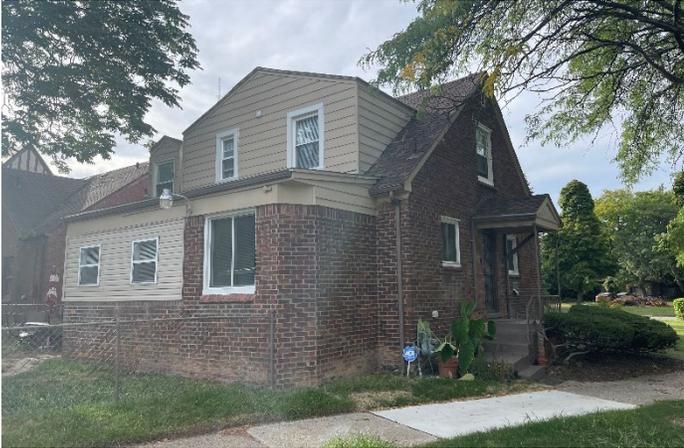
Site Photo 3, by staff September 23, 2022: (Southeast) side/rear elevation showing existing vinyl windows.

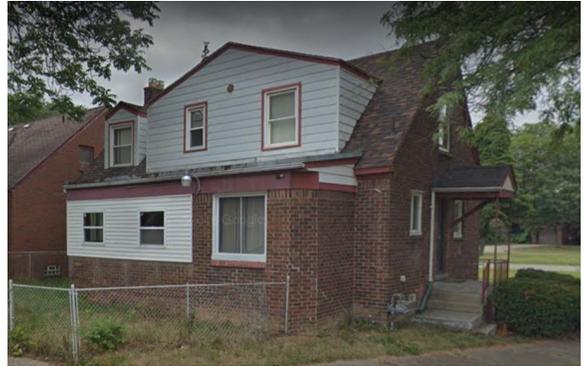
- The side and rear elevation windows did not have these divided light features, but the windows on these elevations had trim and brick molding traits that were clean, thinner design than the current vinyl window's 1-2" coil coverings. It is staff's opinion that original window frame and material are characteristic of Minimal Traditional architecture and therefore character-defining features that were lost when replaced.

*Site Photo 4, by Google Streetview 2018: (South) rear and side elevation showing original double-hung and slider windows.*

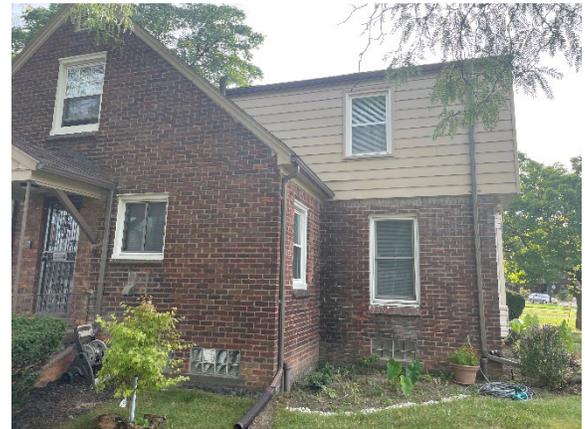
- Staff observed that the installed vinyl windows have several features that are not appropriate:
  - the surrounding coil covering the brickmold is large and gives the windows a chunky appearance

- the between the glass grids give the windows a flat appearance, losing the dimensions of the historic muntins
  - the configuration of the installed windows does not match the original configuration

*Site Photo 5, by Staff: (Southeast) side elevation showing thick, aluminum coil stock around brick mold and seam, and between glass grids (2<sup>nd</sup> floor), of previously installed vinyl windows.*

- The aluminum coil stock around the brickmold is inappropriate
  - The between the glass grids give the windows a flat appearance, losing the dimensions of the historic muntins
