**STAFF REPORT:** 10/12/2022 REGULAR MEETING

**PREPARED BY:** D. RIEDEN

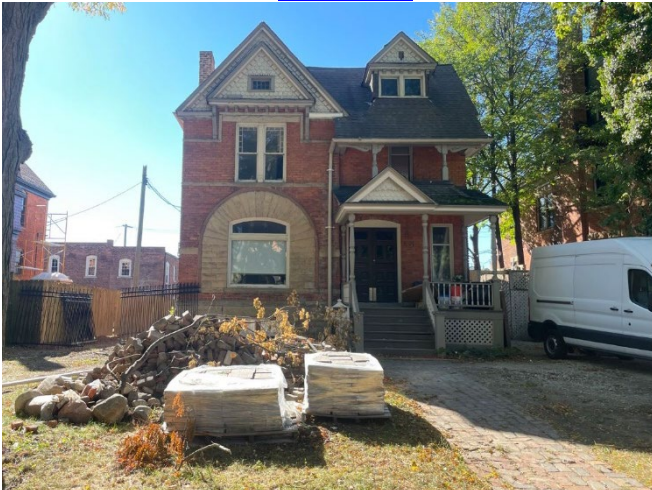
*Site Photo 1, by Staff Sept.23, 2022: (North) front elevation.*

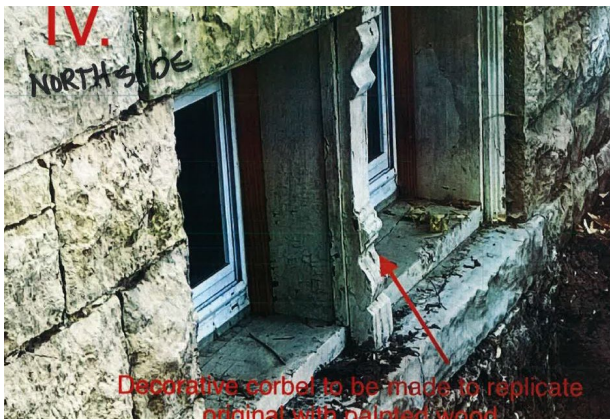
Site Photo 4, by Applicant: (North) front elevation showing before condition of front basement windows stone mullion.

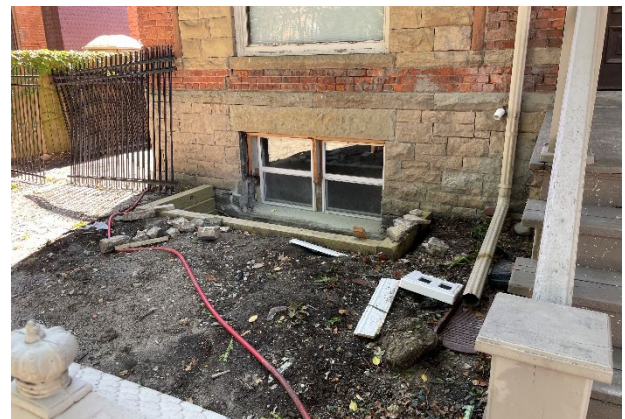
Site Photo 5, by staff September 1, 2022: (North) front elevation showing current basement windows and window-well. The proposed new corbel appears to be missing.

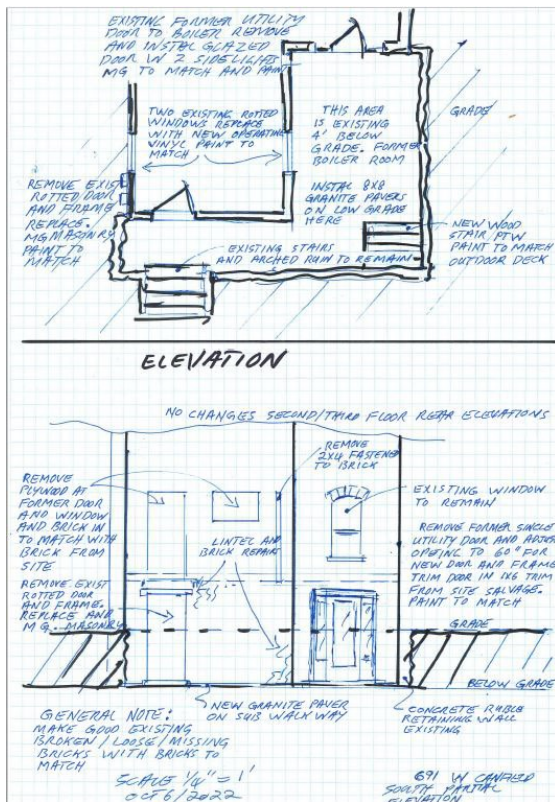
Figures 2 & 3, by Applicant, showing the rear basement site plan and elevation of proposed/completed work.

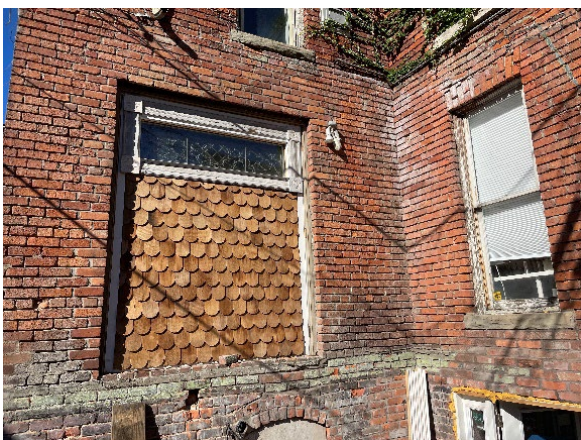
*Site Photo 6, by staff, September 1, 2022 : (South) rear, east facing elevation showing location of removed doors and infill with fish-scale siding and stained glass transom from another building installed in the opening.*

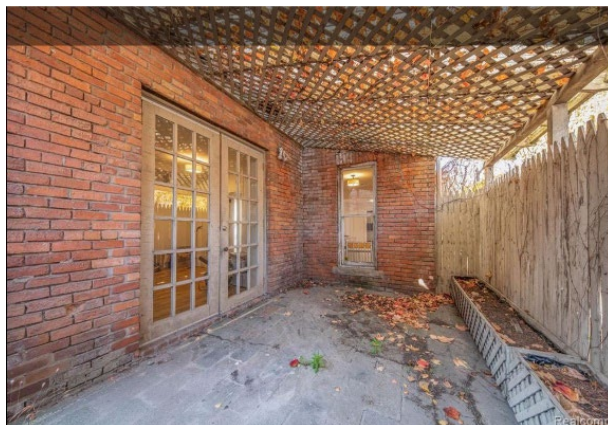
*Site Photo 7, by Real Estate.com, listing date, October 2021: (South) rear, east facing elevation showing original rear porch covering, patio, planter bed and fence over the boiler room below.*

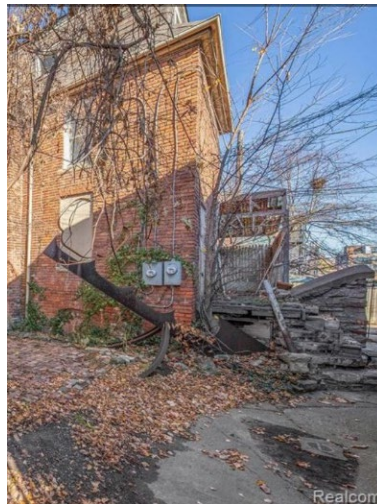
*Site Photo 8, by applicant, date unknown: (South) rear, facing east elevation showing before conditions of rear covered patio. Note the presence of stone steps leading to the now boarded-up door at the rear elevation.*

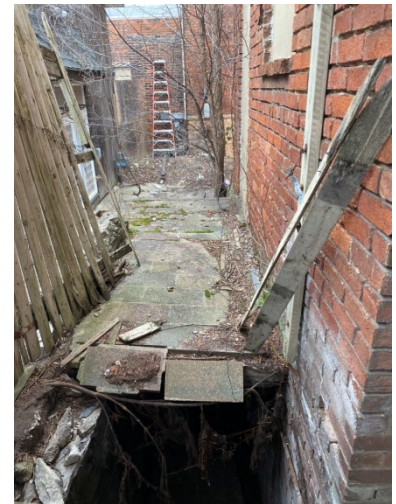
*Site Photo 9, by applicant, date unknown: (South) rear, facing west elevation showing after conditions of location of partially removed patio.*

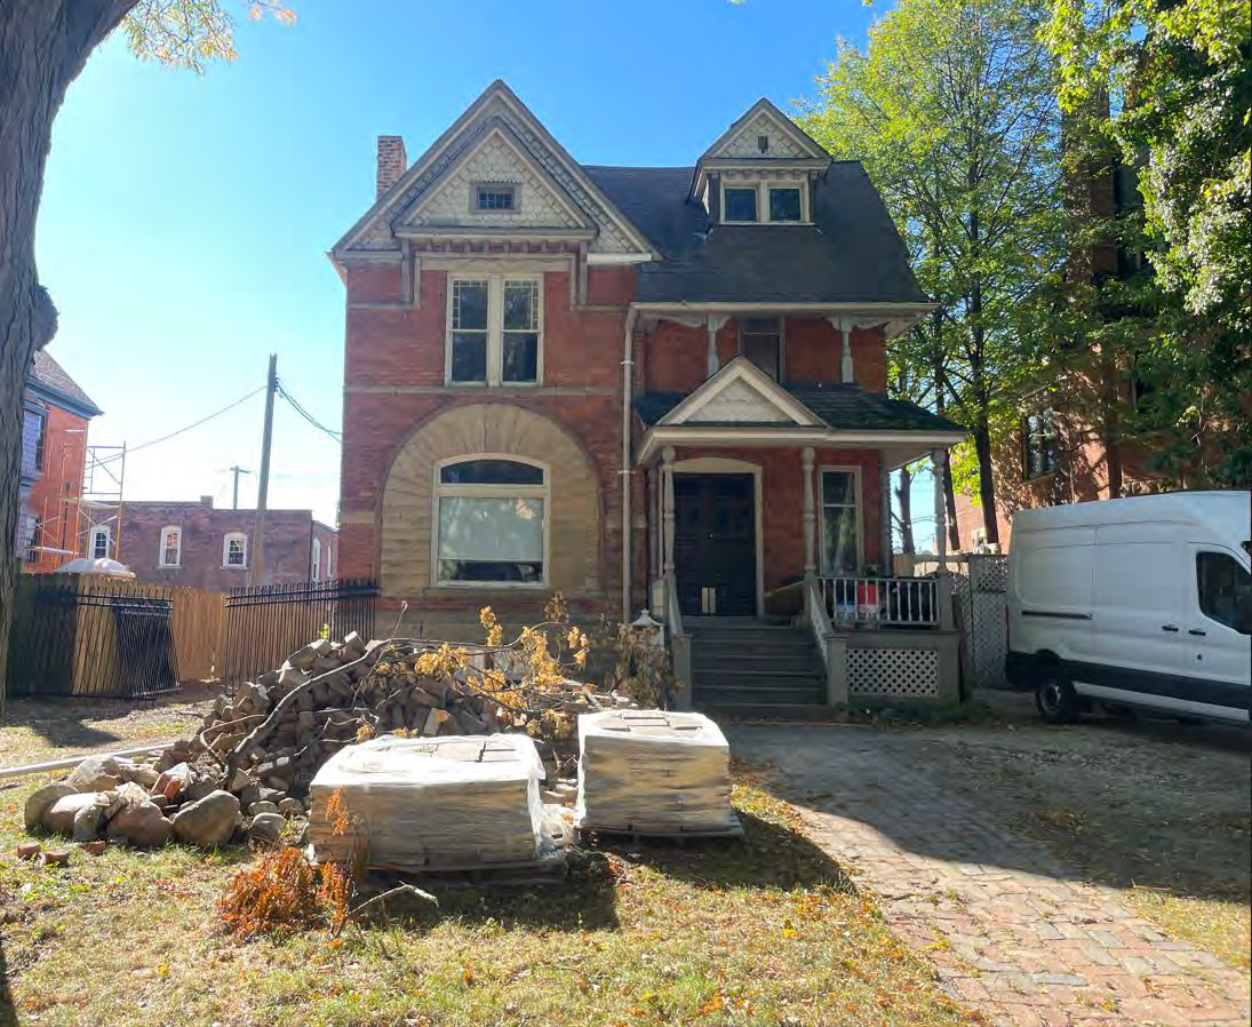
- Applicant supply HDC staff with the asphalt shingles, rear door and metal fence product information for approval.
- The proposed fencing shall conform to the Commission's Fences and Hedges Guidelines and the fencing proposed for the side/east & west property line shall be of one consistent material.

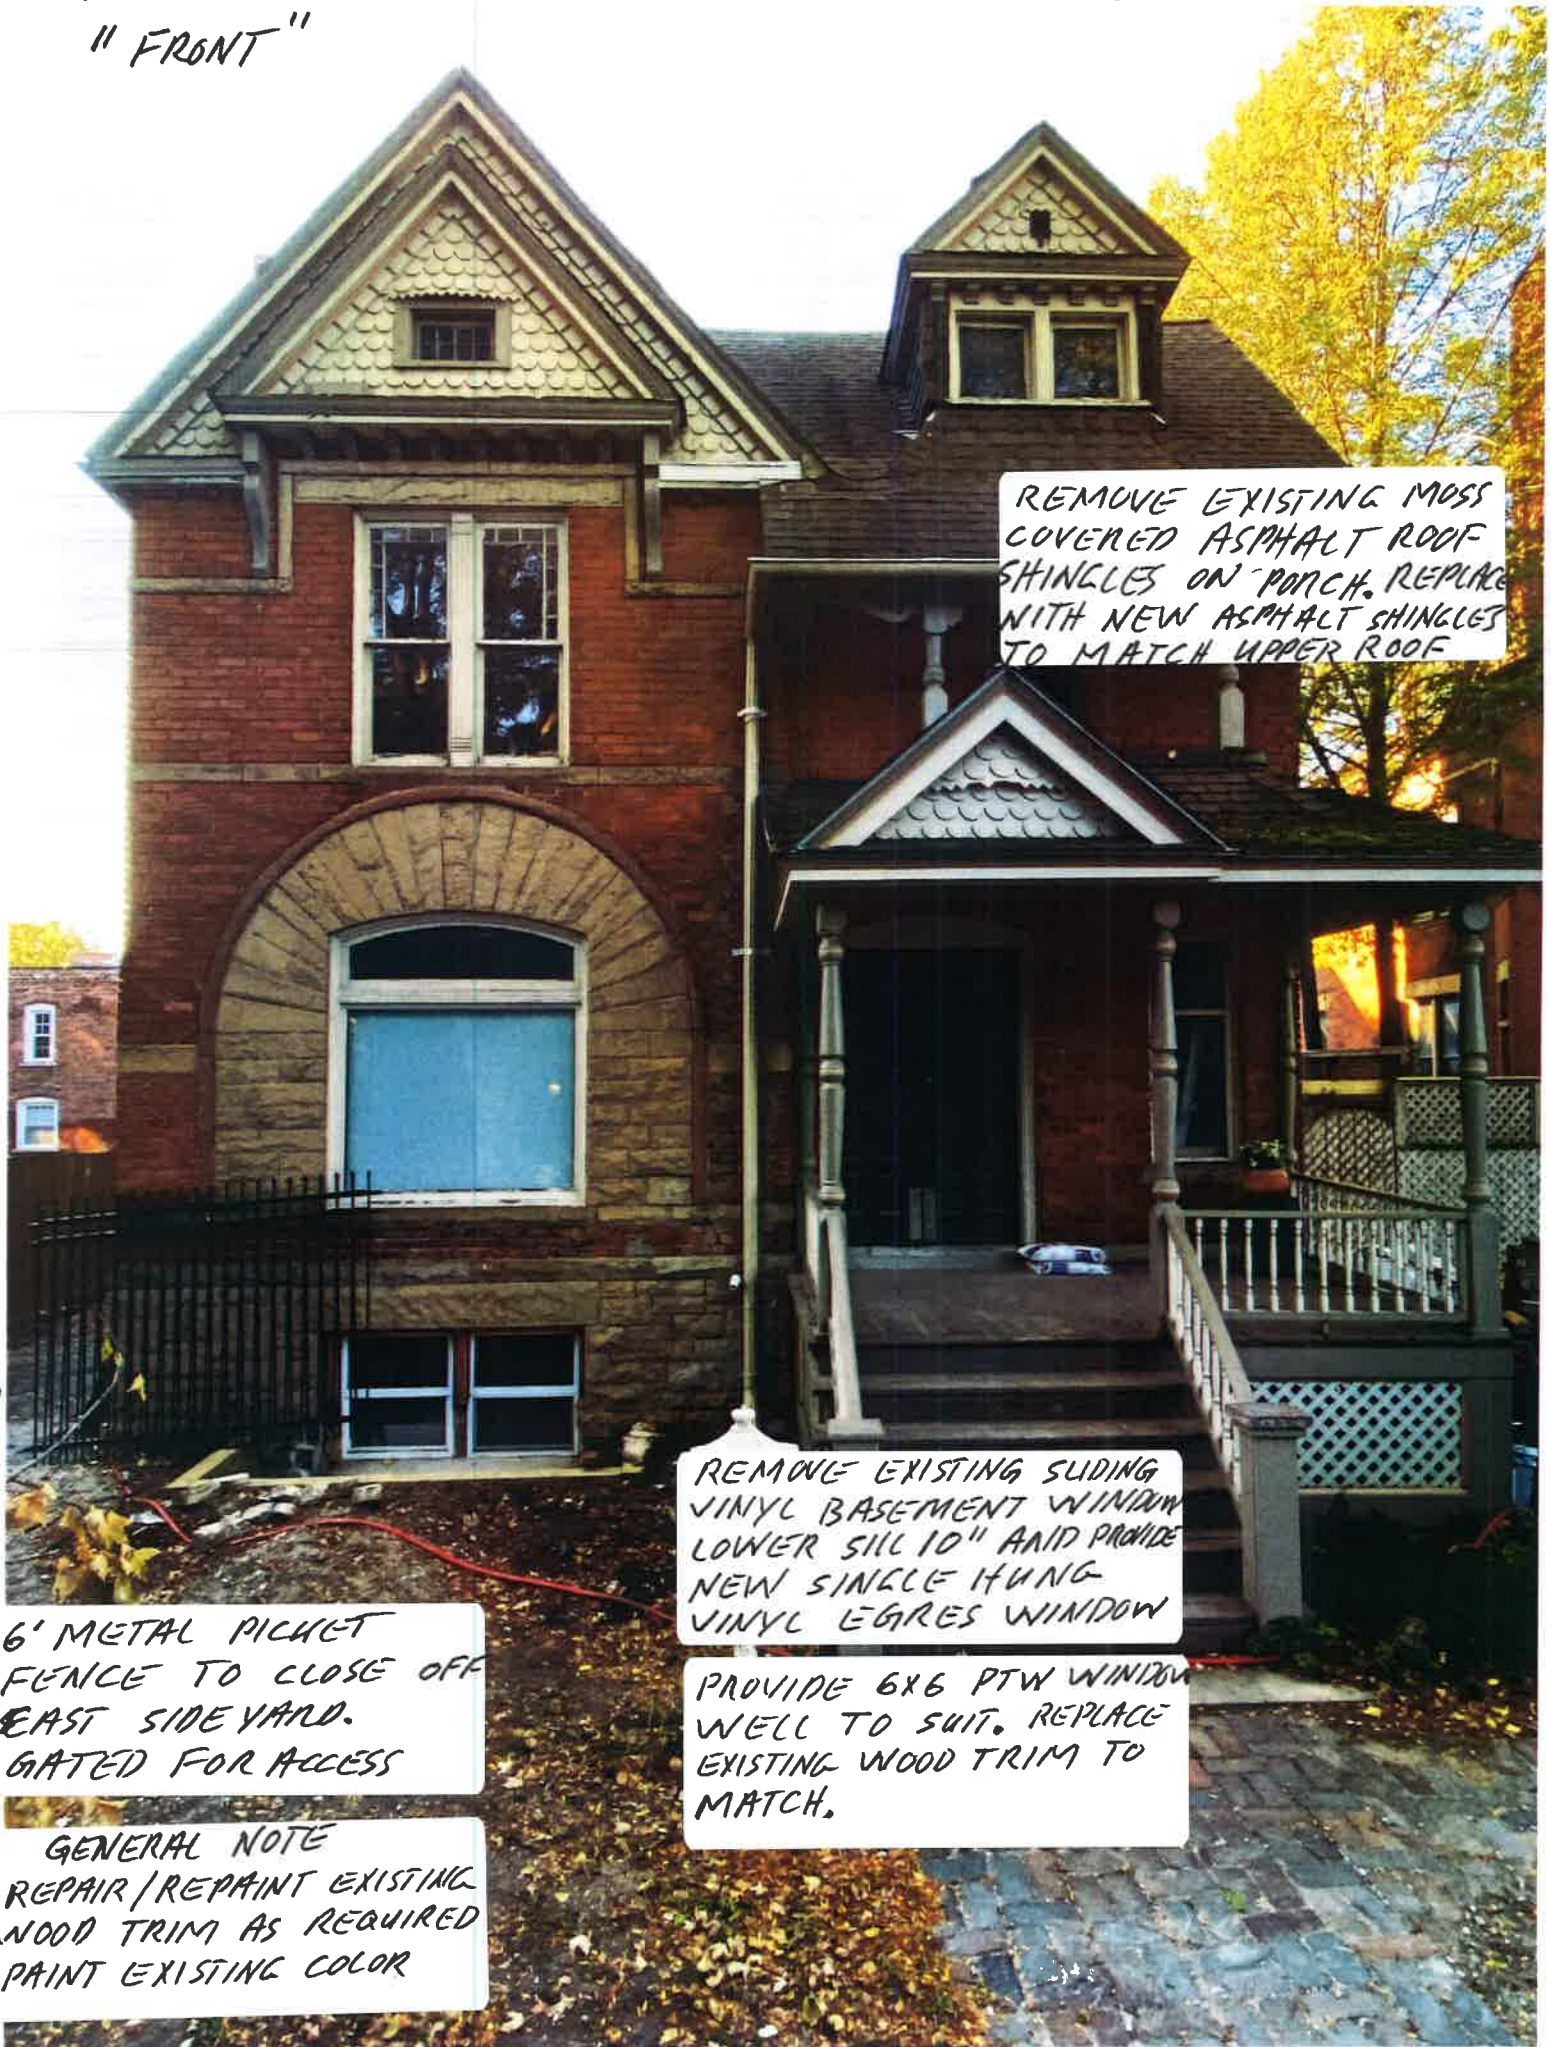
REMOVE EXISTING MOSS COVERED ASPHALT ROOF SHINGLES ON PORCH. REPLACE WITH NEW ASPHALT SHINGLES TO MATCH UPPER ROOF

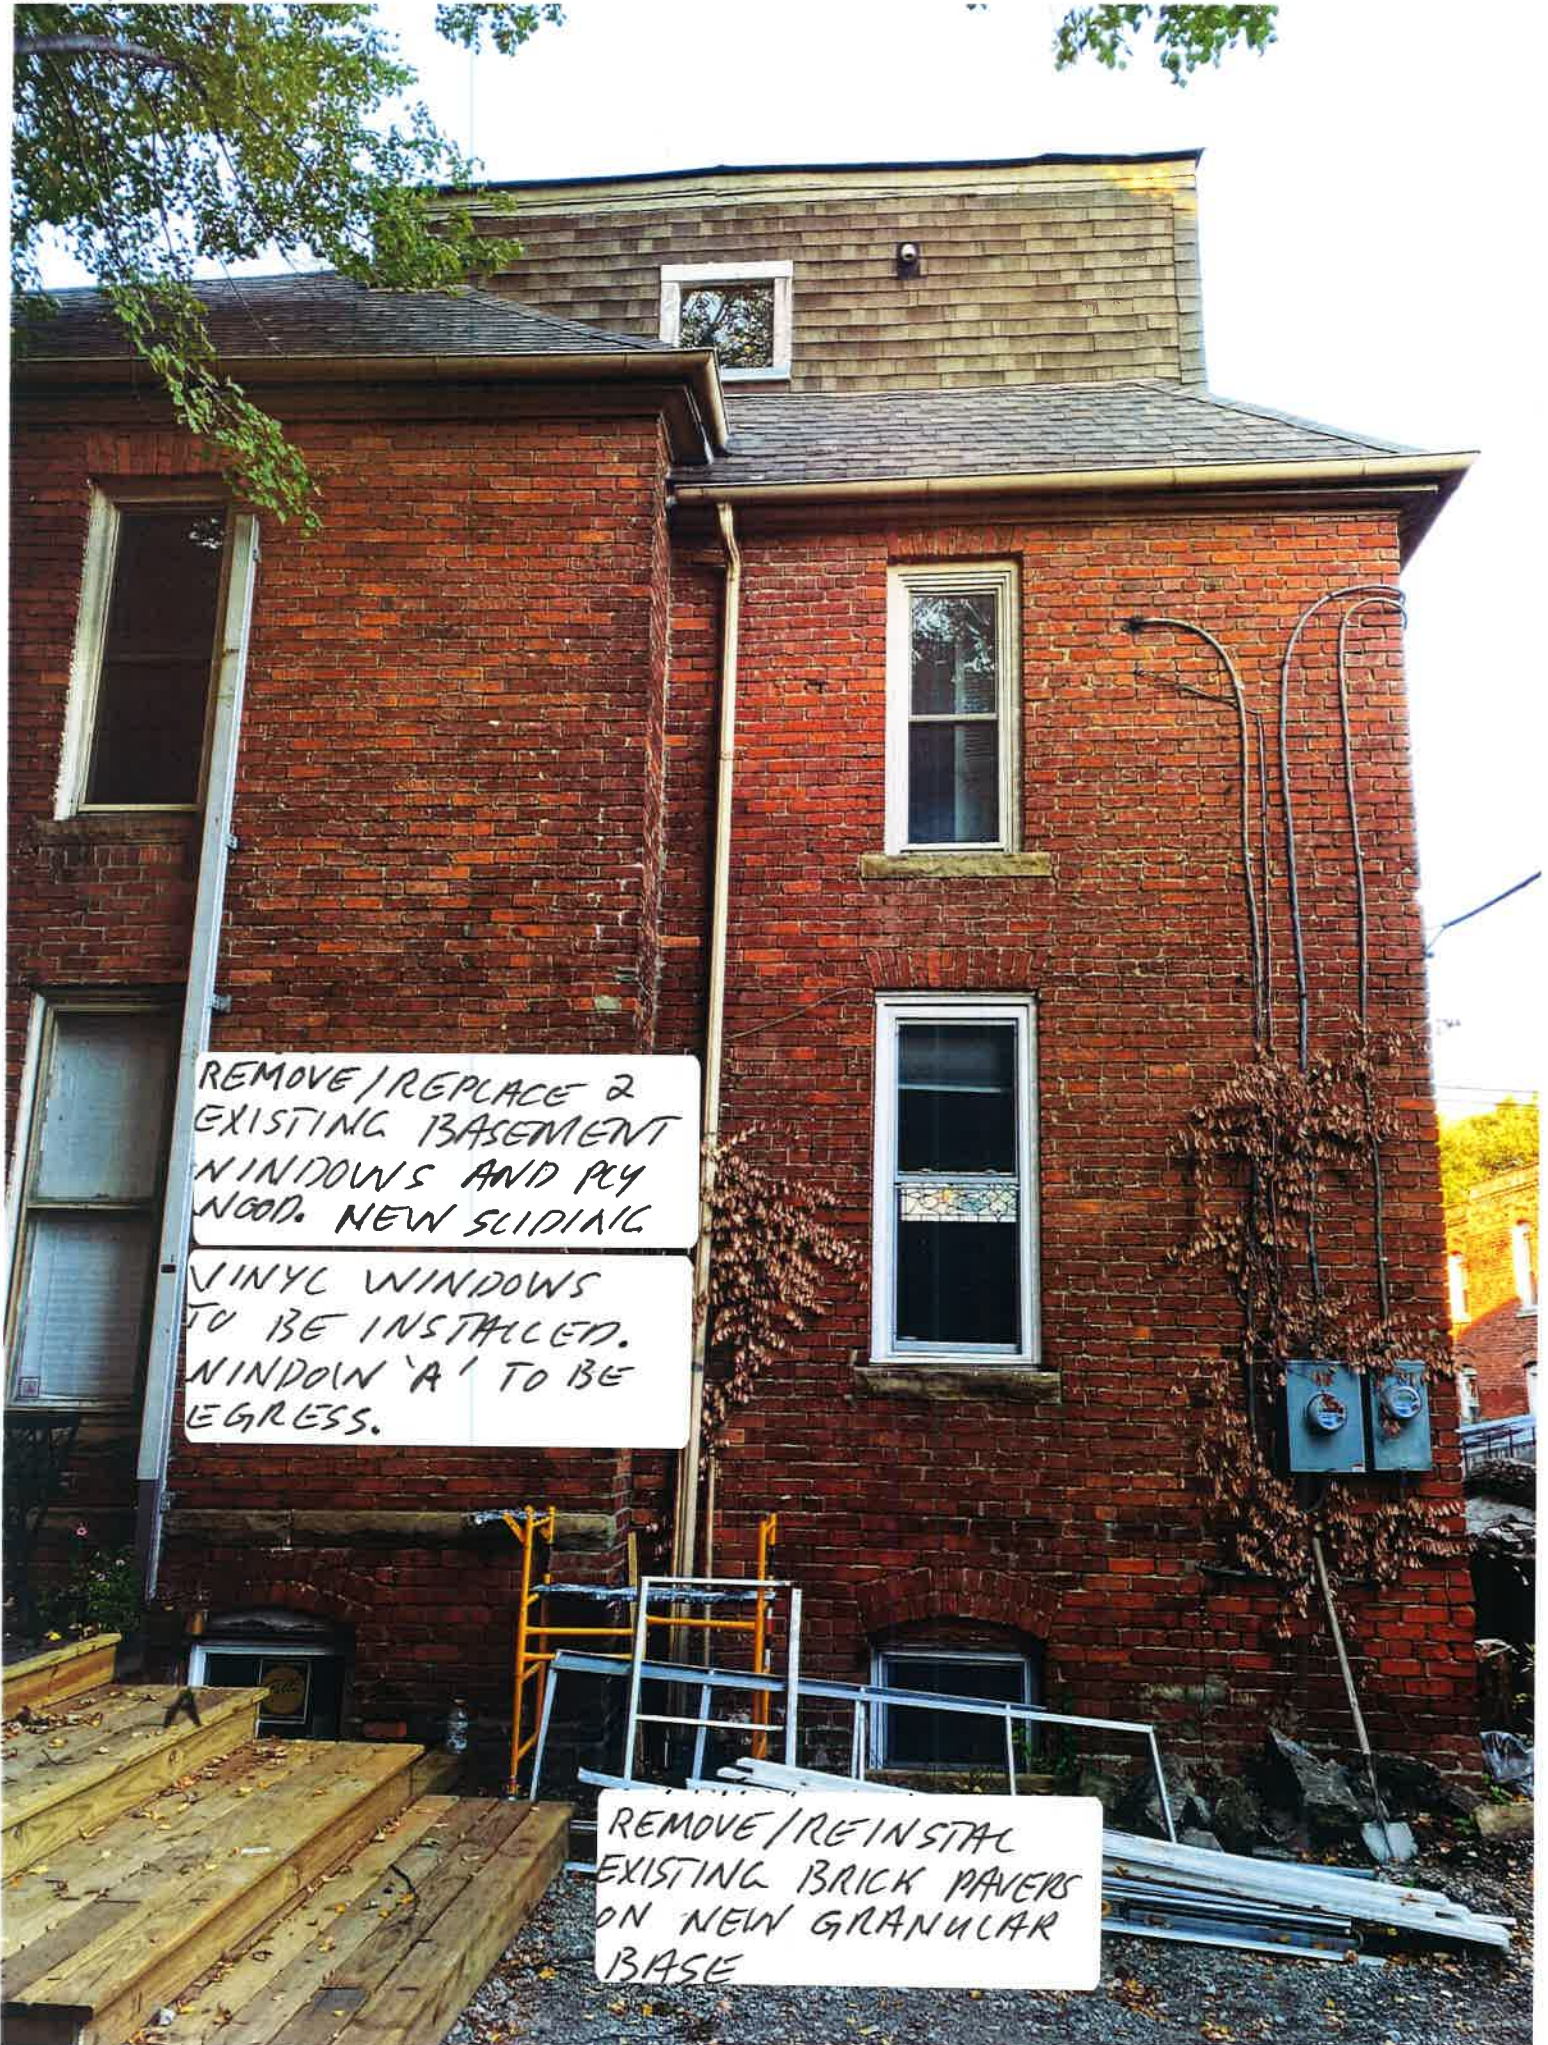
REMOVE/REPLACE 2  
EXISTING BASEMENT  
WINDOWS AND PLY  
WOOD. NEW SLIDING

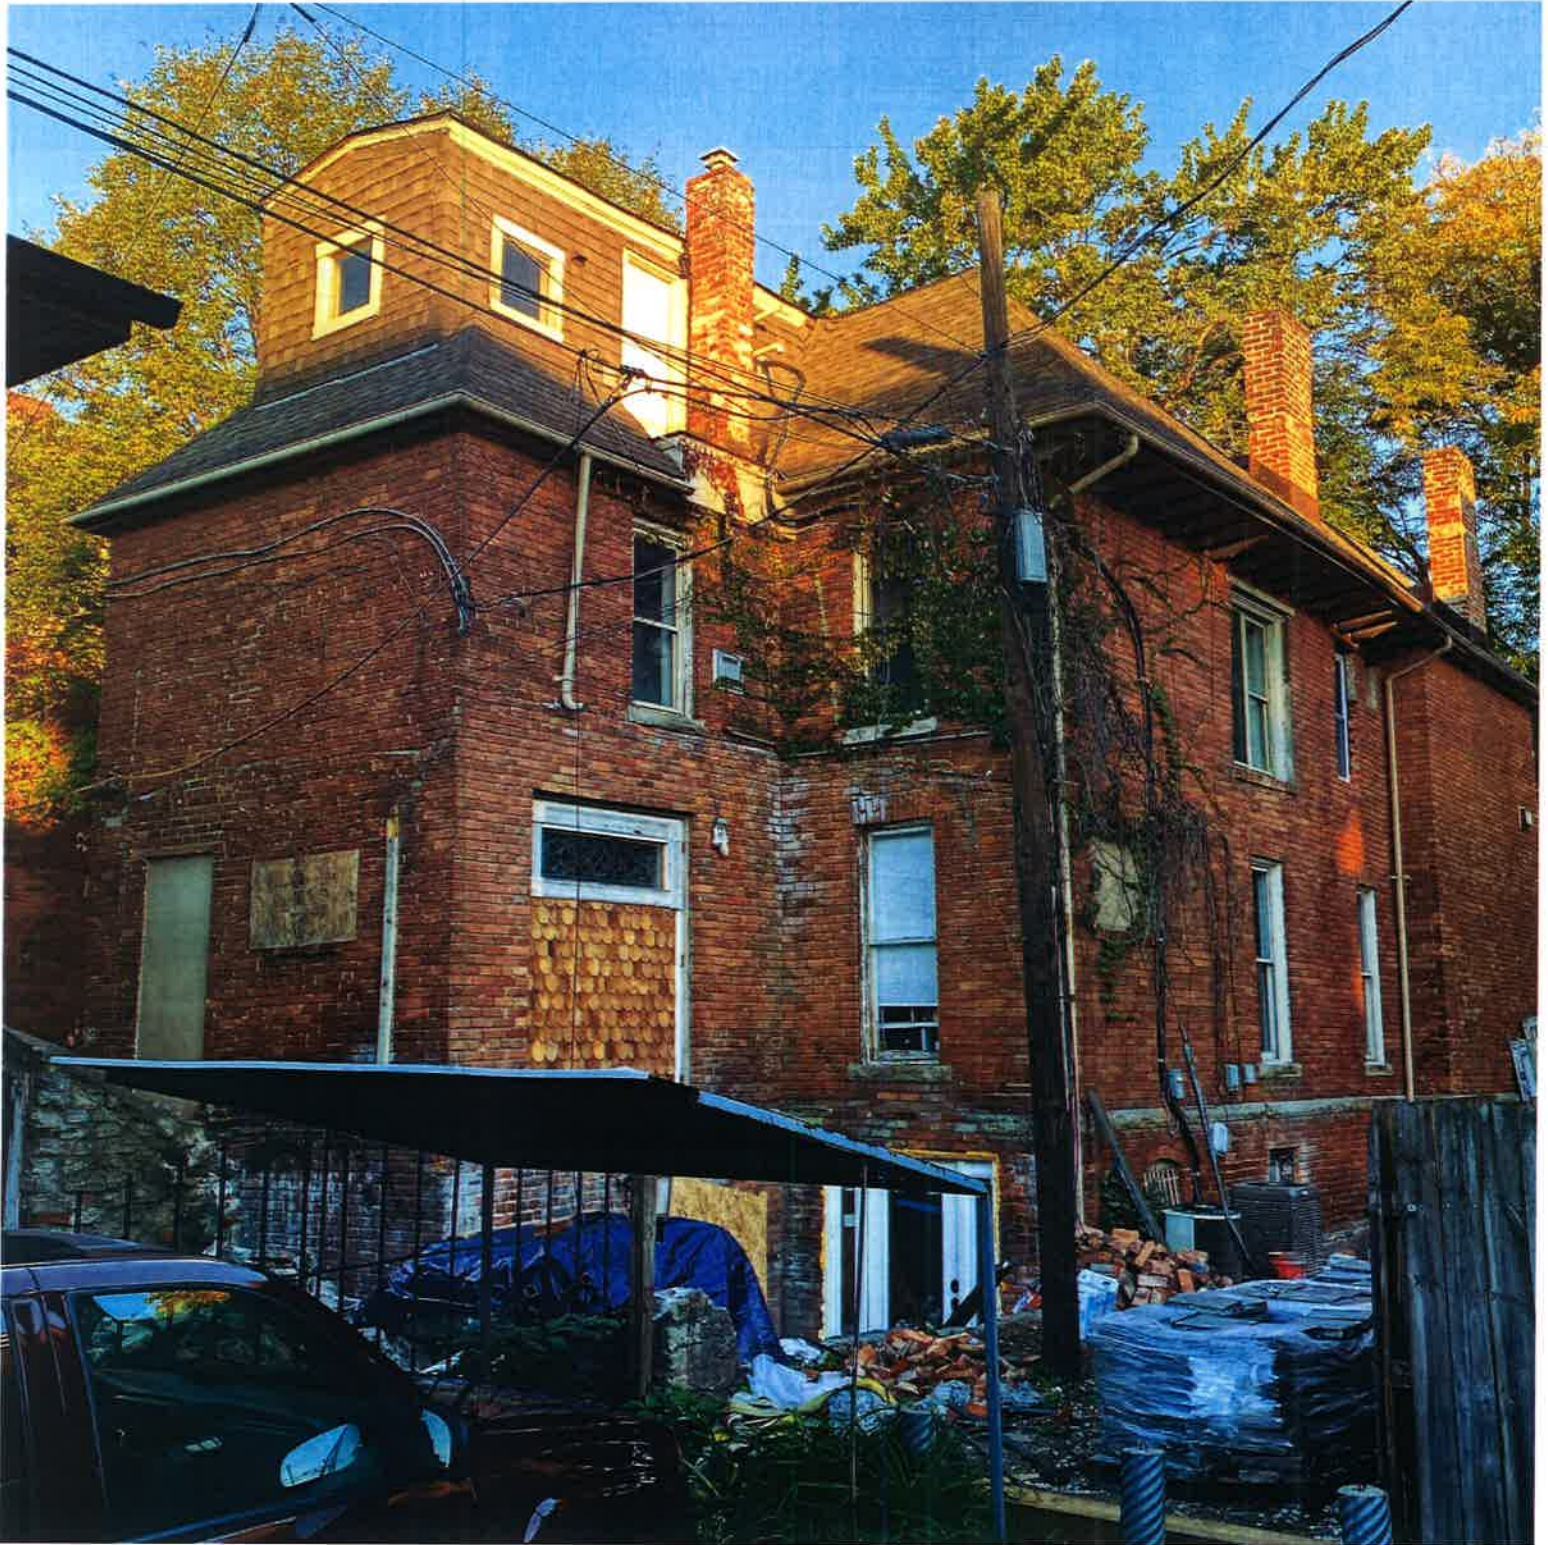
REMOVE PLYWOOD  
AND BRICK IN OPENING  
TO MATCH WITH  
SALVAGED SITE BRICK

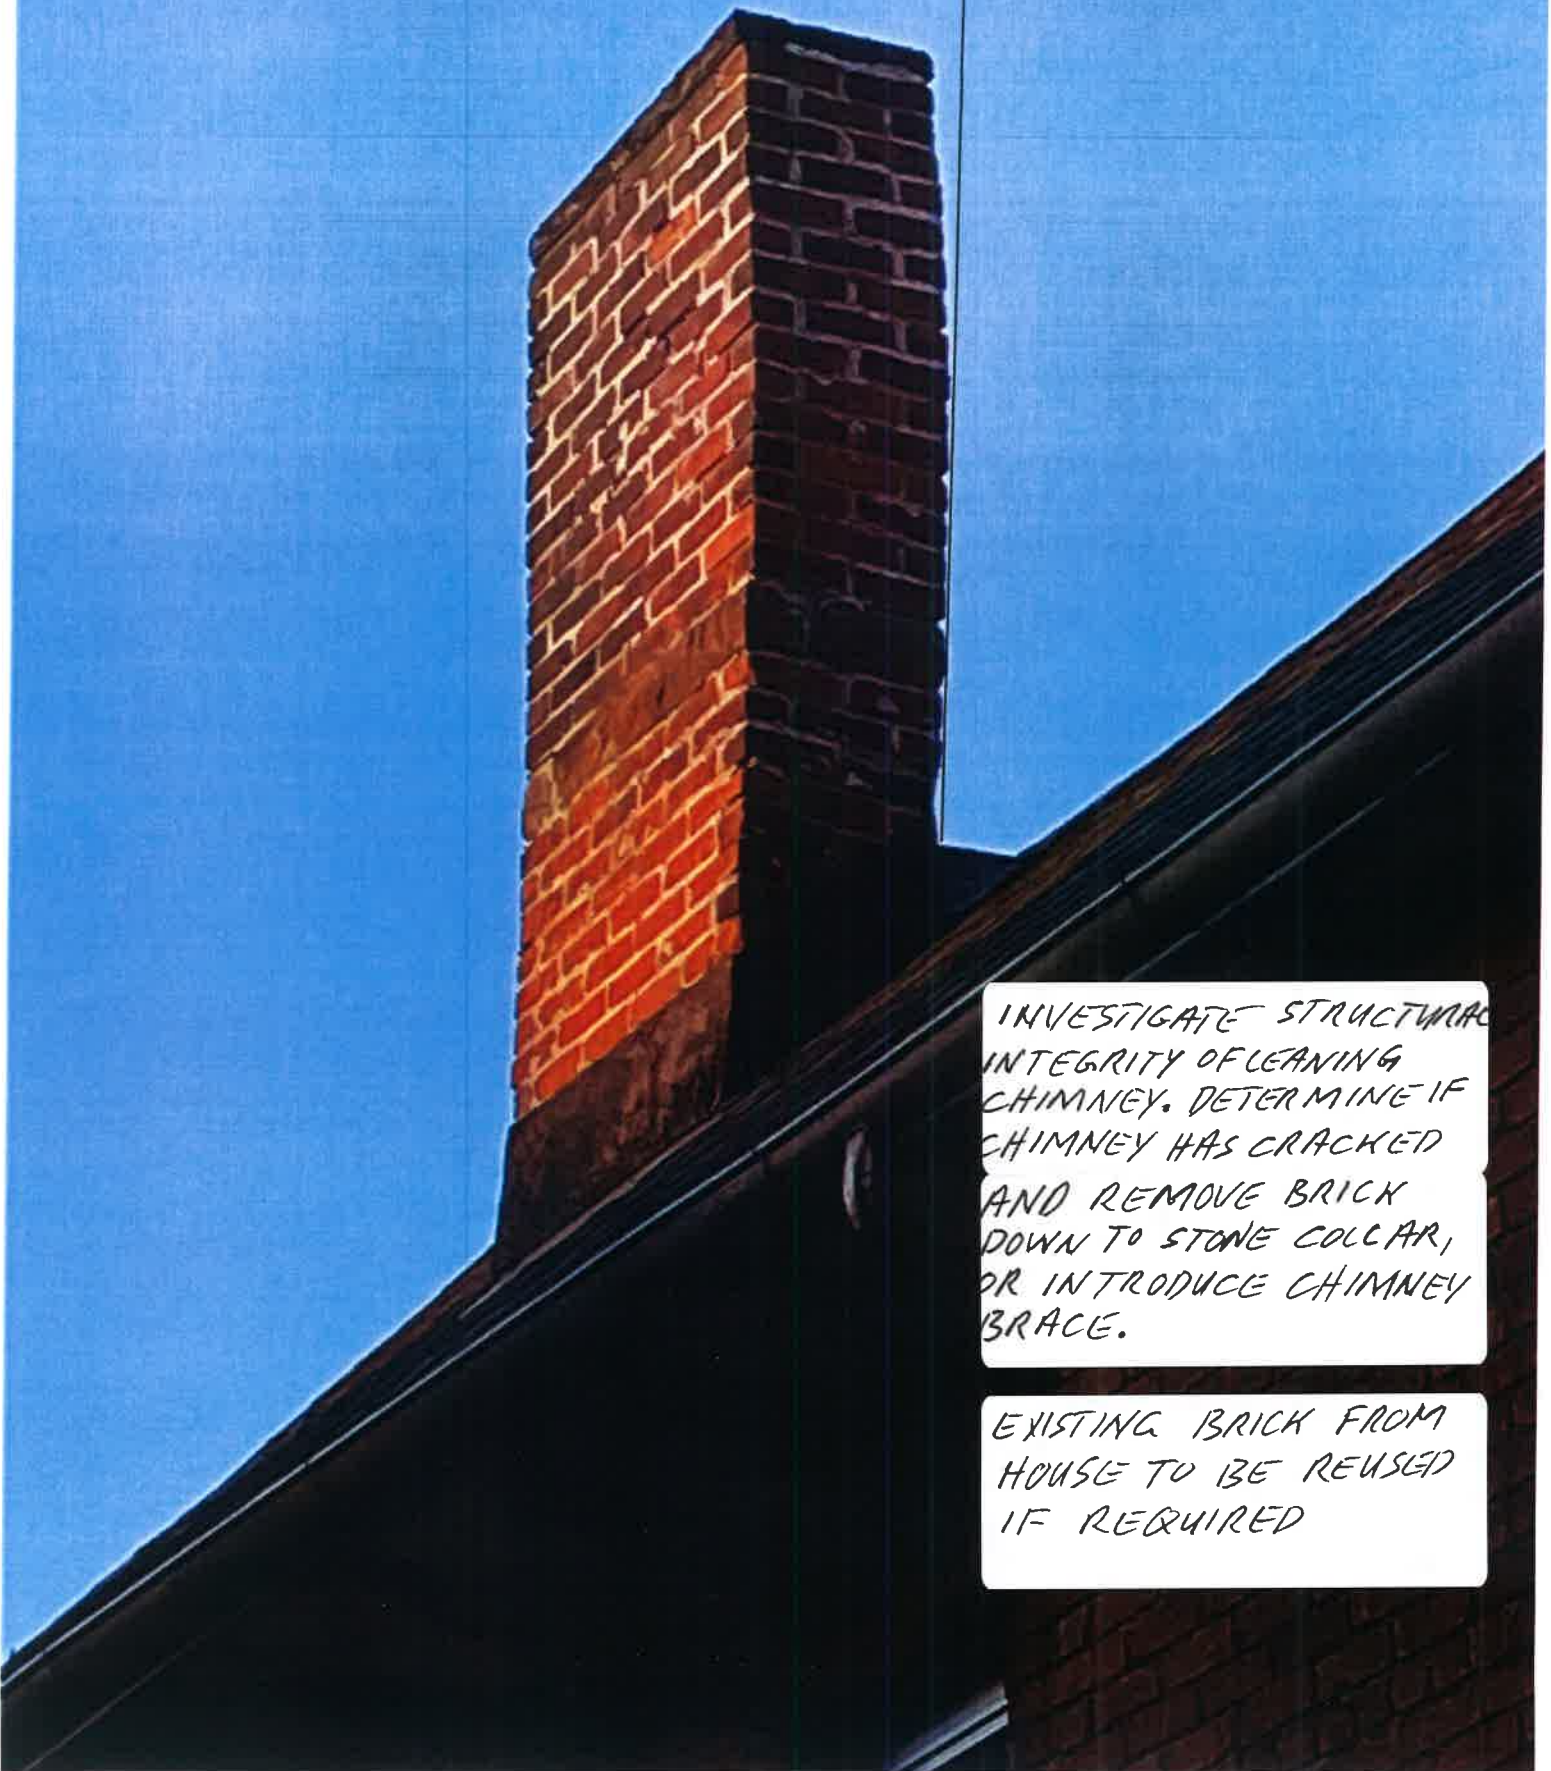
INVESTIGATE STRUCTURAL  
INTEGRITY OF LEANING  
CHIMNEY. DETERMINE IF  
CHIMNEY HAS CRACKED  
AND REMOVE BRICK  
DOWN TO STONE COLLAR,  
OR INTRODUCE CHIMNEY  
BRACE.

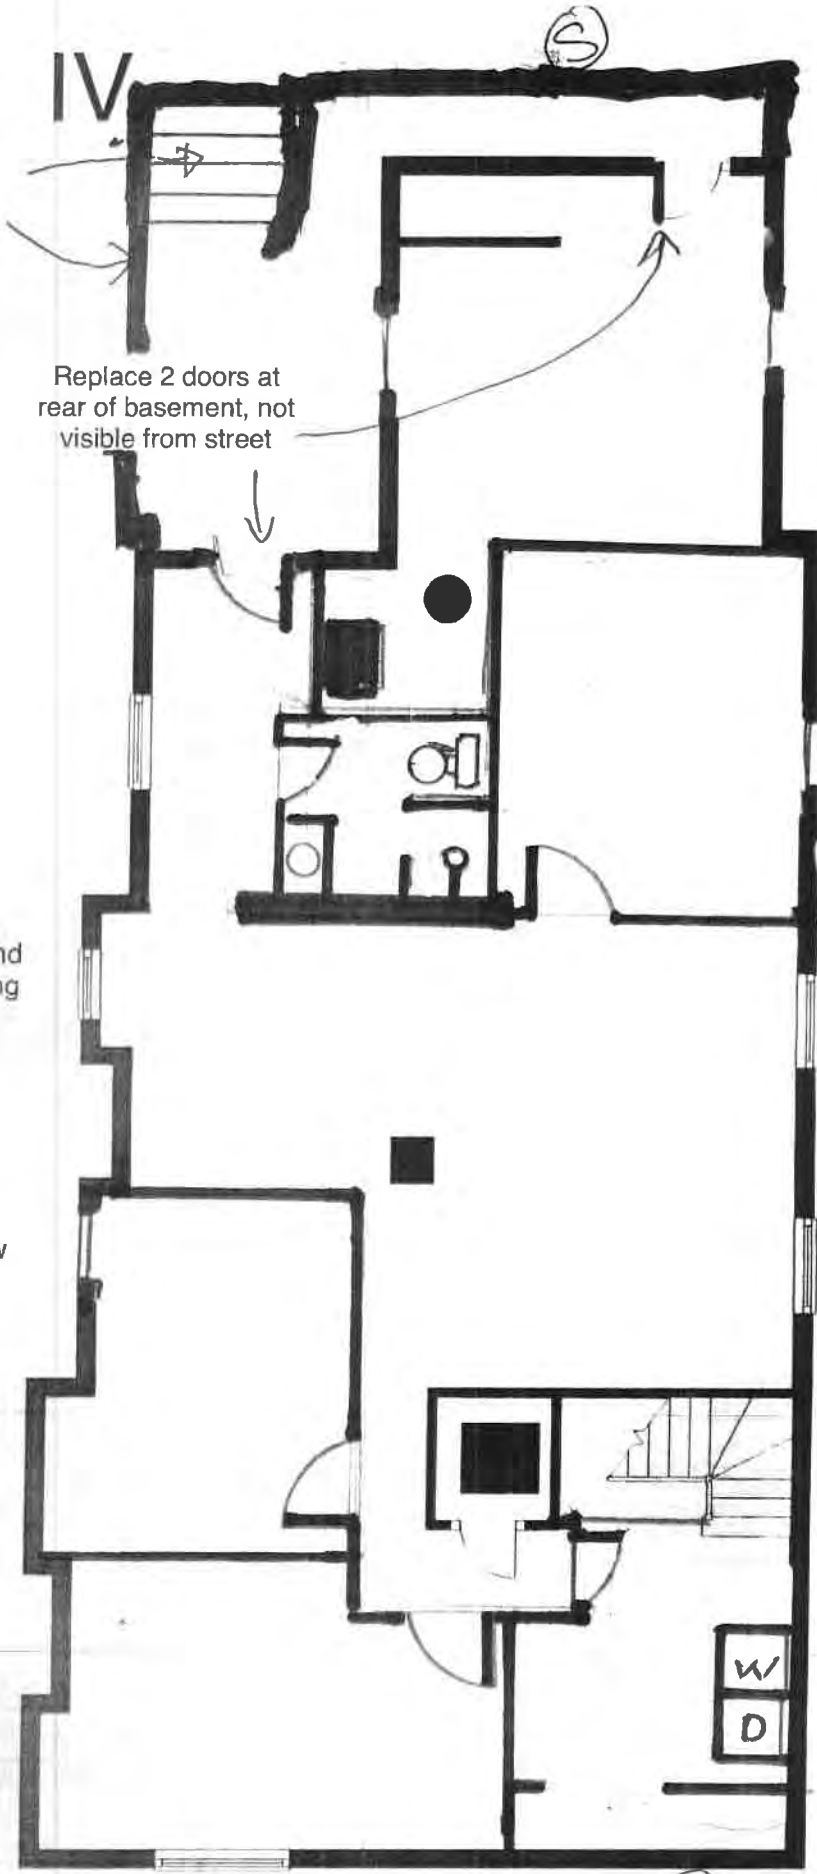
# PARTIAL BASEMENT PLAN VIEW REAR ELEVATION

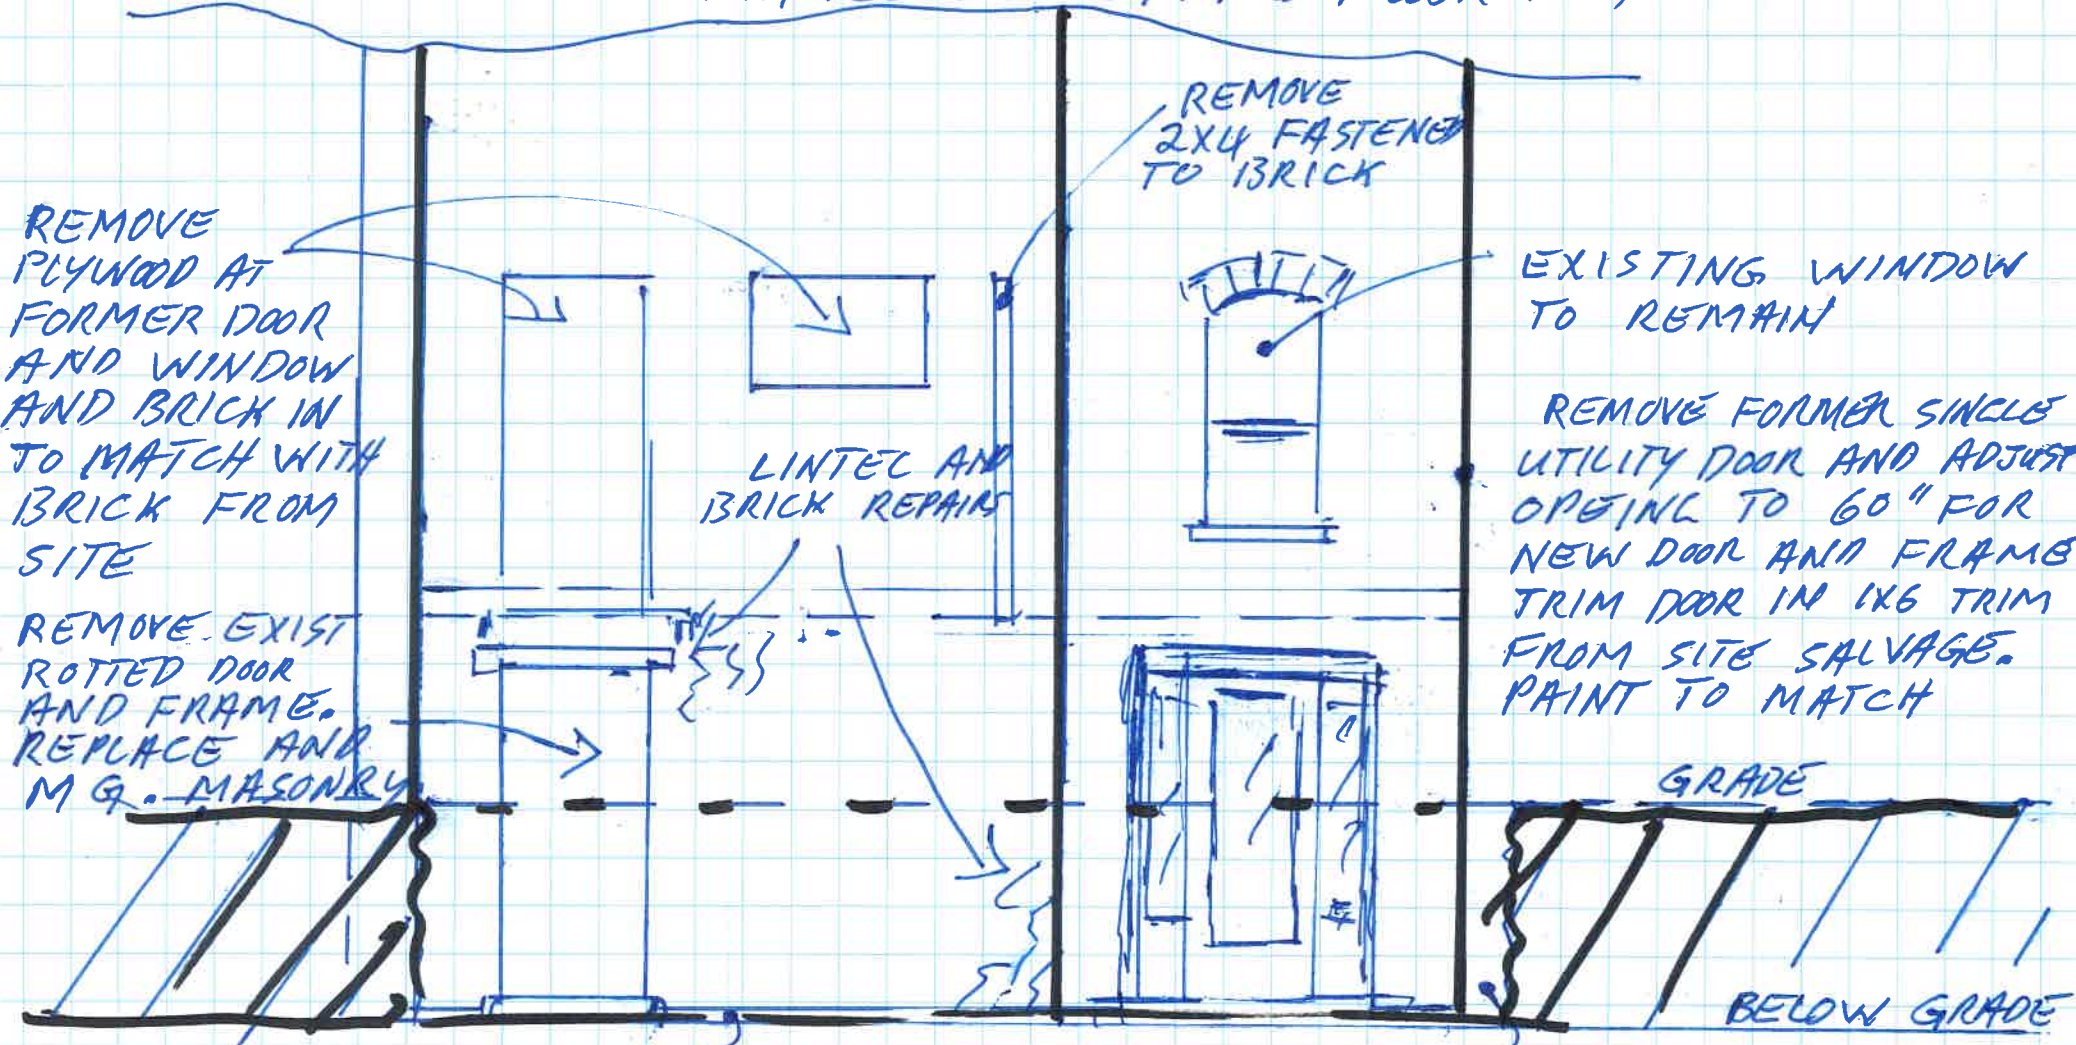
GENERAL NOTE:  
MAKE GOOD EXISTING  
BROKEN / LOOSE / MISSING  
BRICKS WITH BRICKS TO  
MATCH

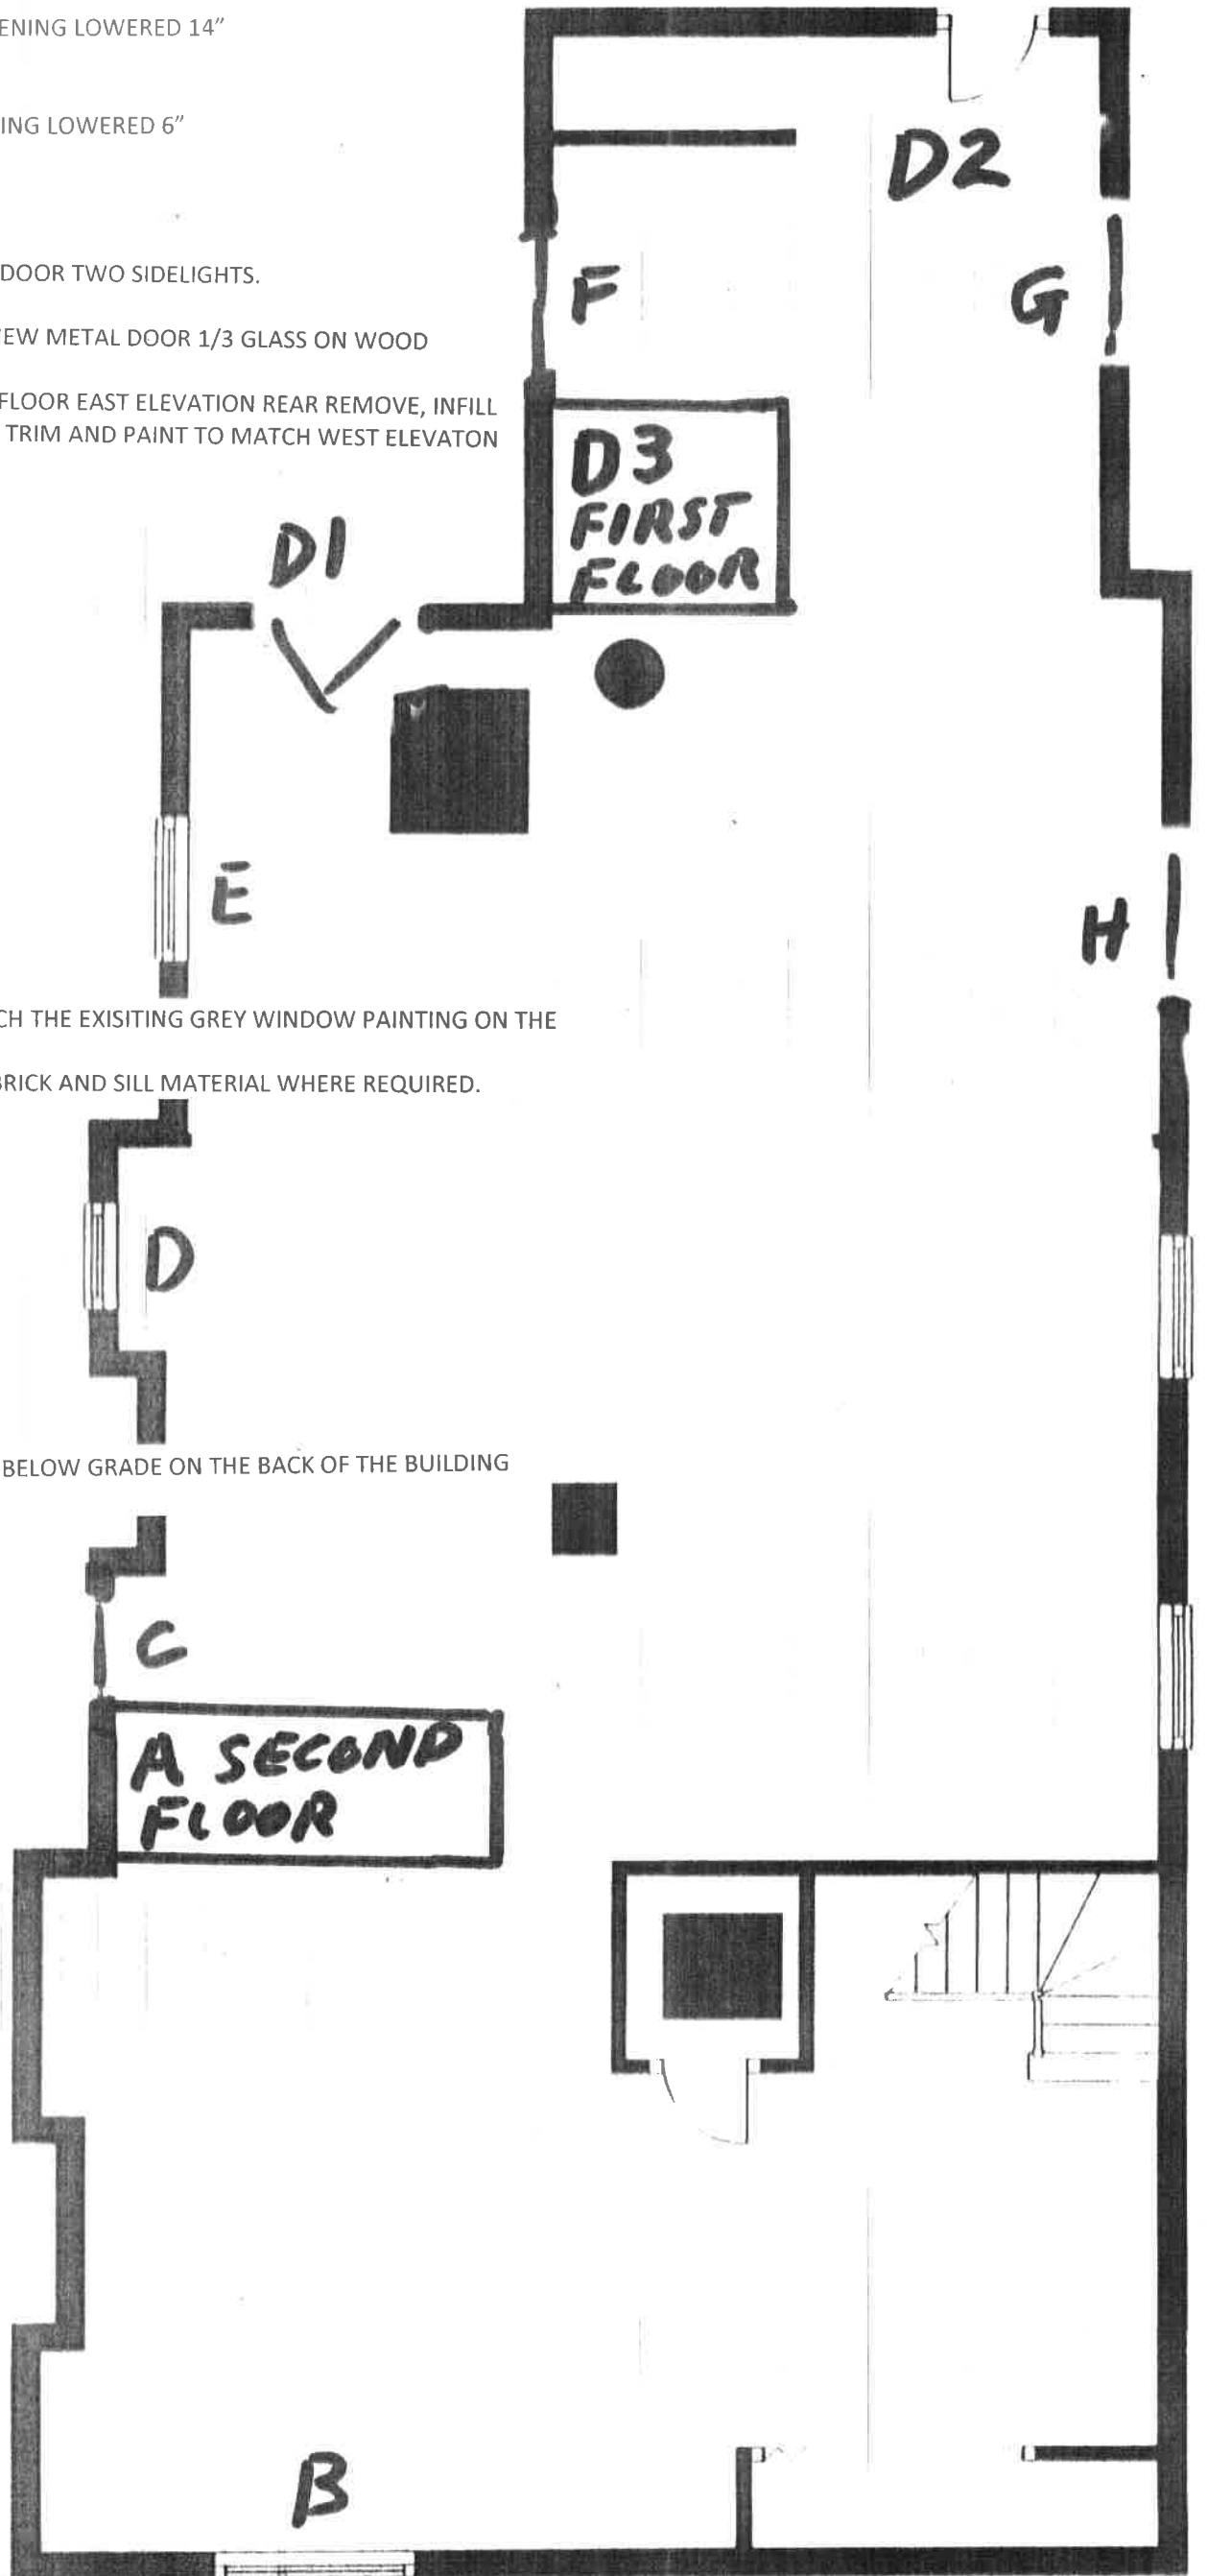
**Basement**  
Approx. 1244.4 sq. feet
