**STAFF REPORT:** 10/12/2022 REGULAR MEETING

**PREPARED BY:** D. RIEDEN

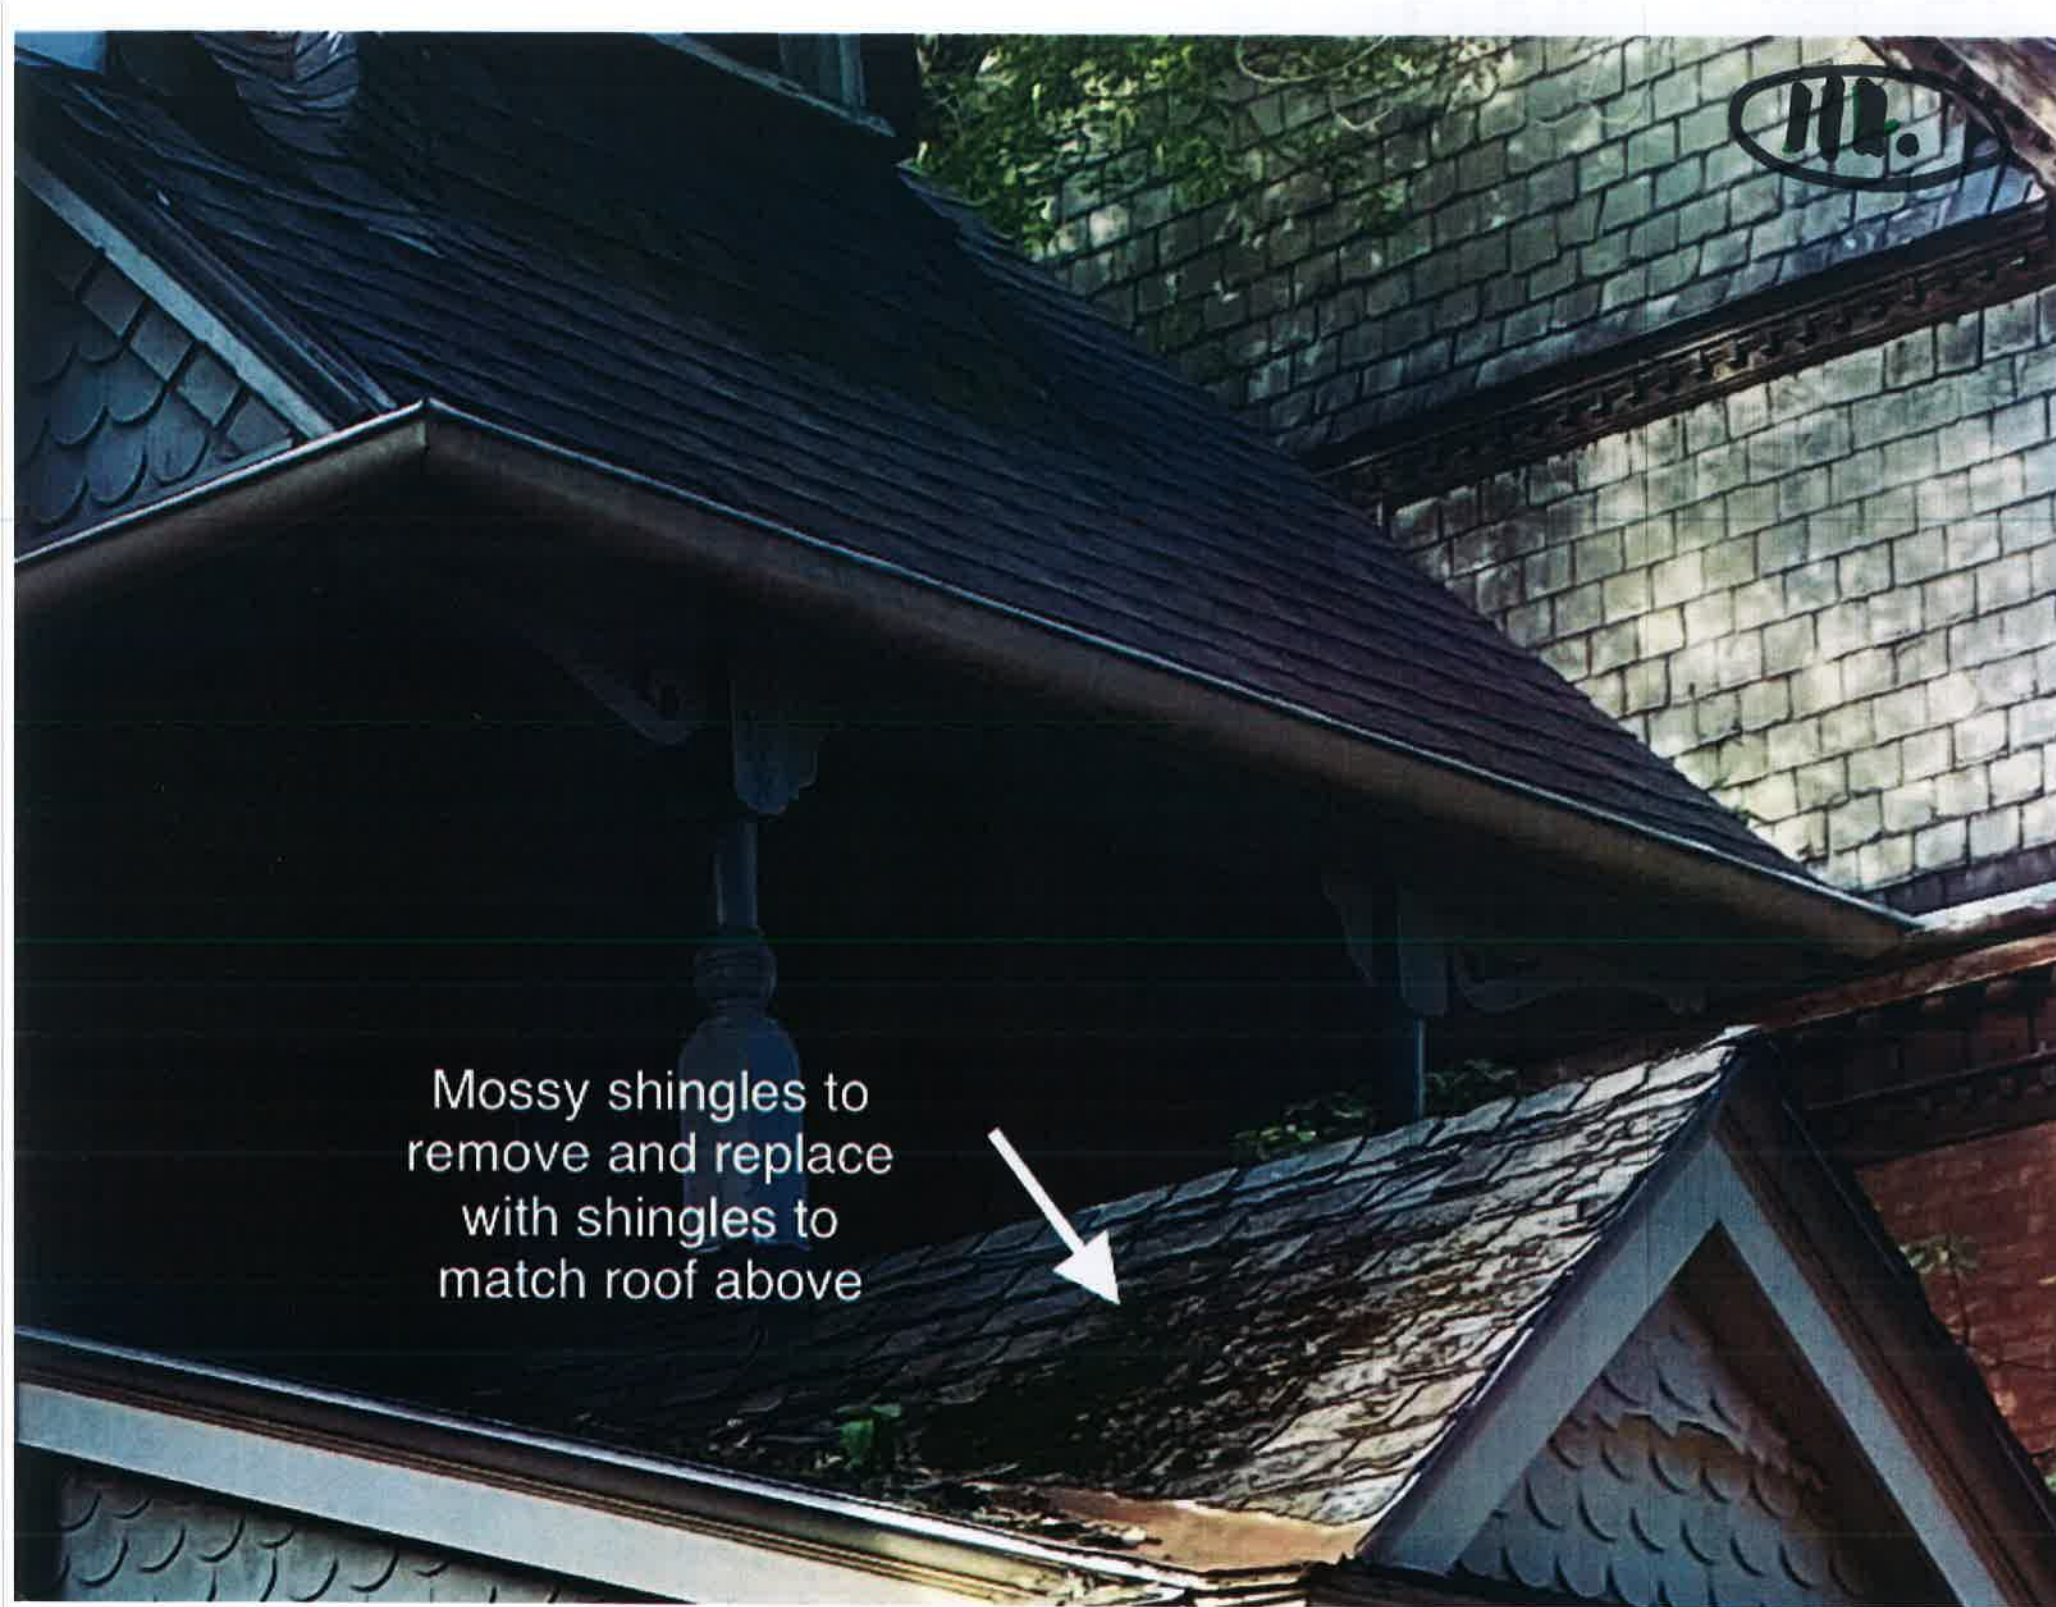
Mossy shingles to  
remove and replace  
with shingles to  
match roof above

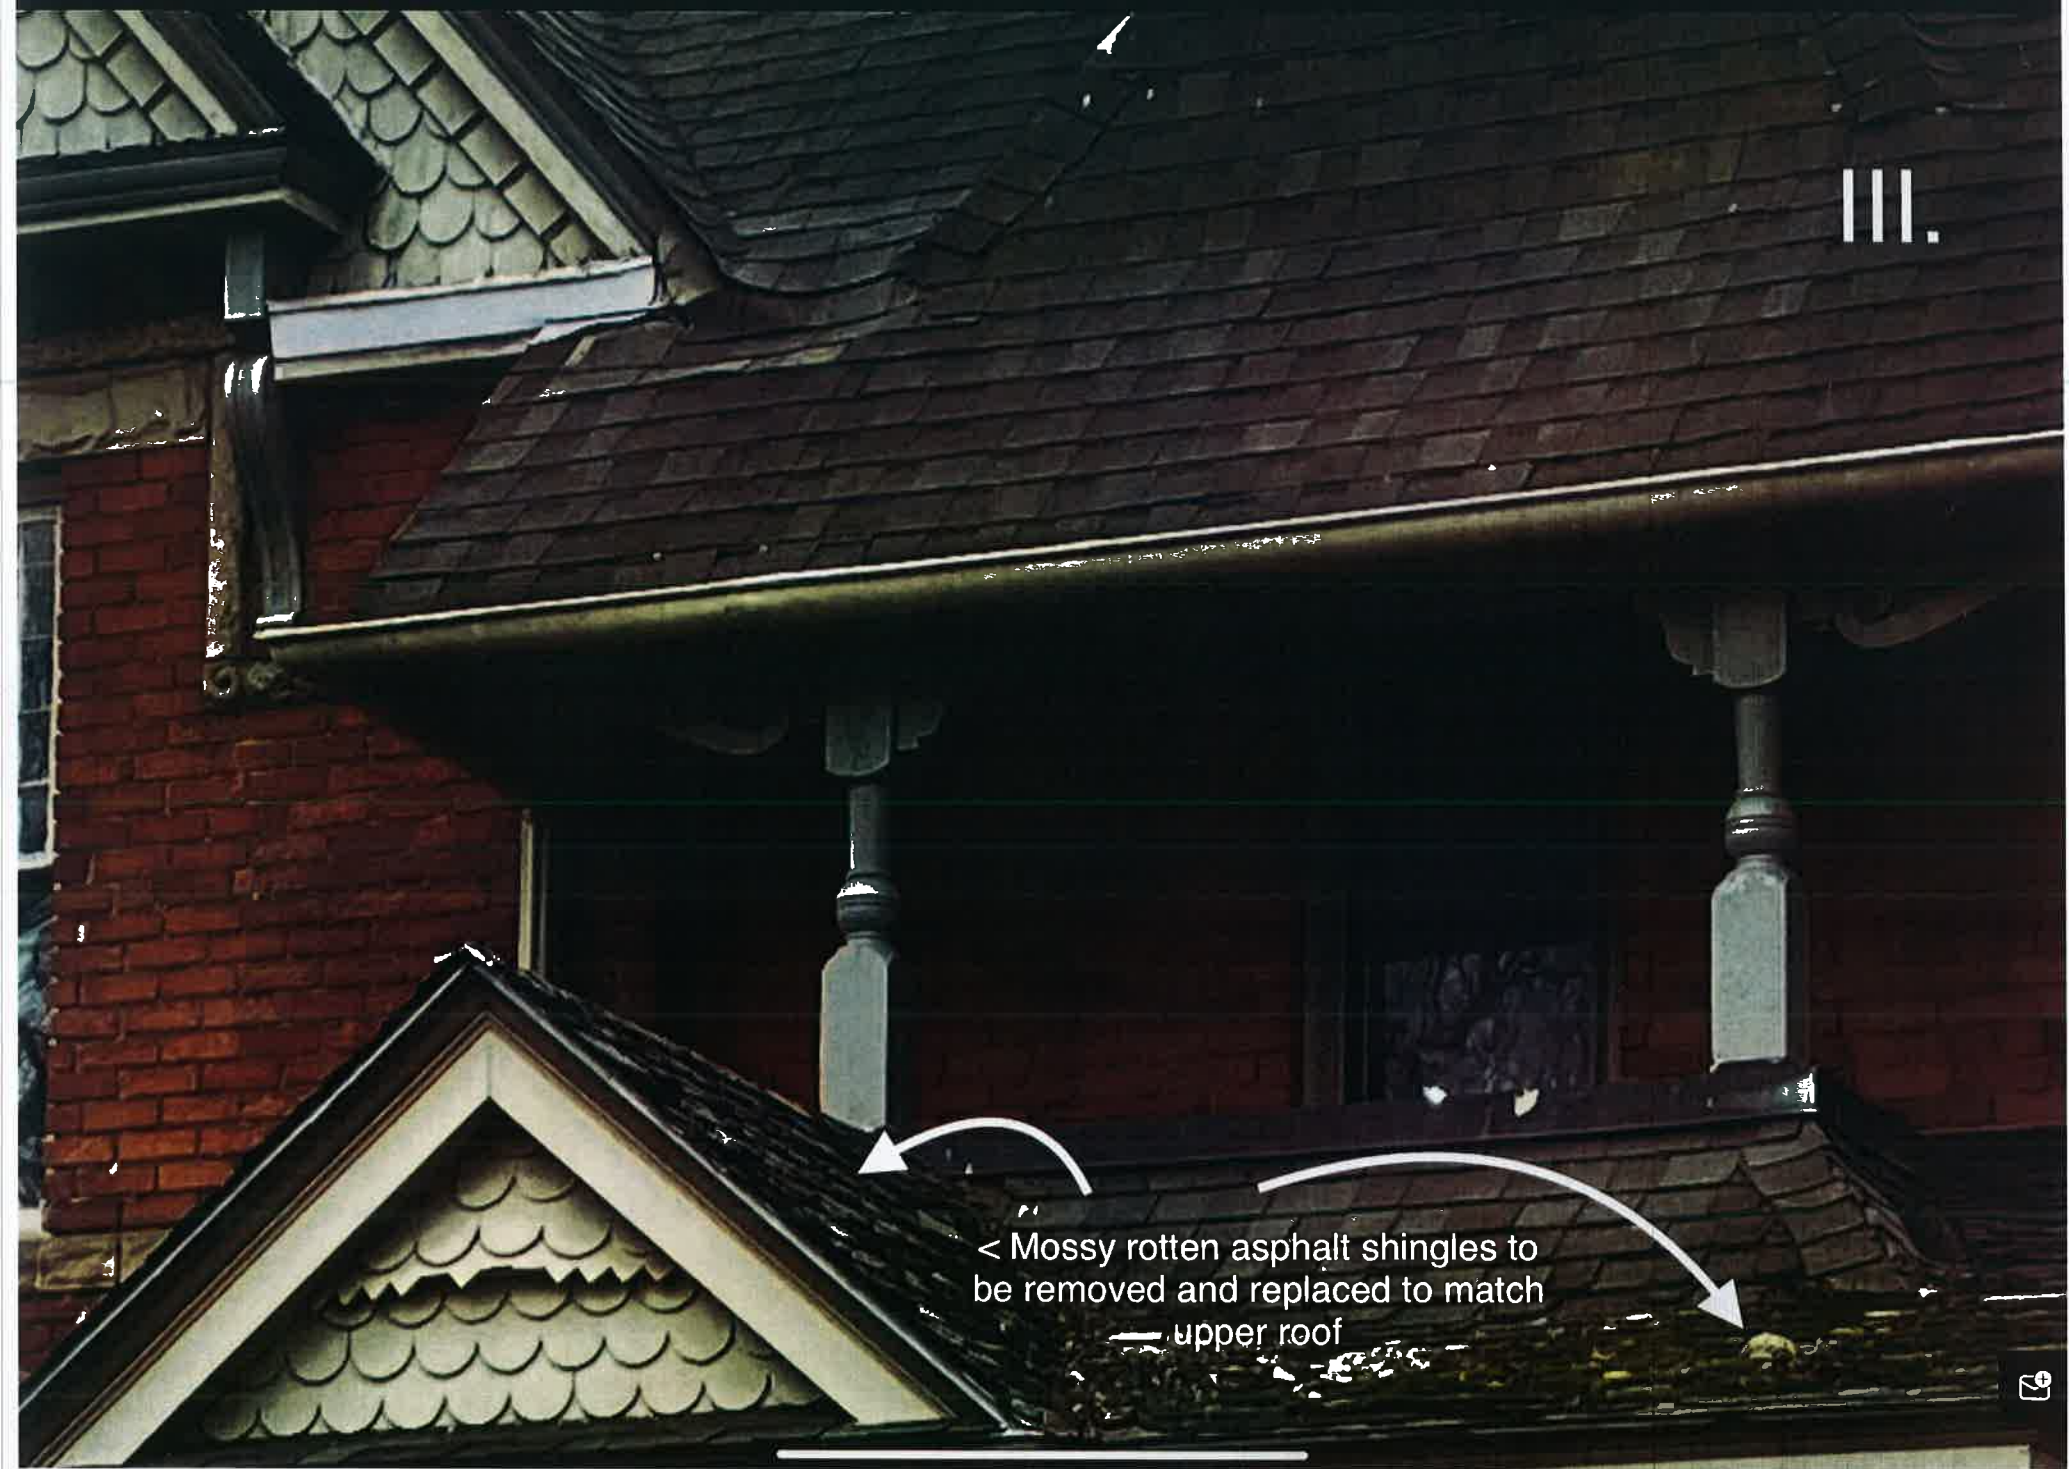
< Mossy rotten asphalt shingles to be removed and replaced to match upper roof

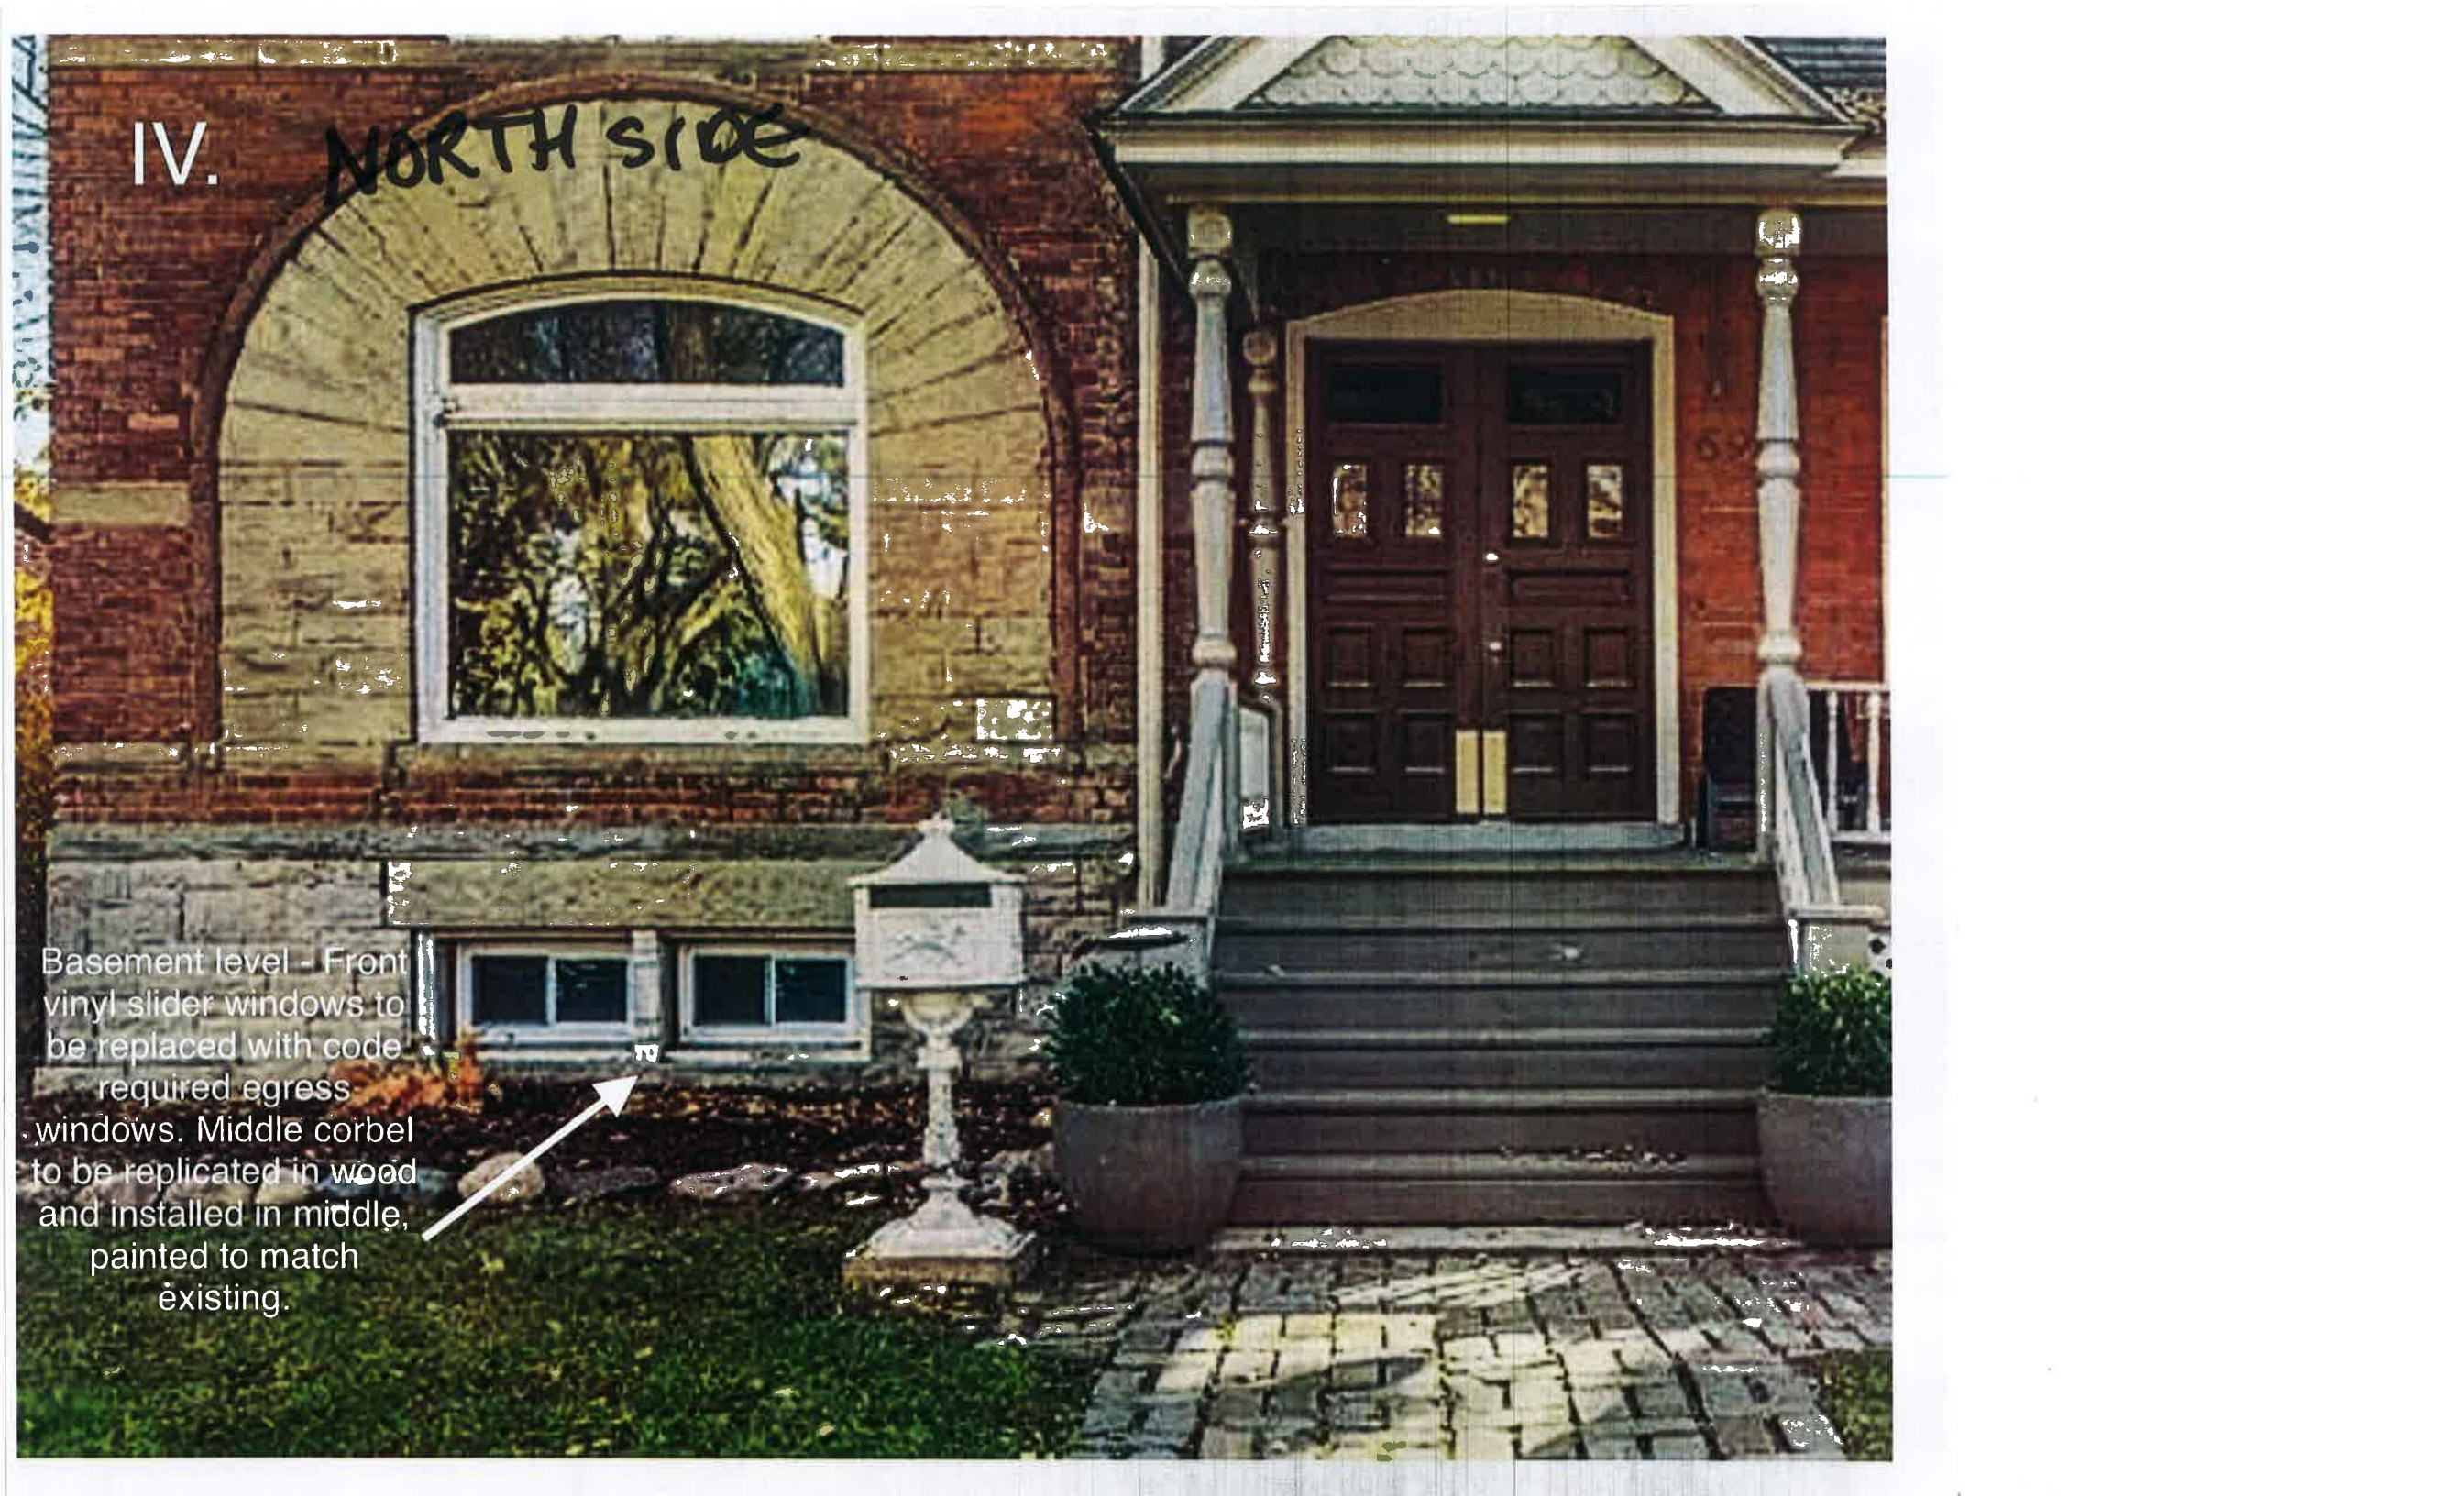
Basement level - Front vinyl slider windows to be replaced with code required egress windows. Middle corbel to be replicated in wood and installed in middle, painted to match existing.

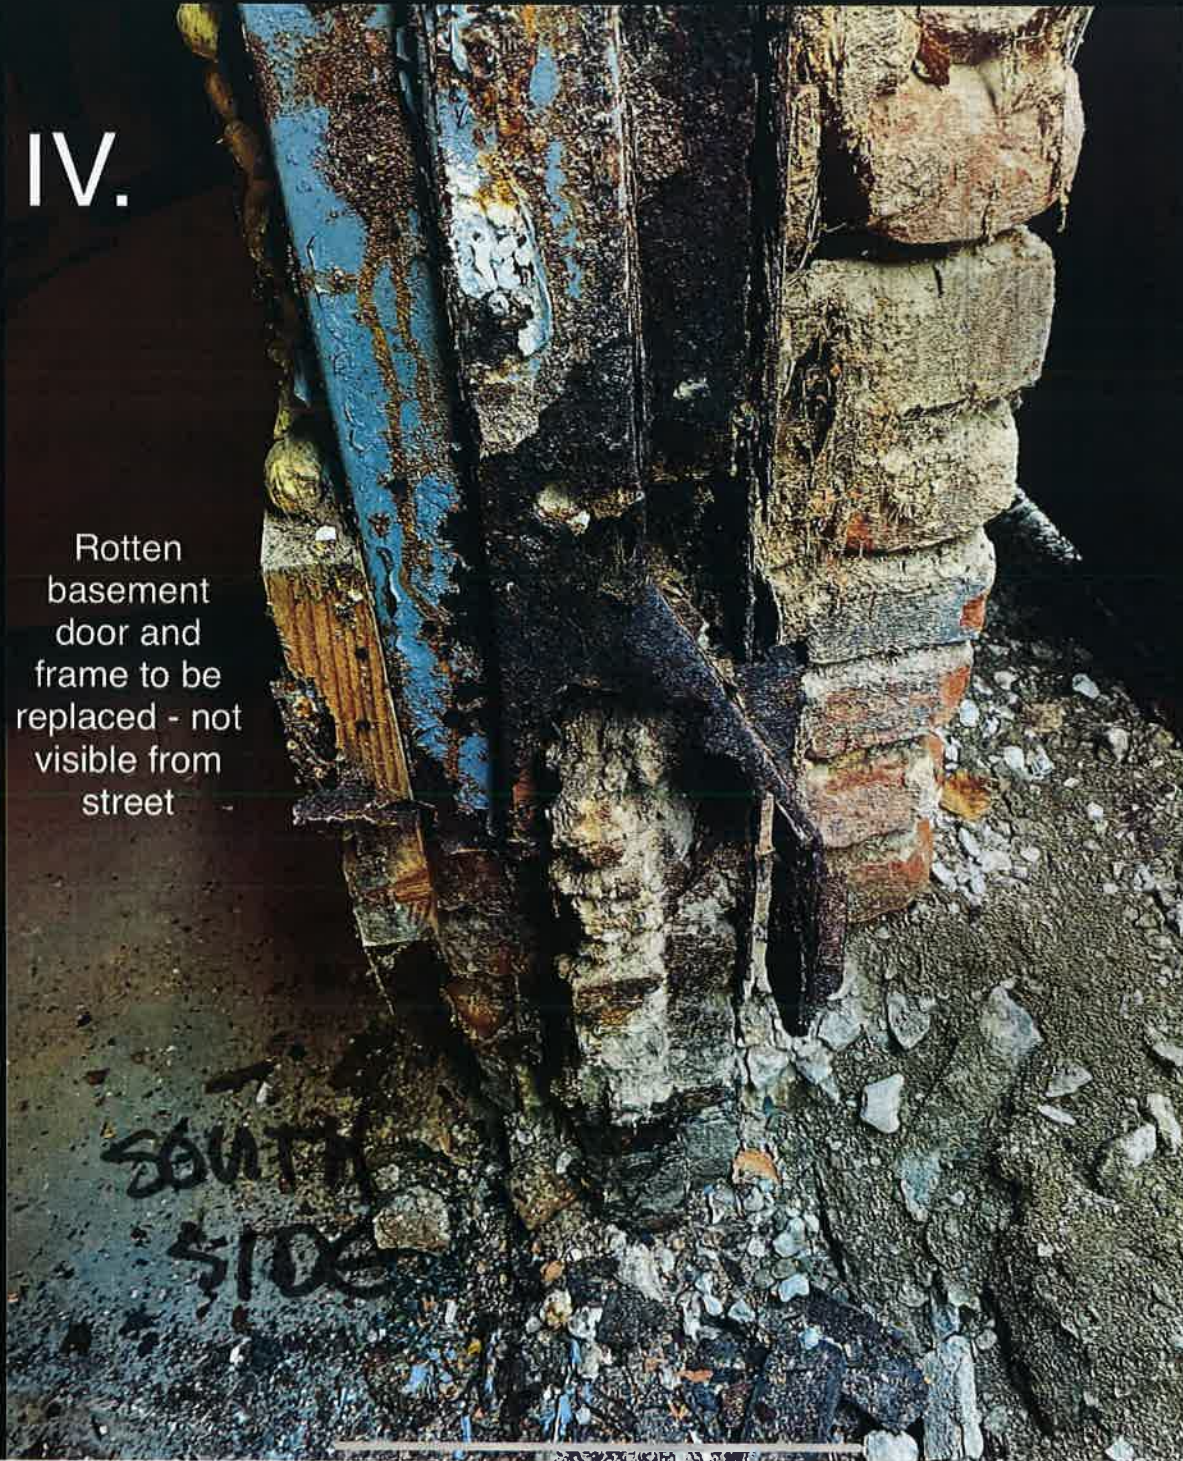
Rotten  
basement  
door and  
frame to be  
replaced - not  
visible from  
street

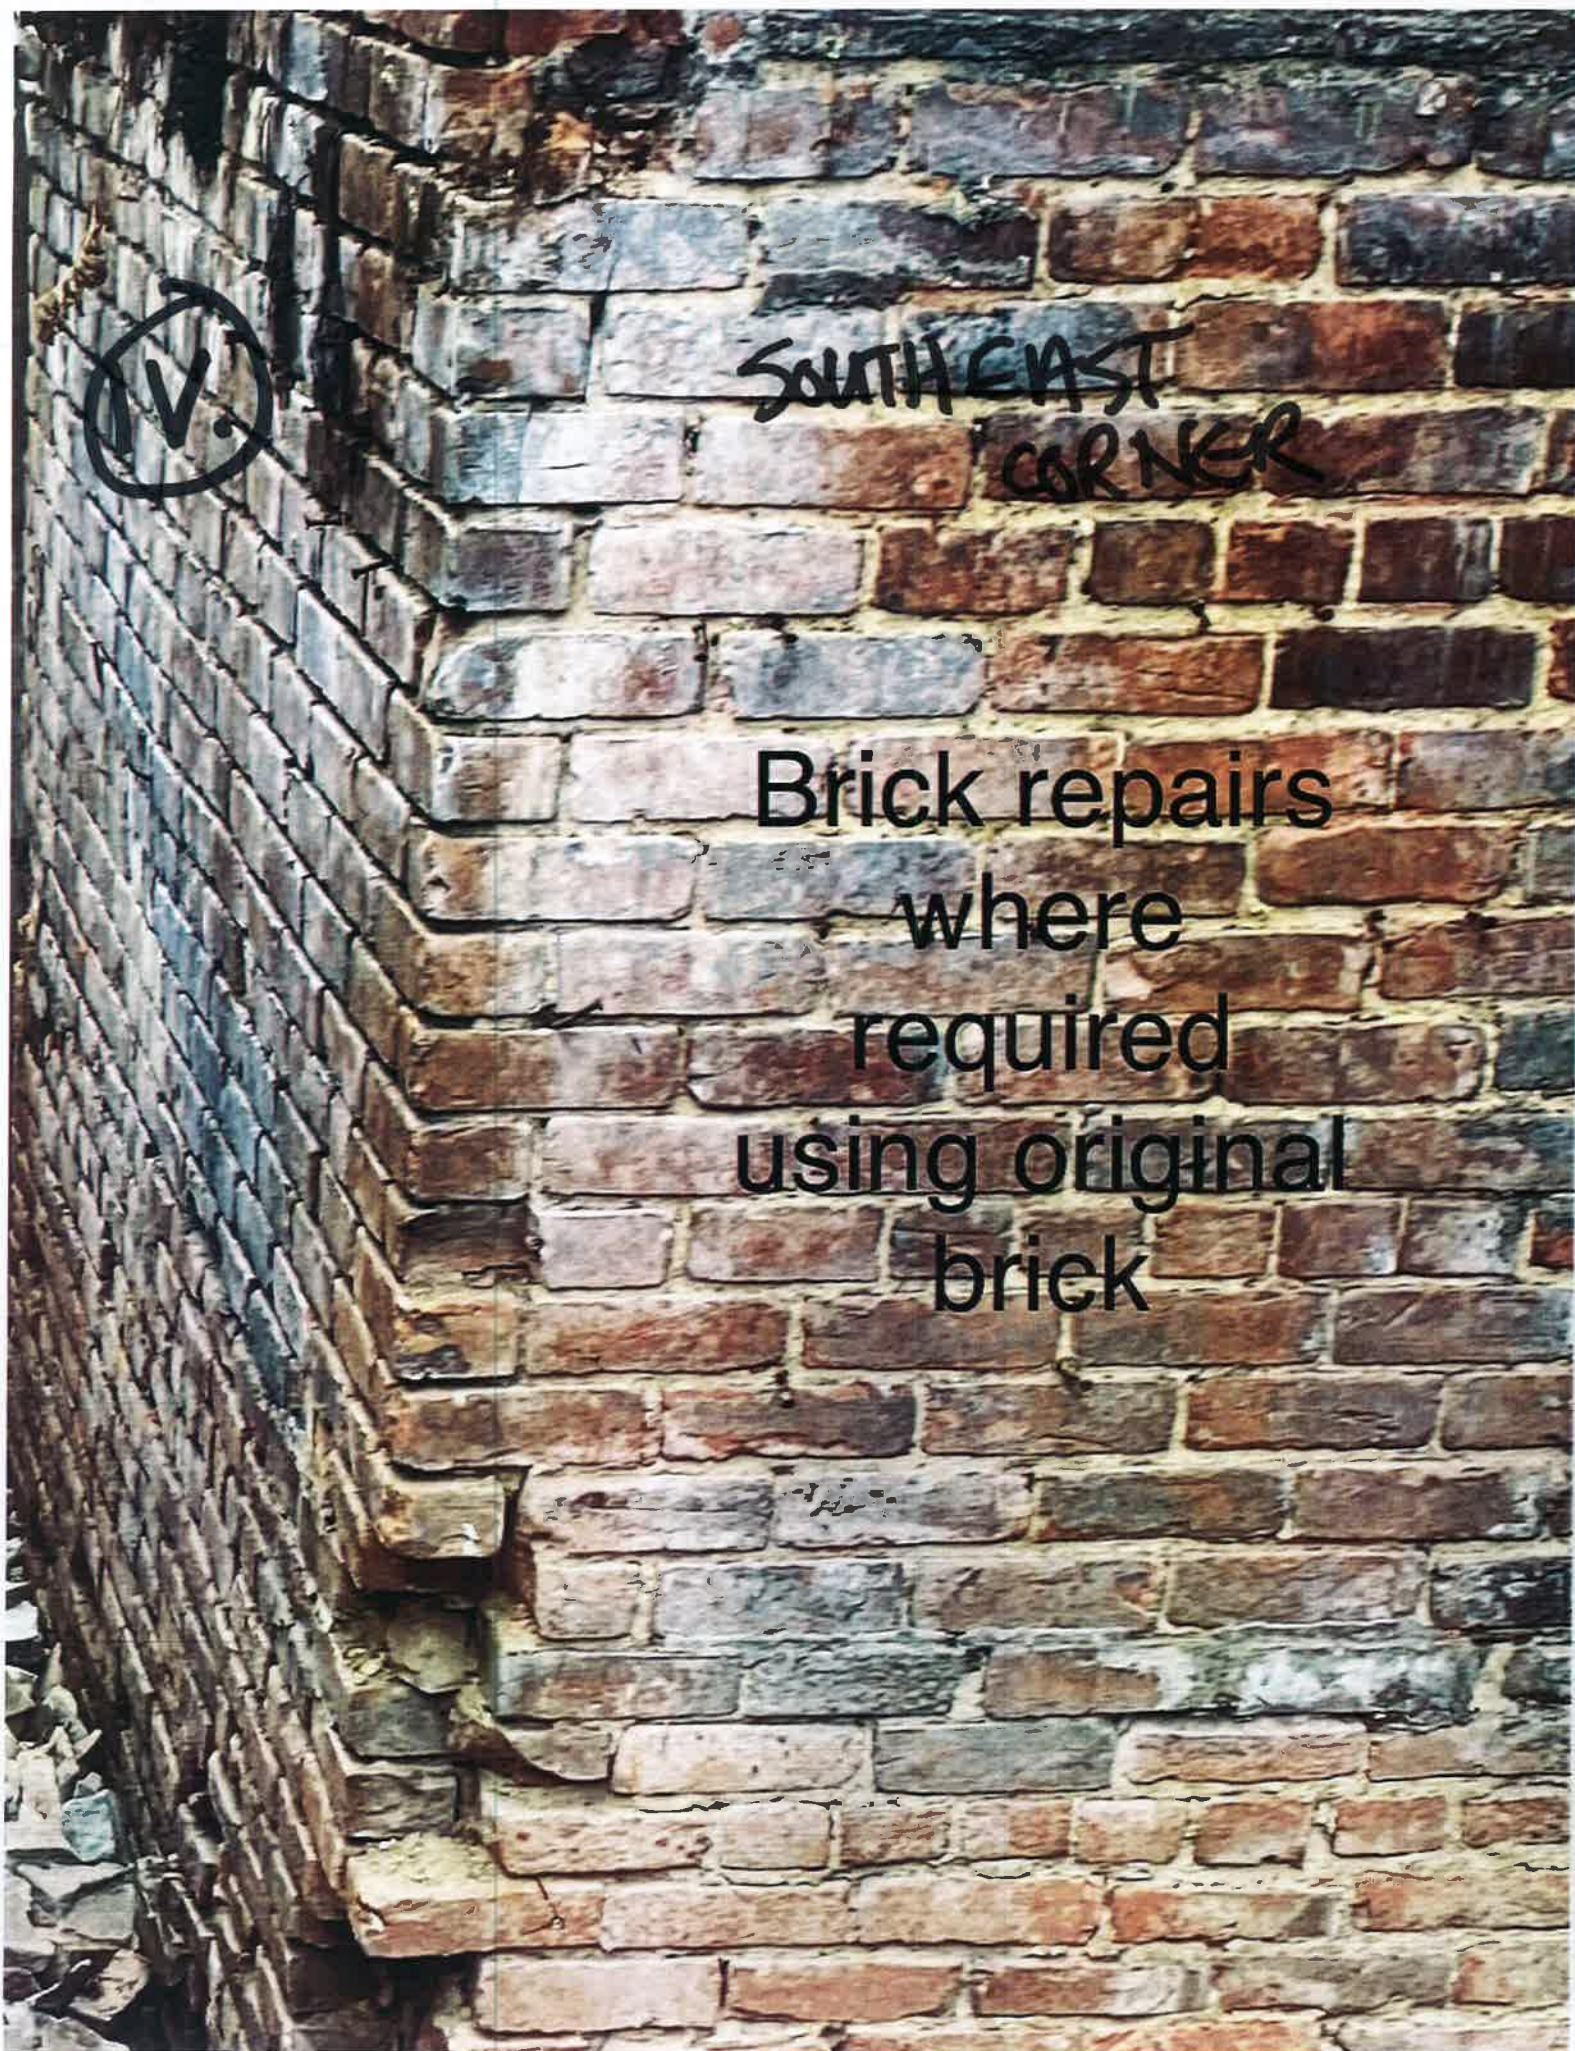
Brick repairs  
where  
required  
using original  
brick

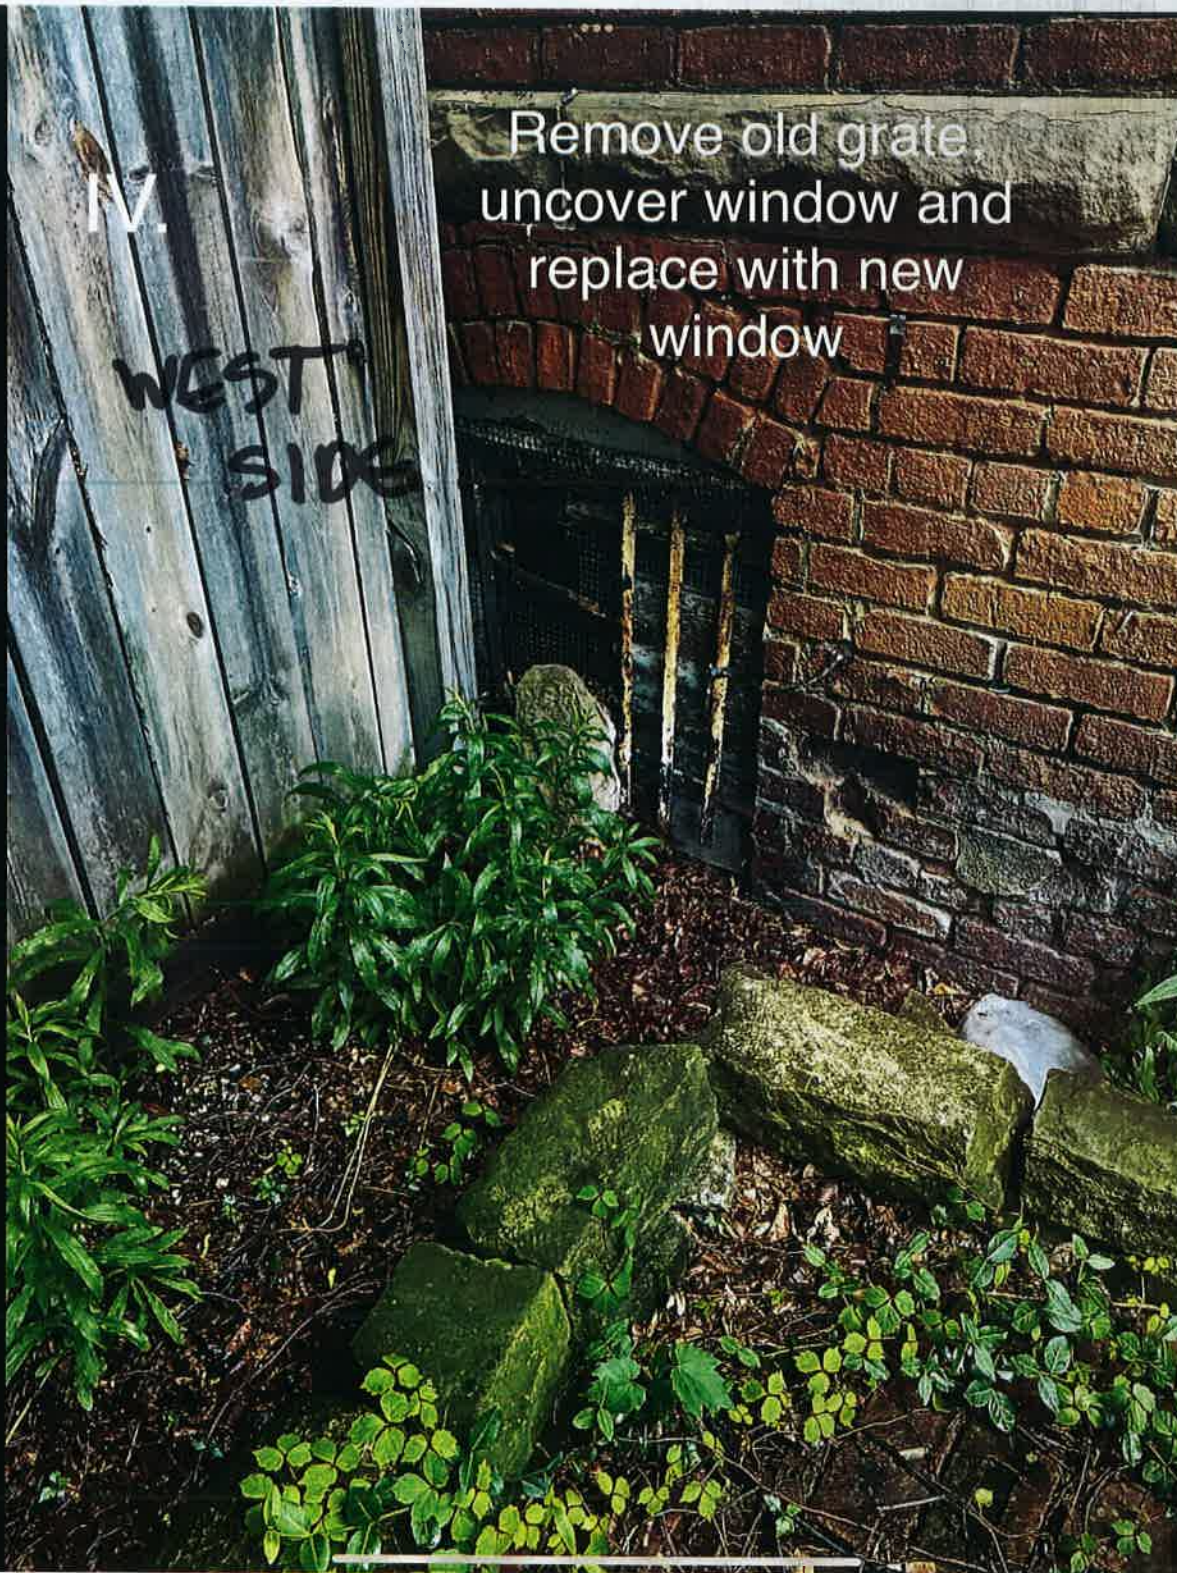
# IV. & V. EAST SIDE
