**STAFF REPORT:** 10/12/2022 REGULAR MEETING

**ADDRESS:** 1424 IROQUOIS

**APPLICATION NO:** #2022-8053

**SCOPE:** REPLACE PORCH DECK

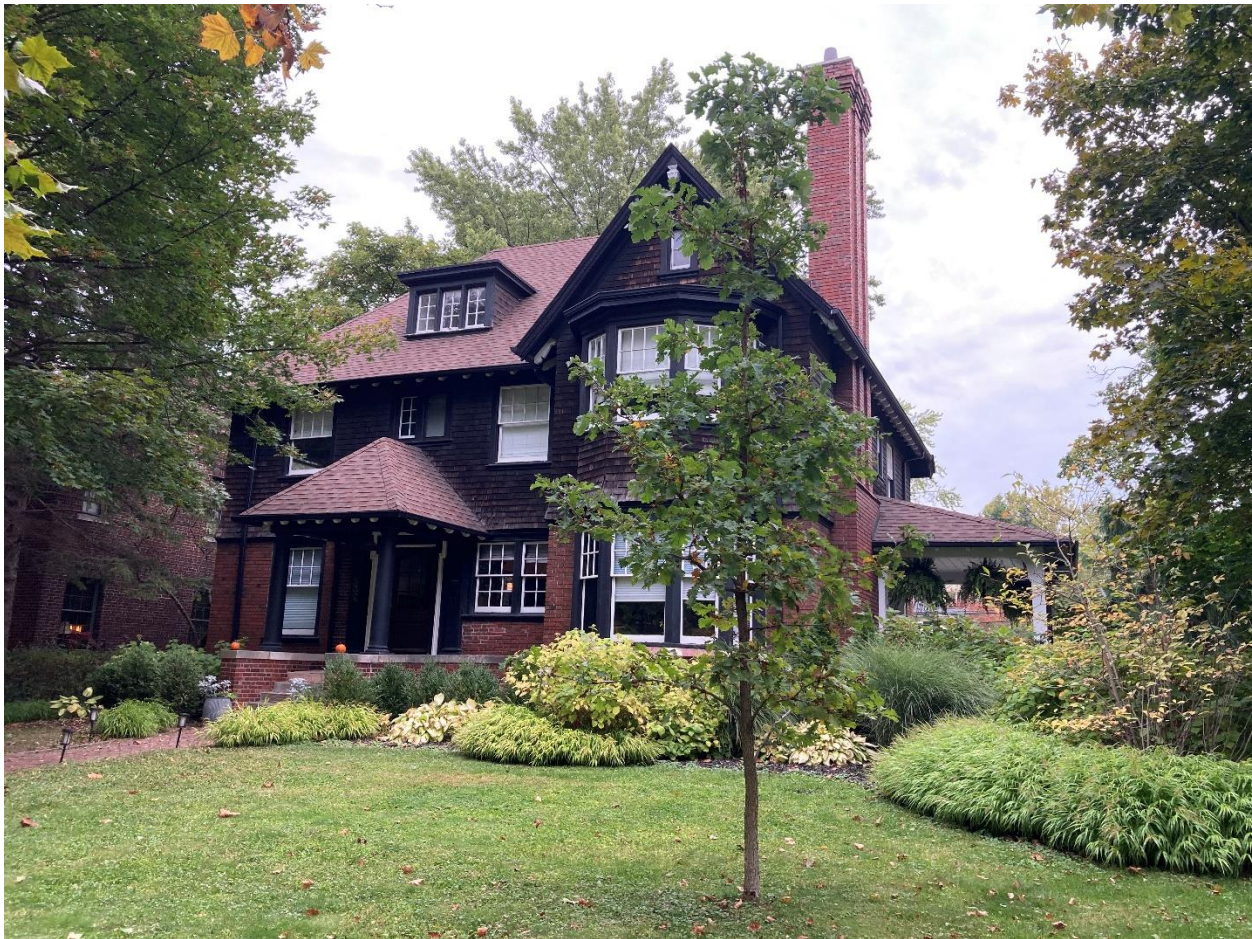
1424 Iroquois, current conditions (staff photo taken 10/5/2022)

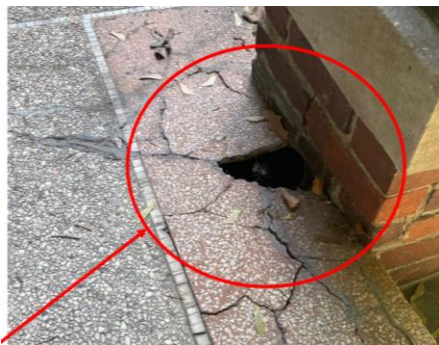
1424 Iroquois. Note that expansion joints are marked by small square pieces of marble.

- The expansion joints at the terrazzo porch floor at 1424 Iroquois are marked by cubes of marble. No metal strips are visible at the porch. It is staff's opinion that the flooring was likely installed prior to 1924 as the cubed marble expansion joints date from the time prior to the introduction of metal strip dividers/expansion joints

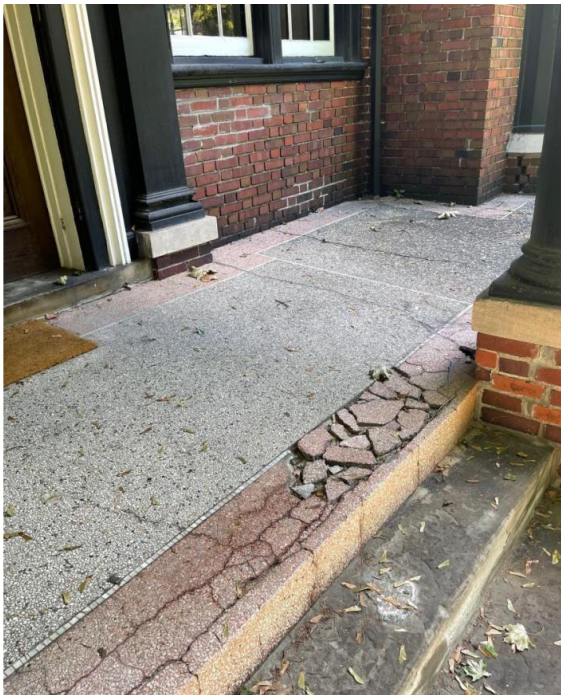
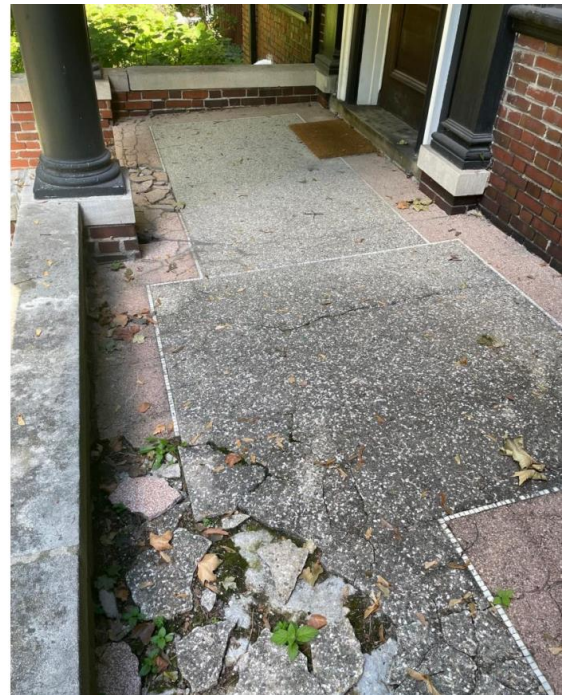
- The applicant has provided photos of the terrazzo porch floor to support their statement that it cannot be repaired. Staff does acknowledge that areas of the border and a small area at the southwestern corner of the central grey terrazzo panel are crumbling. Also, the porch does display a small number of cracks which run east west along the border and central panels. However, staff does find that the flooring can be repaired as the crumbling border sections and southwestern corner of the central grey terrazzo panel can be infilled and the cracks can be patched.

**Existing conditions.** Photos provided by applicant. Note that porch flooring is failing mainly at the red border areas with a small area of deterioration at the southwestern corner of the central grey terrazzo panel. The porch also displays a small number of cracks which run east west along the border and central panels

feature and finish and is an example of craftsmanship that characterizes the property. As noted above, it is staff's opinion that the porch floor is not deteriorated beyond repair. It is therefore staff's opinion that the porch floor should be repaired per the below-listed Standards. Since the current application proposes to replace the porch floor with concrete, it is staff's opinion that the proposed project does not meet the SOI's Standards.
