STAFF REPORT: 11/16/2022 REGULAR MEETING

APPLICATION NUMBER: #22-8095

ADDRESS: 3451 IROQUOIS

SCOPE: REMOVE TREE, REPAIR DRIVEWAY AND PORCH STEPS

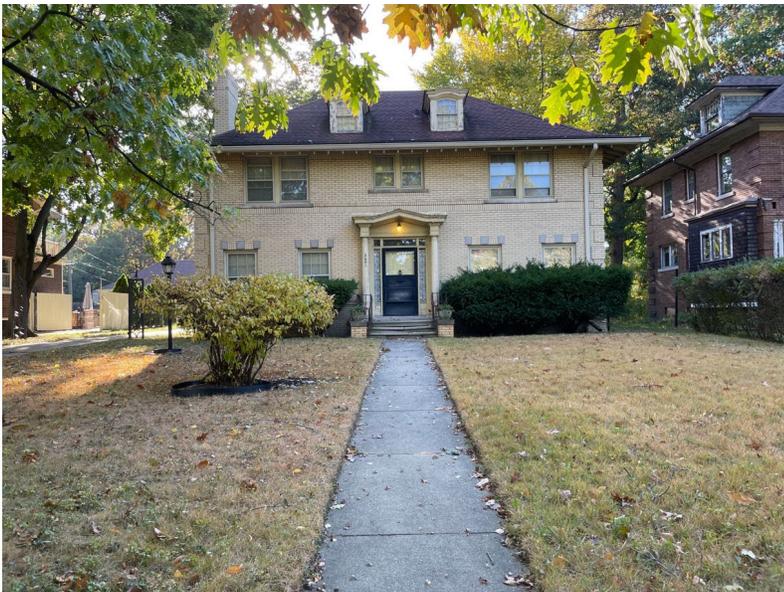
Site Photo 1, by Staff October 21, 2022: (Northeast) front elevation side

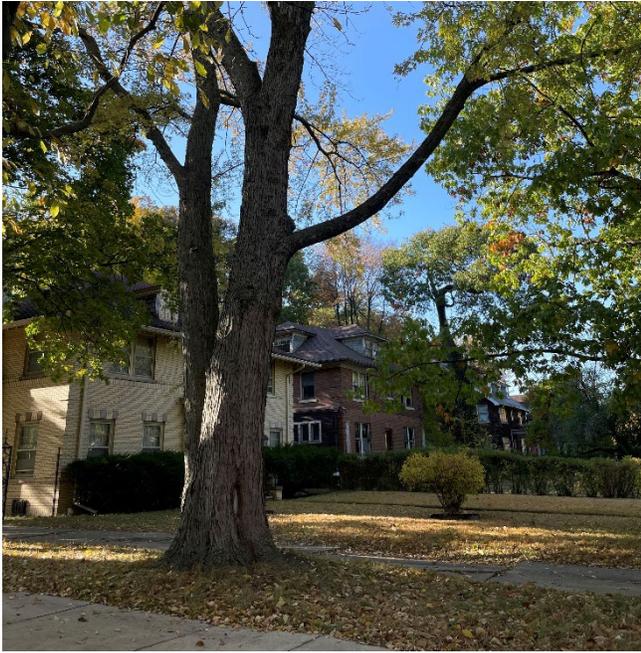
Site Photo 3, by Staff October 21, 2022: (North) front. Silver maple and driveways (foreground is neighbor's drive, rear is applicant's driveway).

- The Indian Village Historic District was established in 1970.
- Staff visited the site on October 21, 2022 and observed the condition of the front yard maple tree, its proximity to the house and any other historic structures, and the proximity to the public right of way. (See staff photos enclosed.) Staff observed that the central trunk is split and has a hollow filled with concrete in one of the trunks. The roots are surfacing, which is a typical behavior of silver maples and will continue to do so in its lifetime. Although the tree's main trunk has some lean, the tree appears to be balanced in its overall structure and appears to be in good health. Staff did observe some smaller branches that require deadwood pruning. Photos show that most branches are still green with life.

its growth habit of a shallow root system that can crack sidewalks, foundations and driveways. The tree itself produces brittle wood, which is commonly damaged in storms. It is staff's opinion that removal of this particular tree, due to its current state of roots, split and hollowed trunk, is advised to prevent further damage. Staff offers this opinion with a condition that two additional shade trees be planted to support the future historic canopy of Indian Village.

- The applicant supply a description of the treatment of the tree's trunk and root removal for HDC review and approval before work is started.
- Two shade trees be planted on the property as a replacement for the loss of this tree. HDC staff review species and location for approval.
- The applicant provides photos of the rear pathway and front steps for HDC review before work is started.

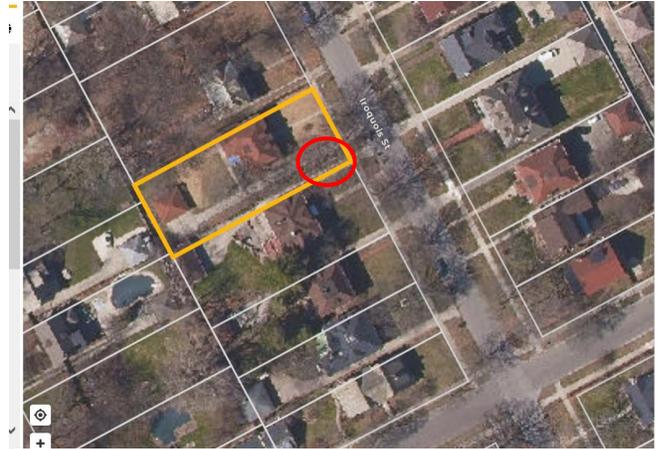
Aerial of Parcel # 17007498: red circle indicates location of silver maple base of trunk
