STAFF REPORT: 11/16/2022 REGULAR MEETING

APPLICATION NUMBER: #22-8096

ADDRESS: 3421 SEMINOLE

SCOPE: INSTALL RETAINING WALL AT SIDEWALK, ENLARGE DRIVEWAY/FRONT YARD PAVING, OTHER EXTERIOR ALTERATIONS (WORK COMPLETED WITHOUT APPROVAL)

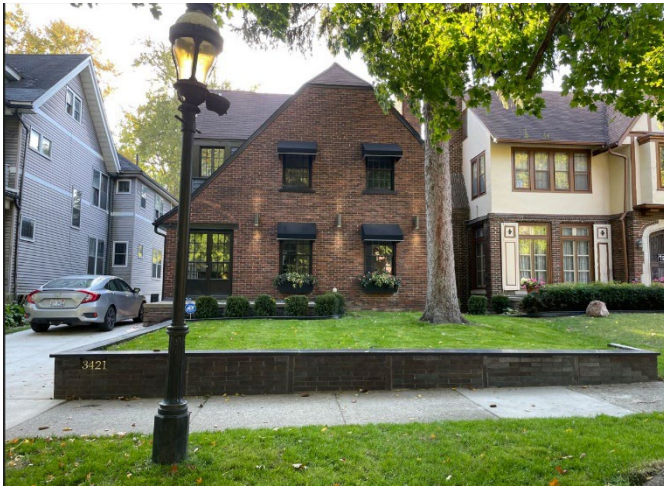
Site Photo 1, by Staff October 21, 2022: (Northeast) front elevation.

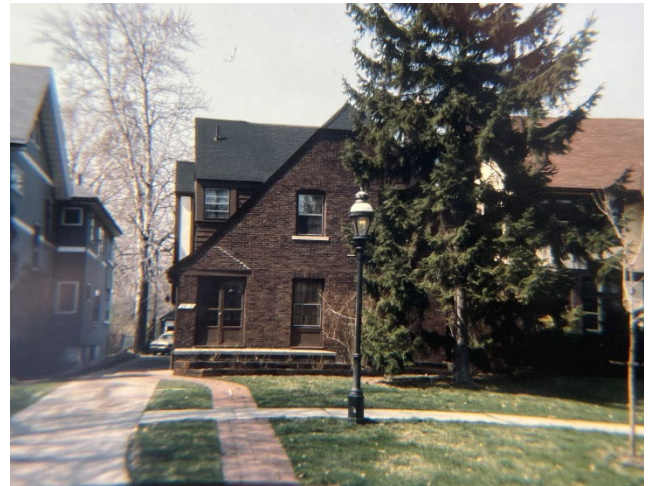
Site Photo2, designation photo 1980: (Northeast) front elevation.

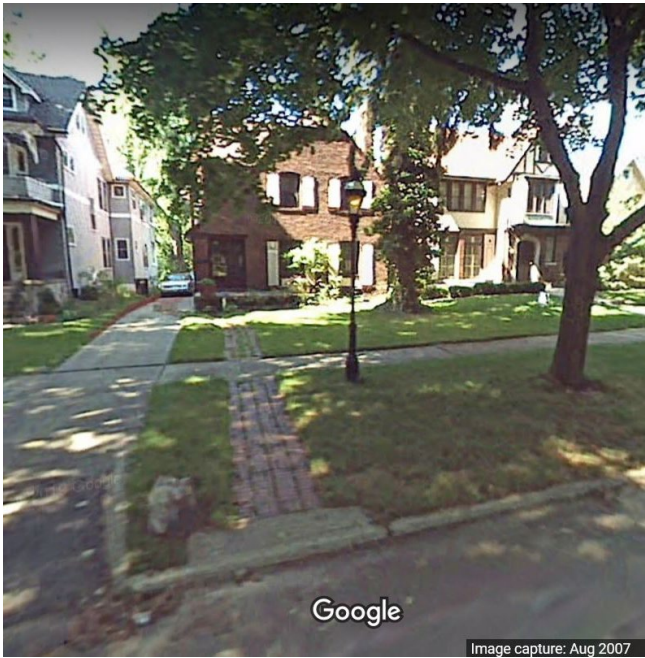
Site Photo 3, by Google Street August 2007: (North) front showing the wood panels, and shutters that were placed after historic designation. Also note the front drive and walkway to the street curb.

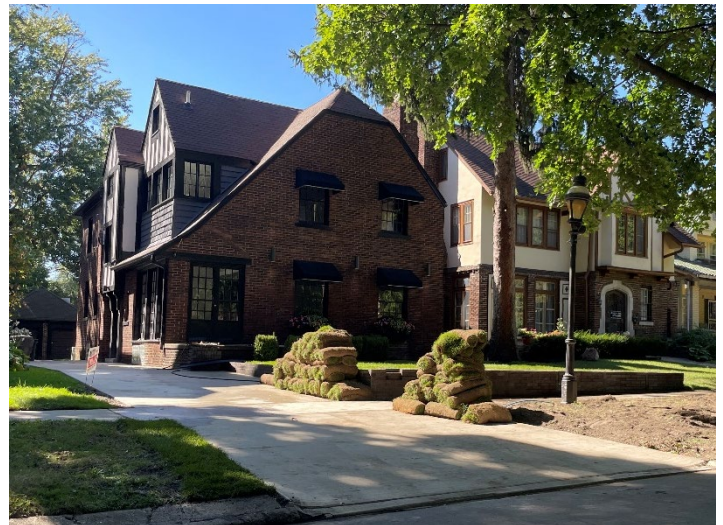
Site Photo 4, by Staff September 23, 2022: (Northeast) front elevation, showing front driveway installed, curb cut, and raised elevated front yard.

- All proposed work is complete without HDC approval.
- It is staff’s opinion that the removal of the original front brick walkway with its distinctive path separated from the driveway contained within the limits of the projected side yard has created a front yard parking lot which destroys the original *scale, design, and materiality* both the pedestrian and vehicular pathways and introduces a new special use that is incompatible and inappropriate for this historic property, and therefore does not meet the Secretary of the Interior's Standards for Rehabilitation.

Staff finds that the replacement of the original pathway and driveway with a single wider concrete driveway and curbcut and the alteration of the front yard with the installation of the raised earth terrace and installation of the retaining wall destroys the historic character of this property and removes distinctive, character-defining features.

Staff therefore recommends that the Commission issue a Denial for the above work items, as it does not meet the Secretary of the Interior's Standards for Rehabilitation, specifically Standards:

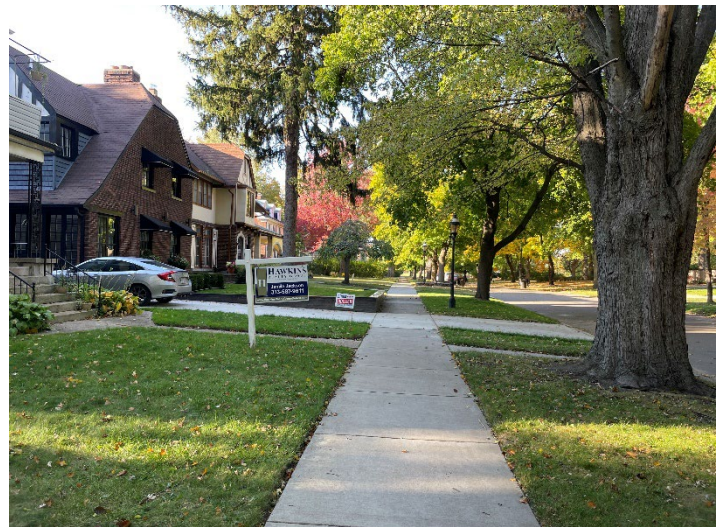
Site Photo 5, by Staff October 21, 2022: (Northeast) front elevation facing north along Seminole street showing no other retaining walls in the front yards between the house and the public sidewalk.

It is staff’s opinion that the fabrication of this new structure, ie., the elevated terrace and surrounding retaining walls interrupt the Walls of Continuity by introducing a new, historically inappropriate structure that destroys the rhythm of the open lawn landscape that is historically established at this location of the neighborhood.

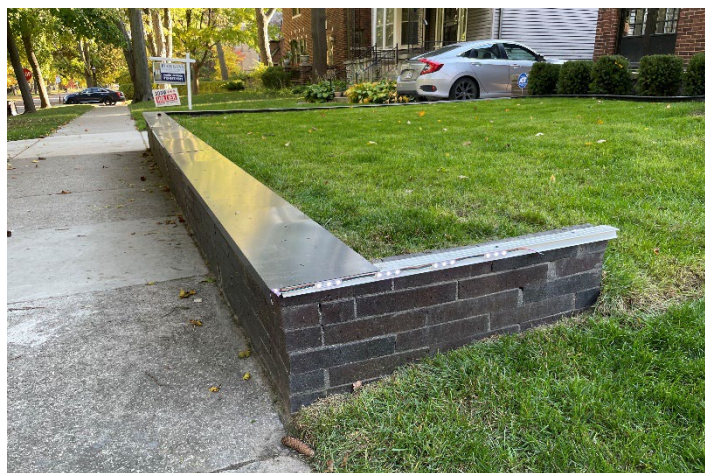
- While staff did not receive the requested information regarding the materiality of the retaining wall, its metal coping and the lighting strip underneath, staff observed that the work appears to be unfinished and of a quality that may lack durability. (See site photo 6.)

Site Photo 6, by Staff October 21, 2022: (Northeast) front elevation, showing installed retaining wall and exposed lighting under metal coping.

- It is staff’s opinion that the front yard installation of the raised earthen terrace and installed retaining wall with metal coping and underlighting does not meet the Elements of Design as described earlier in this report and therefore is not appropriate.

- Staff received no response to questions regarding the materials installed and therefore questions the quality and durability of the materials.
