STAFF REPORT: 8/10/2022 REGULAR MEETING

APPLICATION NUMBER: 22-8019

ADDRESS: 4770 LESLIE

SCOPE: REPLACE DOORS/WINDOWS, OTHER EXTERIOR ALTERATIONS (WORK STARTED WITHOUT APPROVAL)

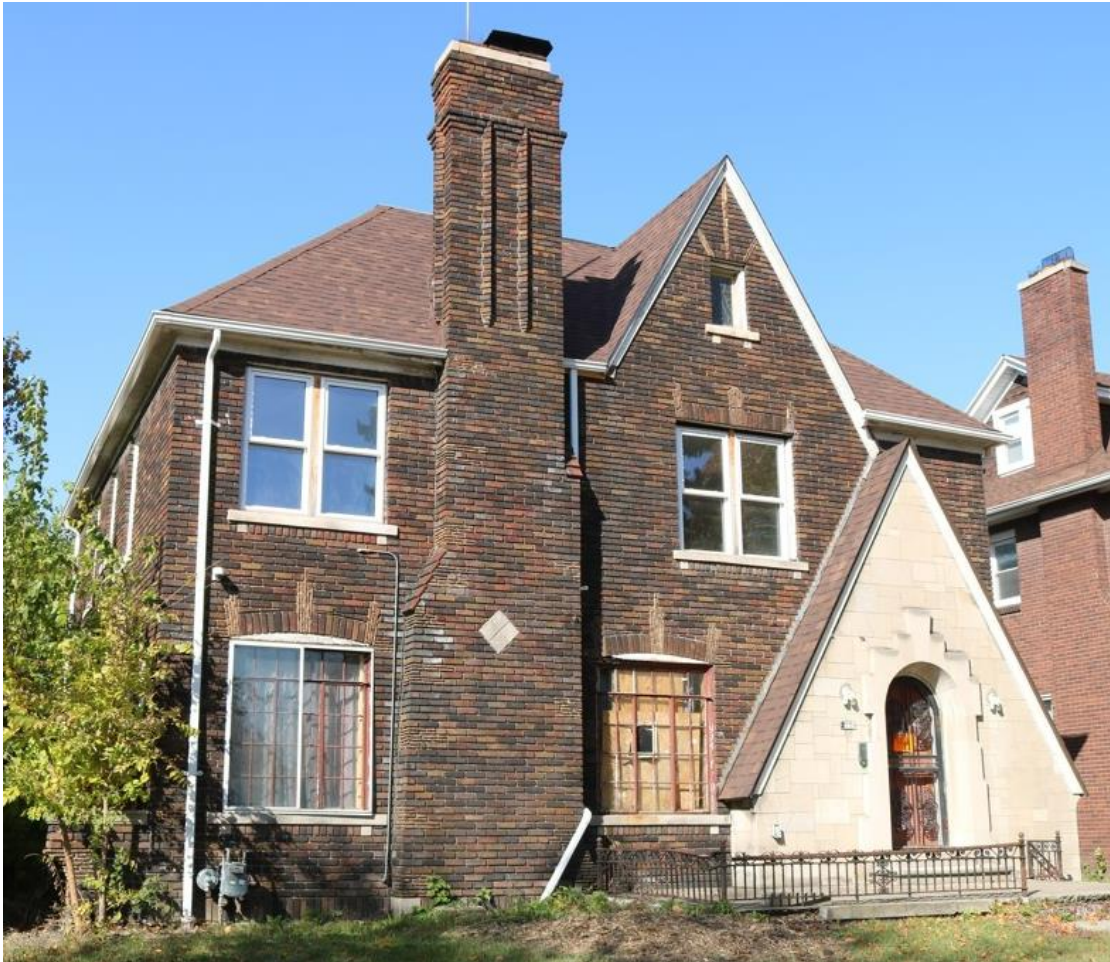
4770 Leslie is a two-and-a-half story, brick, Tudor Revival house built in 1927. It faces south onto the street. Defining features include a prominent wall chimney on the front façade, sharp gables on the front façade and projecting entrance bay, steel windows, and a stone door surround on the entrance bay. Most of the windows have been replaced with vinyl sash windows; a few steel or wood windows remain.

October 2022 photo by staff.

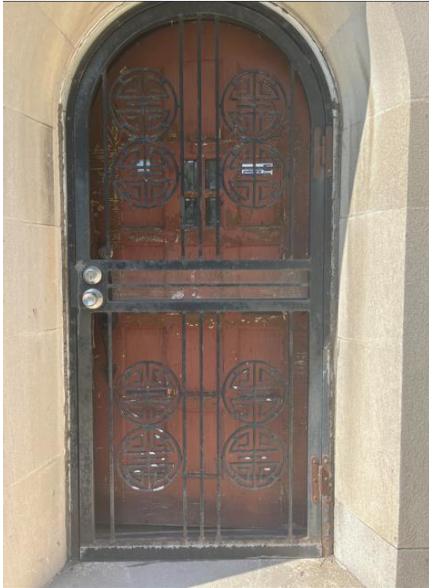
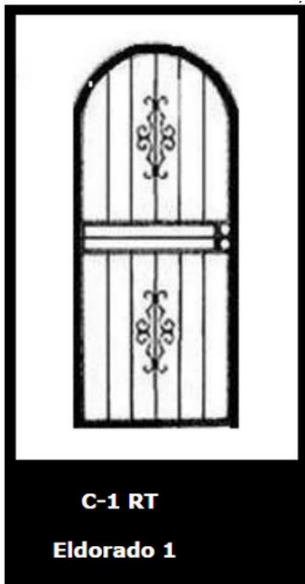
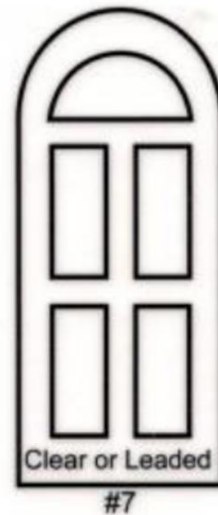
The applicant proposes to replace the current wood panel door and security door. The application does not provide materials, colors, dimensions, or product names for the proposed replacements.

Left to right: Current wood front door and security door, proposed security door, proposed front door. Images from application.

- Based on materials and architectural style, staff believes that the front door is original or historic. Due to its prominent location as a component of the projecting entrance bay, it is a defining feature. The Secretary of the Interior’s Standards #2 and #5 suggest that it be retained.
- The curved pattern on the proposed security door introduces an incompatible visual element which distracts from the architectural character of the doorway and opening (Standards #2 and #9). A design without this element would be appropriate.

Staff recommends that the Commission issue a *Denial* of the proposed front door replacement, and rear balcony door replacement, replacement of historic steel windows, and replacement of historic wood windows on the west elevation, as the proposed work does not meet the Secretary of the Interior's Standards for Rehabilitation, in particular:

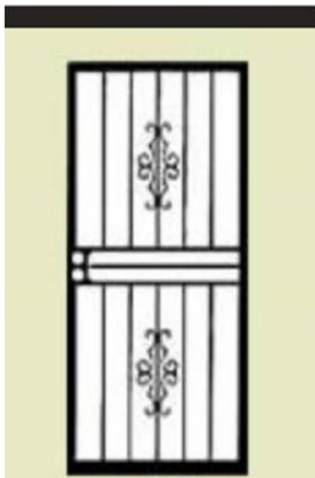
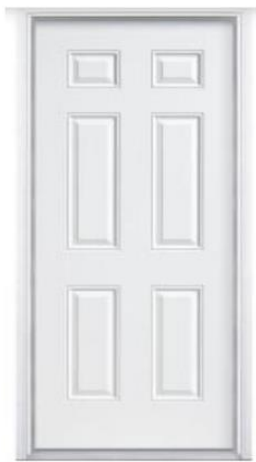
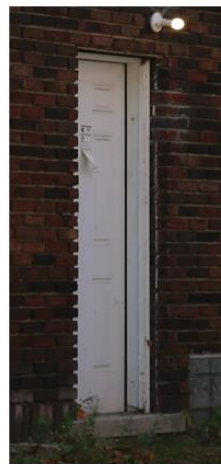
The applicant proposes a new aluminum side (east elevation) door; it appears that this door has already been installed. Also proposed is a black security door at the same location.

Left to right: Proposed security door (image from application), proposed aluminum door (image from application), door already installed (photo from October 2022 site visit).

- Without information on the appearance of the historic side door, staff is unable to determine if it was a distinctive or defining feature, or when it was removed. However, the proposed door (already installed) is appropriate in that it is “clearly differentiated” (Standard #9) and does not introduce incompatible architectural elements.
- The above observations pertaining to the proposed front security door also apply to the proposed side security door.

- The bright white color of the side door is not appropriate for the period and style of the building. The door should be painted an appropriate color from Color System D.

- The design of the security doors shall be subject to approval by staff
- The side door shall be painted an appropriate color selection from Color System D
- The proposed replacement windows shall be subject to approval by staff
- Fascias and soffits may be replaced on the building's rear ell only; elsewhere, the existing fascias and soffits shall be preserved; and
- The design of the front porch and balcony railings shall be subject to approval by staff.

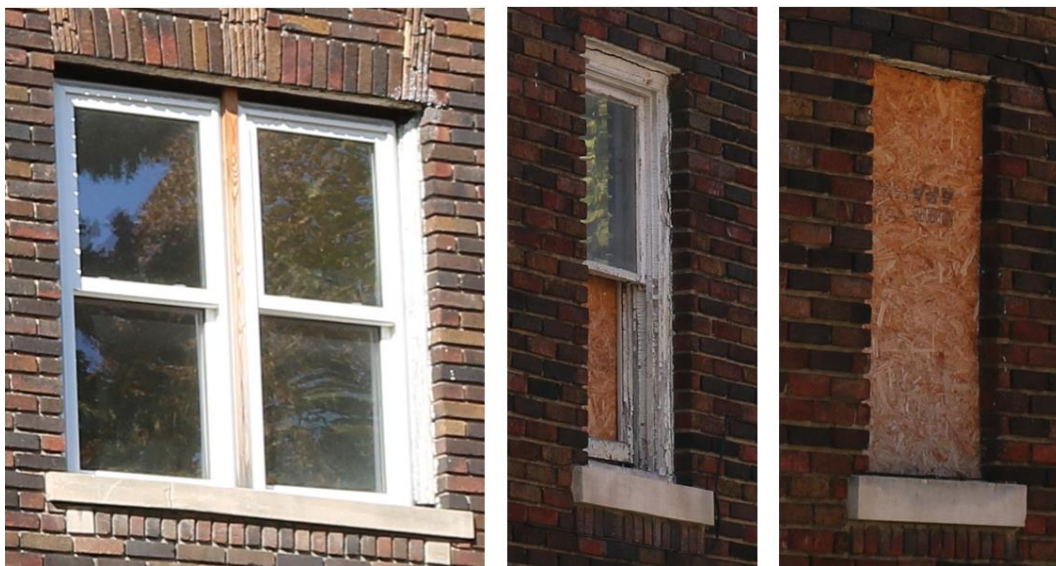
Examples of existing window openings. Left to right: Vinyl windows (note unpainted wood mullion), historic wood window, boarded-up opening. October 2022 photos by staff.

- The vinyl windows currently on the building are an inappropriate, recent addition. With most of the original windows now gone, the proposed aluminum-clad wood windows are potentially an appropriate replacement. Retaining the current vinyl windows would not be appropriate.
- Staff suggests that the remaining one or two historic windows on the east elevation are not important character-defining features, as they are not a component of a broader fenestration pattern, are not on a principal façade, and not subdivided as referenced in the Elements of Design.
- Black is an appropriate sash color, as dark sash colors are typical of Tudor Revival architecture. Black is provided as an optional sash color in Color System D.

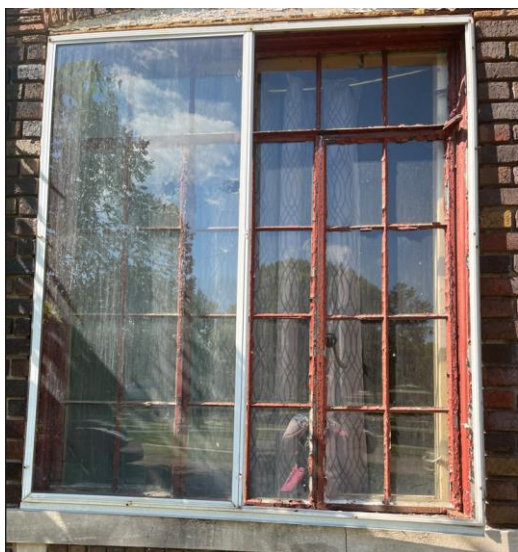
Historic steel window (typical of both windows on the front façade). Photo from application.

- The building's rolled steel casement windows are both historic (original to the house) and distinctive (as suggested by the Elements of Design); such windows are a hallmark of Tudor Revival buildings of the period. Appropriate and feasible preservation methodologies for their repair are well established (see, for example, National Park Service, *Preservation Brief 13: The Repair and Thermal Upgrading of Historic Steel Windows*).¹ Standards #2 and #5 suggest that they be preserved.
- A pair of leaded or zinc glass casement windows on the west elevation create "textural interest," as described in the Elements of Design, and thus are a defining feature. Standard #2 suggests that they be preserved. If historic windows exist within the boarded openings on the west elevation, they are likewise important, defining features.

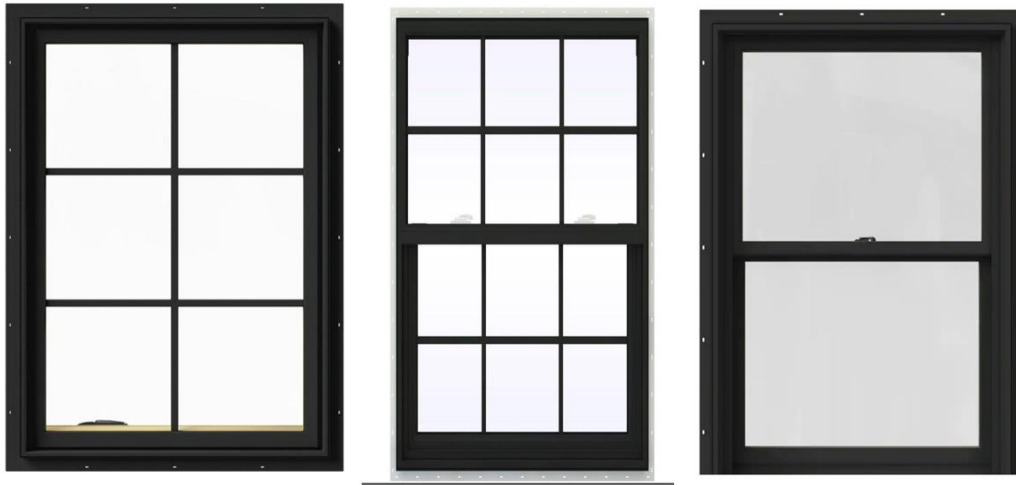
The proposed replacement windows are aluminum-clad wood windows, with casement windows to replace the two steel casement windows on the front façade, and sash windows to replace the remaining sash windows. The application does not provide detailed specifications on the proposed windows, but does include images.

Proposed replacement windows. Left: casement window; Center: six-over-six sash window; Right: one-over-one sash window. Images from application.

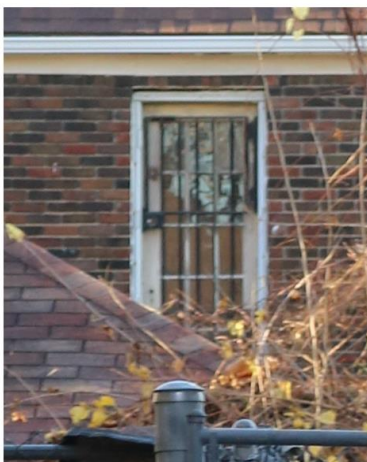
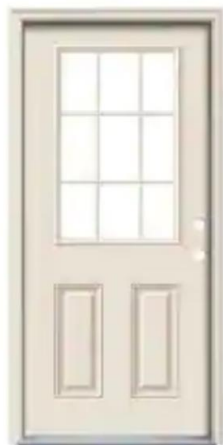
Left: Existing balcony door. November 2022 photo by staff. Right: Proposed new door. Image from application.

- The existing twelve-light door contributes to the historic character of the property, and should be retained if possible (Standard #2). If it has deteriorated significantly, a replacement should "match the old in design, color, texture, and, where possible, materials" (Standard 9). The proposed door does not closely match the old.

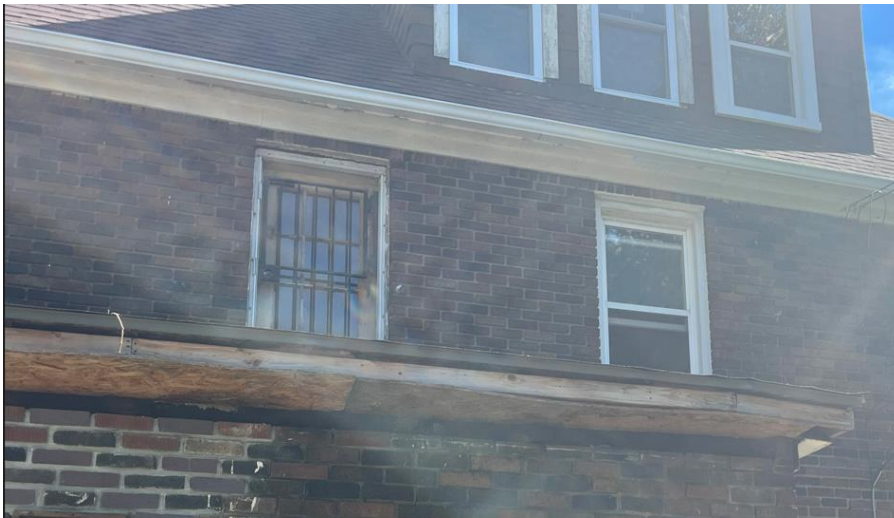
- A rear extension of the building is missing original fascias and soffits; adding new material in this area is warranted.

Photo from application shows historic fascias and soffits on the core block of the house, and fascias and soffits replaced by OSB and dimensional lumber on a rear ell.

- Where original fascias and soffits exist on the building, they should be retained (Standard #2). In-kind replacement of damaged material is potentially acceptable, but would require additional documentation.

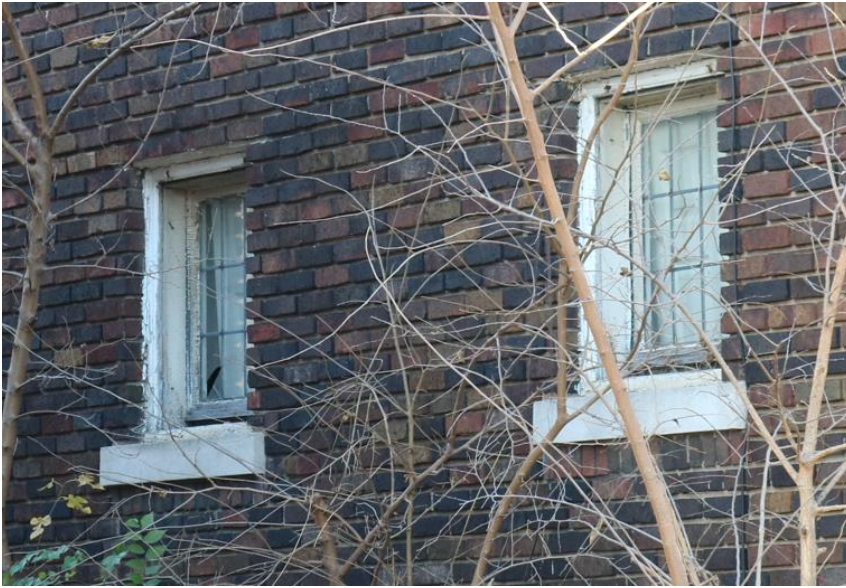
Windows on the west elevation. November 2022 photo by staff.
