STAFF REPORT: 11/16/2022 REGULAR MEETING

APPLICATION NUMBER: 22-8100

ADDRESS: 1517 ATKINSON

SCOPE: INSTALL VINYL AND GLASS BLOCK WINDOWS (WORK COMPLETED WITHOUT APPROVAL)

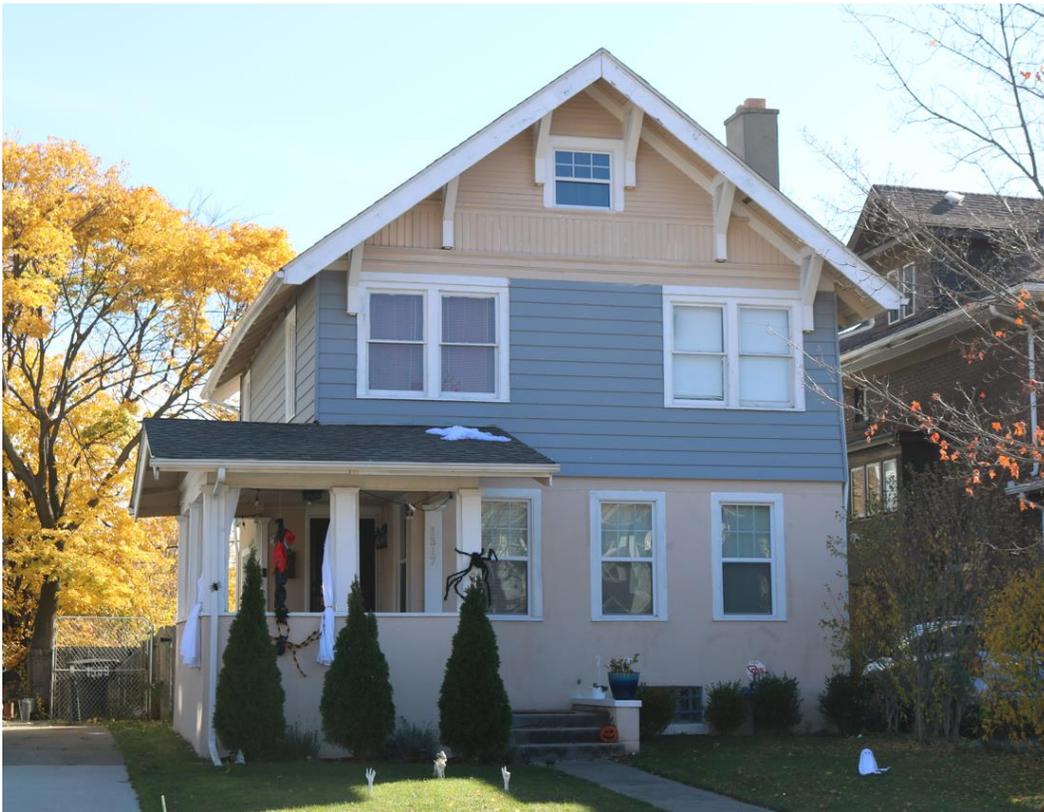
July 2022 photo by staff.

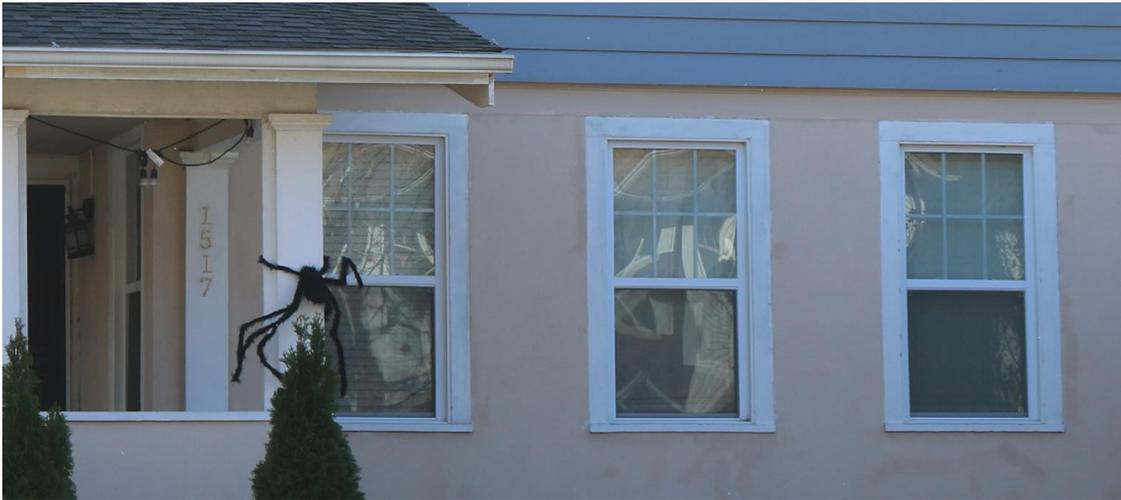
Four windows (three facing south and one within the recessed porch area) replaced in 2018. October 2022 photo by staff.

Staff recommends that the Commission issue a Denial of the proposed work as it does not meet the Secretary of the Interior's Standards for Rehabilitation, in particular:

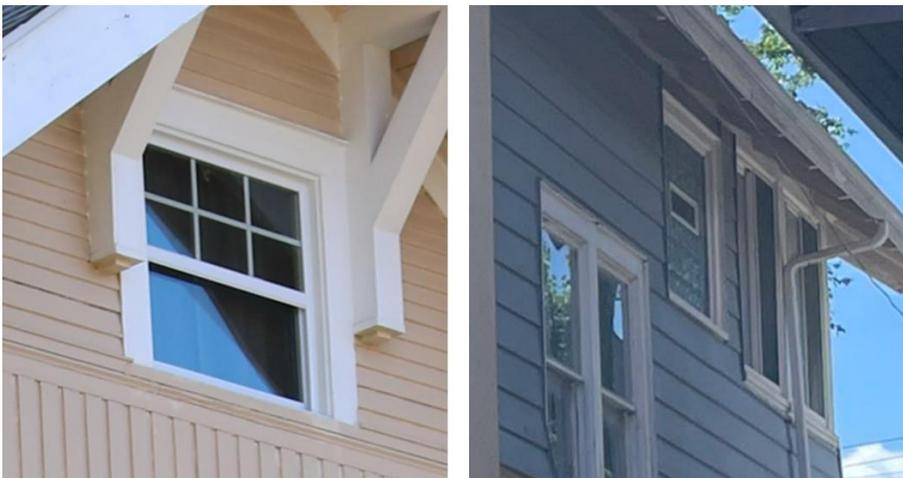
Left: Attic window added in 2018. Right: Glass block window added in 2018. October 2022 and July 2022 photos by staff.

Appropriate new windows would match or closely approximate the dimensional qualities of historic windows found elsewhere on the house. Particularly inappropriate are the attic window, where a prominent vertical mullion has been eliminated, and the second floor west elevation window, where glass blocks have been added.

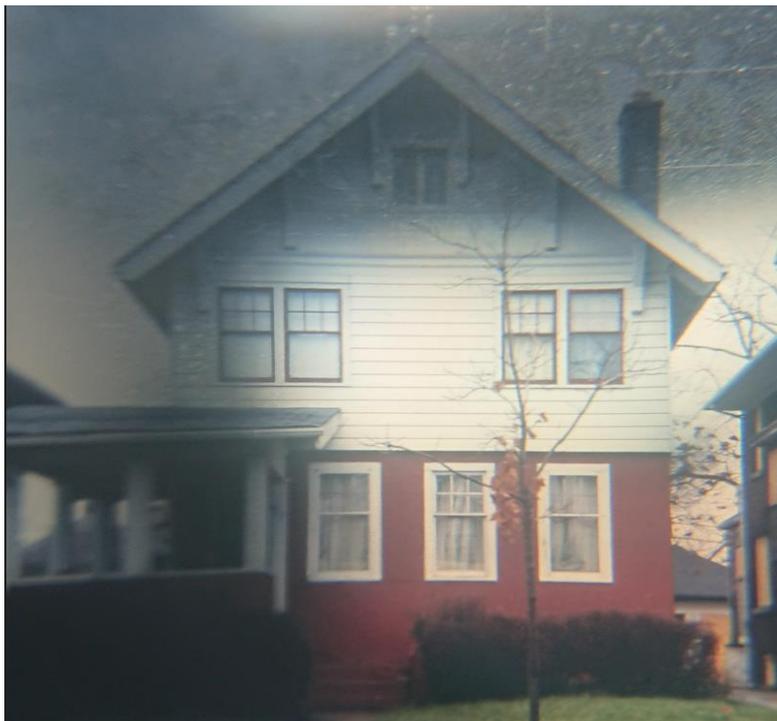
Circa 1984 photo by the Historic Designation Advisory Board. Note the six-over-one sash windows on the first and second floors and the mullioned window on the attic story.

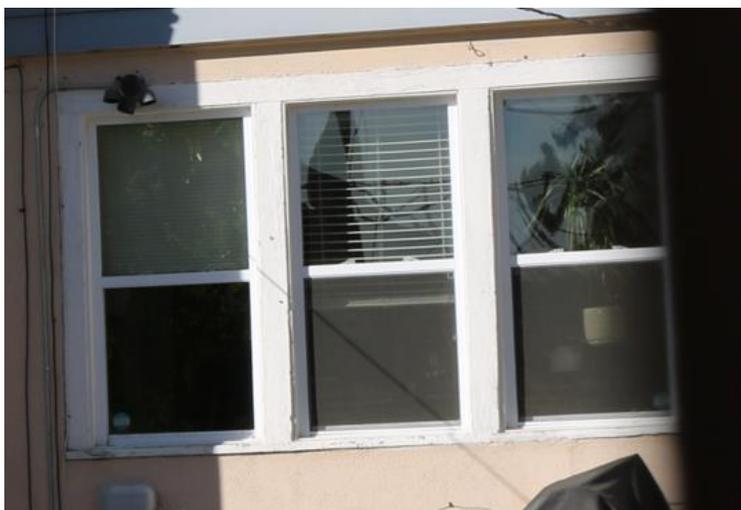
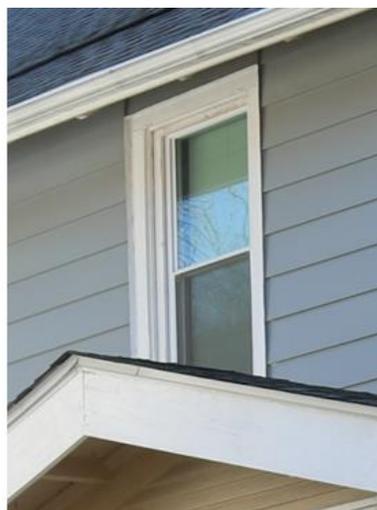
Examples of windows that appear to be newer vinyl windows but are not included in this application. Left: rear elevation. Right: West elevation. October 2022 photos by staff.

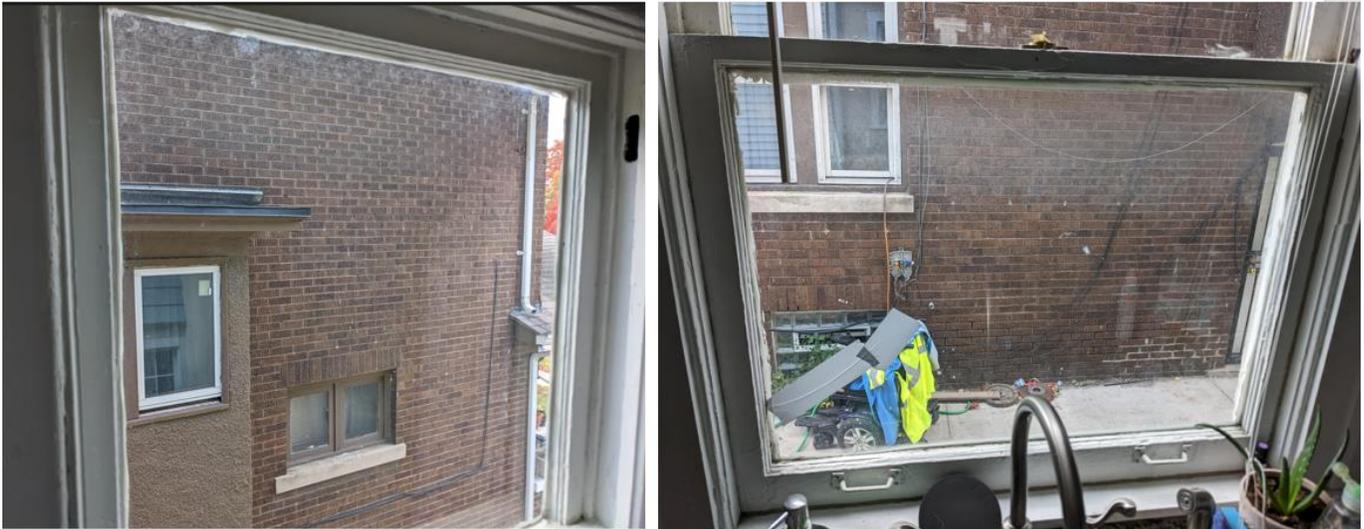
Examples of historic sashes that remain on the building. Photos from application.
