STAFF REPORT: NOVEMBER 16, 2022 MEETING

APPLICATION NUMBER: 22-8103

ADDRESS: 2475 CHICAGO

SCOPE: INSTALL ALUMINUM RAILINGS & SLIDING DOOR, INSTALL VINYL WINDOWS AT REAR DORMER (*WORK COMPLETED WITHOUT APPROVAL*), REVISION OF PREVIOUSLY APPROVED ERECTION OF REAR TWO-STORY PORCH (*WORK COMPLETE*), REPLACE WOOD WINDOWS WITH VINYL & GLASS BLOCK WINDOWS,

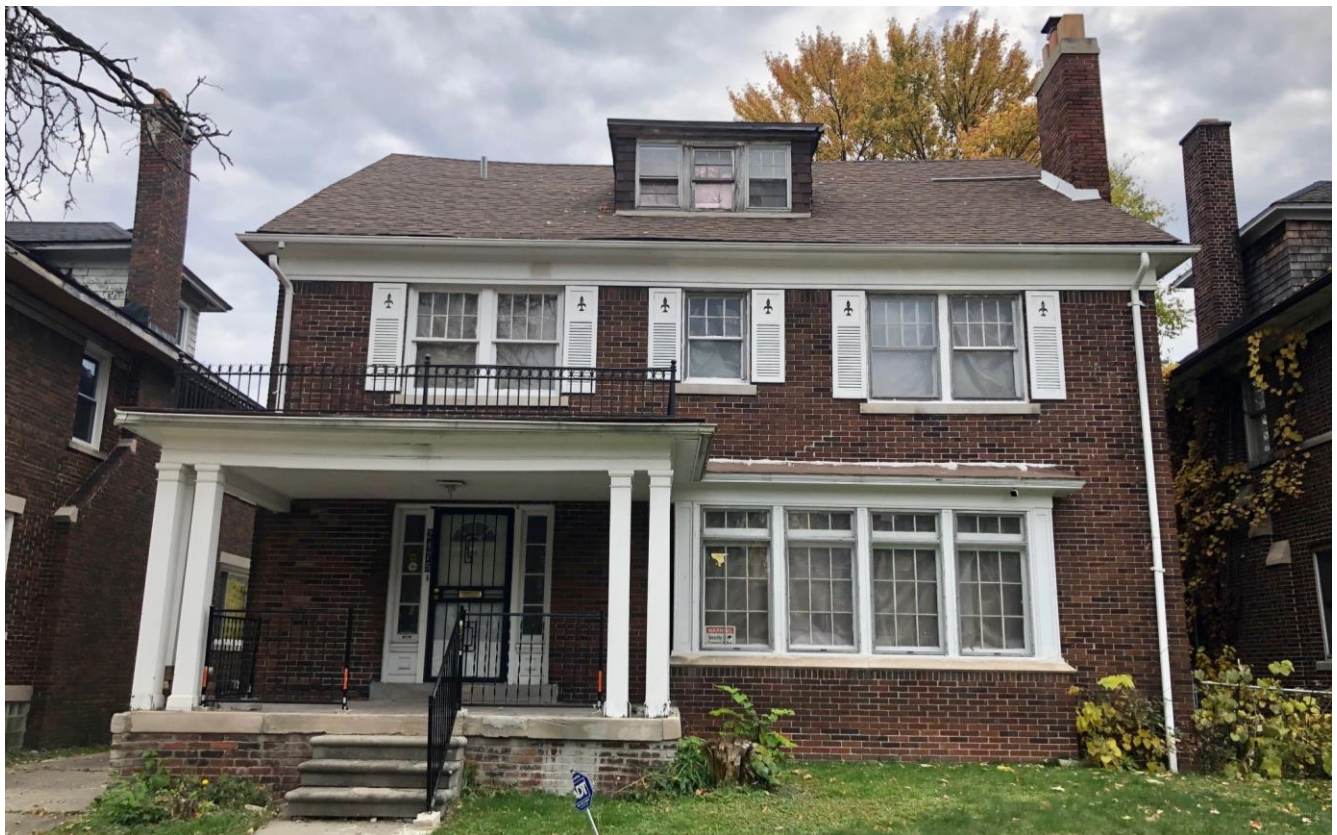
Staff photo, October 25, 2022

The large, deep raised entry porch is covered with a flat roof. Groupings of three slender smooth, square columns with minimally detailed bases and capitals are positioned at each of the two front corners. A recently installed railing encloses the first-floor porch landing and the historic railing remains intact at the upper level.

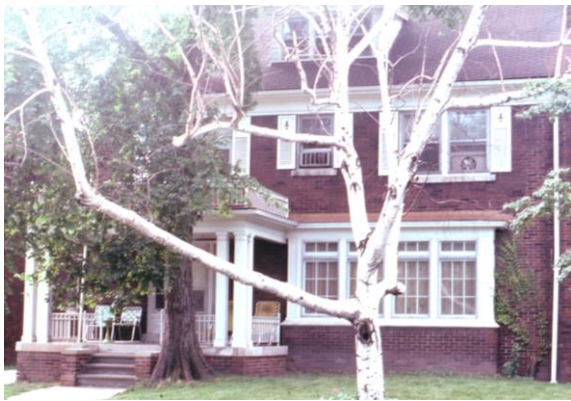
1974 Designation photo, HDAB

- Staff doesn't know when the front porch's first floor railing and step wing walls were removed. Based on photographs on file with the city, the railing disappeared between 1988 and 2017; the wing walls disappeared between 1980 and 1988. There is no record on file for HDC review for the removal of these elements. The existing railing was installed during the review of this application. The applicant's undated photo (below left) submitted with the application documents shows the step railing in place and staff's site visit photo shows a full perimeter railing installed.

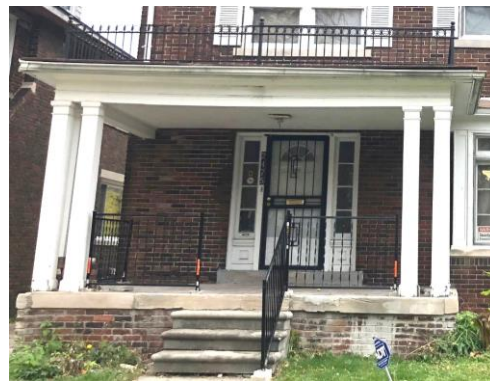
Staff photo, October 25, 2020

- When reviewing the 1974 designation photo, staff noticed a large tree had grown directly adjacent the front porch and wing wall. The tree was removed prior to the city's 1980 image. This could explain the non-matching tuck-pointing, various replacement bricks and white washing of brick at this location, all of which is shown in current images.

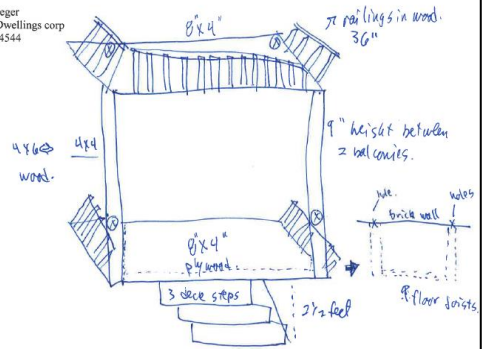
The four holes of the floor joists are still happening in the brick wall of the house. Panel lines are still showing where was the previous wood balcony. I took pictures of neighbors to give an idea of this basic balcony. My balcony collapsed 3-4 years ago it was rotten.

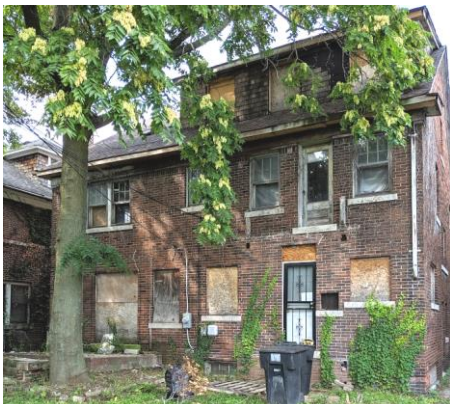
Applicant photo from 2019 HDC application

- The applicant remarked that the sliding door was added about five years ago. A handrail leading down the open porch stairs, and installed adjacent the brick wing wall, was recently installed. The applicant couldn't provide manufacturer information for these items.

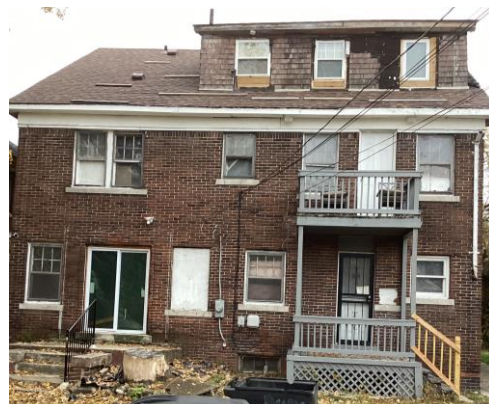
Recently submitted applicant photo.

- The installed vinyl windows within the rear shed dormer are smaller in size than the openings and are not uniform in dimension with each other. Also, the operation and/or design of each window unit is different. The opening sizes submitted by the applicant are: 40" h x 24" w, 40" h x 30" w, 38" h x 36" w. Staff assumes, based on the below picture, the 40" h x 24" w window is at far right, the 40" h x 30" w opening is in the center, and the 38" h x 36" w opening is at far left. The applicant didn't provide information on the manufacturer of the windows.

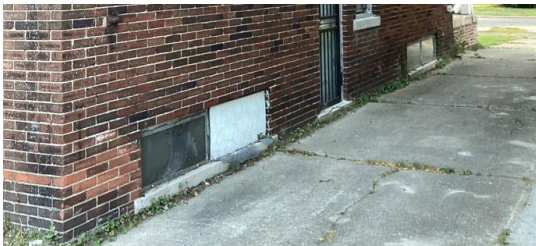
East elevation – applicant photo

- The sliding door opening measures 80" h x 64" w.
 - The side elevation window opening measures 44" h x 36" w. It appears the lower sash is missing.
 - The applicant expanded the number of openings for replacement windows after the Home Depot work order was submitted with his initial application, so the window count is off.

- Based on the applicant's photographs, the basement windows are located on the east and rear elevations. The applicant states the dimensions for the basement openings are 17" h x 38" w. Staff doesn't consider these openings character-defining features of the dwelling.

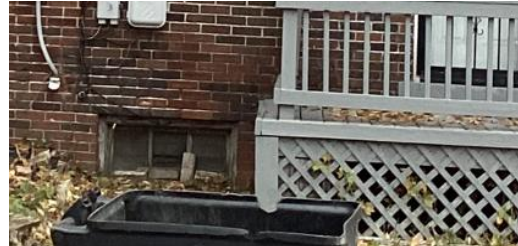
Rear elevation – applicant photo

- The application also consists of the request to replace five wood double-hung windows at the rear elevation second floor, one window at the rear elevation first floor, and one wood double-hung window on the east elevation (adjacent an exterior door). The proposed replacement units are [Jeld-Wen V-2500 series](#), which is an entirely vinyl product.

- The second-floor windows sizes supplied by the applicant are (left to right):
 - 2 @ 54" x 32"
 - 1 @ 45" x 32"
 - 1 @ 60" x 39"
 - 1 @ 60" x 36"
 - The applicant stated the first-floor window opening is 60" h x 38" w.

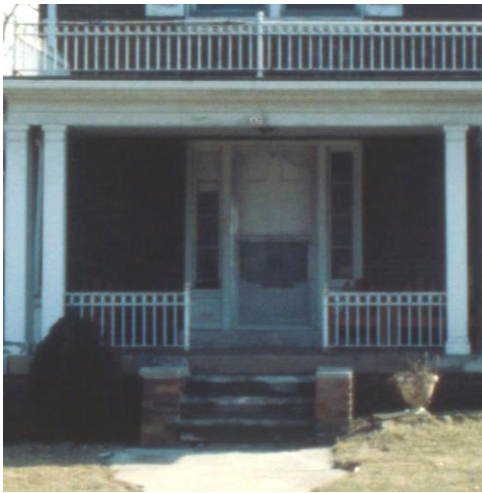
1980 photo, HDAB

- As seen in the 1974 and 1980 photos on page two of the staff report, a strong pattern was set with the historic railing's circular components which created a cohesive appearance to the porch. The recently installed railing is out of scale and does not match or mimic the historic railing in design, thus creating a disjointed appearance to the front porch.

- The 1980 photo shows the first-floor railing was slightly taller than the upper story railing

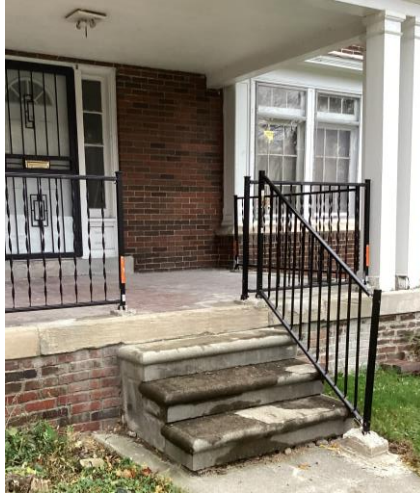
Applicant photo

- Wing walls are common historic features on masonry structures. They frame the steps and act as a buffer to the stair edge. It is staff's opinion that the installed single metal handrail with turned spindles and separately installed components, does not meet Standard 6 *"Deteriorated historic features shall be repaired rather than replaced. Where the severity of deterioration requires replacement of a distinctive feature, the new feature shall match the old in design, color, texture, and other visual qualities and, where possible, materials. Replacement of missing features shall be substantiated by documentary, physical, or pictorial evidence."*

Recommendation One – Denial – vinyl windows, railings, sliding door

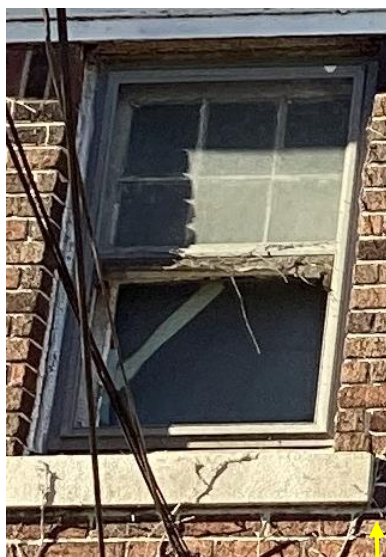
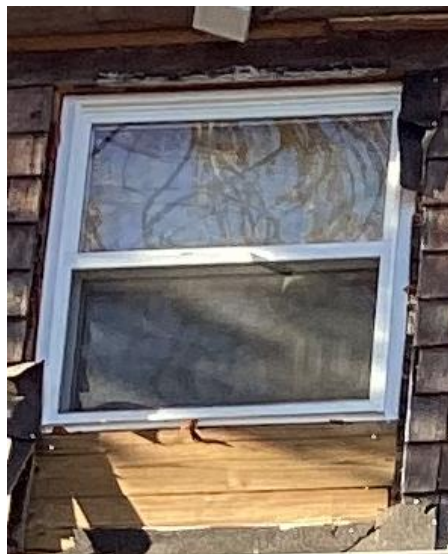
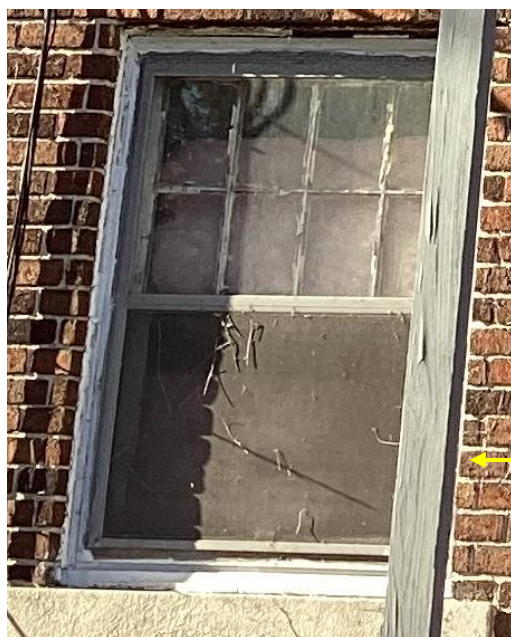
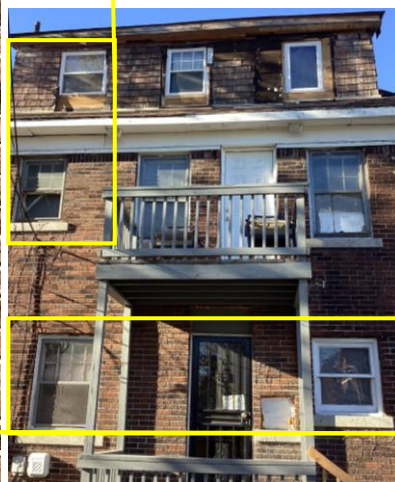
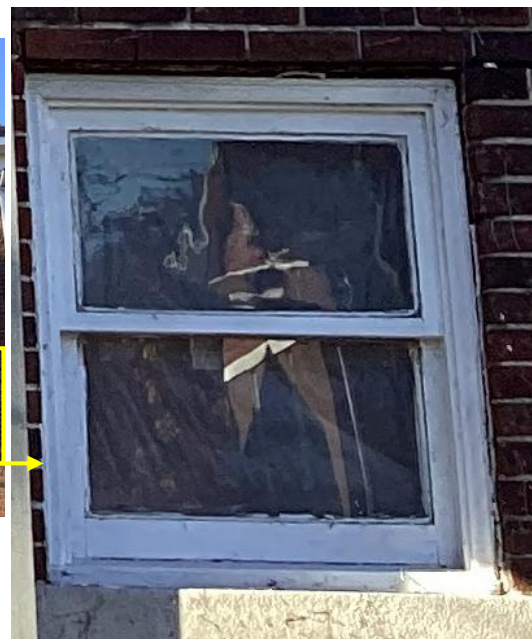
Photo comparison of original and replacement windows

Applicant photos

From a distance, the placement of the historic wood sash is obscured by the frame of the aluminum storm window. Upon closer inspection, the setback of the window sash is noticeable. This recessed placement allows for a subtle shadowing of the windows which further accentuates the openings within the walls.

Taking the above information into consideration, staff believes the older and recently installed replacement sash illustrate how window openings with replacement windows almost become wall components rather than distinctive, dimensional independent features.

Staff isn't clear when this window was replaced and could possibly be an older wood-framed replacement unit. Regardless of frame material, the brick mold is flatter than the historic brickmold (so incremental depth of the unit is lost) and the fabrication as one unit – brickmold and sash – causes a further loss of depth and forward placement within the window opening.

- Staff doesn't believe the applicant has demonstrated that the existing windows are beyond repair. Therefore, the discussion of replacement windows, regardless of proposed replacement design, is premature.

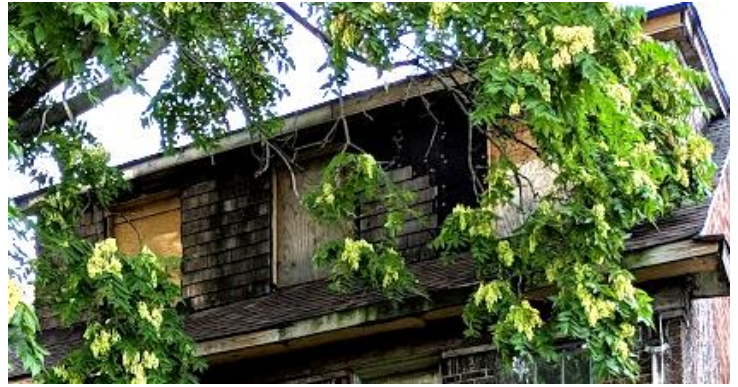
Photo submitted by applicant as part of 2019 application

- The installation without approval of vinyl windows in the rear dormer shows discordant windows installed within three originally identical openings. Listed below are comments from the applicant:
 - *These windows were not replacing any windows.*
 - *That corner back portion of the house was partly demolished. Section of roof missing.*
 - *No windows were left there. That exterior wall had to be rebuilt*
 - *For few years, we temporarily installed a glass and a plywood to bring some light*
 - *When there's no windows left, we don't have indications of what was there before.*

Based on the 2019 photo, staff stipulates that there may not have been windows within the openings. If this was the case, the applicant should have consulted with staff on appropriate windows to install that could have been administratively approved. The 2019 and below left 2022 photos give clear evidence as to the sizes of the original window openings.

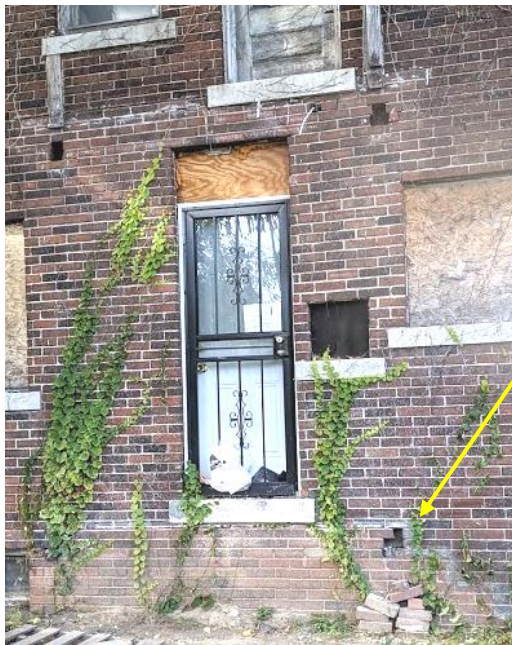
- The erected porch differs from the 2019 approved scope; however, it is staff's opinion the massing references the house's original porch design by its overall size and stairs extending on the side to the driveway, based on the outlines on the brick and structural remnants. The applicant used rectilinear balustrades with flat top and bottom rails, but did not include separate corner posts. It is staff's opinion the porch reads as a distinctly 21st century structure; its minimal design is a small impact to the rear elevation and does not diminish the property's architecturally significant features.

*Photo submitted by applicant.
Outline of previous porch floor and steps.*

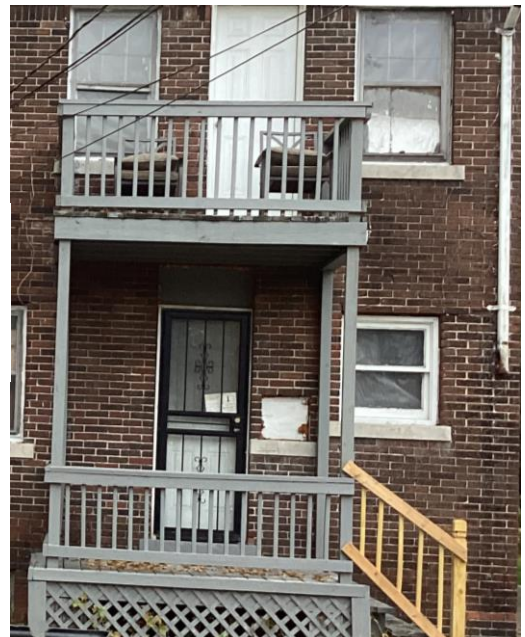
- The constructed stair railing is incompatible with the erected porch; however, staff feels the dimension and design of the at-grade baluster is appropriate for this location.
 - The stair's top and bottom rails should precisely meet the top and bottom rails of the porch balustrade, and the spacing of the stair balustrade should match the dimensional spacing of the porch balustrade.
- The diagonal skirting attached to the outer frame of the lower deck is also incompatible with the erected porch.

- The rear wood porch stair railing will be replaced with a wood railing that matches the design and dimensions of the porch railing. The ends of the existing and new railings will have miter cuts to fit closely together, as well as ending at the inside edge of the at-grade baluster.

- Vertical skirting will replace the diagonal panels that span the area between the bottom of the deck and grade.
- The two-story porch, new stair railing, and deck skirting will be repainted to better align with the existing white trim on the house.

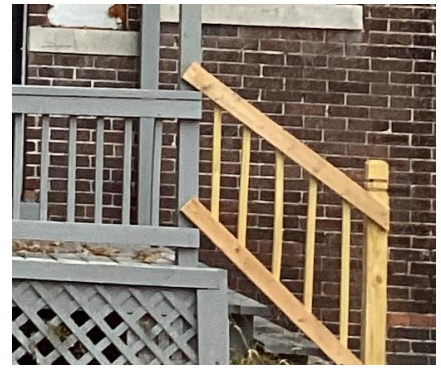
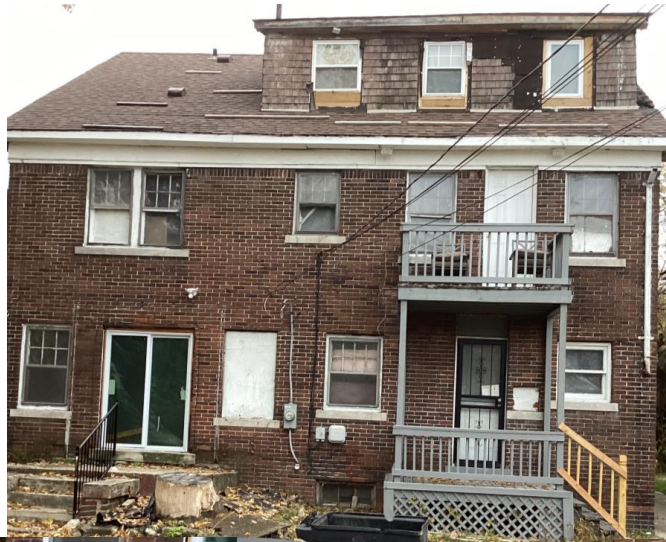
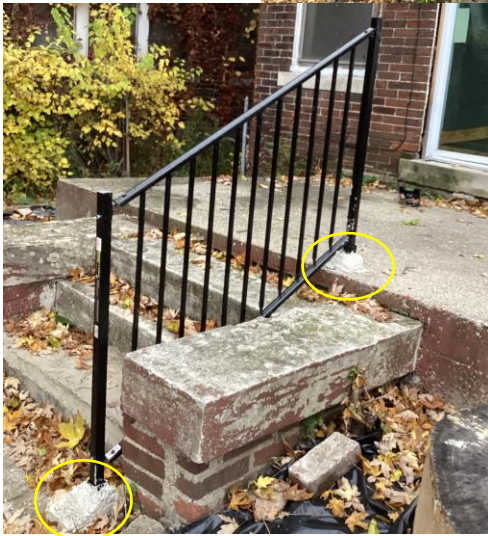
*Applicant photos.
Left: Stairs and wing walls.
The recently poured concrete
for the new railing is circled.
Right: Ghost lines at rear
door leading to open porch.*

- The raised porch with centrally placed steps flanked by brick wing walls with stone (or concrete) caps are a distinctive character-defining feature of the rear elevation. The outline of painted trim gives evidence that there was some decorative detailing that further accentuated this rear porch.

- Originally, the door leading to the open raised patio would likely have been French doors, or a single door with flanking sidelights (like the front door). The frame of the replacement door appears to be vinyl. The operation and materiality of the sliding doors is a contemporary design and their uneven glass walls are not appropriate for historic structures in the Boston-Edison historic district.

- The installed handrail is incongruous with the rear porch, and the installation method (raised concrete) and railing selection (thin turned aluminum spindles and unfinished end posts) are not appropriate for this historic setting.
