STAFF REPORT: 11/16/2022 REGULAR MEETING
PREPARED BY: T. BOSCARINO
APPLICATION NUMBER: 22-8119
VIOLATION NUMBER: 21-463
ADDRESS: 6102 AND 6125 14TH STREET
HISTORIC DISTRICT: KING SOLOMON BAPTIST CHURCH
APPLICANT: REV. CHARLES WILLIAMS II, PASTOR
PROPERTY OWNER: KING SOLOMON MSNY CHURCH (6102 14TH); SON OF DAVID MINISTRIES (6125 14TH)
DATE OF PROVISIONALLY COMPLETE APPLICATION: NOVEMBER 9, 2022
DATE OF STAFF SITE VISIT: OCTOBER 28, 2022; NOVEMBER 3, 2022; NOVEMBER 9, 2022

SCOPE: REPLACE DOORS AND WINDOWS (WORK STARTED WITHOUT APPROVAL)

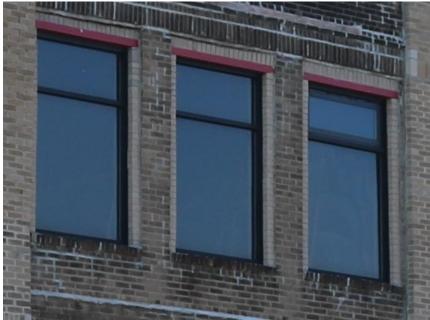
The applicant proposes to replace almost all historic windows on the building (as shown in submitted elevations). Staff has observed that twenty (20) of these windows have already been installed on the building's south (1937) addition in locations that formerly held historic rolled steel windows.

Recently replaced windows. November 2022 photo by staff.

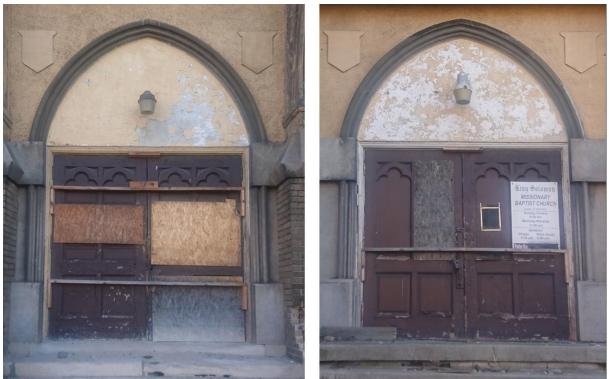
The existing doors consist of two sets of double, wood panel doors with trefoil decoration in relief.

Existing doors proposed for replacement. November 2022 photo by staff.

- The doors proposed for replacement, based on staff's assessment of design and materials, appear to be original to the design of the 1917 building, for which the building has been recognized as significant under National Register Criterion C. They are also mentioned in the Elements of Design. Thus, they are also character-defining features; their removal or alteration "shall be avoided." (Standard #2).

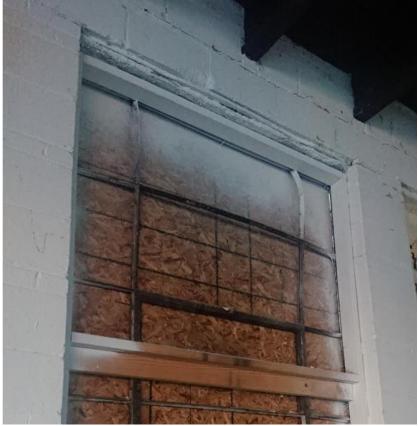
- Staff was invited to view the remaining steel windows during a site visit on November 9, 2022. Staff observed that the upper sections of the remaining windows were bent inwards, apparently due to sagging or expanding lintels. Repairing this condition is labor-intensive, but not impossible:

Typical damaged window. November 2022 photo by staff.

"Sometimes a section, such as the bottom of the frame, will bow out as a result of pressure exerted by corrosion and it is often necessary to cut the metal section to relieve this pressure prior to pressing the section back into shape and making a welded repair."<sup>4</sup>

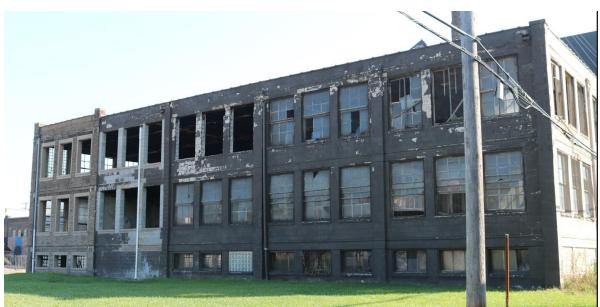
- Staff has observed evidence of vandalism and water infiltration which may have damaged many of the windows. Nonetheless, even if defining features of a building are damaged beyond feasible repair, the Secretary of the Interior's Standards for Rehabilitation, specifically Standard #6, require that the replacement features "match the old in design, color, texture, and other visual qualities." The proposed windows do not match the appearance of the old.
- The building contains many openings where windows are missing. Standard #6 also requires that "replacement of missing features shall be substantiated by documentary, physical, or pictorial evidence." According to the Standards, missing windows must be replaced by new windows which replicate the appearance of the historic windows located elsewhere on the building and shown in historic photos.

November 2022 photo by staff showing missing windows and one glass block window on the north elevation, work done without approval. Masonry repairs visible in the second bay from the left have likewise not received a Certificate of Appropriateness.

- The April 5, 2022, Certificate of Appropriateness 22-7701 for roof repairs (described above) includes as condition that "once additional funding is in place, a new application is to be submitted to the Commission to complete an historically appropriate rehabilitation of the building." Staff suggests that the above-listed work performed without approval also violates this condition.
- Staff's opinion is that the proposed work does not meet the Secretary of the Interior's Standards for Rehabilitation, and should be denied. Staff also encourages the applicant to submit a complete application for the other work items performed without approval, as described above.
