STAFF REPORT: NOVEMBER 16, 2022 MEETING

APPLICATION NUMBER: 22-8118

ADDRESS: 1688 BAGLEY

SCOPE: REPLACE SIDING, REBUILD PORCHES

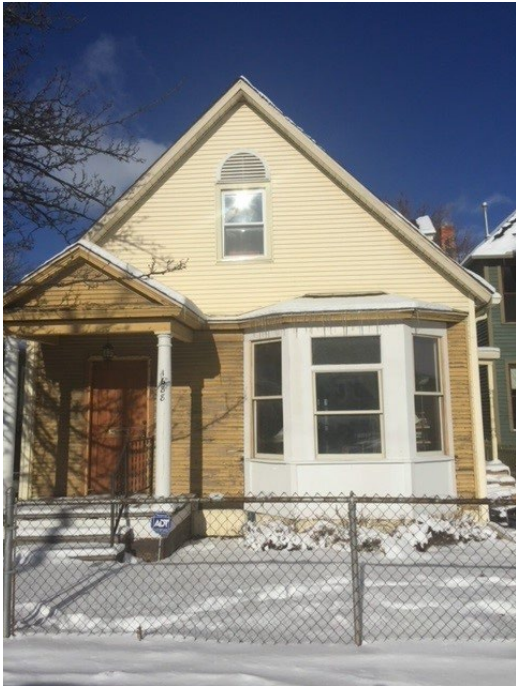
Figure 8: Dwelling before construction.

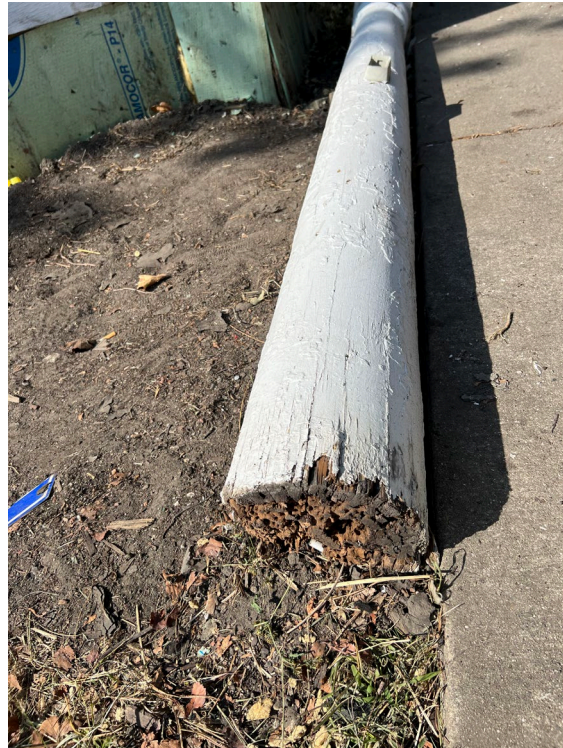
Figure 9: Image illustrating front porch column deterioration.

- The Corktown Historic District was established in 1984.
- The current owners initiated the proposed work in early October, and were issued a stop work order by BSEED on October 13th. The front porch has been demolished, but the original columns remain on site. The vinyl siding has been removed.

1. The applicant provide HDC staff with dimensioned photographs or drawings of the existing (removed) columns.
2. The applicant provide HDC with dimensioned and detailed drawings illustrating the construction of the porches including material callouts for approval prior to construction.
3. The applicant provide HDC with documentation of replacement columns, including dimensions, materiality and finish color, for approval prior to construction.

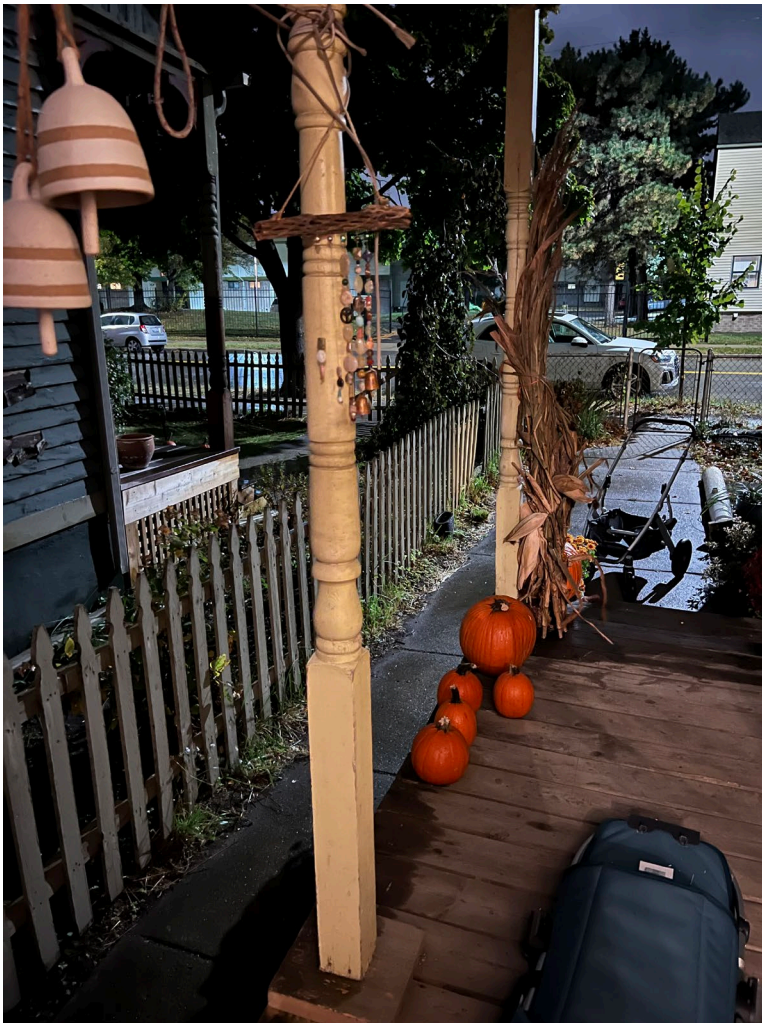
Figure 10: View of side porch.

- **Porches:** The proposals for the front and side porch appear to meet the Secretary of Interior Standards for rehabilitation. However, the applicant has not provided sufficient documentation to confirm the design of the replacement columns, foundations and decks will be an accurate and appropriate in-kind replacement.

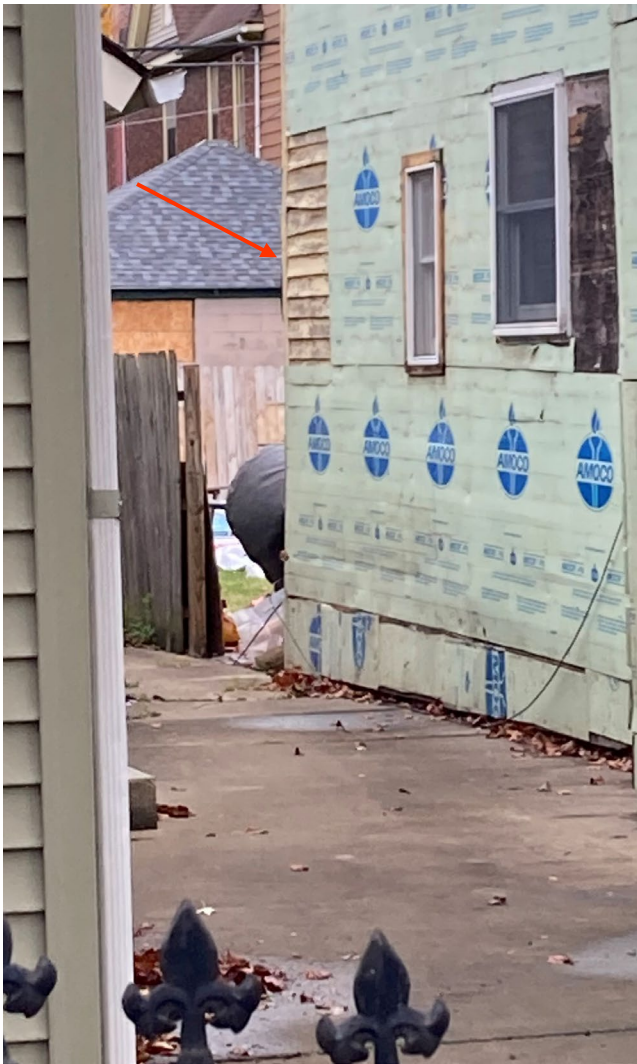
Figure 12: Wood siding on the western elevation

- **Siding:** The extent and condition of the remaining wood siding on the house is not known at this time. The removal of the vinyl siding and portions of insulation suggests it remains on a substantial portion of the building, and what was revealed appears to be in repairable condition. Wood siding is a character defining feature of many historic dwellings in the Corktown Historic District, including this one. It is staff's opinion that the application does not demonstrate the condition of the historic wood siding to an extent that justifies its replacement with a non-historic material. The installation of the engineered wood siding product conflicts National Park Service document's *Evaluating Substitute Materials in Historic Buildings*;

- *"Substitute materials, like all replacements, must closely match the design, color, surface texture, reflectivity, finish, details, and other qualities of the material or element to be replaced."*Staff recommends that the condition of the historic wood siding be fully evaluated, and the existing wood siding be repaired or replaced in-kind to preserve the material integrity of both the dwelling and historic district.

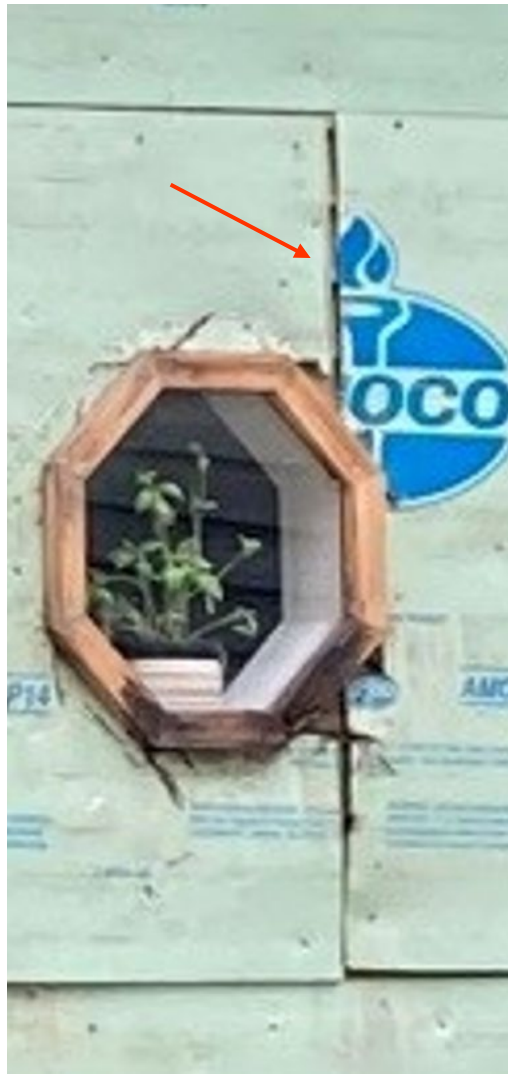
Figure 13: Wood siding under insulation, east elevation.

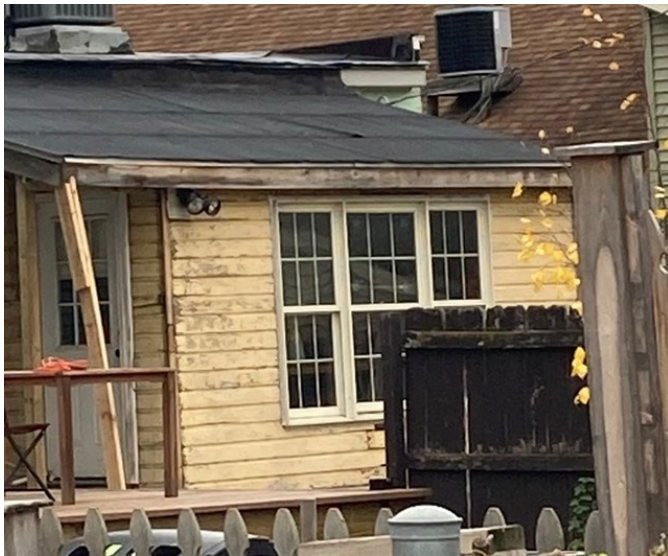
Figure 14: Ca. 1885 rear portion of the dwelling showing existing wood siding.
