STAFF REPORT: 12/14/2022 REGULAR MEETING

APPLICATION NUMBER: #22-8159

ADDRESS: 4762 CORTLAND

HISTORIC DISTRICT: RUSSELL WOODS - SULLIVAN

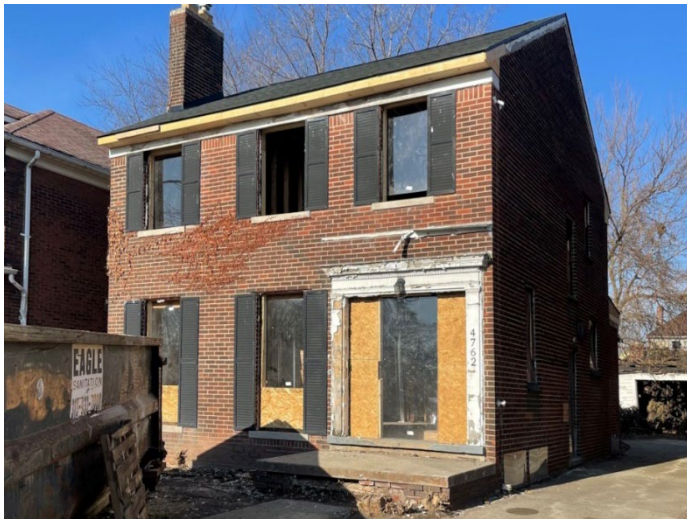
Site Photo 1, by Staff November.23, 2022: (South) front elevation.

- Staff received confirmation that the wood panels below the front, first floor windows are no longer present and the sidelights on either side of the front door are still present. Both are currently covered in plywood and not visible. (*See photos 1 & 4*)

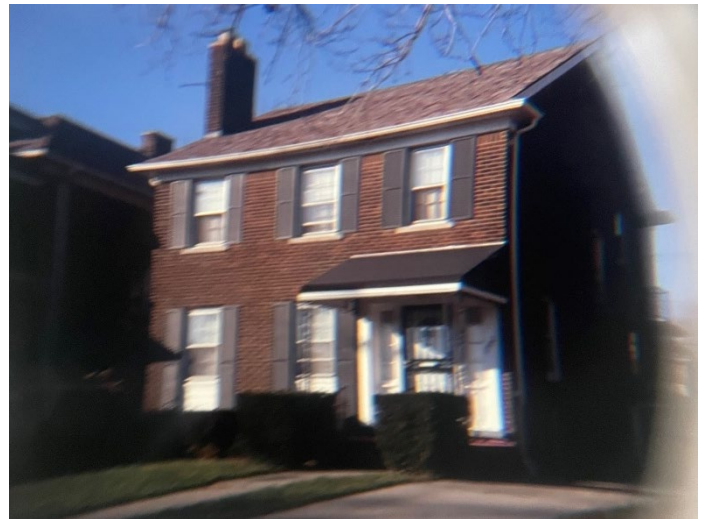
Designation Slide, 1999: (South) front/side elevation showing original windows, porch, entrance, and roof. Note greater eave depth.

- From the designation slide, it is staff's observation that the original windows were wood, double-hung with a 6/6 or 4/4 configuration. Some remains of these wood frame windows are partially or fully present on the rear side of the house. It is staff's opinion that the remaining two windows on the rear, first floor could be potentially repaired and not replaced. (Staff has not received a detailed report on the condition of these windows.)

- The designation slide, staff observed, shows the front entrance has side lights with a wood panel base and 4 divided lights on each side that match the scale and design of the windows. Staff has not received details on the work for the proposed restoration of the sidelights at the date of this report, but did receive verbal confirmation that they are present and will be restored.

- As best as staff could see from the ground on the sidewalk the asphalt roof work appears to be appropriate.
- The wood soffits and fascia have not yet been painted, and the eaves appear to have been reduced in depth from their historic extension beyond the edge of the roof at either side of the house (*see designation photo above*). It is staff's opinion that the eaves are distinctive character-defining features that have been reduced in dimension at both the front and rear elevations, which alters the building's historic expression.

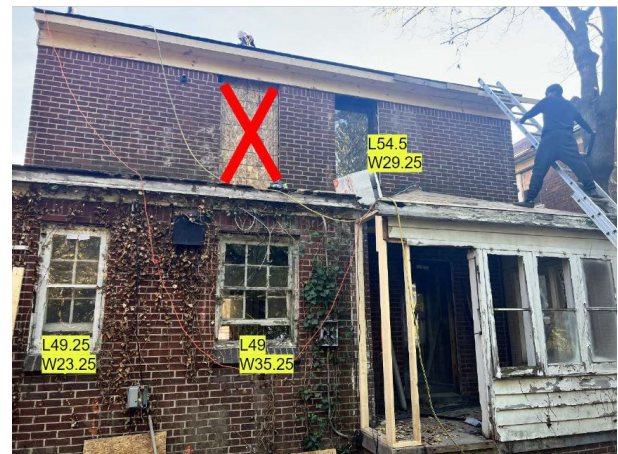
Site Photo 6, by Applicant 2022: (North) rear elevation showing proposed locations for new windows.

- The applicant states that there were no wooden windows upon purchase of the home. However, staff sees in the applicant photos that some wood windows remain in the rear.
