STAFF REPORT: 2/8/2023 REGULAR MEETING

APPLICATION NUMBER: #23-8201

ADDRESS: 761 WHITMORE

SCOPE: INSTALL VINYL WINDOWS, REPLACE DOORS (WORK COMPLETED WITHOUT APPROVAL)

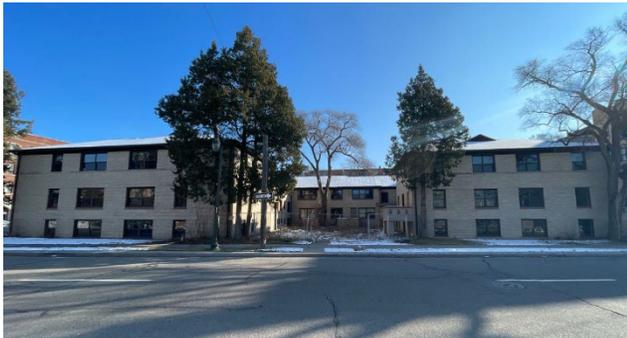
Site Photo 1, by Staff January 24, 2023: (West) Front elevation and courtyard on 3rd Street, showing vinyl window installation.

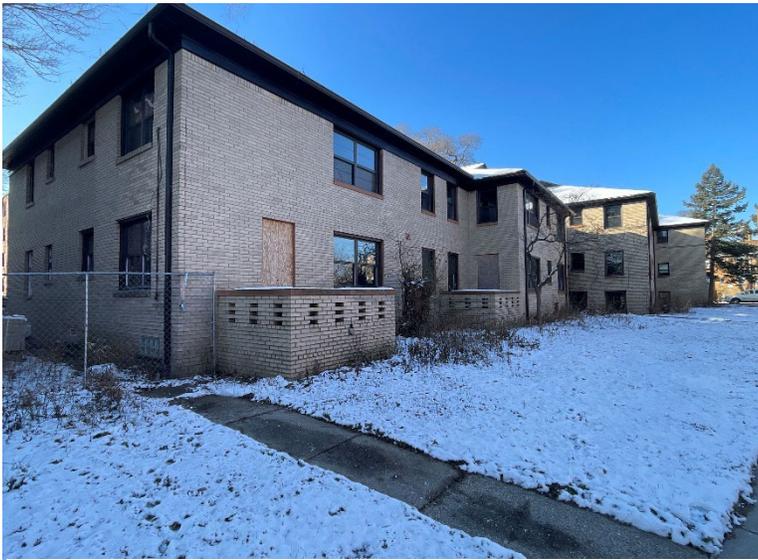
Site Photo 3, by Staff January 24, 2023: (North) side elevation on Whitmore, showing vinyl window installation.

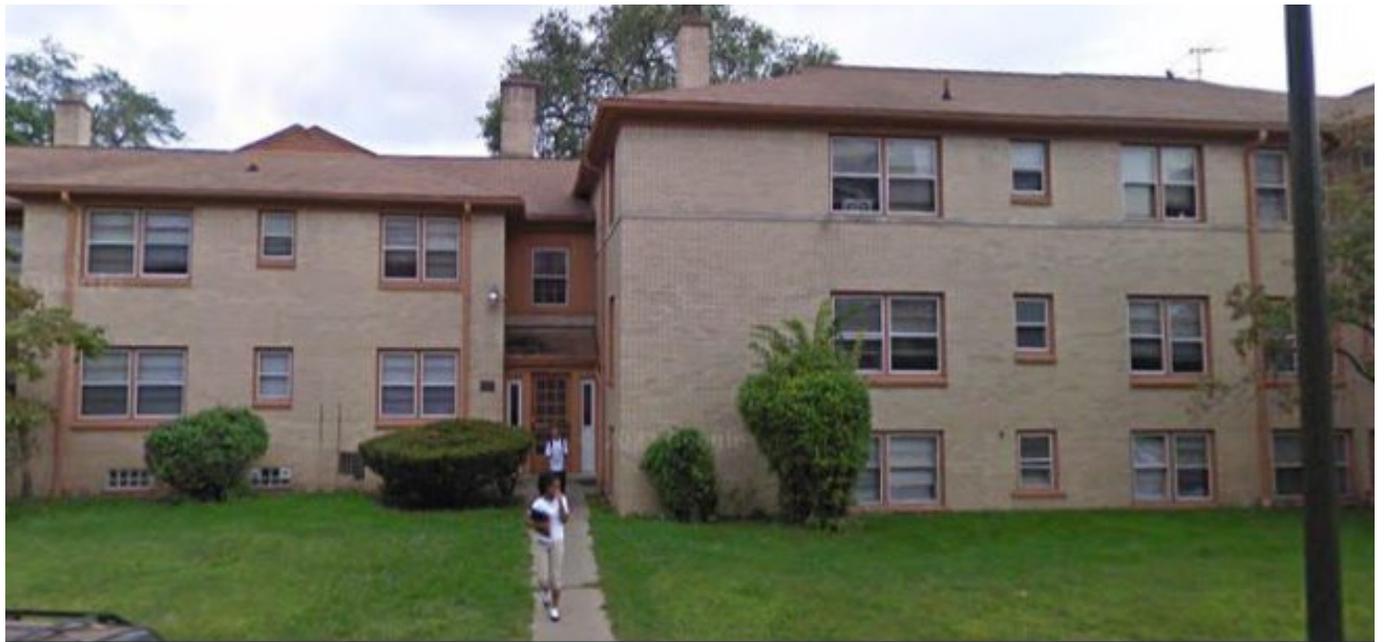
Site photo 4, by Google Street, September 2009: Whitmore (North) elevation, showing 2/2 horizontal muntin, double hung wood windows, and 3x6 front door glass and wood panel entrance.

- Staff observed from Google Street View, that in September 2009, a vast majority of the original windows appeared to be in place. Staff observed that the building was vacated since at least July 2011 with the windows and doors boarded up. (*See site photos 4&5*) Staff observed that the Buildings, Safety Engineering and Environmental Department (BSEED) shows a Vacant Property Registration issued in March 2012.

- Staff observed that the original wood windows were double hung with a horizontal muntin in both the upper and lower sash, creating a 2 over 2 configuration.

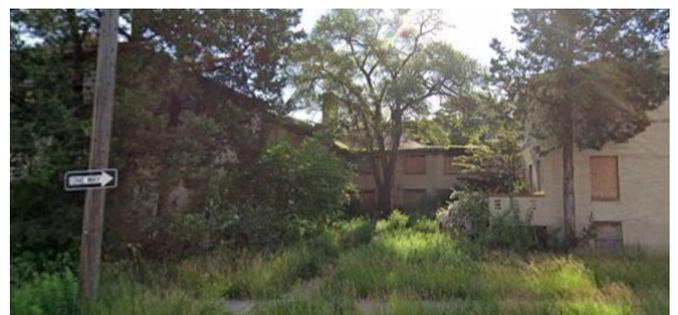
Site photo 5, by Google Street, June 2019: Third street (west) front elevation, showing windows and doors boarded up, and property overgrown with inactivity.

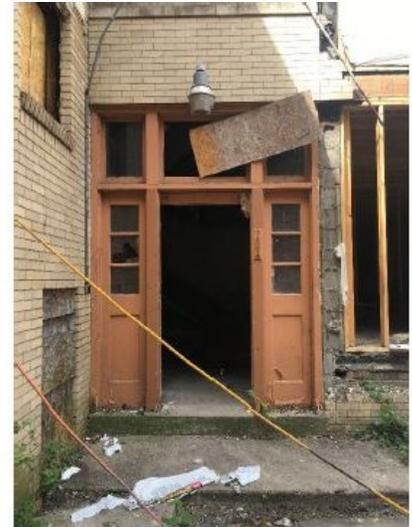
Door 4 – Existing prior to securing.

Detail Photos 1&2, by applicant, in courtyard (west elevation), showing 2 entrances prior to securing.

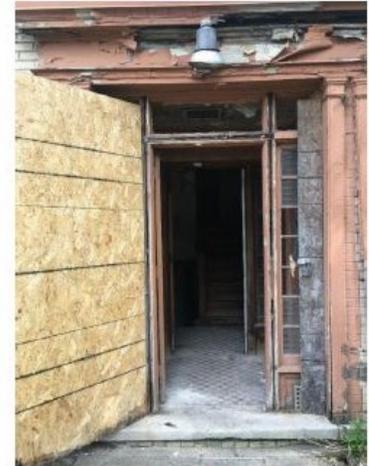
Door 2 – Existing prior to securing.

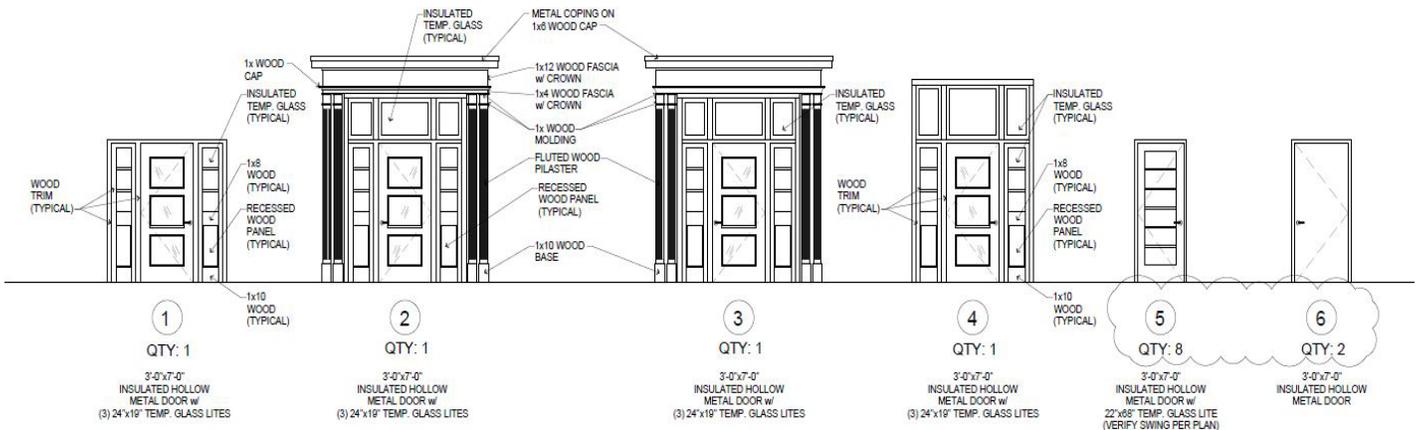
Figure 1, by applicant, showing proposed 4 entrance designs, 6 door type designs for all 14 doors. See also drawing A700

- Staff observed that the original wood doors for the four entrances had a 3x6 glass configuration over wood paneling. The applicant's design reduces the configuration to 3 glass panels for the four front entrances, which changes the configuration of their original design. It is staff's opinion that changing the original door material from wood to metal will not cause an adverse impact and is an appropriate material. However, it is staff's opinion that the configuration and scale of the glass panels can be more appropriately designed to their original configuration to approximate the scale, design or arrangement of the 3x6 original glass configuration. Staff has no issue with the patio door's 6 panel glass configuration or the solid configuration for the two utility doors.

- While staff has no issue with the proposed door entrance design and materiality, staff does offer the opinion that the four front door's window configuration, which contribute to the character defining features of the mid-century modern architecture and the adjacent pattern of the side lites, could be more appropriately designed to resemble the 3x6 glass panel arrangement of the original front entrance doors.

It is staff's opinion the proposed installation of the 14 doors and the 4 doorways is appropriate. Staff therefore recommends the Commission issue a Certificate of Appropriateness for the work as proposed because it meets the Secretary of the Interior Standards for Rehabilitation.

- Applicant supply HDC staff with modified design for the four front entrance doors' window configuration for approval and before installation.

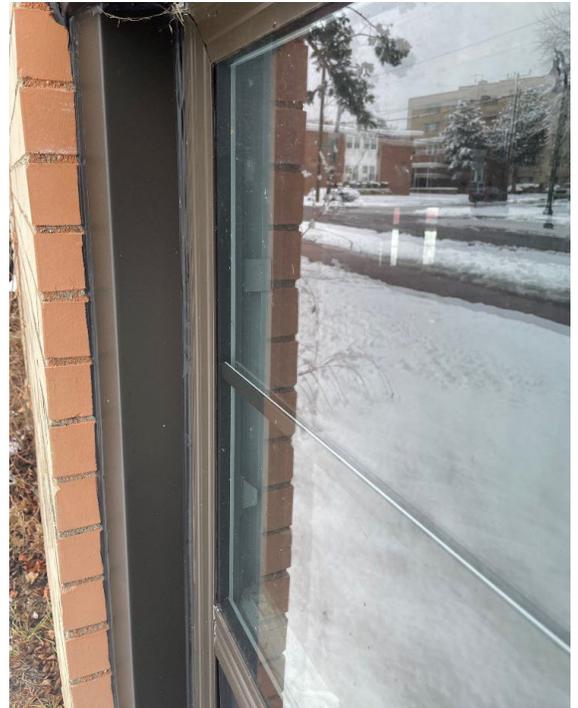
- The Palmer Park Apartment Buildings Historic District was established in 2012.
- Staff requested the applicant to provide documentation of the original condition of the windows and doors. The applicant stated that both were removed before he was involved with this project. He stated that the contractor believed the entries were beyond repair with rotted wood. The applicant provided some photos of these doorways (*see detail photos 1&2*). The applicant confirmed that no documentation of the original condition of the windows and doors exists. The applicant also confirmed that the original brick moulds were replaced with aluminum brick moulds. (*See detail photo 3*)

- Staff has the opinion that the original wood windows with true-divided light and original wood brick moulds were distinctive, character-defining features that were lost when replaced with the current vinyl windows and the installation of the thick, aluminum brick moulds.

Detail photo 3, by applicant: Third street (west) front elevation, showing where original brick mould was replaced with aluminum brick mould and horizontal muntin between the glass.

- Vinyl is not a historically appropriate material for the Palmer Park Apartment Buildings Historic District or this particular property.
- Staff identifies that both the removal of wood windows and wood brick moulds and the installation of vinyl windows and aluminum brick moulds are inappropriate as they introduce a material and design that greatly diminishes the historic character of the property (Standards 2 and 3), destroyed distinctive features of the building (Standard 5), and does not match the old character-defining feature of the original windows (removed without permit) in design, texture, and other visual properties (Standard 6).

Staff therefore recommends that the Commission issue a Denial for the proposed window replacement, as it does not the district's Elements of Design nor meet the Secretary of the Interior's Standards for Rehabilitation, specifically Standards:

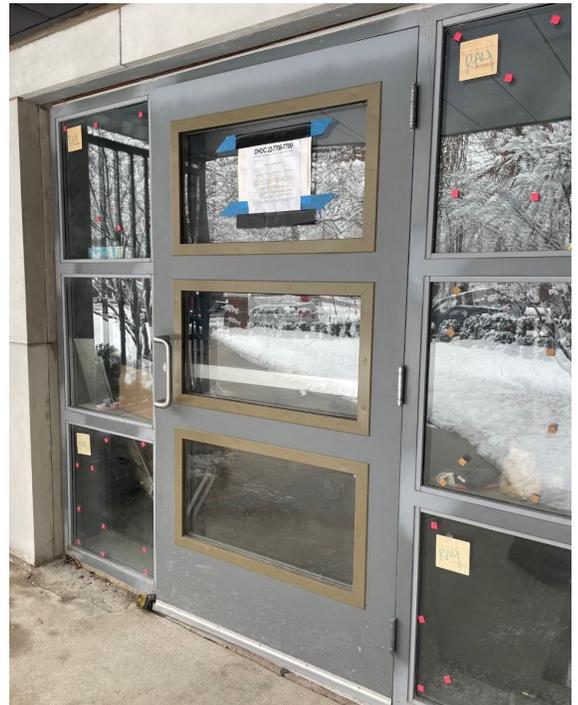
Detail photo 4, by applicant: Custom metal door with 3 panels of glass, proposed to be installed for the four entrances. (This photo is not on site and is shown as an example.)
