ADDRESS: 1652 EDISON

APPLICATION NO: #23-8240

HISTORIC DISTRICT: BOSTON EDISON

SCOPE: ALTER FRONT PORCH, REMOVE REAR ENCLOSED PORCH, AND INSTALL REAR DECK

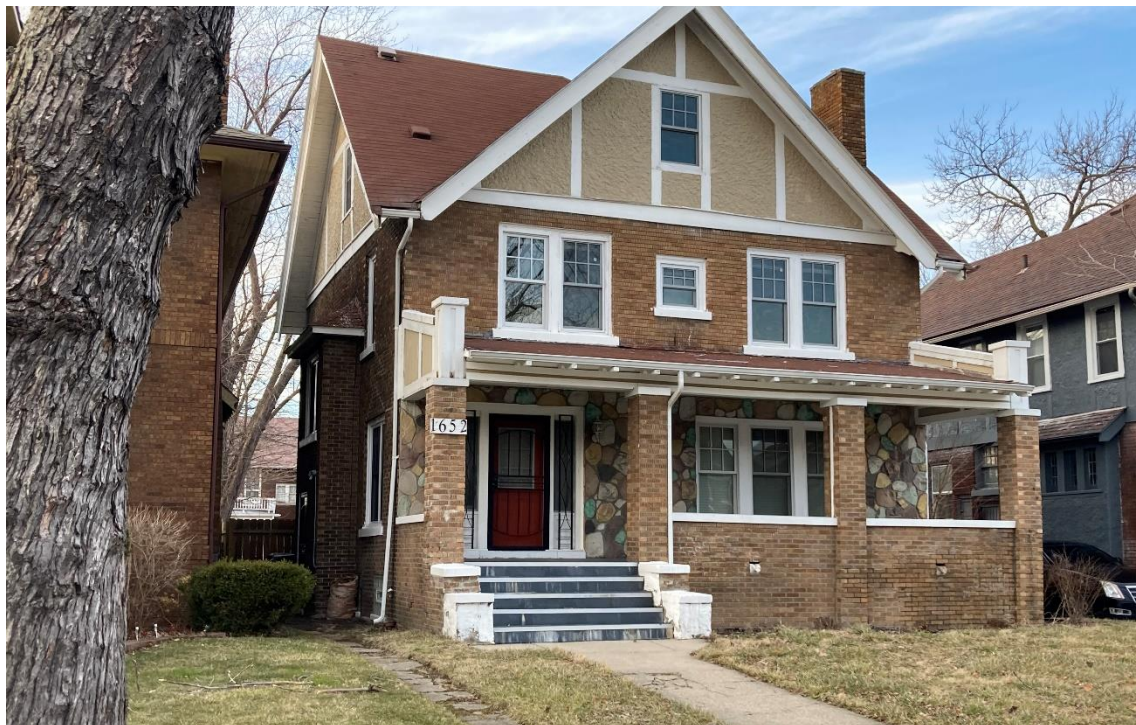
1652 Edison, current appearance, staff photo taken 2/28/2023

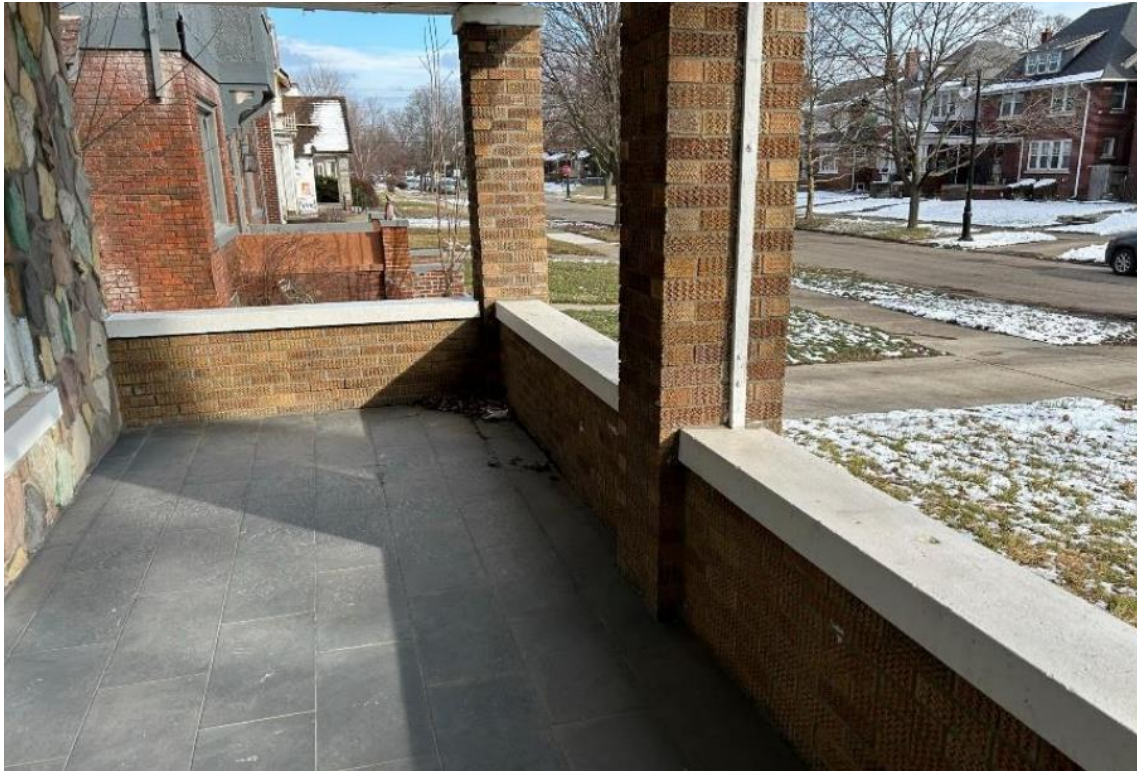
Front porch, current appearance, showing slate tiles added without HDC approval in 2017

- Similarly, it is staff’s opinion that the concrete steps and porch floor were highly-visible, distinctive, character-defining elements of the property. The installation of black slate tiles at the porch floor in addition to the ceramic/faux slate tiles and metal nosing at the porch steps do not meet the Standards as the new elements do not replicate the original concrete material. Also, the new porch floor and stair elements are incompatible with the building’s historic appearance as they appear to be more appropriate for an interior application and are not in keeping with the home’s Tudor Revival stylistic detailing.

Staff therefore recommends that the Commission issue a Denial for the wood brackets at the front porch roof, the slate tile at the front porch floor, and the ceramic tile and metal nosing at the front

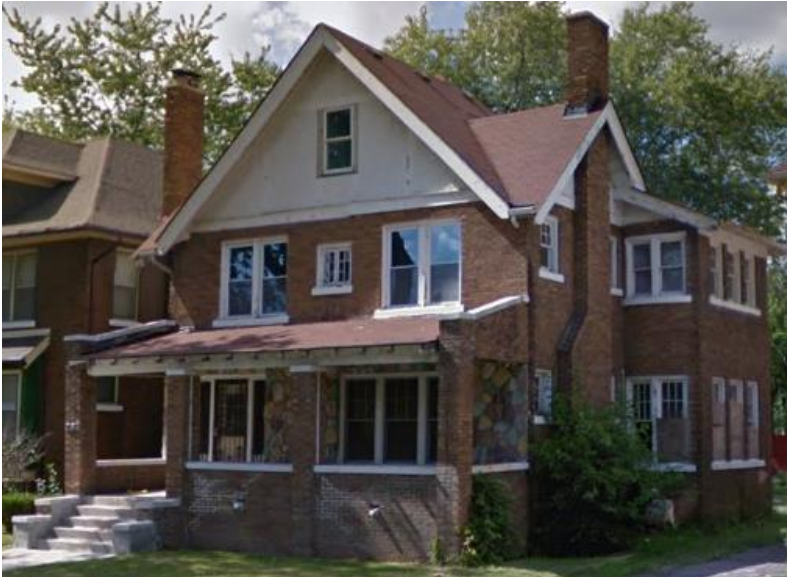
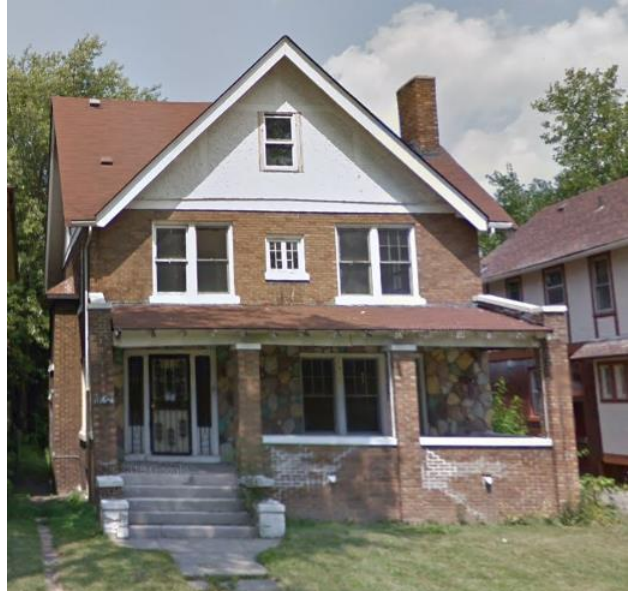
Google Streetview image of 1652 Edison, appearance in 2015 prior to the unapproved work which was undertaken in 2017.

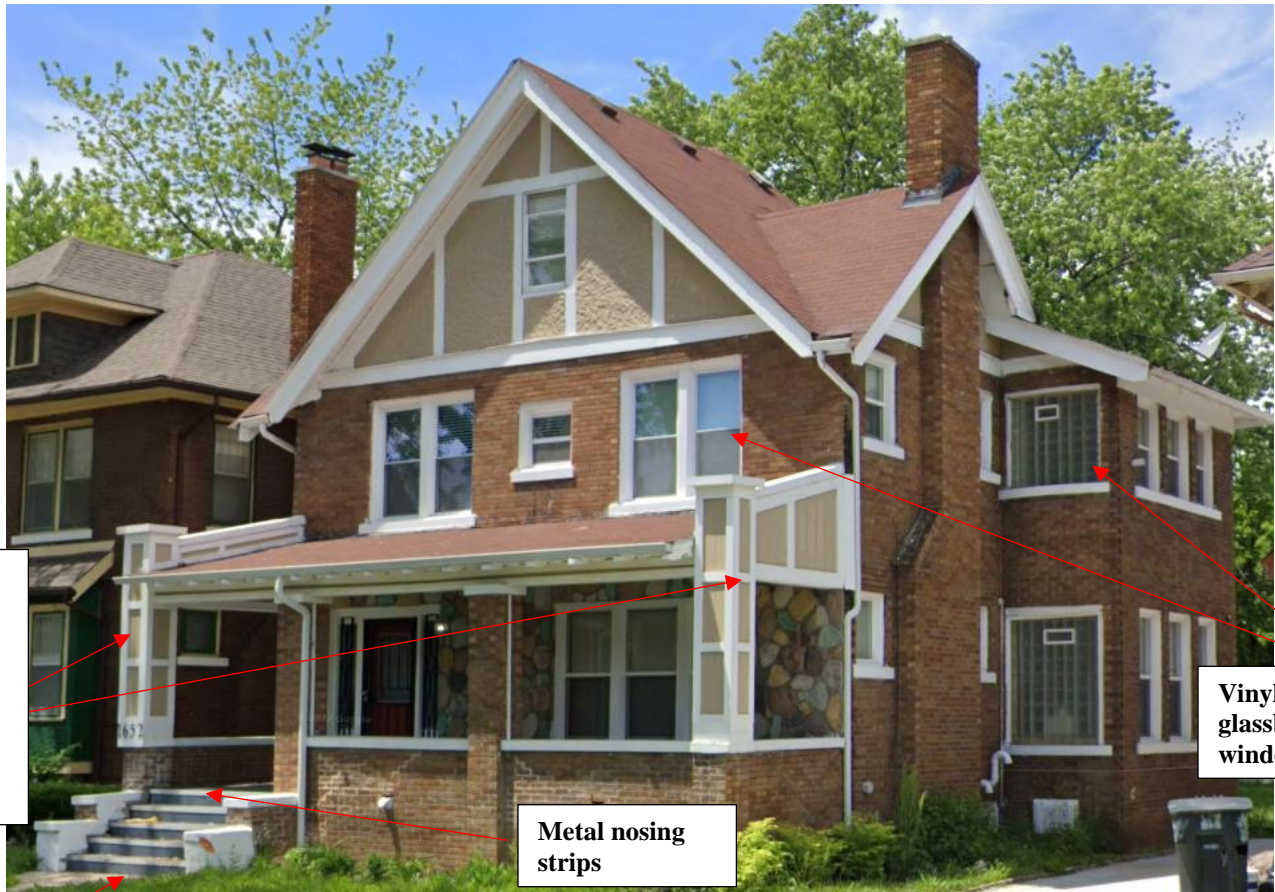
Google Streetview image of 1652 Edison, appearance in 2017 after the unapproved work

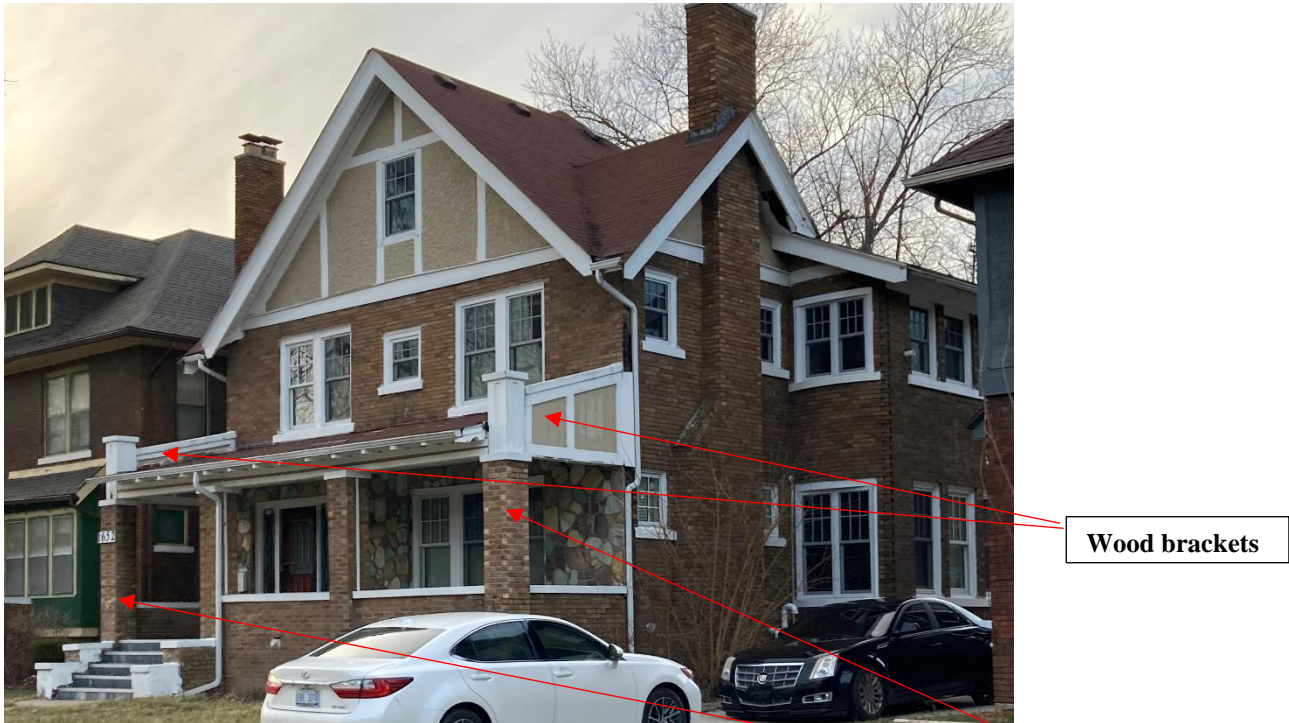
1652 Edison, staff photo showing current appearance. Note that the vinyl windows and glassblock windows were replaced in 2019 with new aluminum clad wood units and the wood has been removed from the corner columns at the front porch. However, note that the unapproved wood brackets above those columns, at the porch roof, and the slate tiles at the porch steps and floor remain.

- It is staff’s opinion that the front porch brick elements which were replaced in 2017 were highly-visible, distinctive character-defining elements of the property. Therefore, according to the Secretary of the Interior Standards, if these elements were deteriorated they should have been repaired. If the elements were deteriorated beyond repair, they should have been replaced in kind/to replicate the original. It is staff’s opinion that the current wood brackets are not an adequate replication of the original brick elements. Staff therefore recommends that the Commission deny this work item. However, please note that staff does recommend that the wood brackets be painted one uniform color to match the building’s trim if the Commission does decide the approve the current wood brackets.

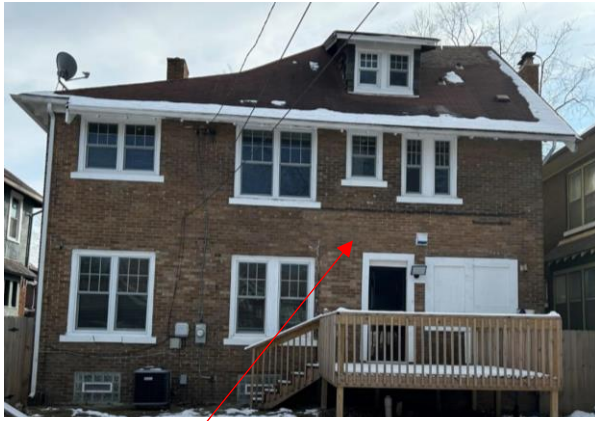
- Per the current application, an enclosed porch at the rear façade's west end was removed without approval during the 2017 rehabilitation. See the below photo which indicates the location of the former porch. A Sanborn Fire Insurance map from 1971 indicates that the porch was added sometime after 1971 and therefore was not historic age. However, note that the current applicant was unable to access a photo/image of the porch.

Rear of 1642 Edison, current appearance. Ghosting indicates the location of former porch (west end) removed in 2017

- Staff does recommend that the plywood door and window infill which was added without COA at the rear elevation be painted a neutral/brown color which in more in keeping with the color of the brick. Also, the new wood rear deck should be painted or stained a color which in in keeping with that found at the home’s trim.

- The plywood door and window infill at the rear elevation shall be painted a neutral/brown color which is in keeping/compatible with the color of the brick.
- The new wood rear deck shall be painted or stained a color which is keeping/compatible with the home's trim color

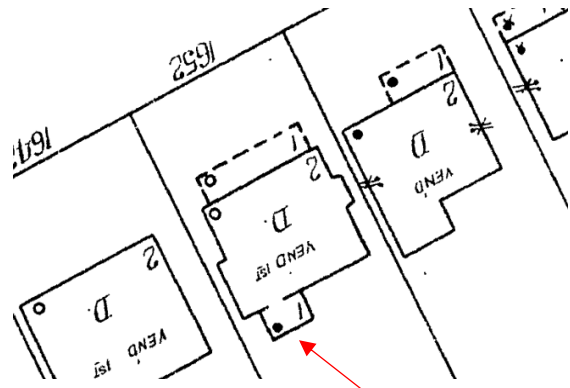
Rear of 1642 Edison, 1971 Sanborn map. Note that the map indicates an enclosed porch on the opposite/east end of the rear elevation vs the porch which was removed in 2017
