STAFF REPORT: MAY 10, 2023 MEETING

APPLICATION NUMBER: 23-8327

ADDRESS: 206 EAST GRAND RIVER AVENUE

SCOPE: RESTORE BUILDING EXTERIOR, REPLACE WINDOWS

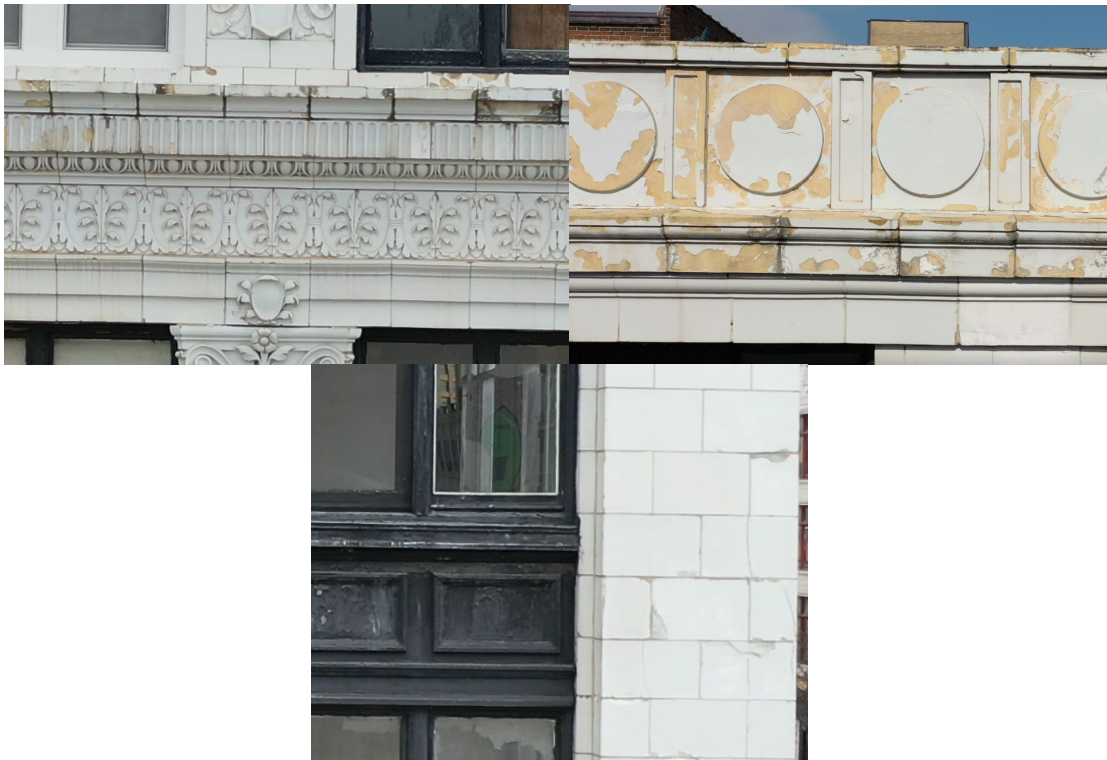
1. **Masonry Restoration:** The brick, terracotta, and exposed concrete will be cleaned using the gentlest means possible in accordance with the National Park Service's Preservation Briefs 1, 2, and 6, and subsequently inspected for damage. Paint will be removed from the brick at the first-floor rear elevations. Spalling concrete at the exposed structural members will be removed and patched. Deteriorated masonry joints will be tuckpointed. Missing or severely damaged brick and terracotta elements will be replaced to match the existing in size, color, texture, and compressive strength.

Figures 4-6: Images of existing masonry conditions provided by the applicant.

- The Broadway Avenue Local Historic District was established in 2005.
- Staff conducted a site visit and was able to observe the deterioration of masonry elements and the fire escape as described in the conditions assessments submitted by the applicant.

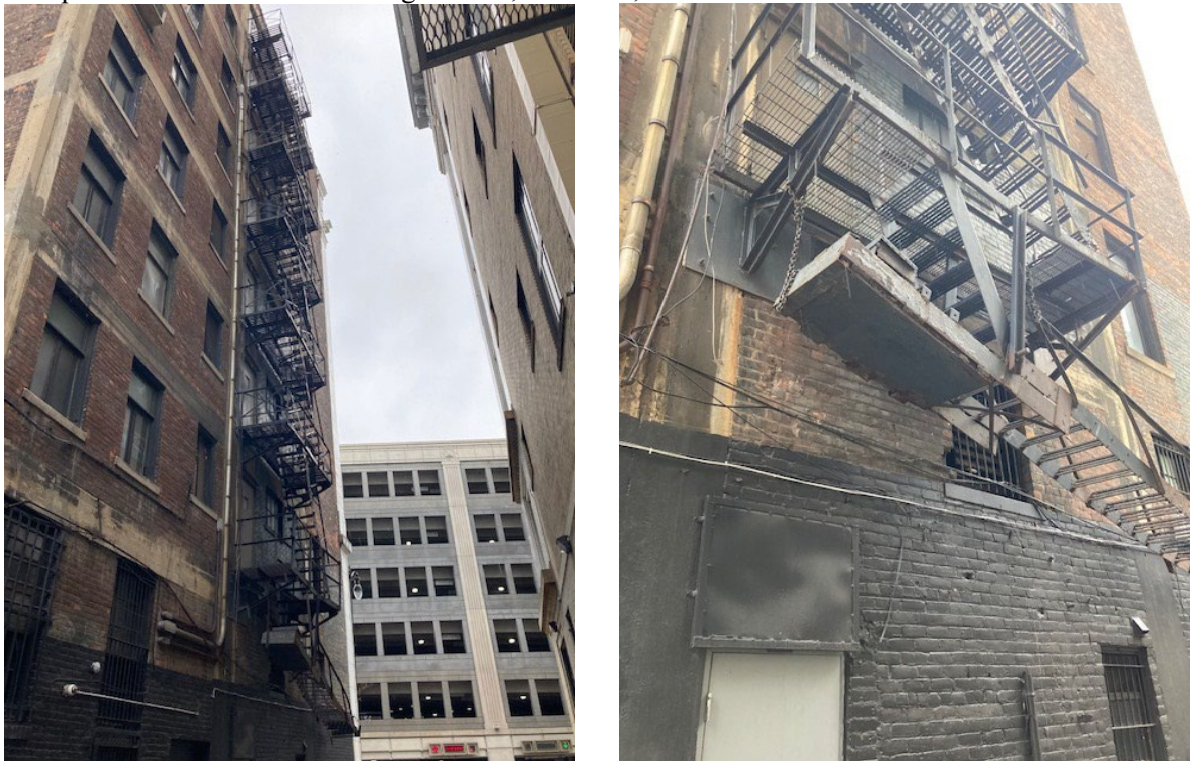
2. Fire Escape: The existing steel fire escape on the eastern elevation is corroded and showing signs of deterioration at its connections with the masonry wall. The fire escape will be removed and replaced with a new fire escape that will match the existing in form, materials, and color.

Figures 7,8: Images showing the existing fire escape.

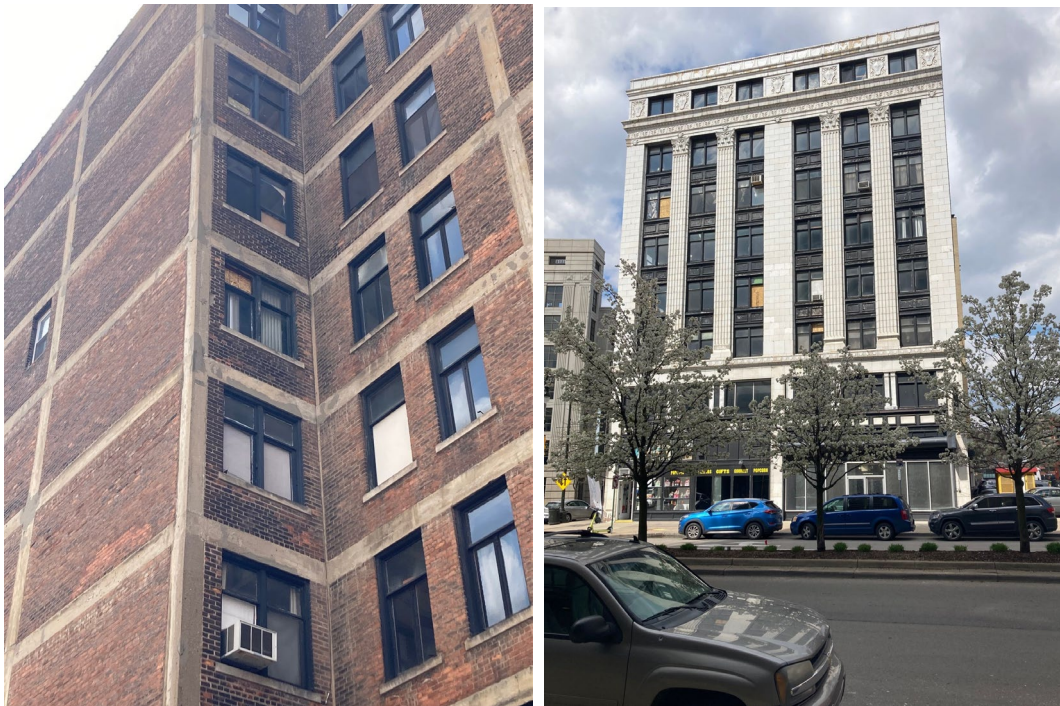
- There are a number of different window types present on the rear elevations including industrial steel sash windows, casement windows divided by a mullion and surmounted by two transoms, and paired casement windows with a shared transom unit and no mullion. The applicant proposes to replace the steel sash windows with fixed aluminum frame windows that feature both between the glass muntins and applied exterior grids that match the existing configurations. The casement windows surmounted by transom windows will be replaced with the double hung units utilized on the facades. A “sightline adapter” is proposed for the casement windows without mullions that will match the width of the existing stiles.

Figures 9,10: Photographs of the existing windows at the rear of the building and west façade.

- The windows on the rear elevations were historically minimally visible from the street due to the presence of intervening structures. It is staff's opinion that the rear windows are not distinctive character defining features of the building, and the proposed aluminum windows are appropriate replacements at these elevations.

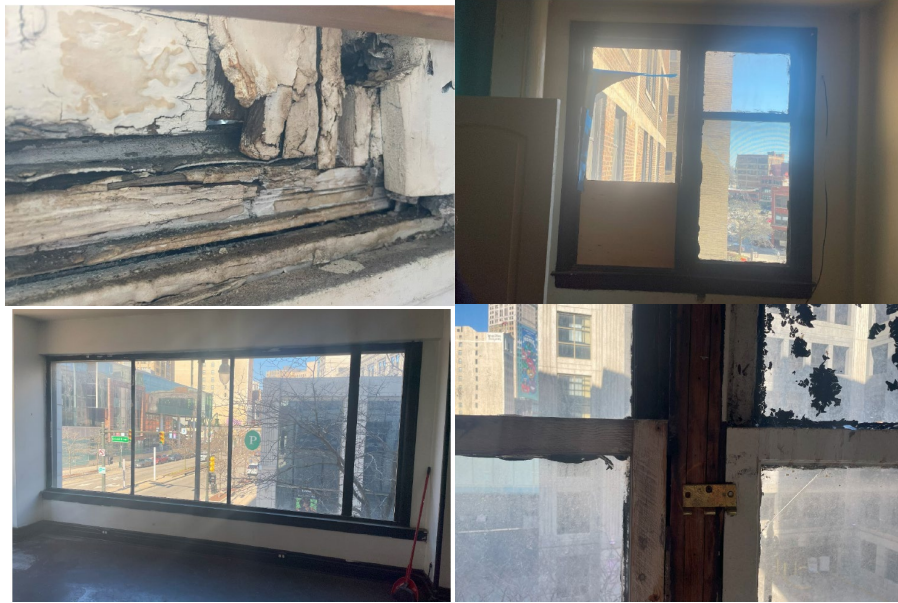
- In addition to the documentation provided in the application materials, staff site visits confirmed that many of the window sash members are exhibiting advanced deterioration, and that numerous windows have been removed or heavily altered over the course of the 20th century. Many of these alterations are related to the installation of window air-conditioning units. It is staff’s opinion that existing conditions merit consideration of historically appropriate replacement windows.

Figures 11-14: Images of existing window conditions at the interior provided by the applicant.
