**STAFF REPORT: MAY 10, 2023 MEETING**

**APPLICATION NUMBER: 23-8331**

**ADDRESS: 4071 LESLIE**

**SCOPE: REPLACE ORIGINAL WINDOWS WITH WOOD ALUMINUM-CLAD WINDOWS**

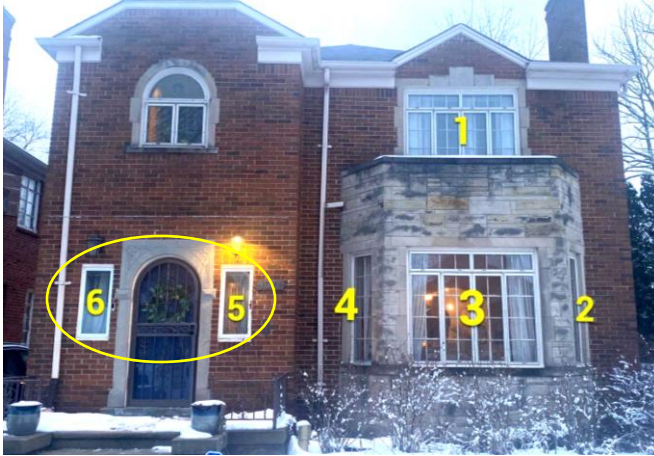
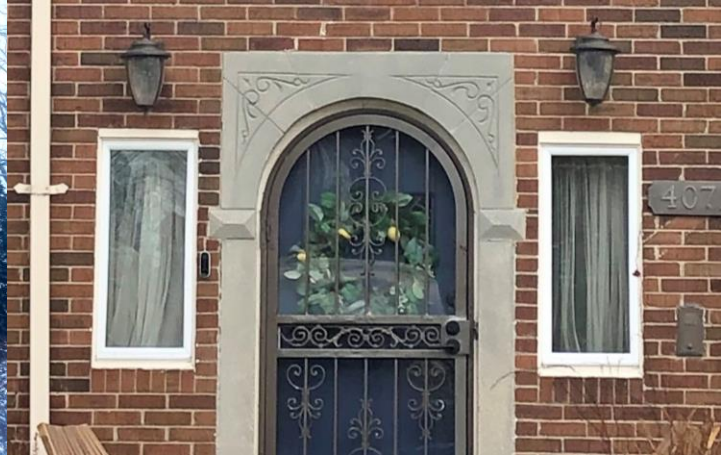
Front elevation – Window #5 and #6 – casement/fixed replacement units

Staff finds that the proposal to replace non-historic windows and one severely altered original window to be appropriate as the new units will be compatible with the historic casement units while being differentiated from the historic sash, and therefore meets the Secretary of the Interior’s Standards and the Russell Woods-Sullivan Historic District’s Elements of Design.

- The cladding color of the replacement windows shall match the sash color of the historic units. This can be achieved by 1) painting the historic sash brown or 2) selecting another cladding color that matches the existing paint color of the historic window sash.

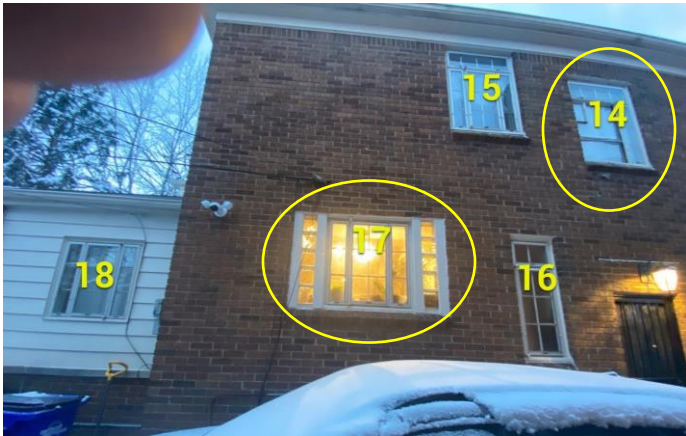
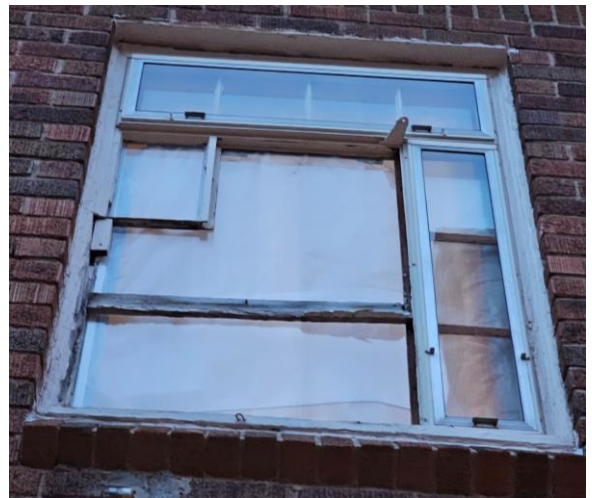
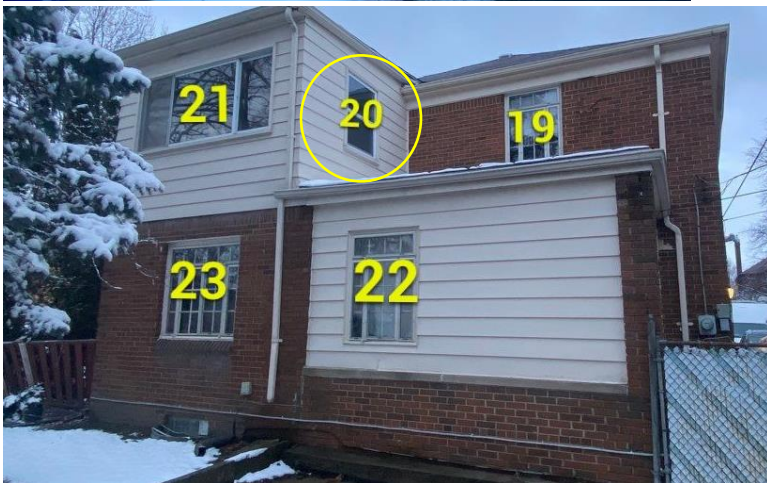
East/side elevation – Window #14 – severely altered original unit, #17 – glass block in sidelights, #20 – double-hung replacement unit

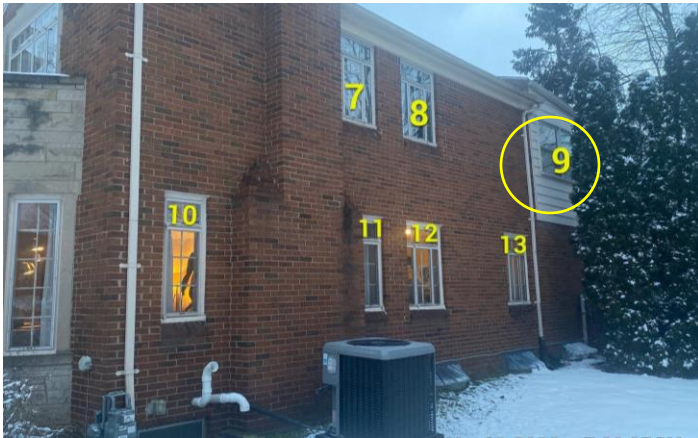
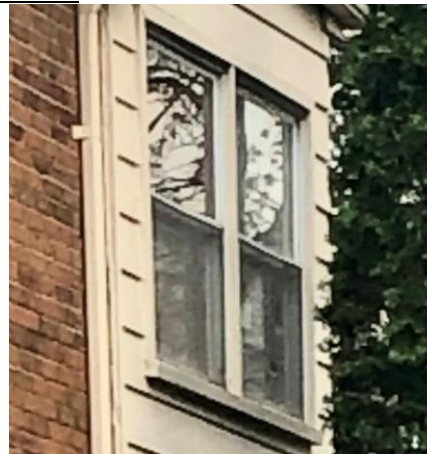
West/side elevation – Window #9 – double-hung replacement units

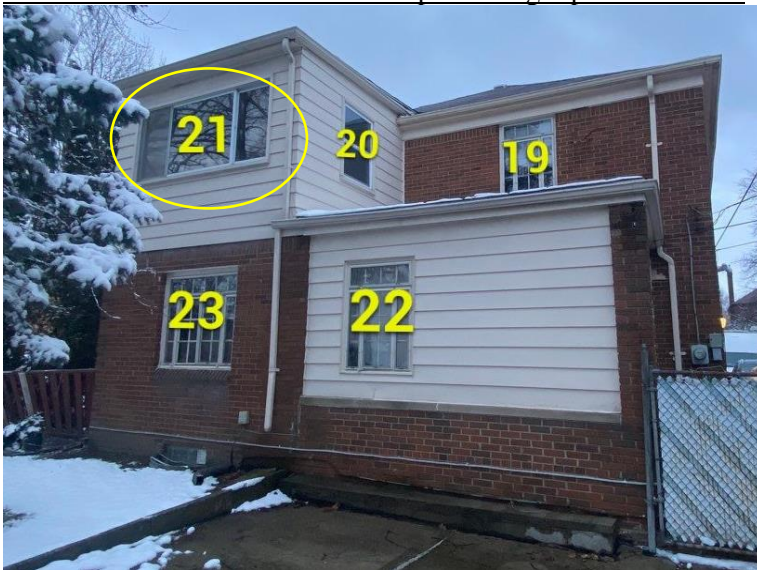
Rear elevation – Window # 21 – triple sliding replacement unit

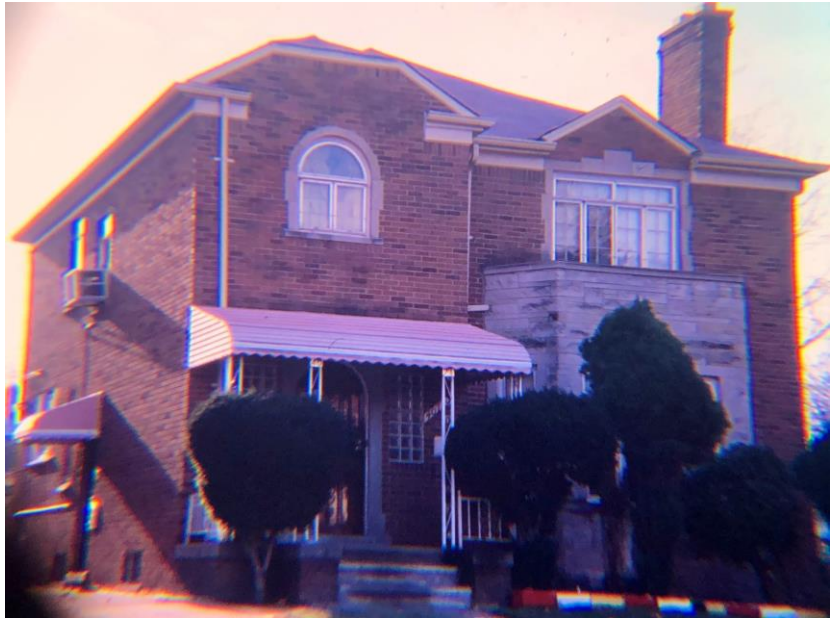
1999 district designation photo, Historic Designation Advisory Board.

- Glass block was in place adjacent to the front door; this was not an original condition. Staff has no visual confirmation of the original window design.
- An a/c unit is in the second floor window on the east elevation. This gives substantiation as to why the existing window was so heavily altered.
- The metal awning and supporting iron posts that were installed in 1967 are evident. The only remaining visual clue of this installation is a thin horizontal white paint line above the front door and windows.

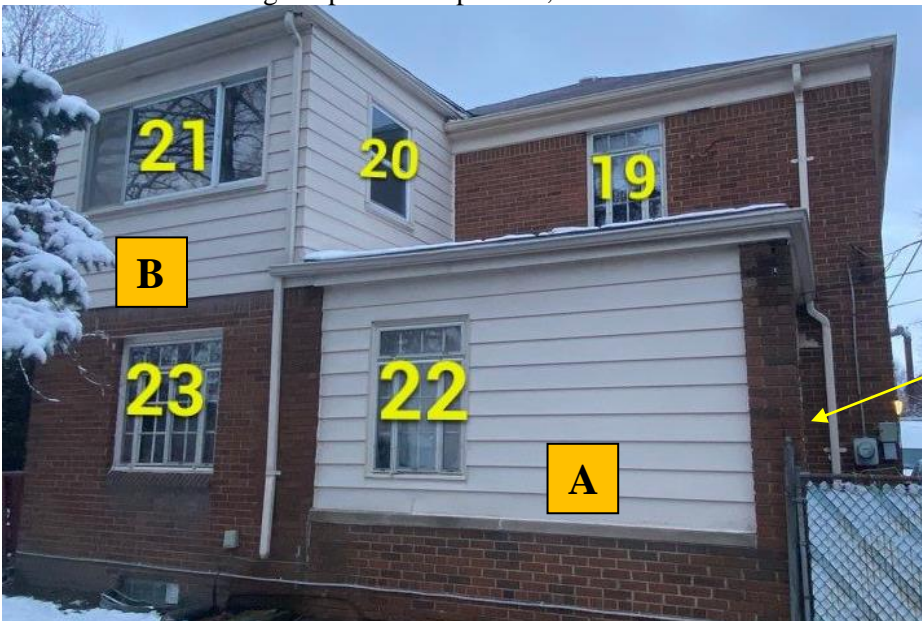
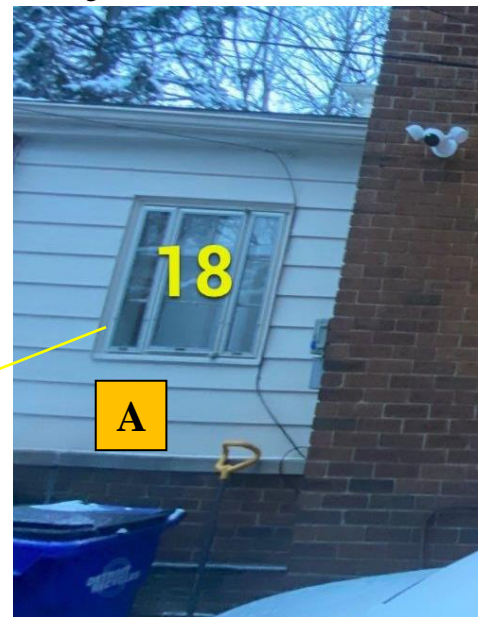
- The rear porch was converted to a bedroom in 1948 (A). This could explain why the windows within that enclosure (#22, #18) match the windows on the house, as only seven years had passed since the house’s initial construction.

- The 1967 sun porch at the second floor (B) has been enclosed. Due to its late 60’s construction (and/or later enclosure), it is understandable that the windows are different material and operation than those of the earlier enclosure and the main house. Staff doesn’t have pictures of the rear elevation prior to this application, so the existing conditions at time of designation can’t be confirmed. However, due to the 1999 designation date (as opposed to much earlier districts), it is possible the current enclosure and windows were in place at the time of designation. Therefore, it is staff’s opinion that the upper story rear windows are not historically or architecturally significant and can be replaced (with HDC approval). The windows at the first floor enclosure, however, are historic and do require assessment of condition and reparability prior to considering a replacement product, similar to the windows on the remaining elevations of the house.

Applicant photos. “A” is the area of the 1947 porch enclosure; “B” is the area of the 1967 sun porch and subsequent full enclosure.

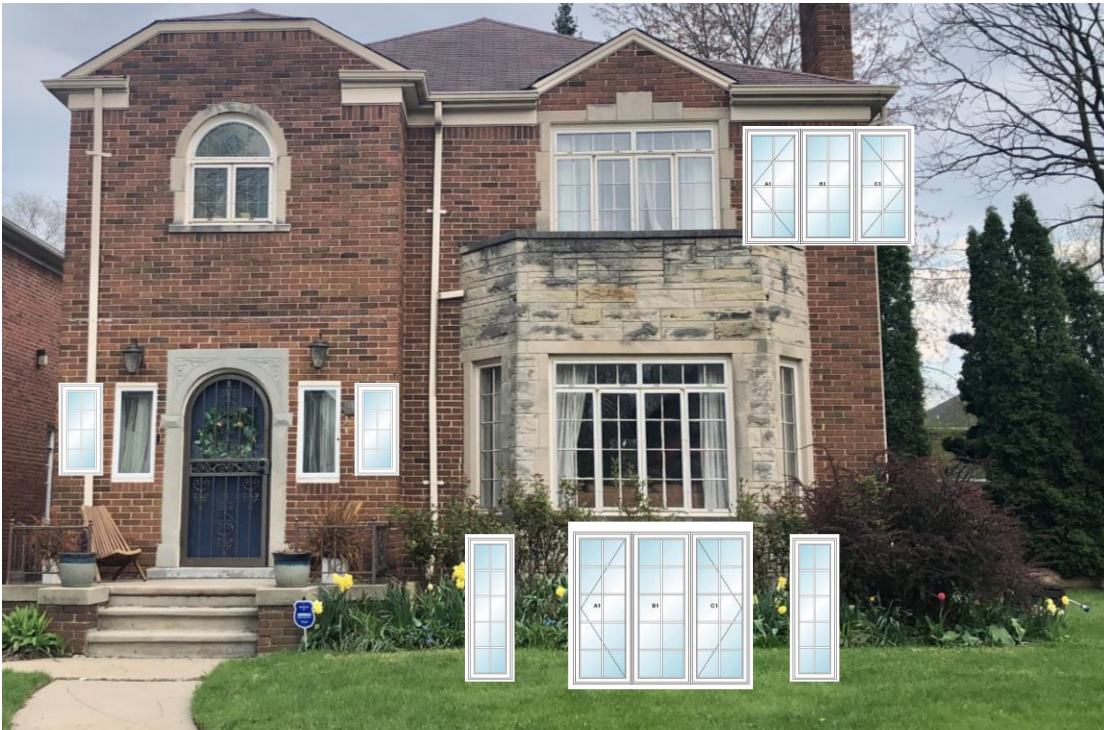
FRONT ELEVATION

*Staff photo, April 26, 2023. The rough opening width of the first and second floor openings are the same; the upper windows are approximately 12” shorter in height. The single casement side windows in the first floor bay would mimic the operation and design of the existing windows, whereas the other openings change operation and appearance.*

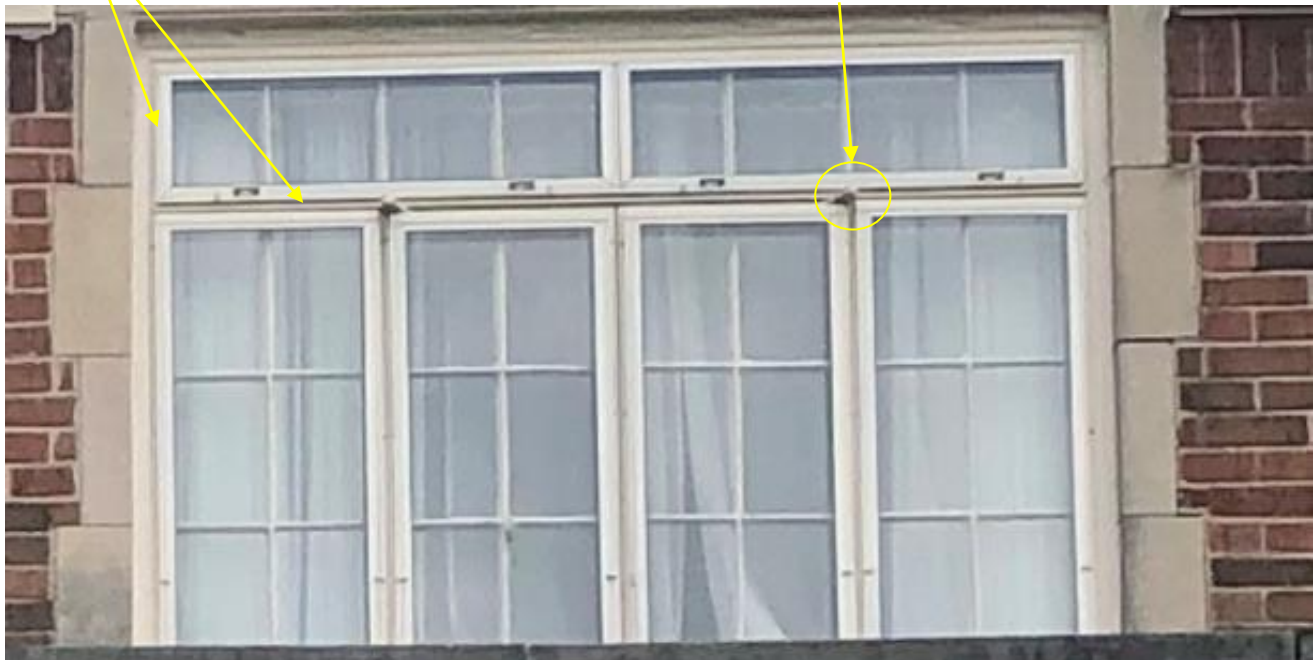
- The existing historic windows are steel, which means the frames, muntins, and mullions are exceptionally thin due to the inherent strength of steel. This is a distinctive character-defining feature of these windows, and important to the property and the district. The outfacing hinges of the casement units offer an additional dimensionality to the openings and identification of material and sash age.

Staff therefore recommends that the Commission issue a Denial for the work as proposed, as it does not meet the district’s Elements of Design #3 as well as the Secretary of the Interior’s Standards for Rehabilitation, specifically Standards 2, 5, 6, and 9:
