STAFF REPORT: 6/14/2023 REGULAR MEETING

APPLICATION NUMBER: #23-8396

ADDRESS: 2405 BURNS

SCOPE: REPLACE VINYL WITH WOOD WINDOWS; REPLACE FENCE; REMOVE PAINT; REPAIR CHIMNEY, PORCH STEPS, AND FRONT WALKWAY (WORK COMPLETED WITHOUT APPROVAL)

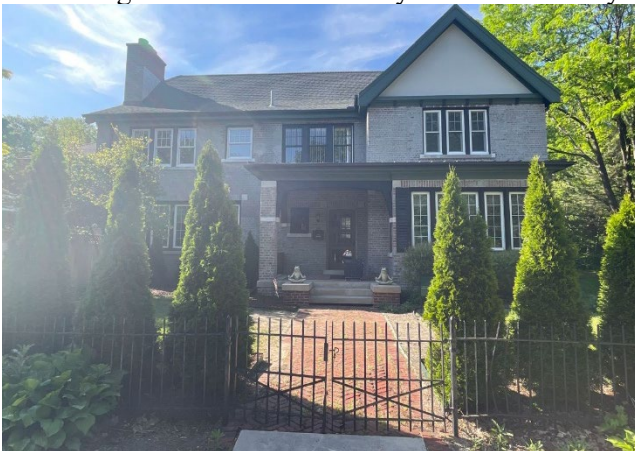
Site Photo 1, by Staff May 24, 2023: (Southeast) front elevation, showing vinyl windows from a previous owner and some wood windows.

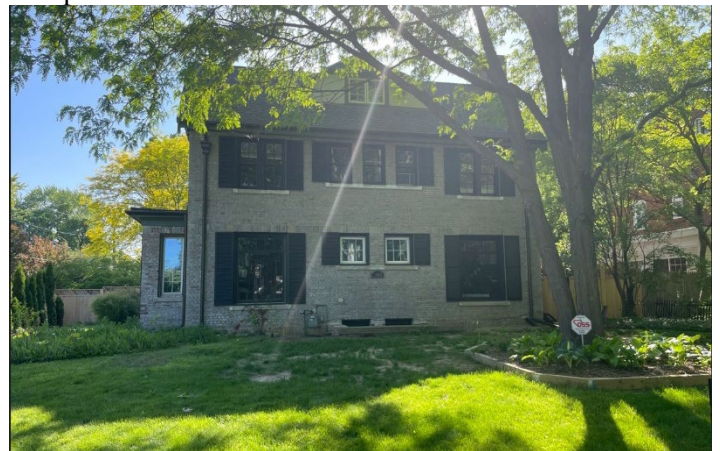
Site Photo 2, by Staff May 24, 2023: (Northeast) side elevation, showing three white vinyl windows that were previously installed by a former owner and replaced by current owner before June 5, 2023. The other windows were replaced by the current owner, replacing vinyl windows.

- The same observation for windows #3 and #6 also applies to newly installed window #7, and its pairing (between windows #16 & #17) on the opposite side of the bay. This appears to be a newly constructed, fixed picture window. Similar to the concerns raised previously, it appears that the intention is to continue this pattern across the front elevation of the house, windows #16. (See site photo #5, and figures 1&2). The applicant states that no work was being done on window #7 in their application, but this window, and windows #4 & #5 and the one next to #16 facing the porch, were replaced during the application process. (See Site photos 2&5).

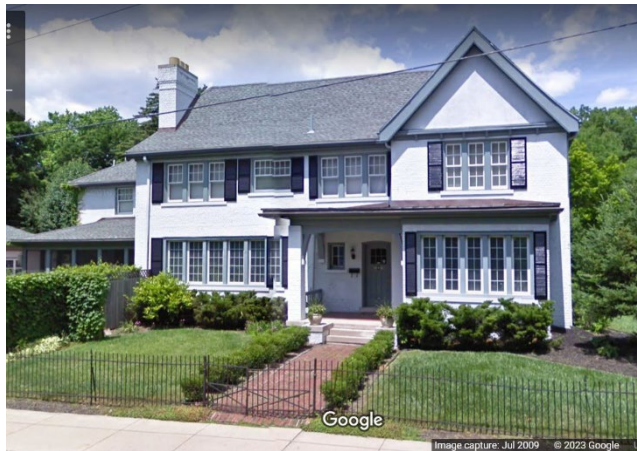
Site Photo 3, by Google Streetview, July 2009: (Southeast) front elevation, showing original and vinyl windows (by previous owner), painted brick, and original front door.

- The designation slides of both 1975 and 1980 show that the Southeast and Northeast elevations had some windows replaced, particularly on the first floor. It is not clear their material, but they have been since replaced with vinyl windows, which was done before 2009. (See site photos 3 & 4).

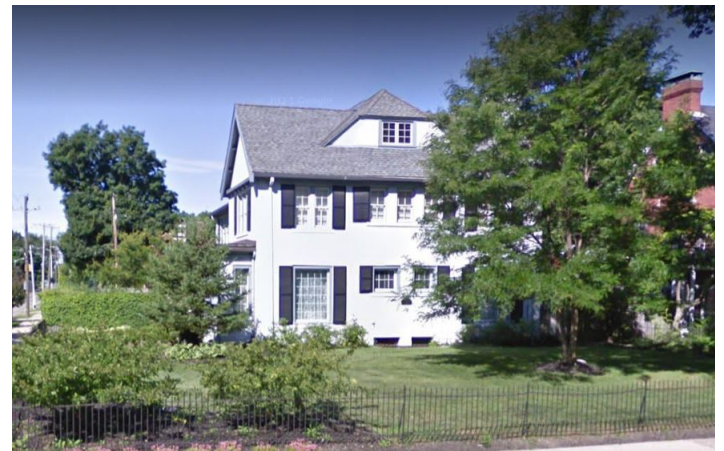
Site Photo 4, by Google Streetview, July 2009: (Northeast) side elevation, showing original and vinyl windows (by previous owner), and painted brick.

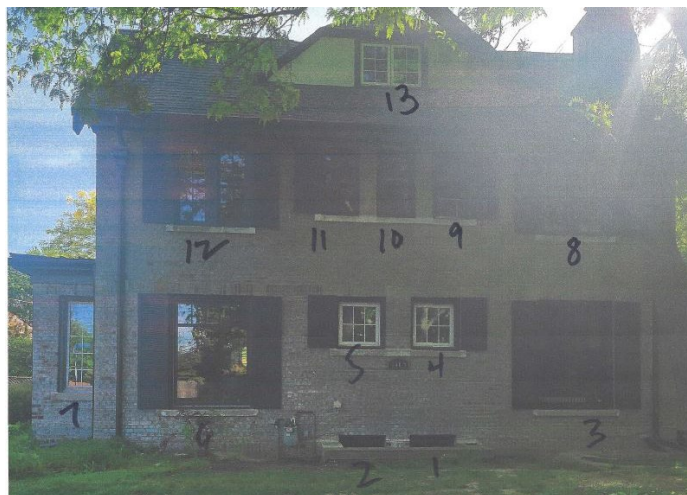
- Some windows do not appear to be restored original windows, while others may be. For example, the applicant states the two picture windows of the first floor, southeast elevation (ie. windows 3&6) were "found in the garage, stripped, repaired, and reglazed" to replace the vinyl windows that were present. These windows, in staff's observation, appear to be newly constructed wood windows with modern insulated glass. They are of a design, operation and configuration that do not appear to be historic. The designation slides and other preceding images do not show the original windows either. Because at these window locations the configuration of the windows is unknown, staff has the opinion that the application shows *incompatible* solutions because they do not meet the following minimum conditions:

Figure 1, by Applicant: (Northeast) side elevation, picture windows #3 and #6, and replaced vinyl window #7.

- The operation of the windows are fixed, rather than double hung, and do not provide ventilation, which would be a distinctive historic function of these windows.
- The design language of this house has ribbons of double hung windows in sets of at least two with muntins to divide the individual sashes. These picture windows introduce a new scale and design that is not likely to occur for this type of architecture.
- The configuration of the picture window conveys a new style that calls attention to itself rather than blending in and being compatible with the 6/1 or 4/1 configuration of the adjacent original wood windows.

- The configuration of the divided light does not match the 4/1 or 6/1 pattern of the other original windows.
 - The absence of a muntin between two windows to create a single picture window for windows #3 & #6 breaks up the continuity of the window pattern, particularly with how the muntins would like align tie the first and second floors together.

- The newly constructed windows at the front and side elevations of the house are not compatible with historic architecture in the house in that they:
 - introduce a new operation, configuration, design and scale,

- and destroy the distinctive, character-defining features of the relationship to the original remaining windows, particularly the muntins and ribbon series of windows of the house.

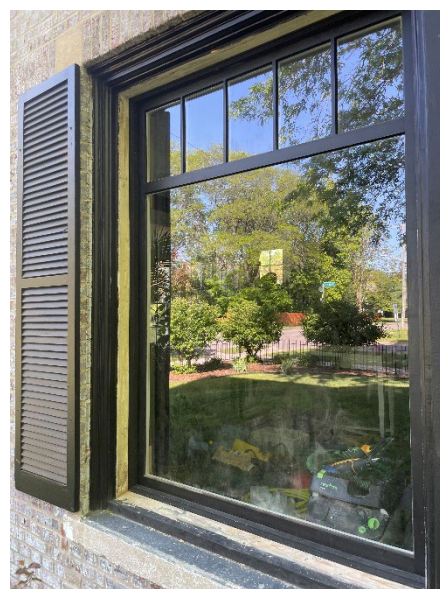
Site Photo 5, by Staff May 24, 2023: (Northeast) side elevation, detail of window #6 showing what appears to be a newly constructed wood window.

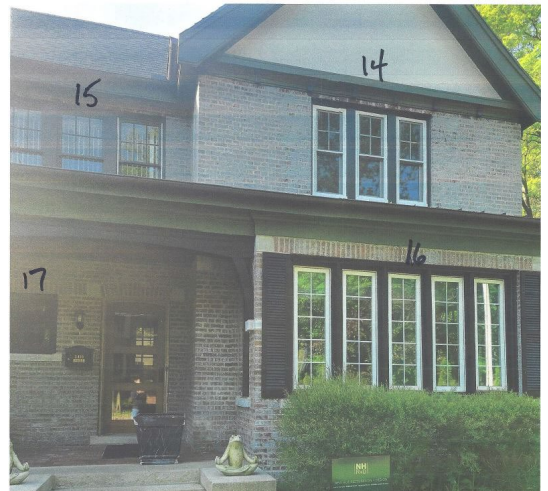
Figure 2, by Applicant: (Southeast) front elevation, showing existing vinyl windows #16.

- As work continued through the application process, staff has the concern that the practice of newly constructed windows, instead of true repair of existing windows, are continuing to proceed to other locations, such as windows #7 and #16, which is the set at the front elevation, one of which has also been replaced.

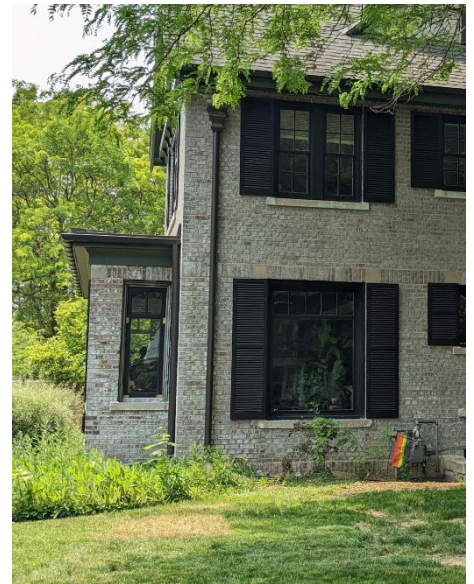
Site Photo 5, by Staff June 5, 2023: (Northeast) side elevation, detail of window #7 showing what appears to be a newly constructed wood window.

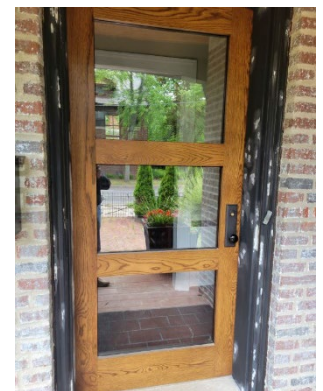
- Staff observed that the new front door is different from the original design in the following ways:
 - The 6 divided light glass top portion and wood paneling below, is replaced with 3 large picture windows.

- The wood is naturally stained instead of painted.

Site Photo 5, by Applicant 2023: (Southeast) front elevation, showing newly installed front door

- The design of this new door, in staff’s opinion, introduces a new scale for the windows of the door, while taking away the direct relationship of the divided light, smaller windows that matched the original windows.

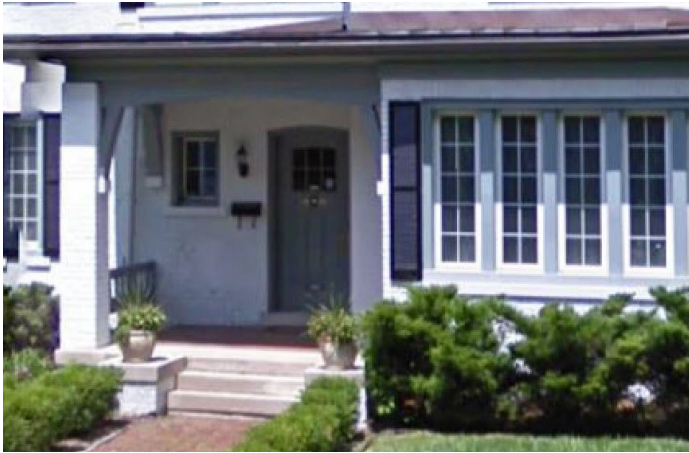
- Staff requested photos of the original front door but did not receive them and therefore have not been able to determine if the conditions were irreparable. (See site photos 6&7).

Site Photo 6, by Googles streetview July 2009: (Southeast) front elevation, showing original front door.

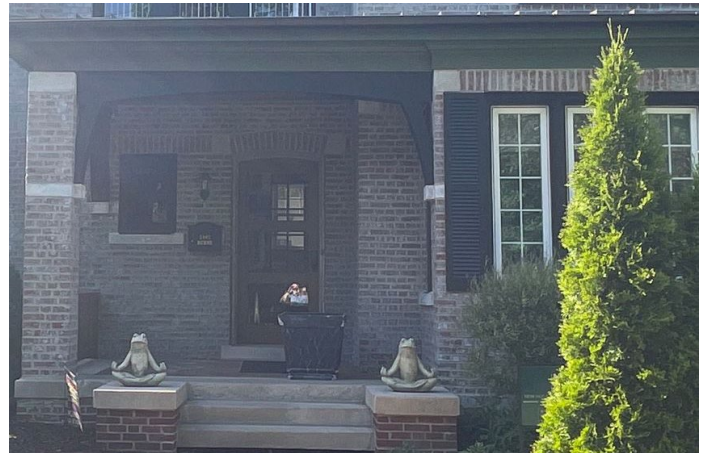
Site Photo 7, by Staff May 25, 2023: (Southeast) front elevation, showing new front door (work completed without approval).

- The newly constructed front door replaced the wood paneling by introducing glazing that is not in scale with the house, thereby destroying the relationship between the door and windows which shared the same scale and configuration of divided light, which are historic character defining features of the building.

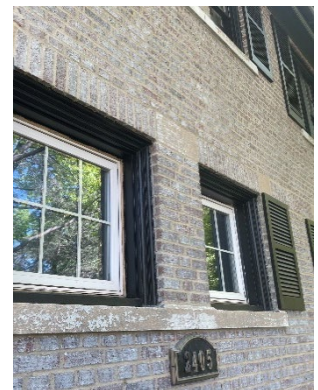
- Although the application states that no chemicals were used and that power washing was done in a careful manner, staff observed that the brick still has a considerable amount of paint remaining, giving the appearance of a washed rather than a natural brick color look.
- Staff also observed that the brick appears to have an abraded surface which may or may not have been caused by the paint removal process. Staff observed that because the house was already painted at the time of designation, a repainting of the brick with an appropriated paint would likely have been the best approach to preserve the brick.
- It is staff’s opinion that the architecture of the house would best use Color System D for trim and sash colors. The already painted trim and sash are appropriate colors.

Site Photo 8, by Staff, May 24, 2023: (Northeast) side elevation, showing removed paint surface from brick and

- Staff have concerns that the brick surface of the house may be exposed to greater damage due to the abrasion that may have occurred during the paint removal process. It is staff's opinion that a note from a professional to assess whether the brick should be repainted to restore protection is required.

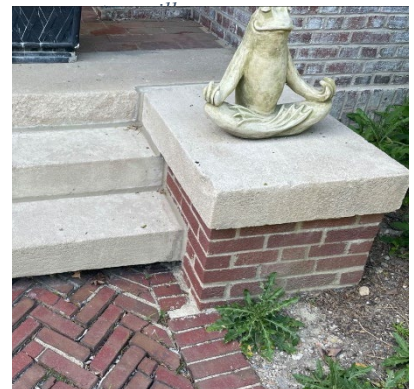
- Staff observed that both the windows and the window well at the northeast, side elevation are appropriate.
- Staff has no issues with the tuck-pointing of the brick work around the house and chimneys.
- Staff observed that the newly reconstructed brick wing-walls of the front porch do not match closely to the brick of the house due to the surface type of the brick and the “wash” effect of the removed paint from the house. The brick does match in scale and color to the front walkway. While the applicant states that some of the original brick was reused in the wingwalls, it appears that that all of the brick is new. (See site photo 9)

Site Photo 9, by Staff, May 24, 2023: (Southeast) front elevation, showing front porch steps and wing-walls.
