**STAFF REPORT: AUGUST 9, 2023 MEETING**

**APPLICATION NUMBER: 23-8404**

**ADDRESS: 8022 KERCHEVAL**

**SCOPE: WINDOW REPLACEMENT ON SIDE AND REAR ELEVATIONS**

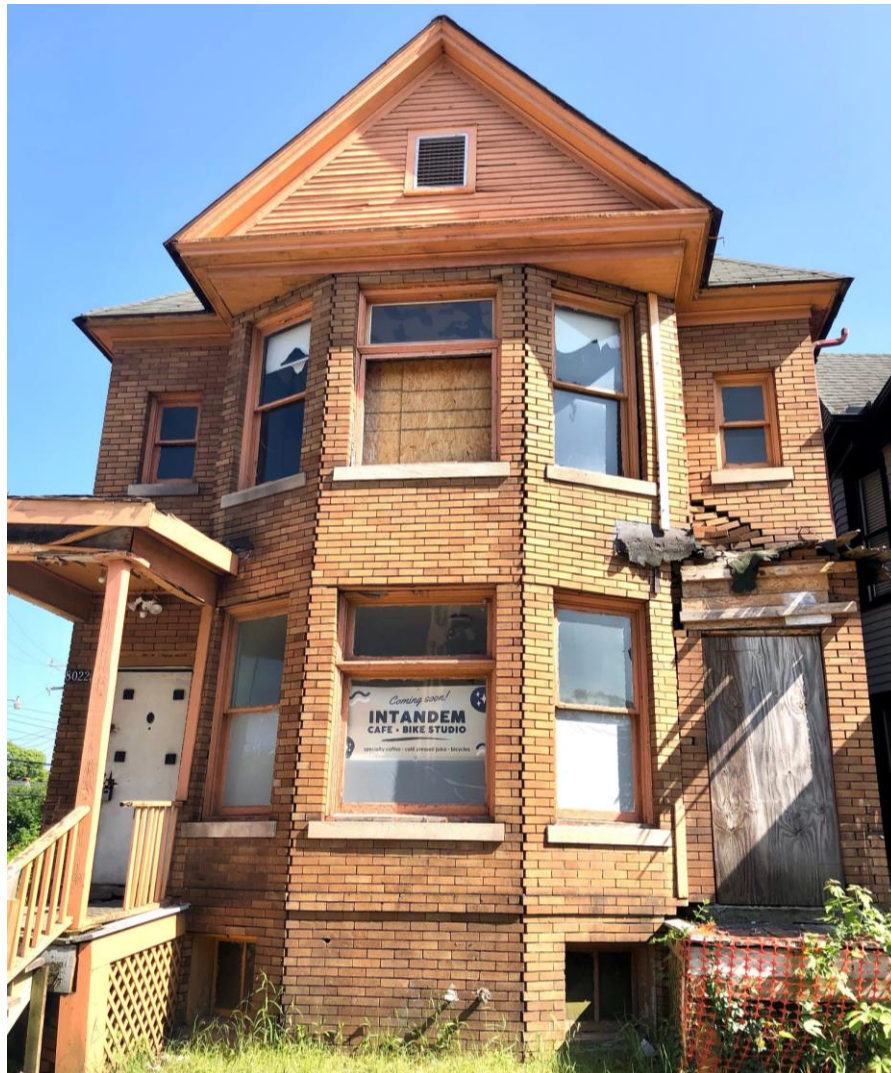
*Front elevation. Staff photo, May 30, 2023.*

- A new window is planned for the third-floor front gable, replacing a vent. A window was in this location at the time of designation.
- *The lower sash of the second-floor fixed bay window is missing.*
- Remaining window sash are proposed to be repaired.

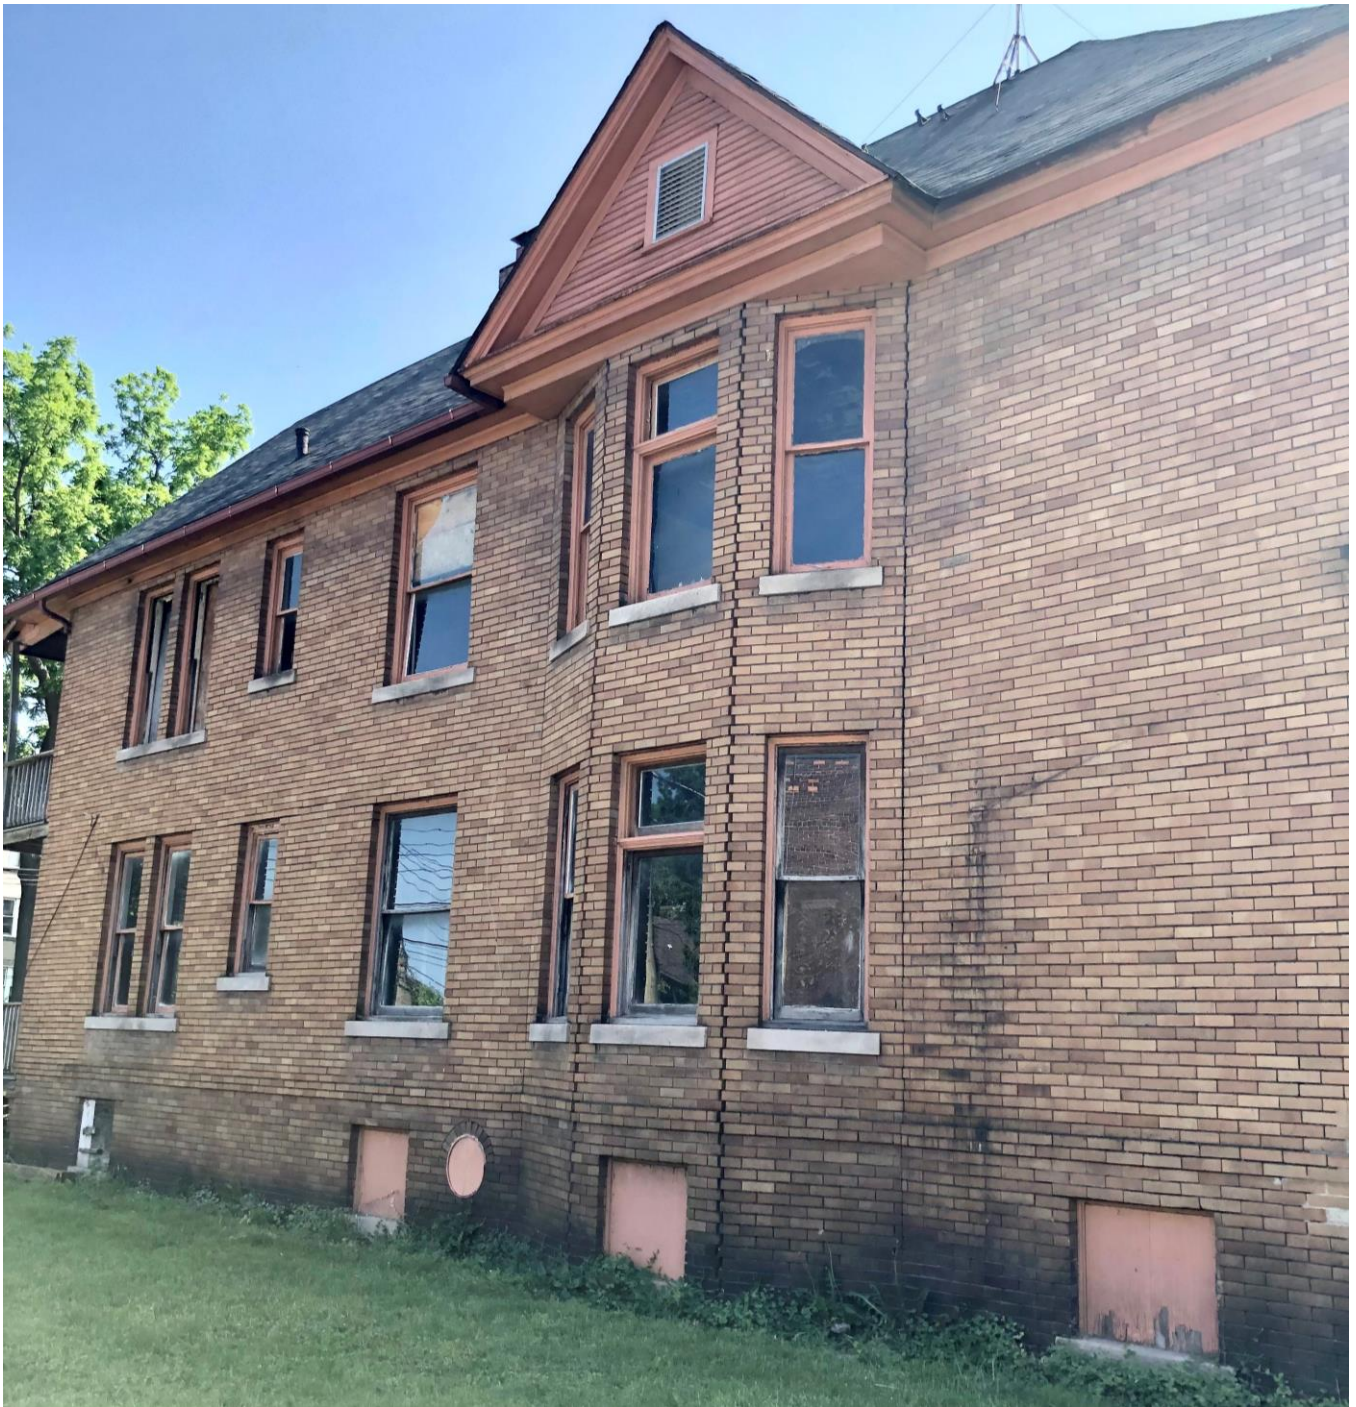
*East elevation. Staff photo, May 30, 2023.*

The two-story bay element was repeated on the east-side elevation, is fully visible due to the demolition of the previously adjacent structures. The window openings on the structure retain wood sash and stone sills, however glass in a lower sash is occasionally missing. The dominant operation and pattern on the structure is one-over-one double-hung; the middle bay windows are transom over picture window, with a 1/3 to 2/3 division of openings. The raised basement allows for tall, almost square above-grade window openings and have stone sills; the basement windows are boarded over.

- *The two double-hung openings at the second floor, near the rear wall, are missing windows.*
- Applicant proposes to replace all the windows on this wall.

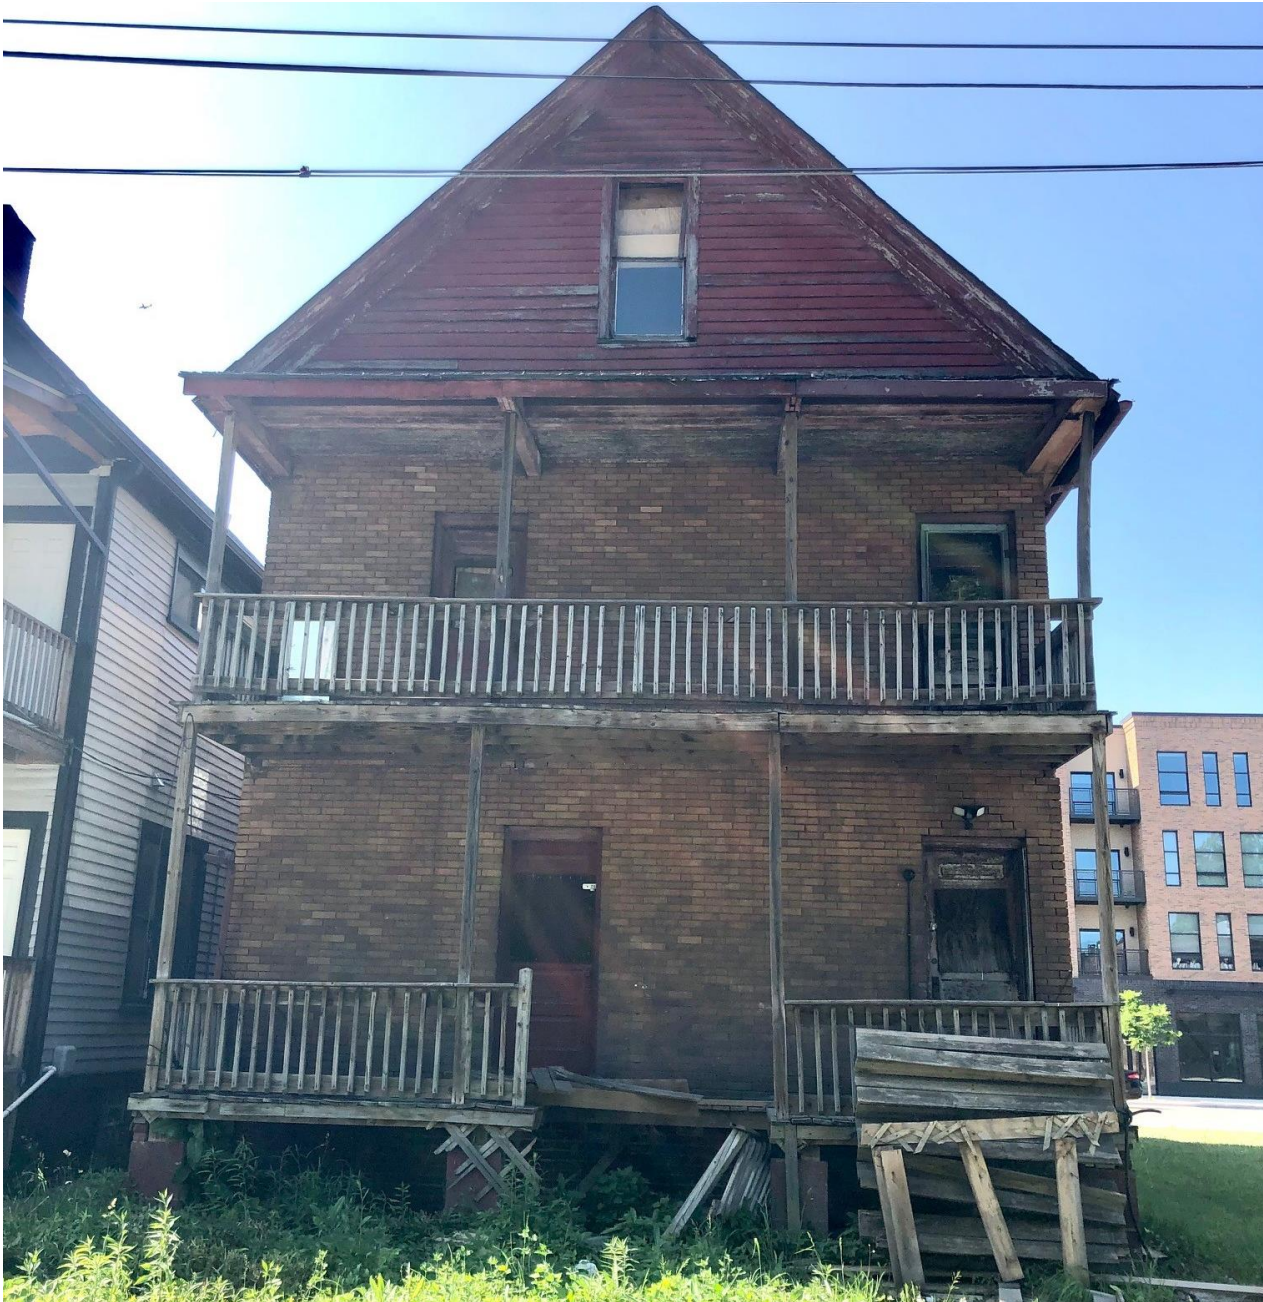
Wood porches and a gable extend across the rear elevation. Although much larger in size, the gable matches the design of those at the front and east side elevation. A wood double-hung window with wood sill is centrally placed, whereas the front and side gables have centrally placed vents.

*Rear elevation. Staff photo, May 30, 2023.*

- The elevation includes two window openings; one new opening and one historic opening in the gable (which is proposed for replacement).

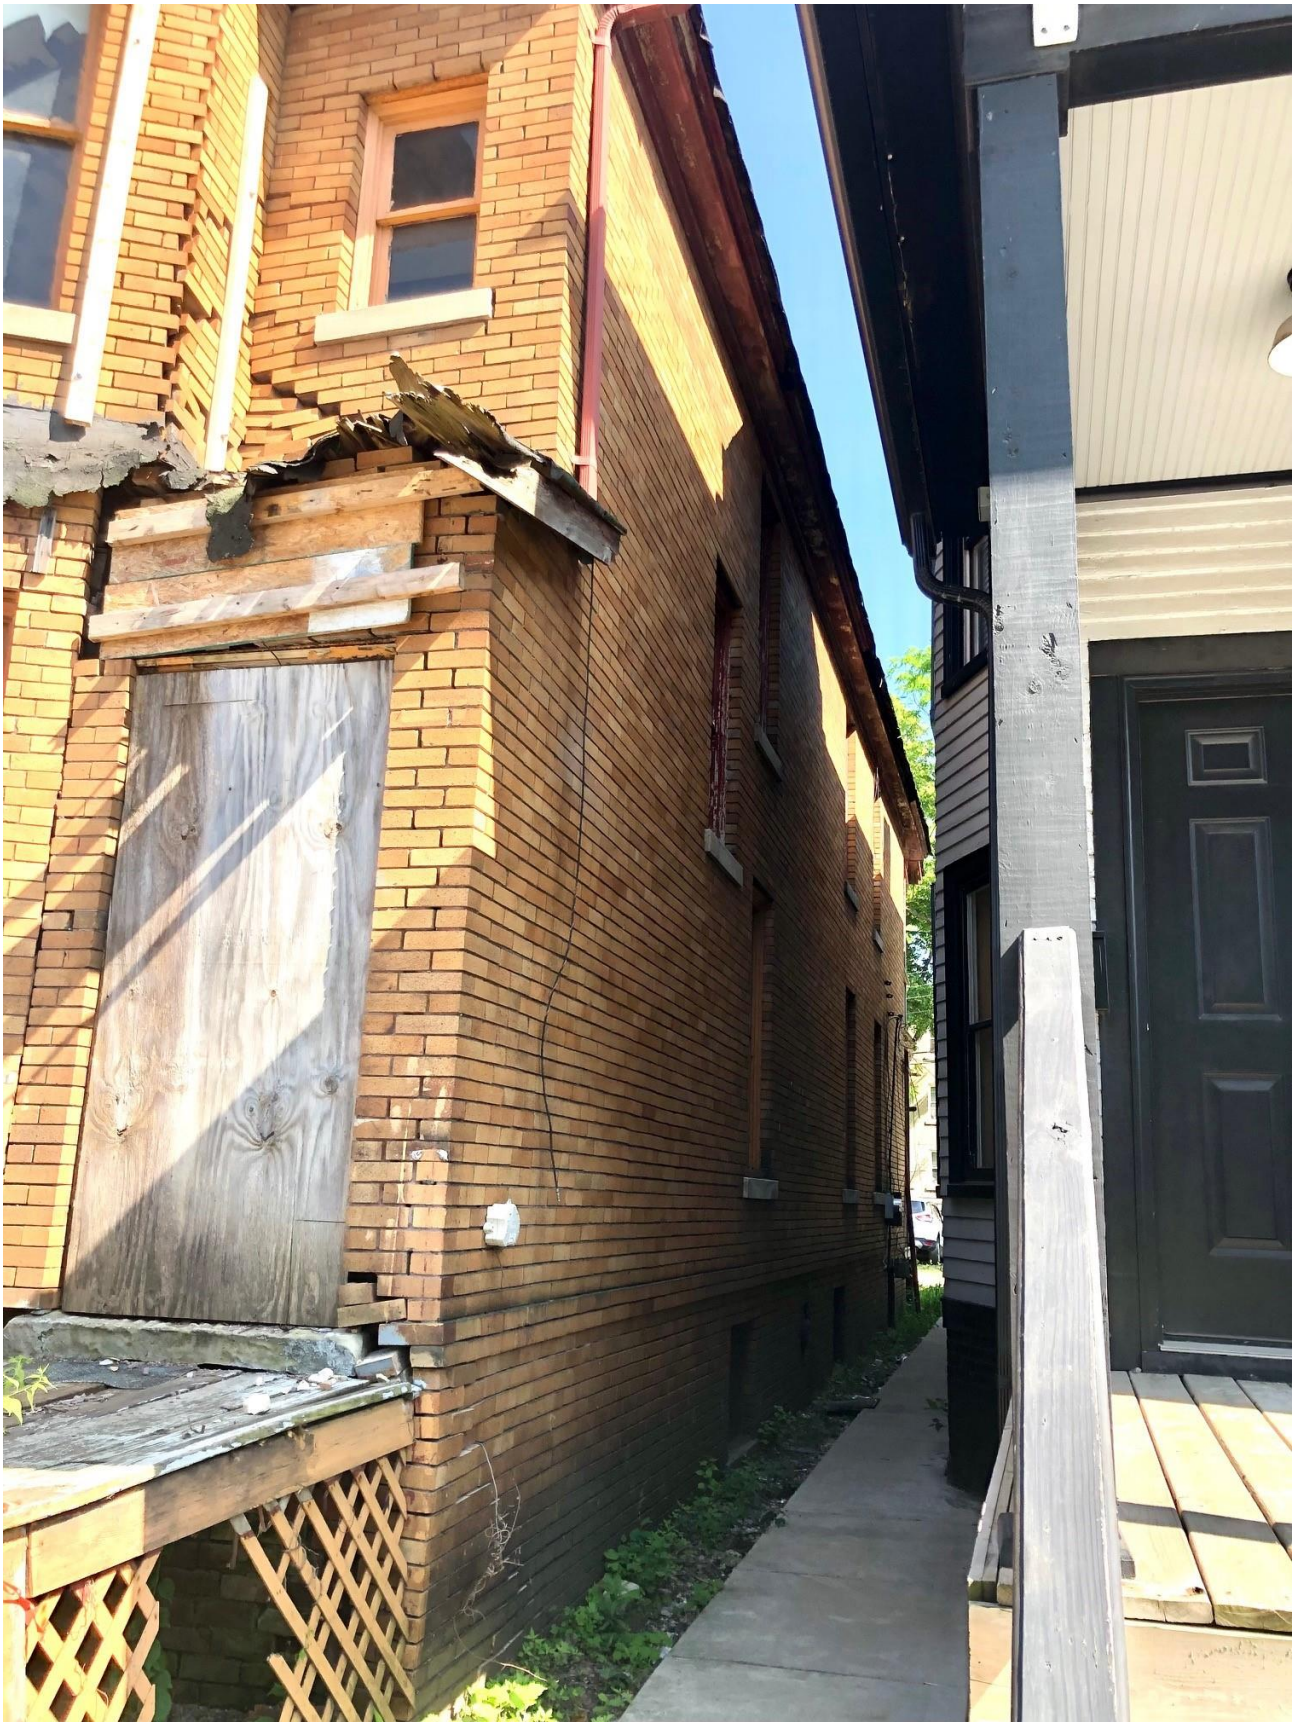
*West elevation, looking south toward alley from Kercheval sidewalk. Staff photo, May 30, 2023.*

- The window openings are minimally visible from the right-of-way- due to the proximity of the adjacent property.
- *The window openings at the second floor are each missing the lower sash.*
- The applicant intends to retain and repair the window sash in the opening that is halfway between the first and second floor.
- The first-floor window opening closest to Kercheval is intended to be bricked-in; the specification calls for brick to be placed flush with the exterior masonry wall.

- Should the west elevation window be infilled, then the brick should be recessed slightly (approximately one inch) from the exterior edge of the masonry wall so that a shadow line of the existing opening remains within this wall.

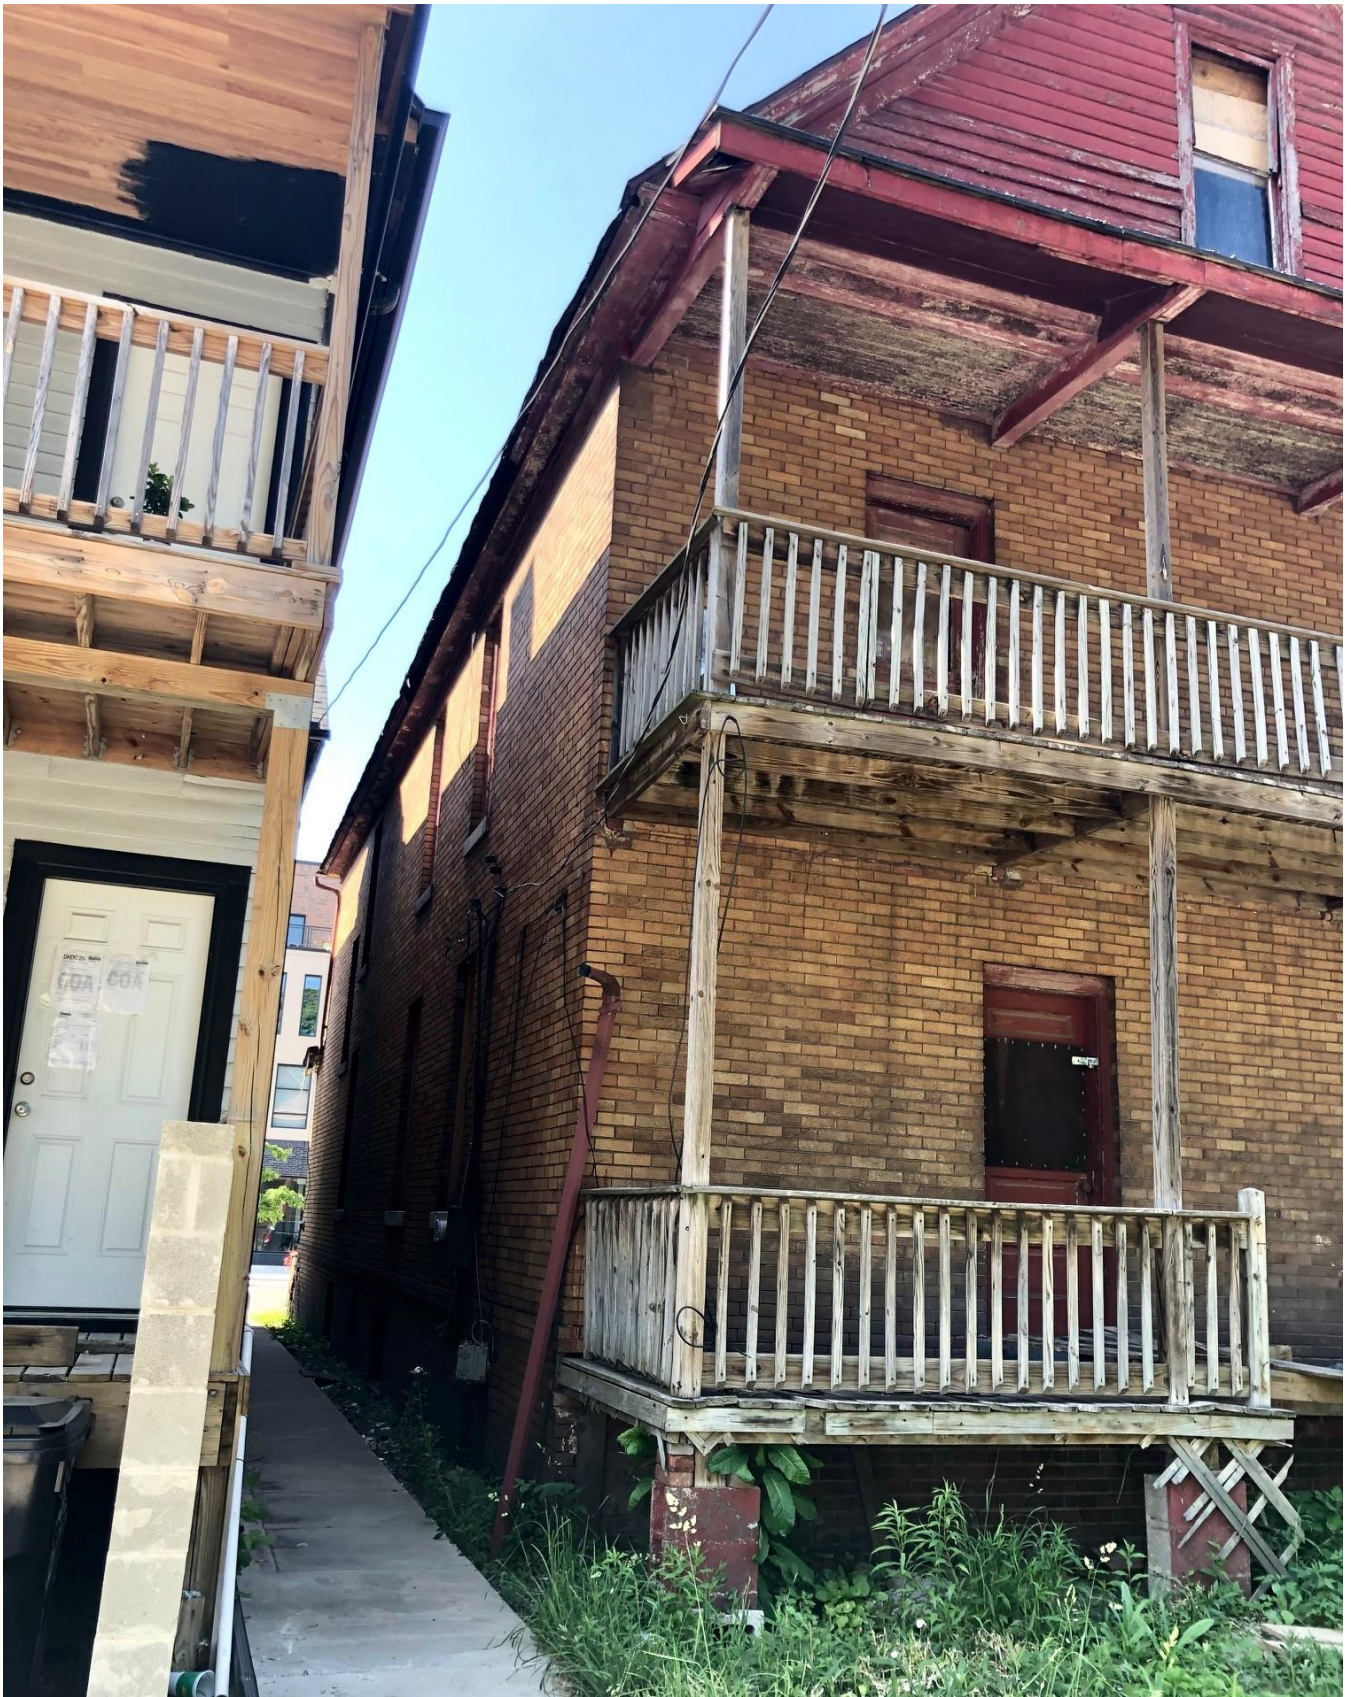
West elevation, looking north towards Kercheval from alley. Staff photo, May 30, 2023.
