**STAFF REPORT: OCTOBER 11, 2023 MEETING**

**APPLICATION NUMBER: HDC2023-00055**

**ADDRESS: 9120 DWIGHT**

**SCOPE: REPLACE WOOD WINDOWS WITH COMPOSITE WINDOWS**

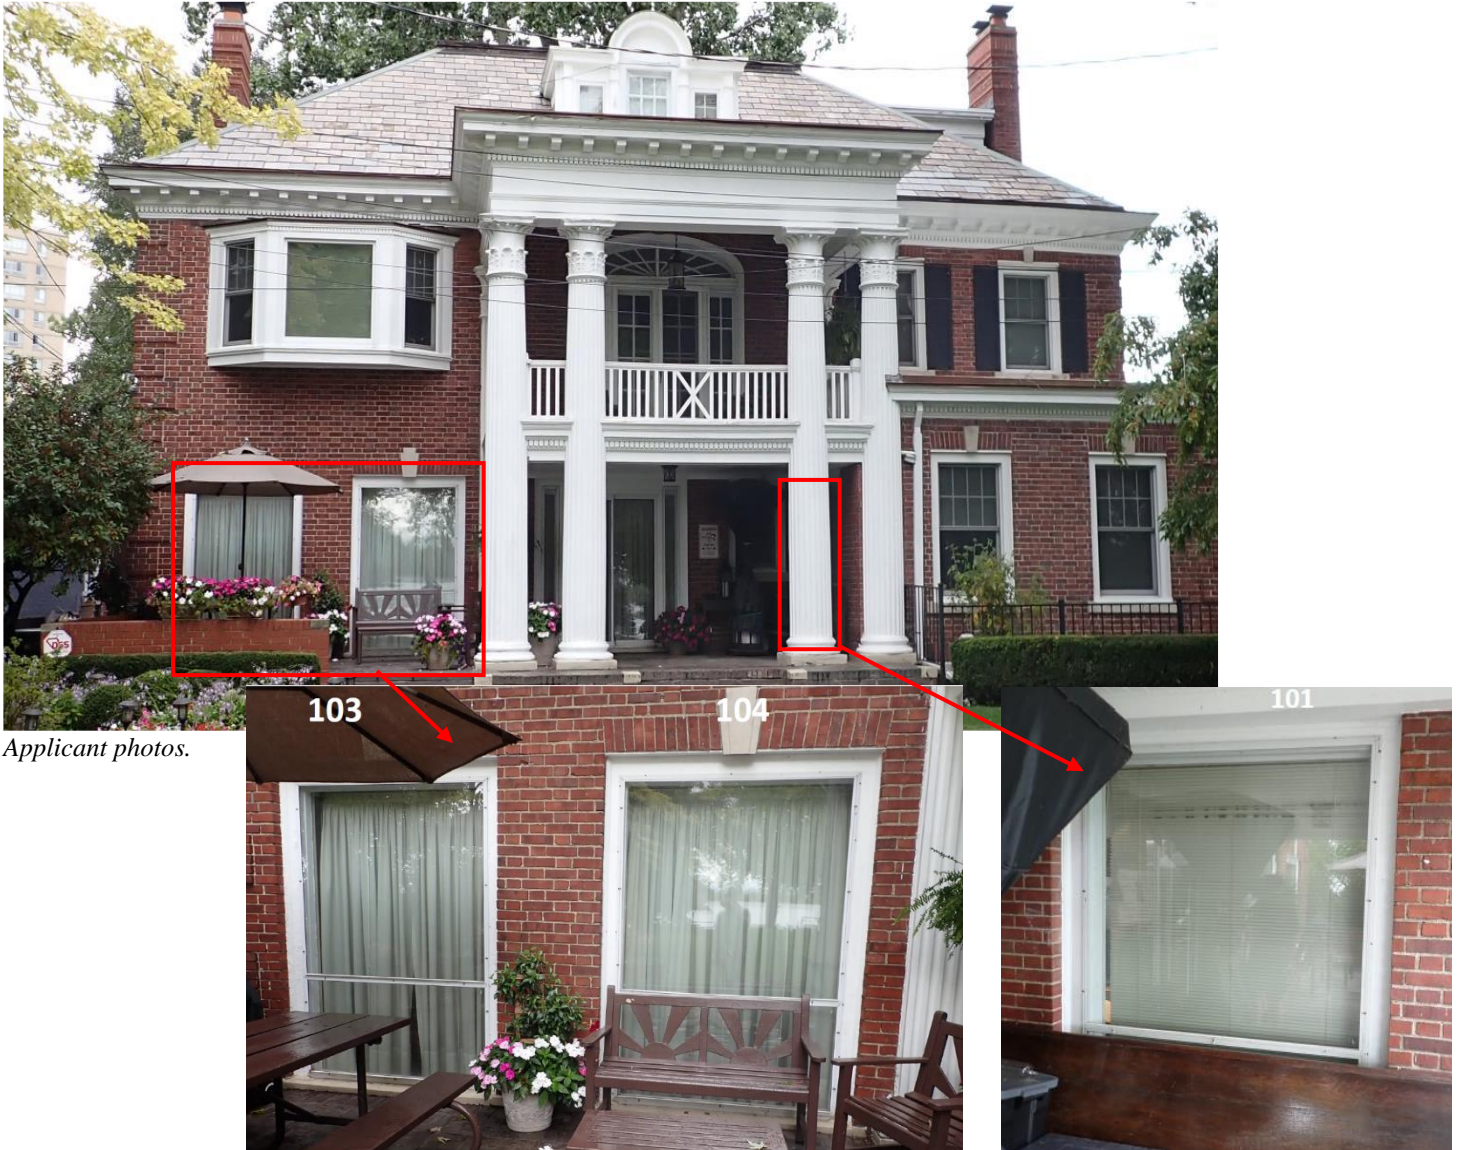
- It is staff's opinion that the large openings at the first floor rear elevation likely had French doors that led to the rear yard patio, but there is no visual confirmation on what had been in these openings. The current fixed glass windows are not historic nor character-defining features of the property.

Applicant photos.

- The submitted photos show the third-floor window sash as intact and protected behind storm windows. Documentation to substantiate that the existing dormer windows are beyond repair wasn't submitted, which could include a detailed repair estimate provided by a window repair company.

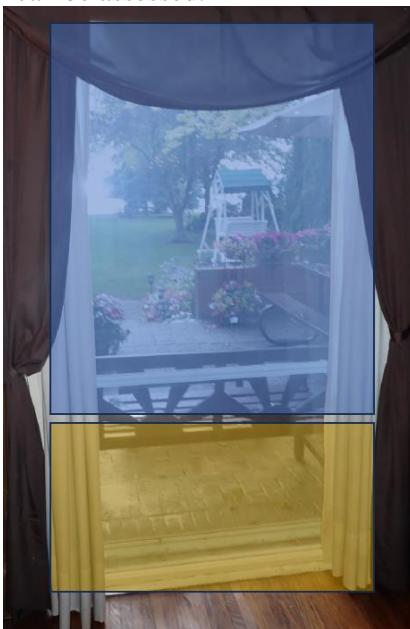
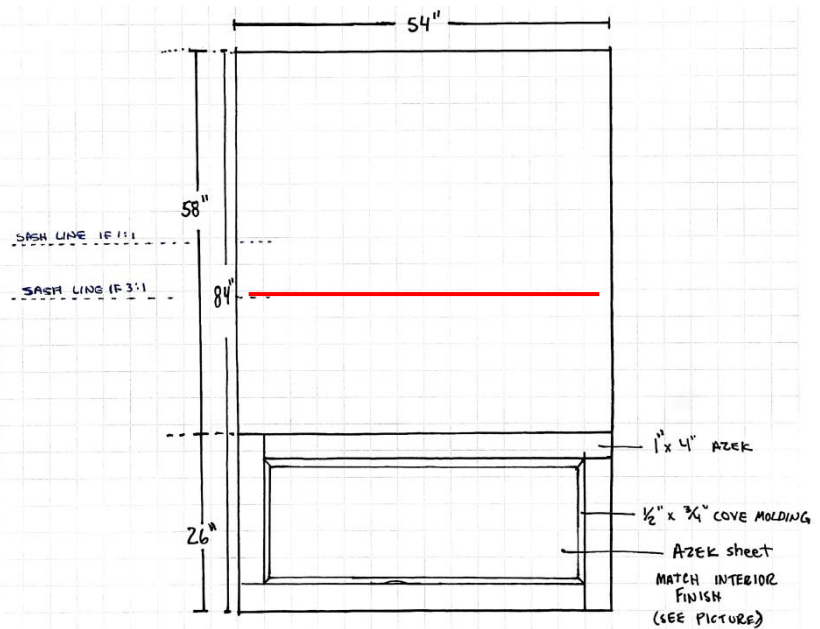
- Staff received clarification that the exterior lower wall will receive the paneling design as shown below, which mimics the paneling in place on the interior walls. Staff asked for a more detailed mock-up to show the cottage window in place so its proportionality, in contrast to a double-hung window, can be assessed.

Applicant photo and drawing. The trim detail for the lower wall panel will be the exterior treatment below the window.

- A dimensioned drawing that clearly shows how the reverse cottage-style window will look within the newly sized opening, as well as clarification over the exterior detailing of the lower wall, will be submitted to staff for review.
- Should staff determine the reverse cottage-style window is not appropriate for these windows openings, a standard double-hung window (no grid pattern in the upper or lower sash) will be selected.

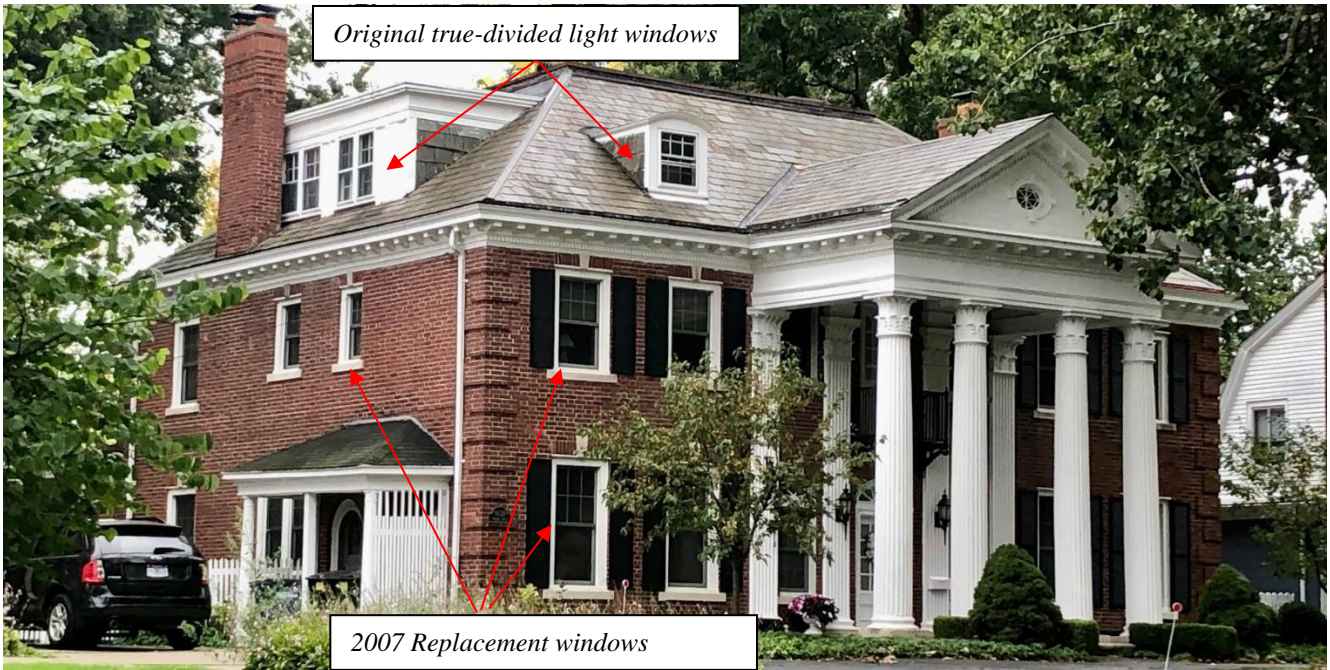
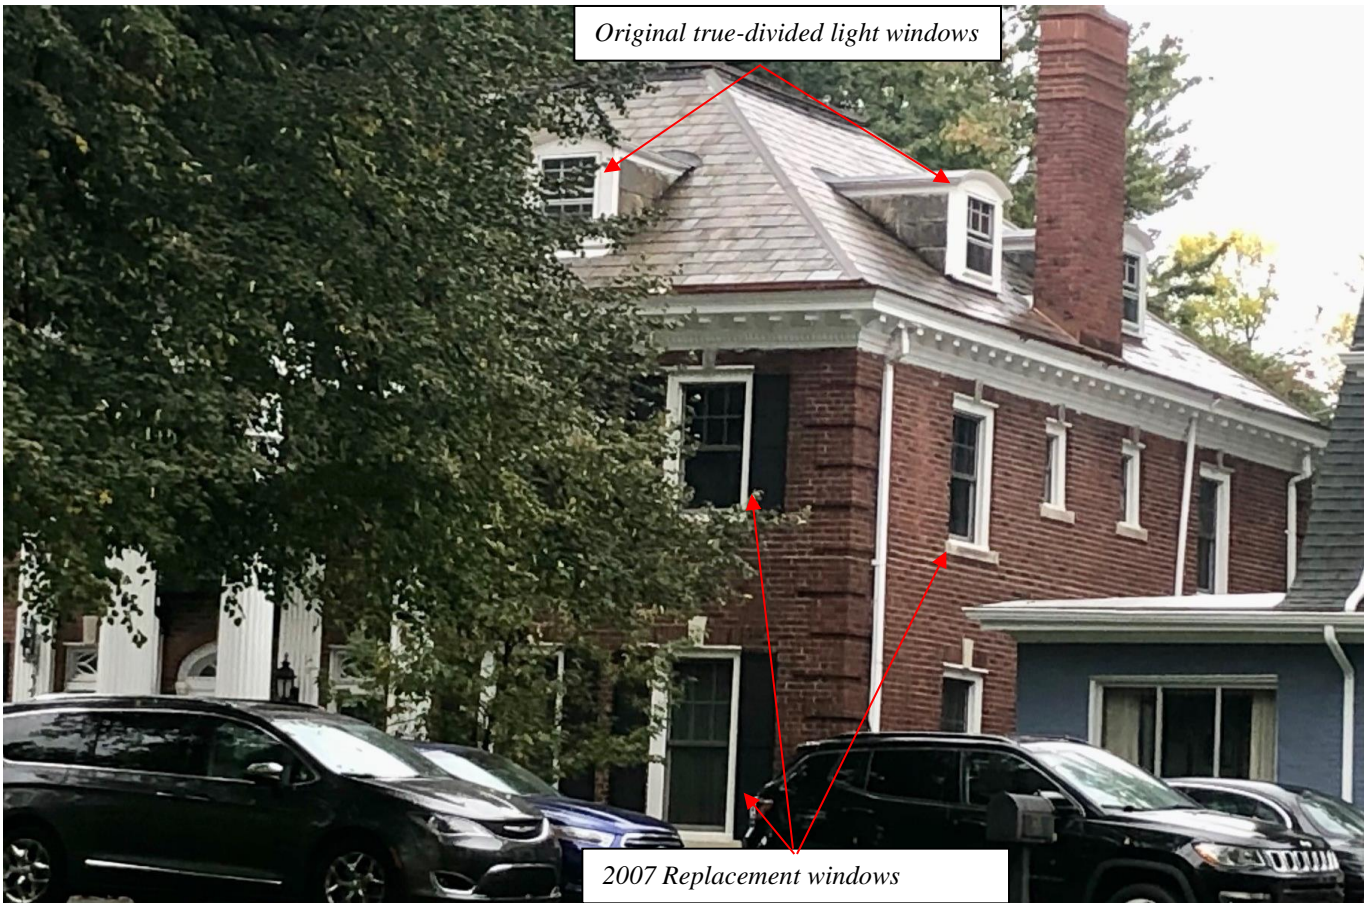
- It appears the existing replacement windows have between-the-glass grilles. This placement eliminated the dimensionality for each window and creates a lighter/hazier appearance for the upper sash grille pattern. The Renewal by Anderson order specifies between-the-glass grilles.

- In contrast, even with storm windows in place, the existing true divided-light windows offer a depth and visual weight that is equal to the exterior detailing on the house. The photographs on the following page illustrate this point.

Staff photos, September 26, 2023. The visual difference of the replacement windows' grid pattern compared against the original windows' muntin pattern is noticeable from the street. The depth of the true-divided light muntins offer a sharp contrast to the glass and create a decorative visual plane equal to the surrounding architectural features. It is staff's opinion that the replacement windows offer a weak pattern in the upper sash and therefore, the windows openings appear much darker than the surrounding heavily articulated surfaces.

### **Recommendation One – Denial – Replacement of third floor historic wood double-hung windows**

- The historic wood windows appear to be intact and in solid, repairable condition. Visual and physical information substantiating the windows are beyond repair was not submitted.
