STAFF REPORT: 9/13/2023 REGULAR MEETING

APPLICATION NUMBER: HDC2023-00023

ADDRESS: 13320 BROADSTREET

SCOPE: REBUILD EXTERIOR OF HOUSE AND GARAGE (WORK COMPLETED WITHOUT APPROVAL)

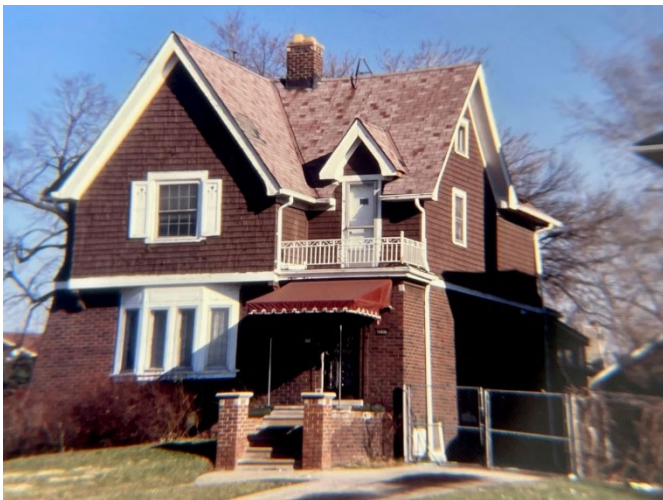
Designation Slide, 1999: (West) front/side elevation showing original condition.

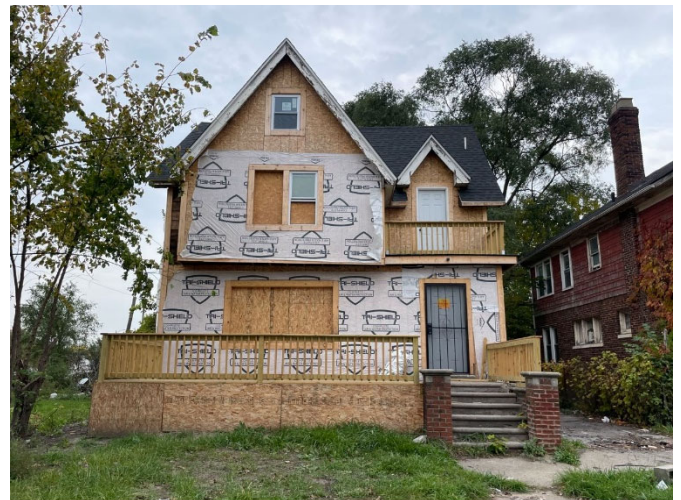
Site Photo 1, by Staff October 19, 2023: (West) Front elevation showing replaced roof, removed chimney, removed arched doorway, bay windows, siding, porch, and other features, and introducing new window in the gable without approval.

- The Russell Woods- Sullivan Historic District was established in 1999.
- Staff observed that the property had some fire damage at the roof and south elevation of the house, as observed in Google Street view images from August 2018-June 2019. (See site photo 1.)

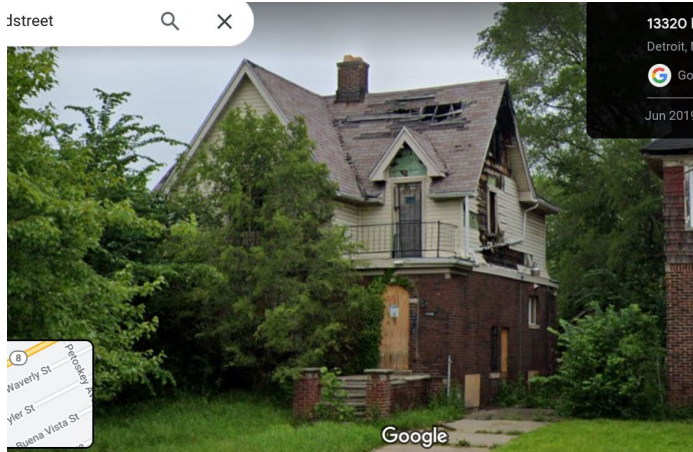
Site Photo2, Google Streetview October 2022: (West) front/side elevation showing roof and siding conditions prior to applicants work.

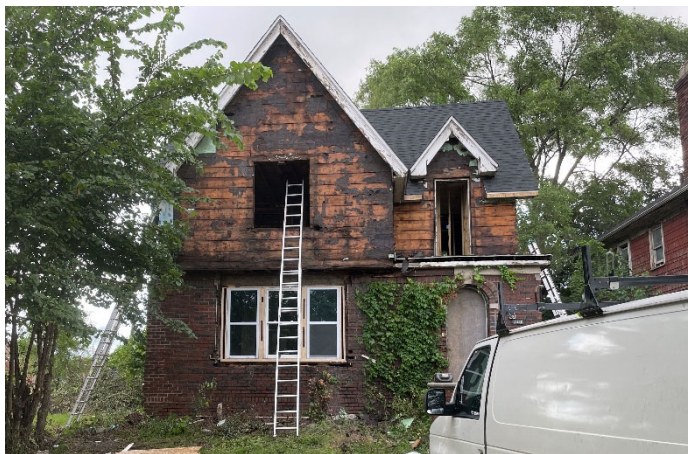
Site Photo 3, by Staff July 21, 2023: (West) front elevation, showing work in progress without approval.

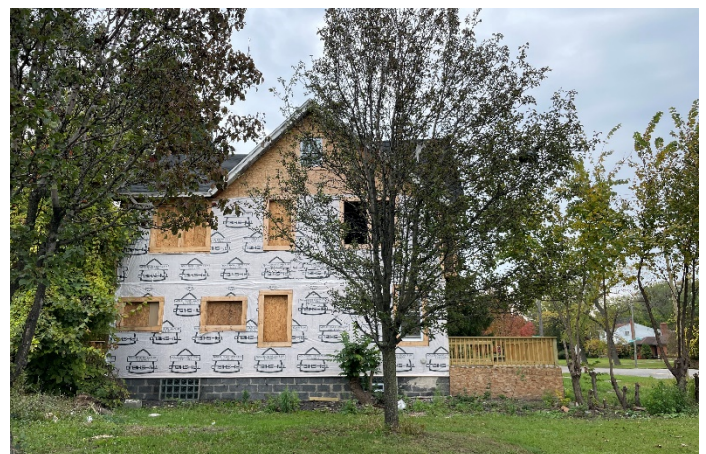
Site Photo 4, by Staff October 19, 2023: (North) Side elevation showing removed windows, removed brick and shake siding, and installation of the front deck.

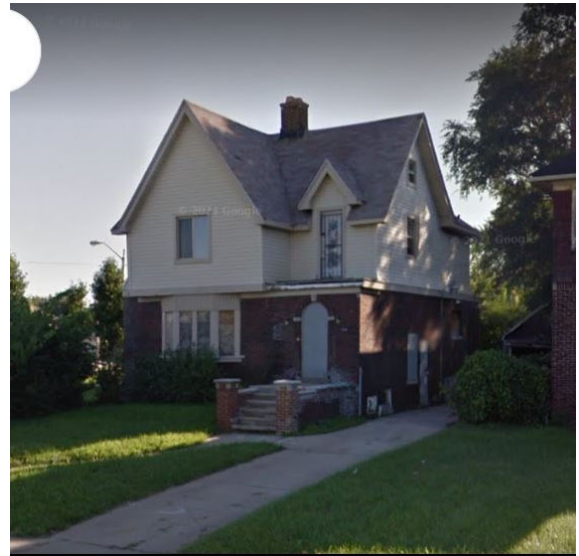
- The cedar shake siding of the second floor was covered at some time prior to September 2007. (See Site photos 5-6.)
- Staff observed that the brick wall extension that swept from the first-floor façade, crumbled in 2009 and was removed by a former owner by August 2011. (See Site photos 5-6.)

Site Photo 5, by Google Streetview August 2011, showing shake siding covered with vinyl, brick wall extension and balcony railing removed.

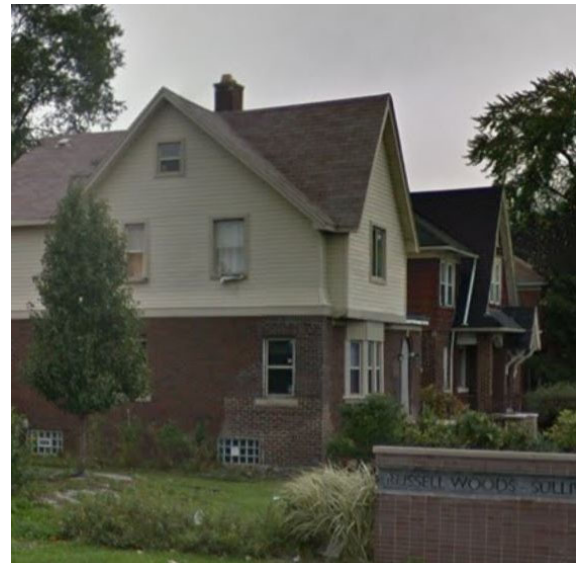
Site Photo 6, by Google Streetview October 2011, showing shake siding covered with vinyl, brick wall extension removed and patched with new mortar.
