REVISED STAFF REPORT: 11/08/2023 MEETING

APPLICATION NUMBER: HDC2023-~~0085~~00093

ADDRESS: 400 FISKE

SCOPE OF WORK: REPLACE SLATE ROOF WITH ASPHALT SHINGLES (WORK PARTIALLY COMPLETE)

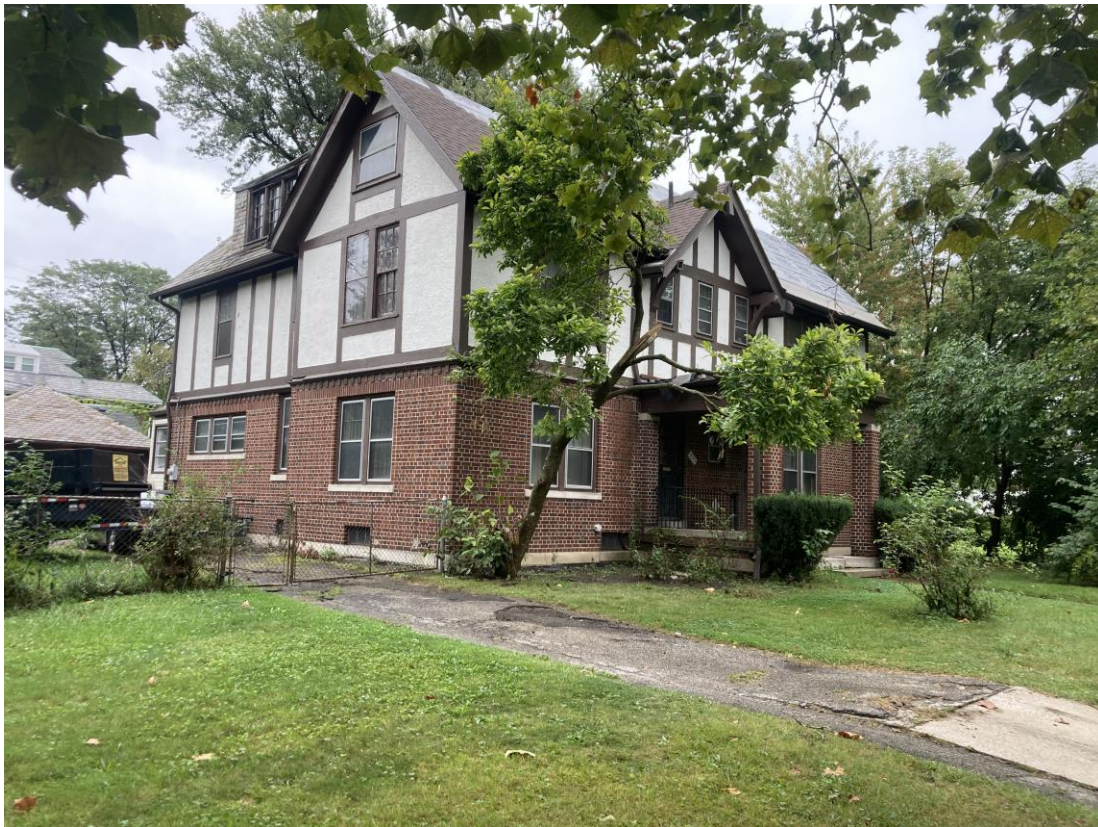
400 Fiske, current. Staff photo taken 11/1/2023, facing southeast

Rear, intersecting gabled wing. Slate remains at this roof

Rear, flat/mansard-roof wing

Shed-roof dormers atop rear gabled wing. Slate remains at the dormer front and side walls

Side-gabled main roof,. The slate has been completely removed from this roof

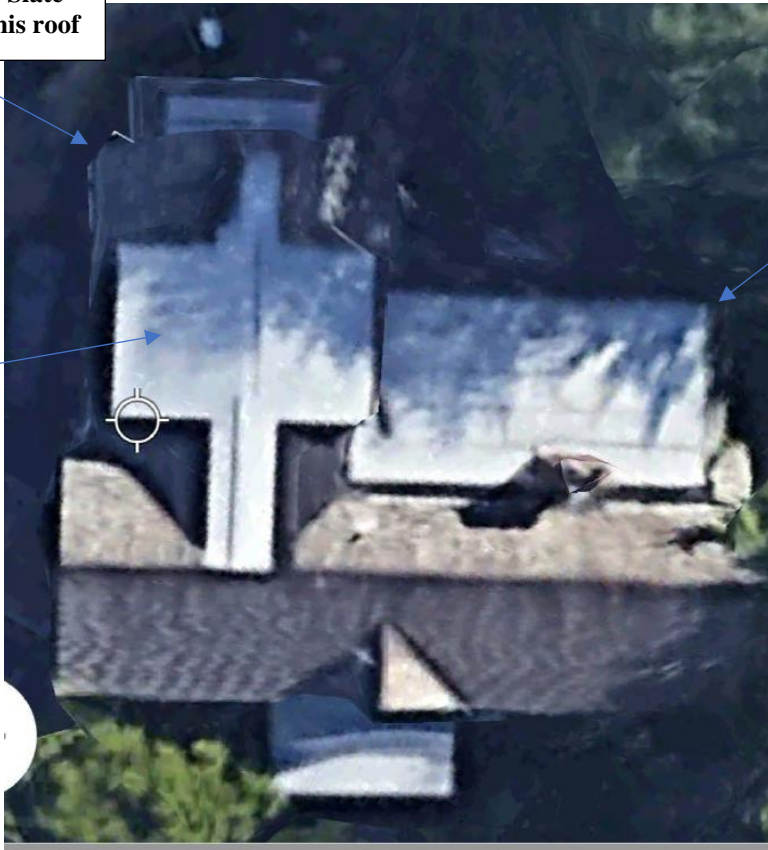
Aerial photo of roof. Photo provided by applicant

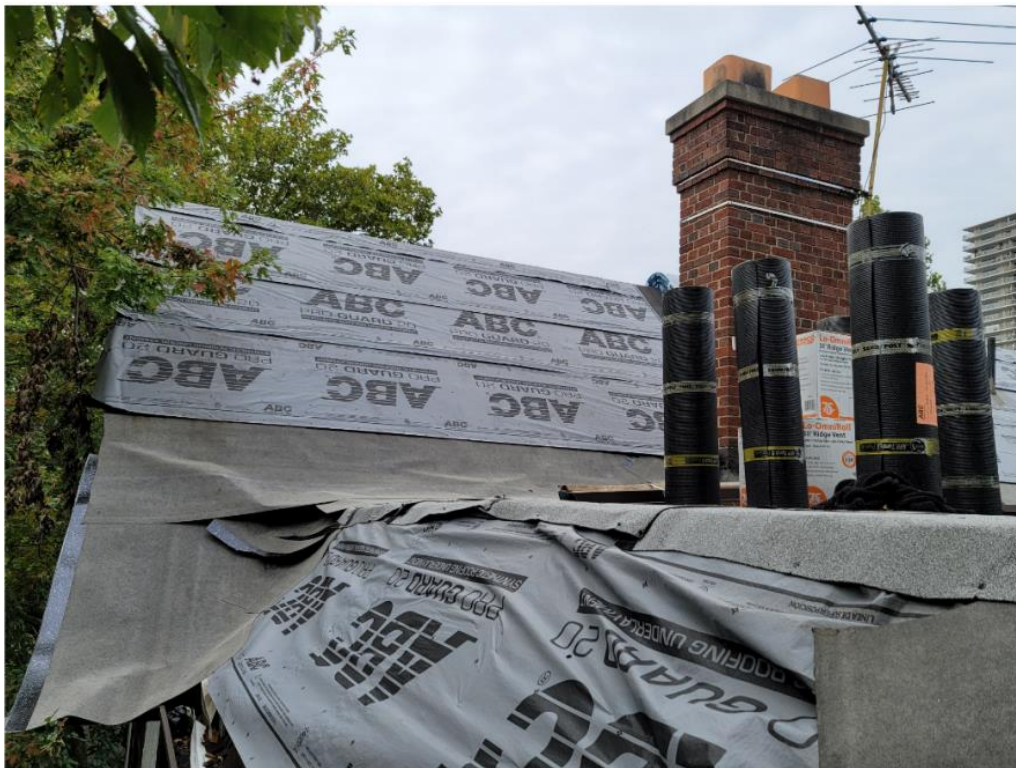
Rear of main side-gabled roof, south portion, facing northwest. Current conditions. Note that the slate has been removed and the area has been covered/weatherproofed with underlayment. Photo provided by applicant

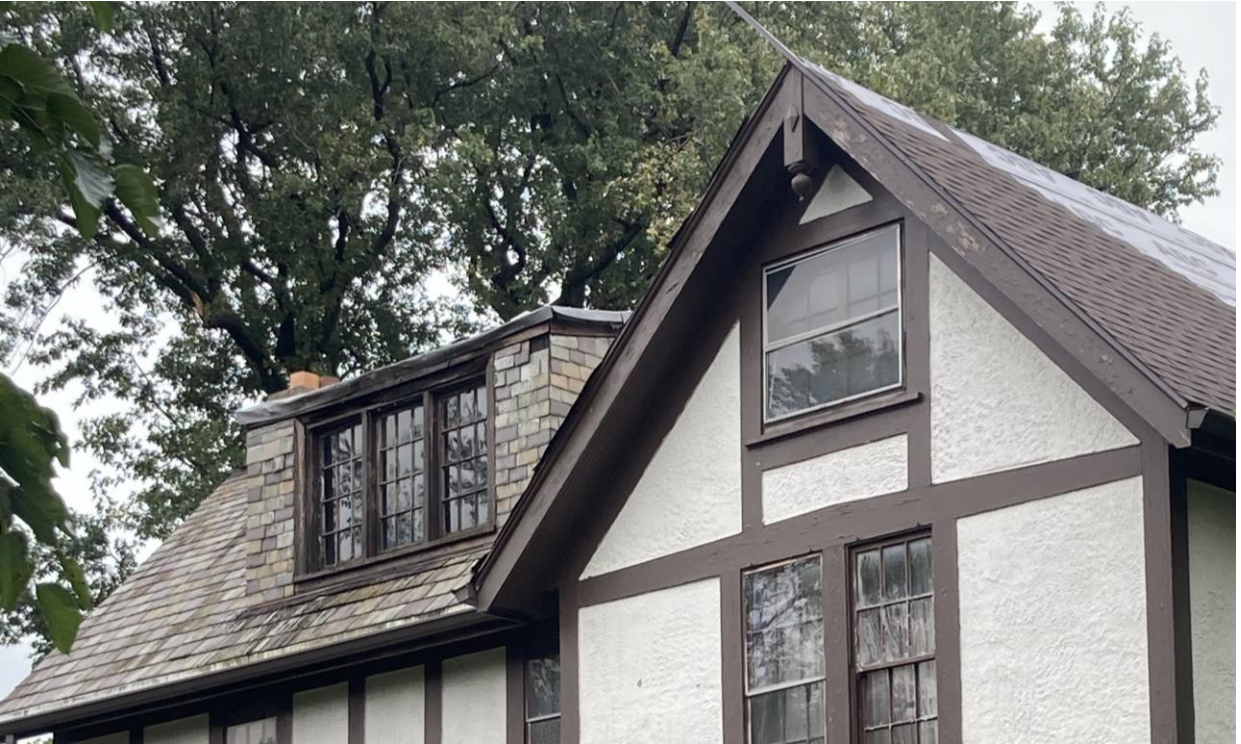
Rear gabled wing and dormer, showing current conditions, facing southeast. Photo taken on 11/1/2023 by staff

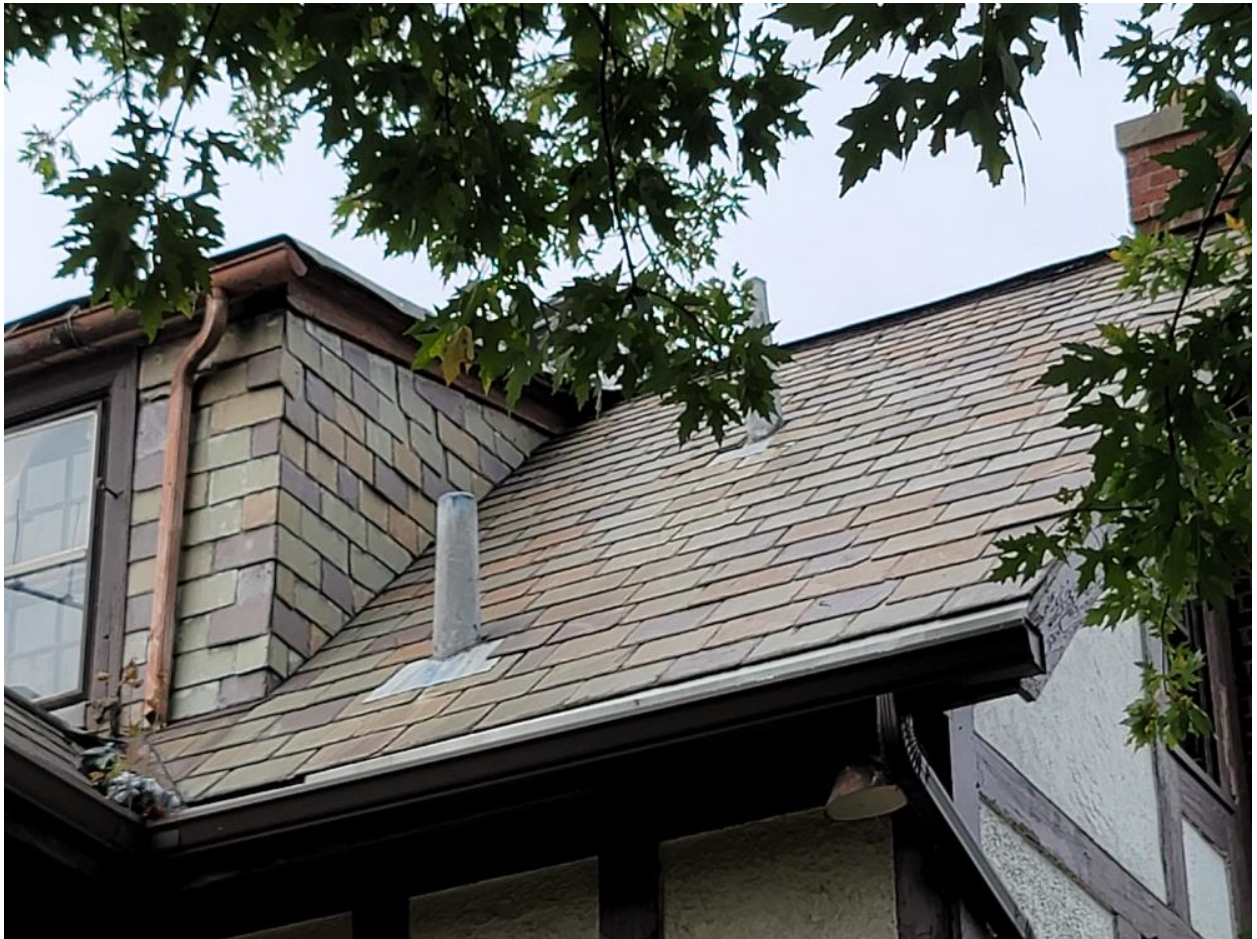
Rear gabled wing and dormer, showing current conditions, facing northwest. Photo taken by applicant

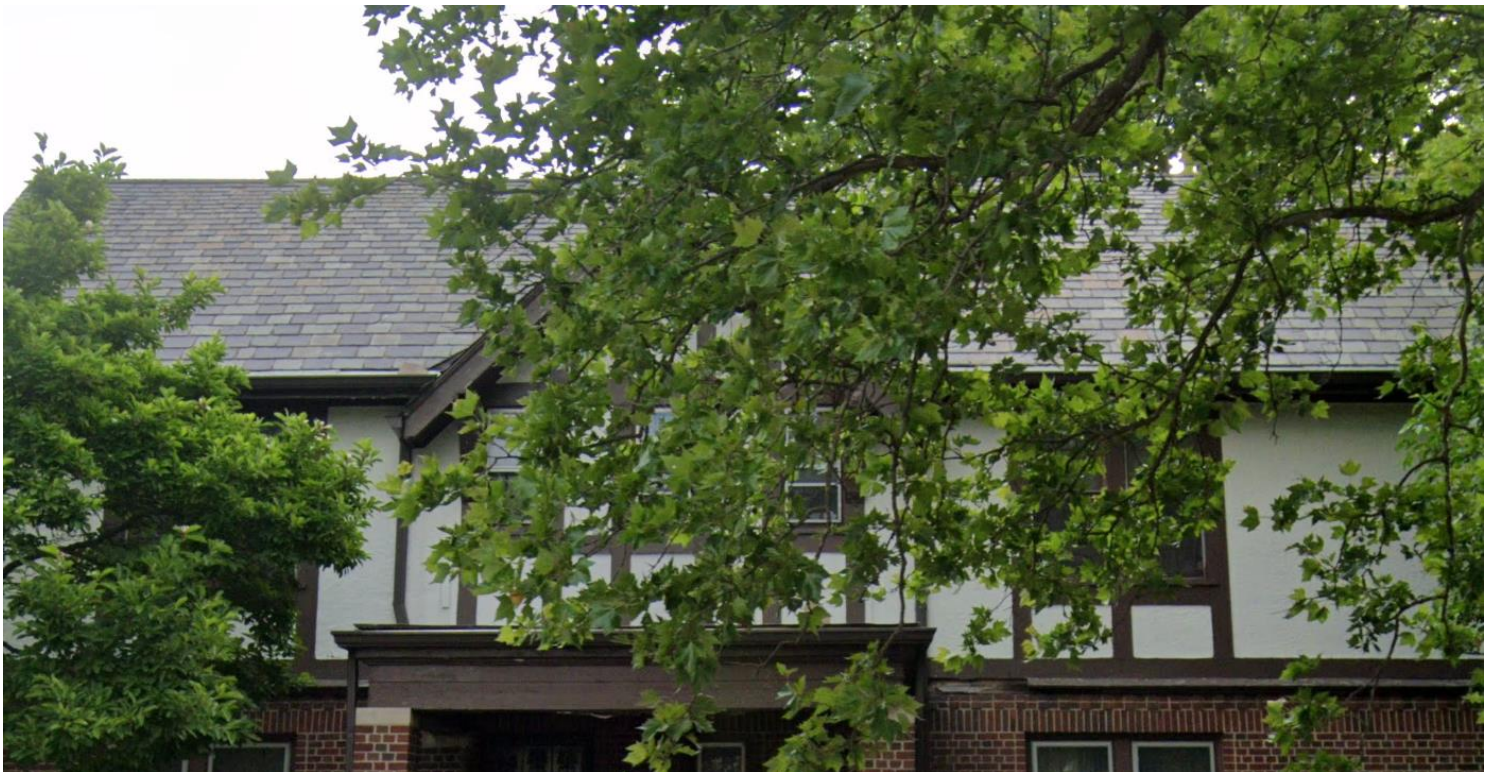
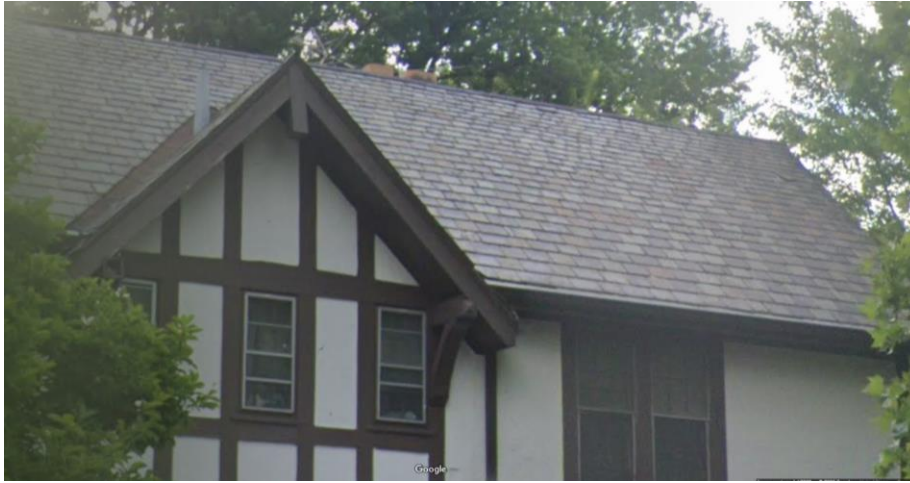
Google Streetview images, 2022

- Staff did view the designation photo of the home, the remaining portions of the slate on the property's roof, and recent Google Streetview images which were taken prior to the current unapproved roof removal. It is staff's opinion that the slate roof was a distinctive, character-defining feature of the home.

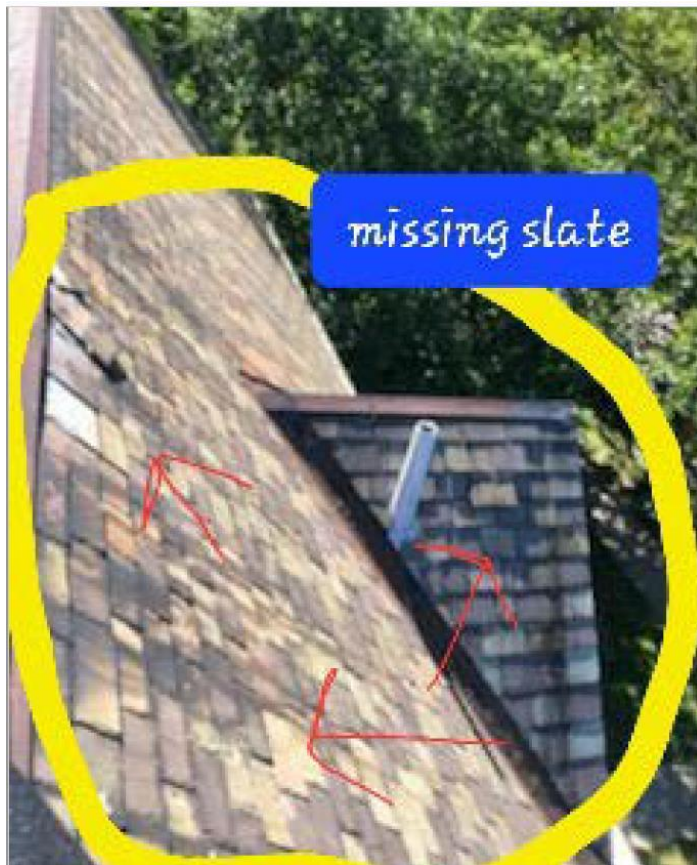
- Slate tiles were missing at the front surface of the main side-gabled roof (per the submitted narrative)
- Slate tiles at the vertical areas of the roof/the dormer front and side walls are sliding out of place per submitted photos

Front of main, side-gabled roof. Photo provided by applicant

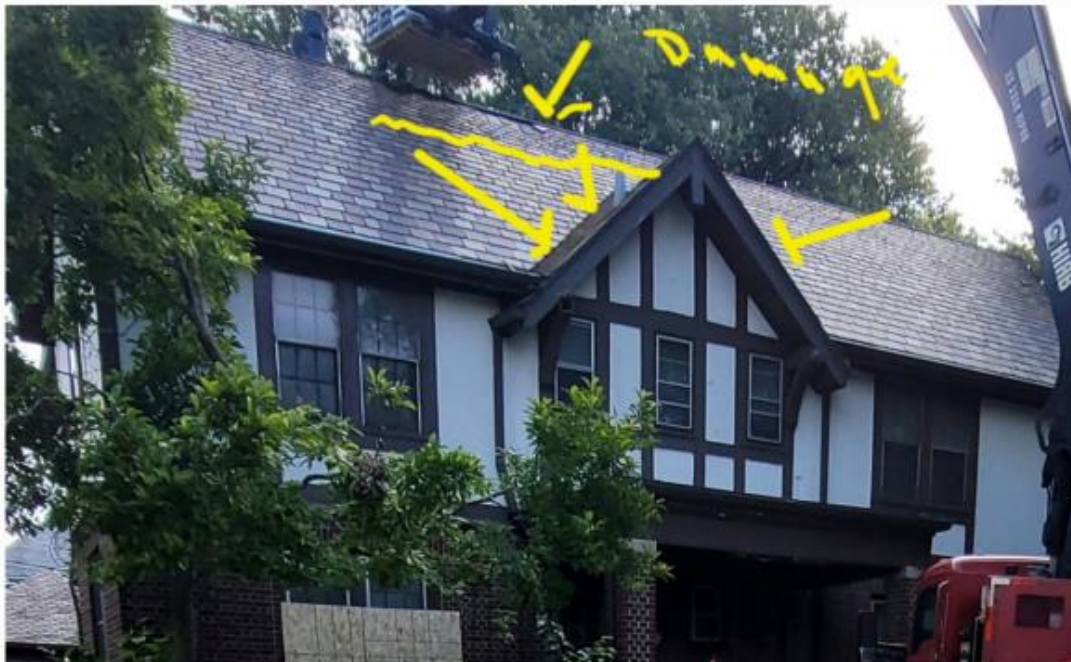
Front of main, side-gabled roof. Photo provided by applicant

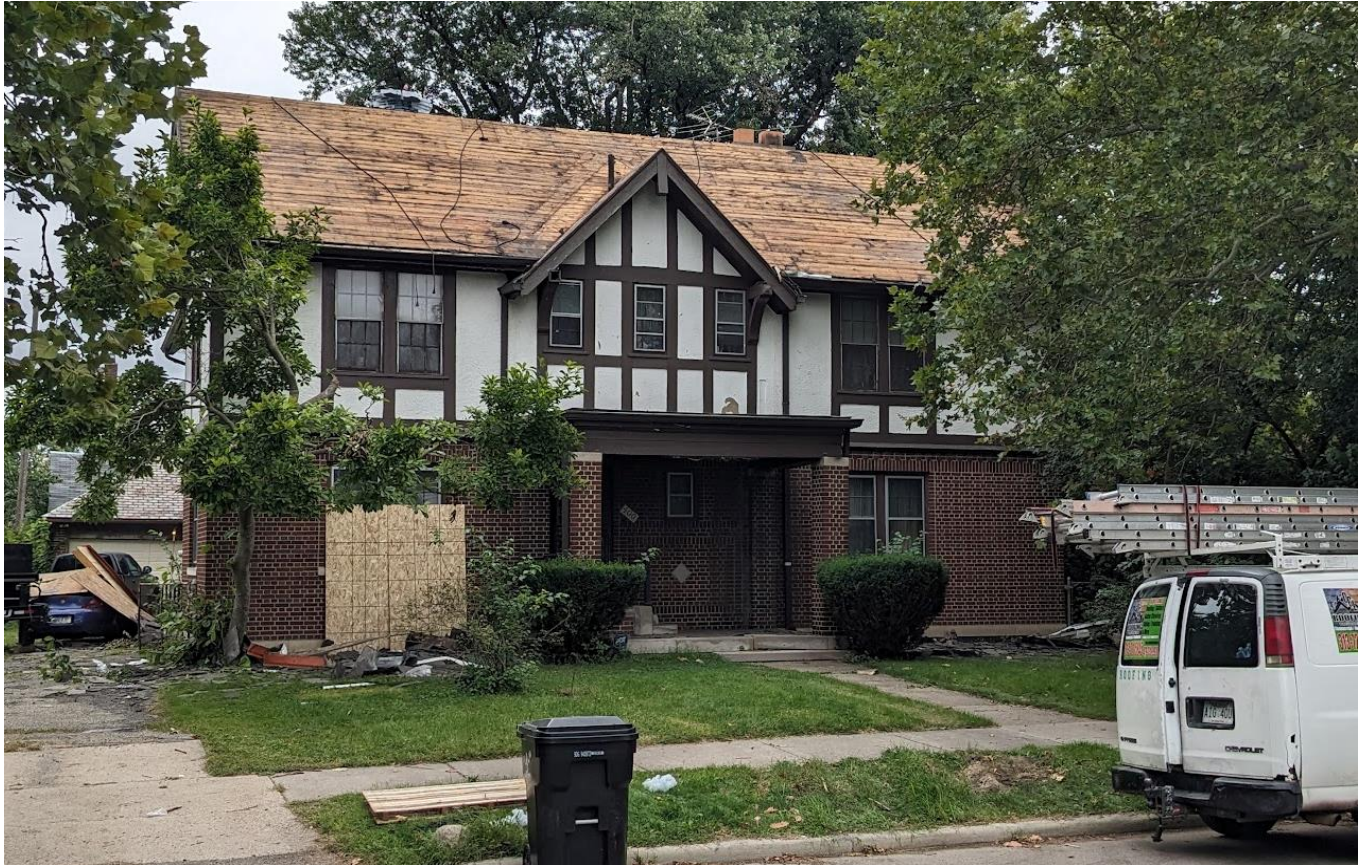
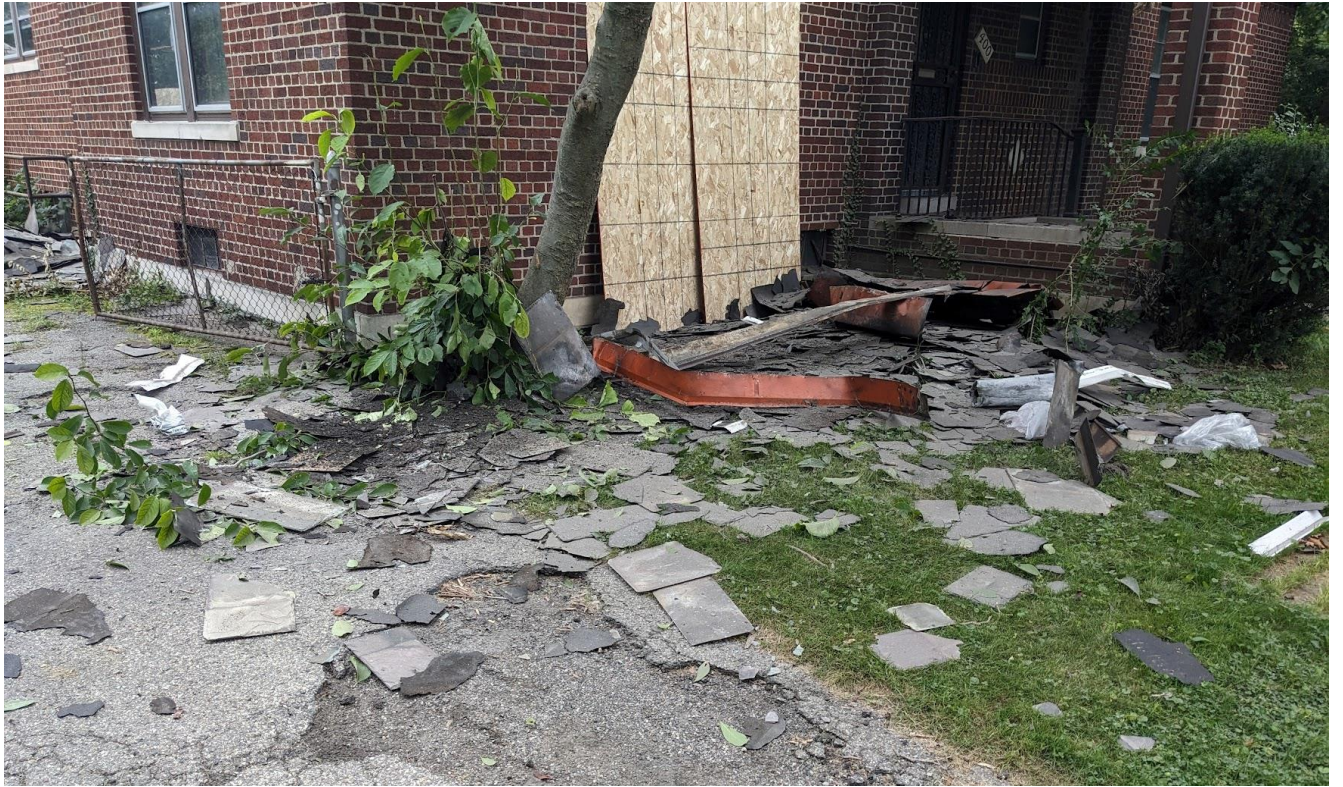
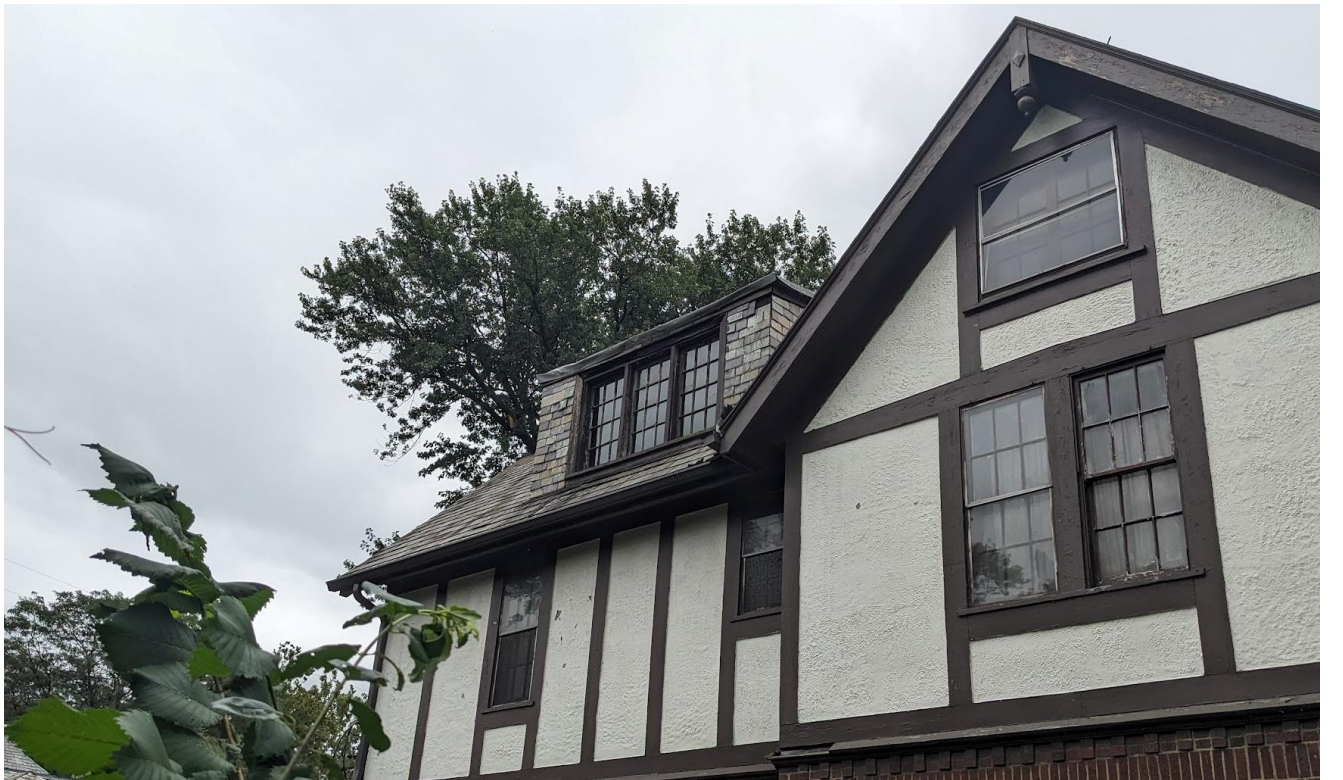
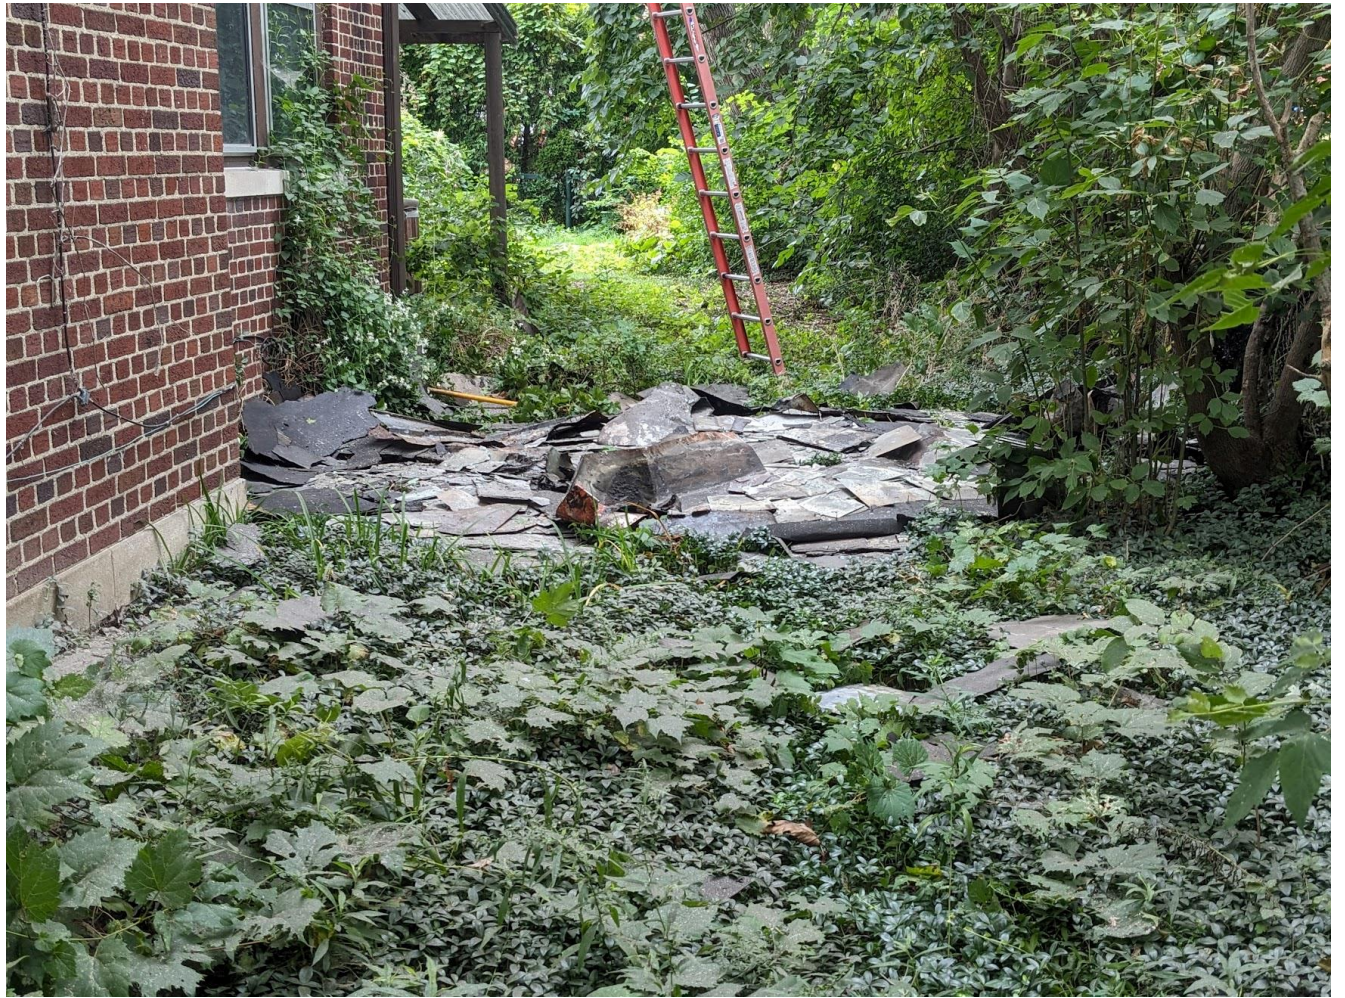
Staff photos, taken on 9/8/2023 during unapproved slate roof removal

- During the initial 9/8/2023 site visit, staff observed the condition of slate tiles which had been removed from the roof and dropped to the ground. Staff noted that the slate roof tiles did vary in size and that many appeared to have been in good condition. See below photos taken during the 9/8/2023 field visit.
