REVISED STAFF REPORT: 11/08/2023 MEETING

APPLICATION NUMBER: HDC2023-~~0085~~00093

ADDRESS: 400 FISKE

SCOPE OF WORK: REPLACE SLATE ROOF WITH ASPHALT SHINGLES (WORK PARTIALLY COMPLETE)

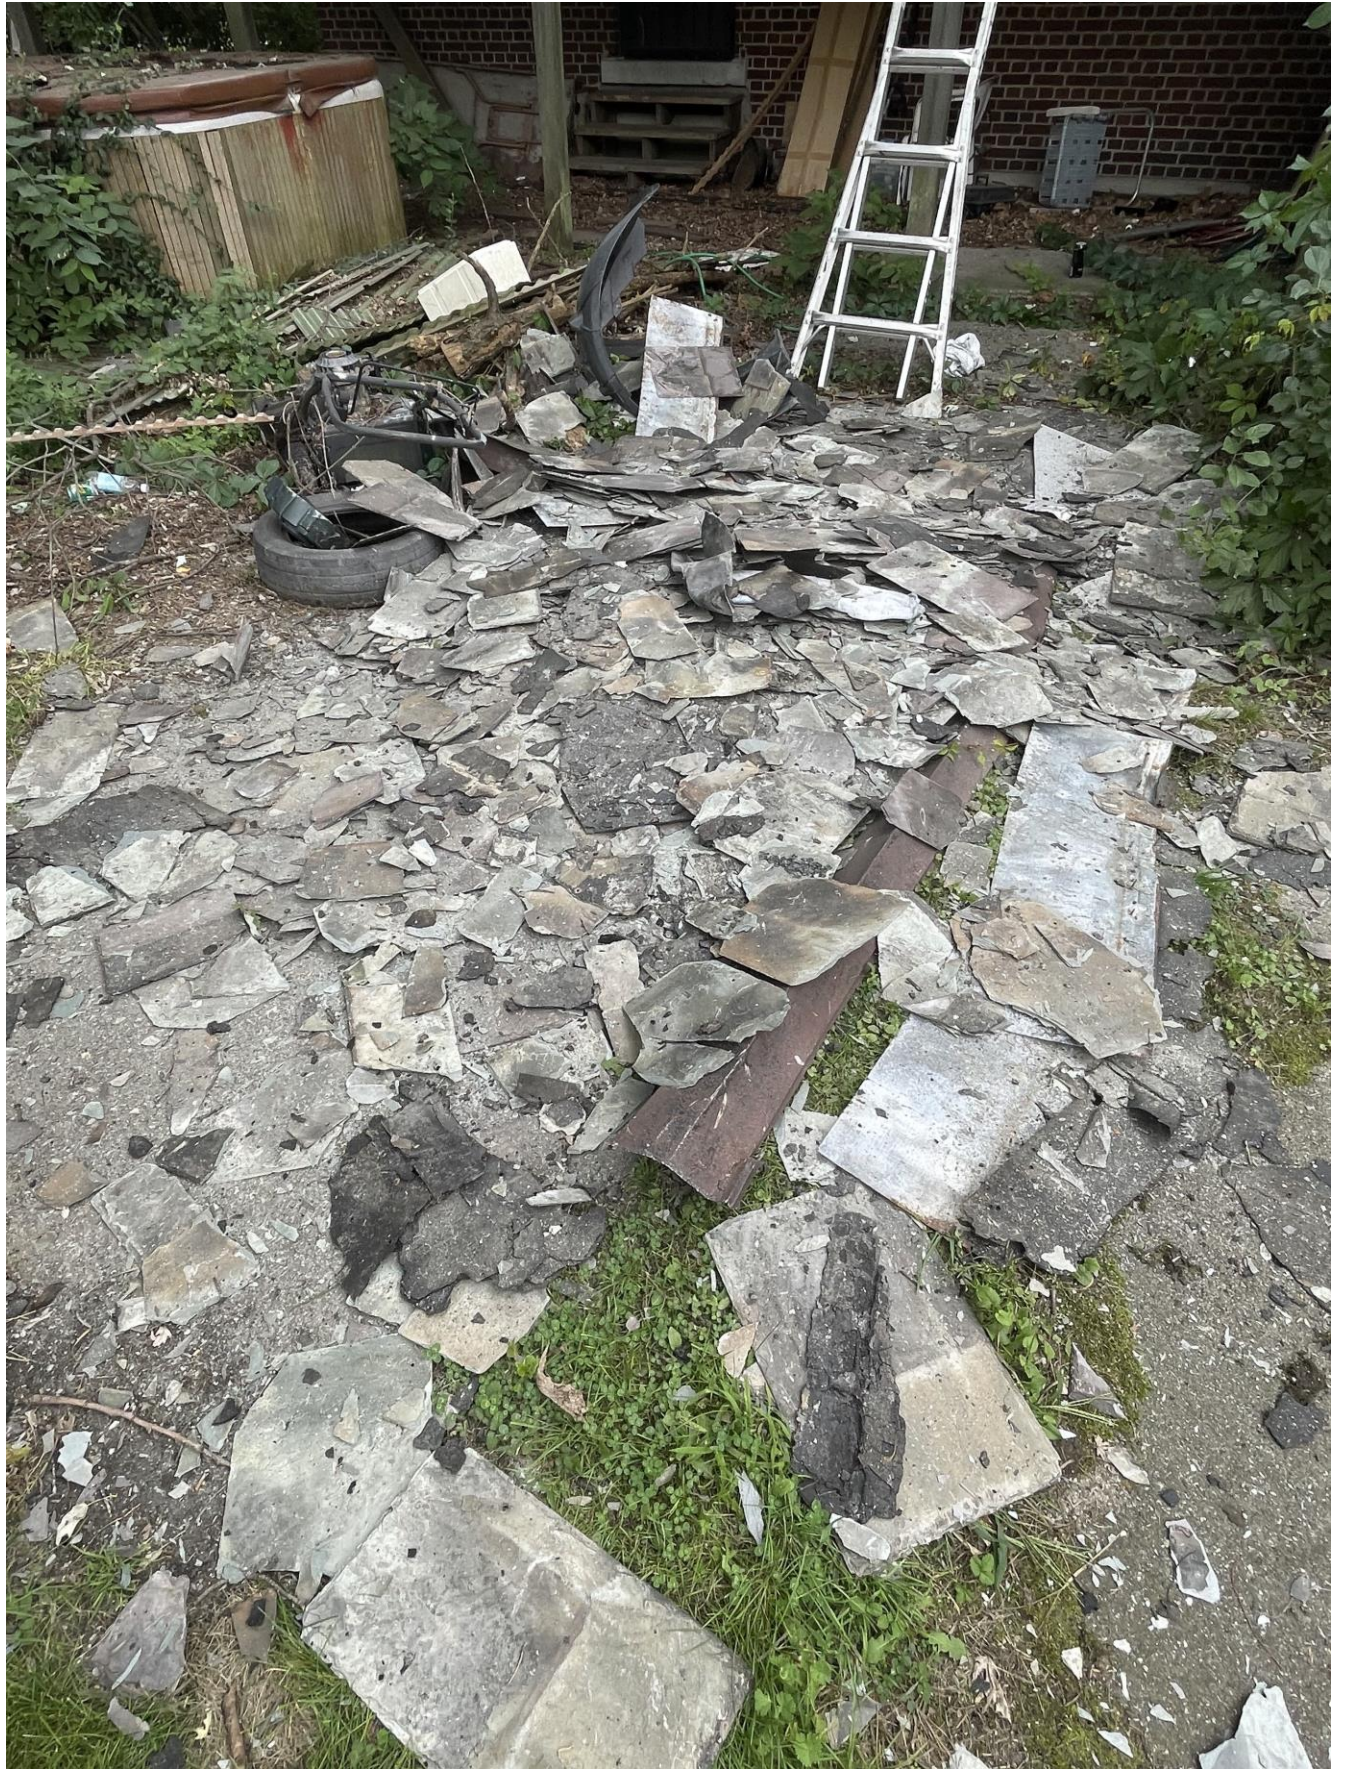
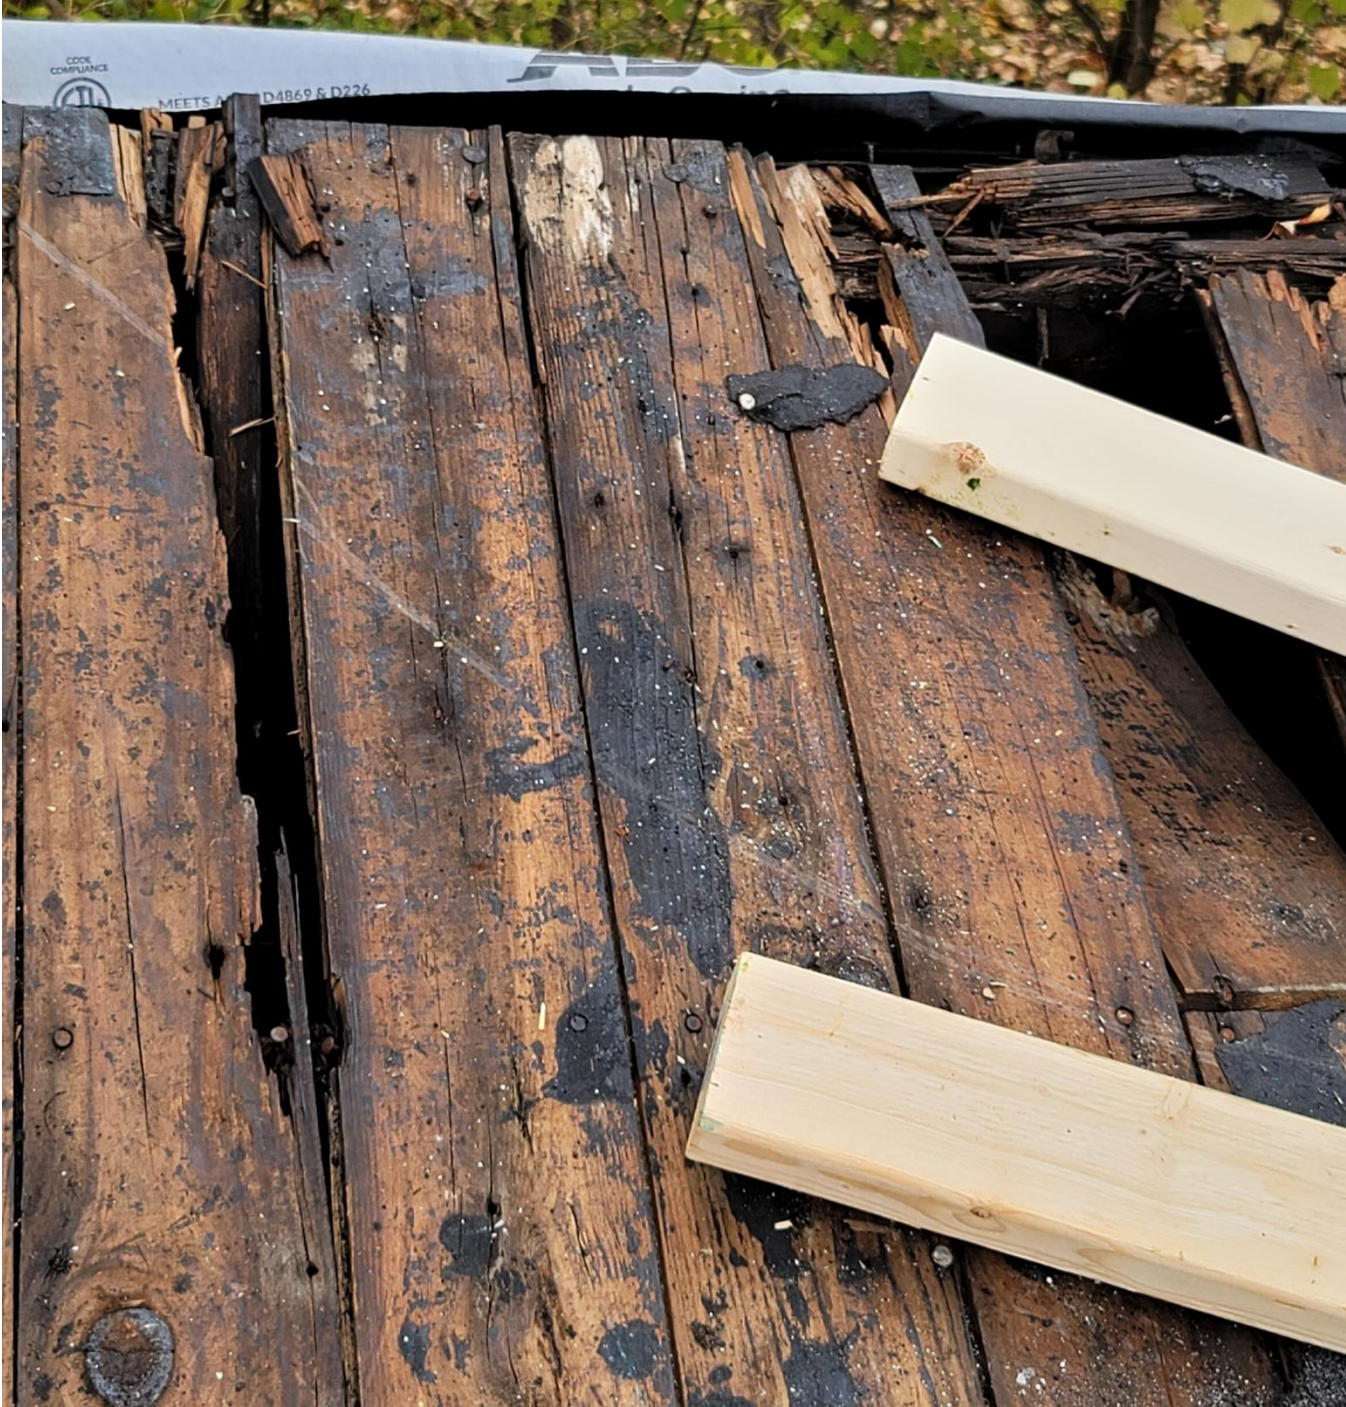
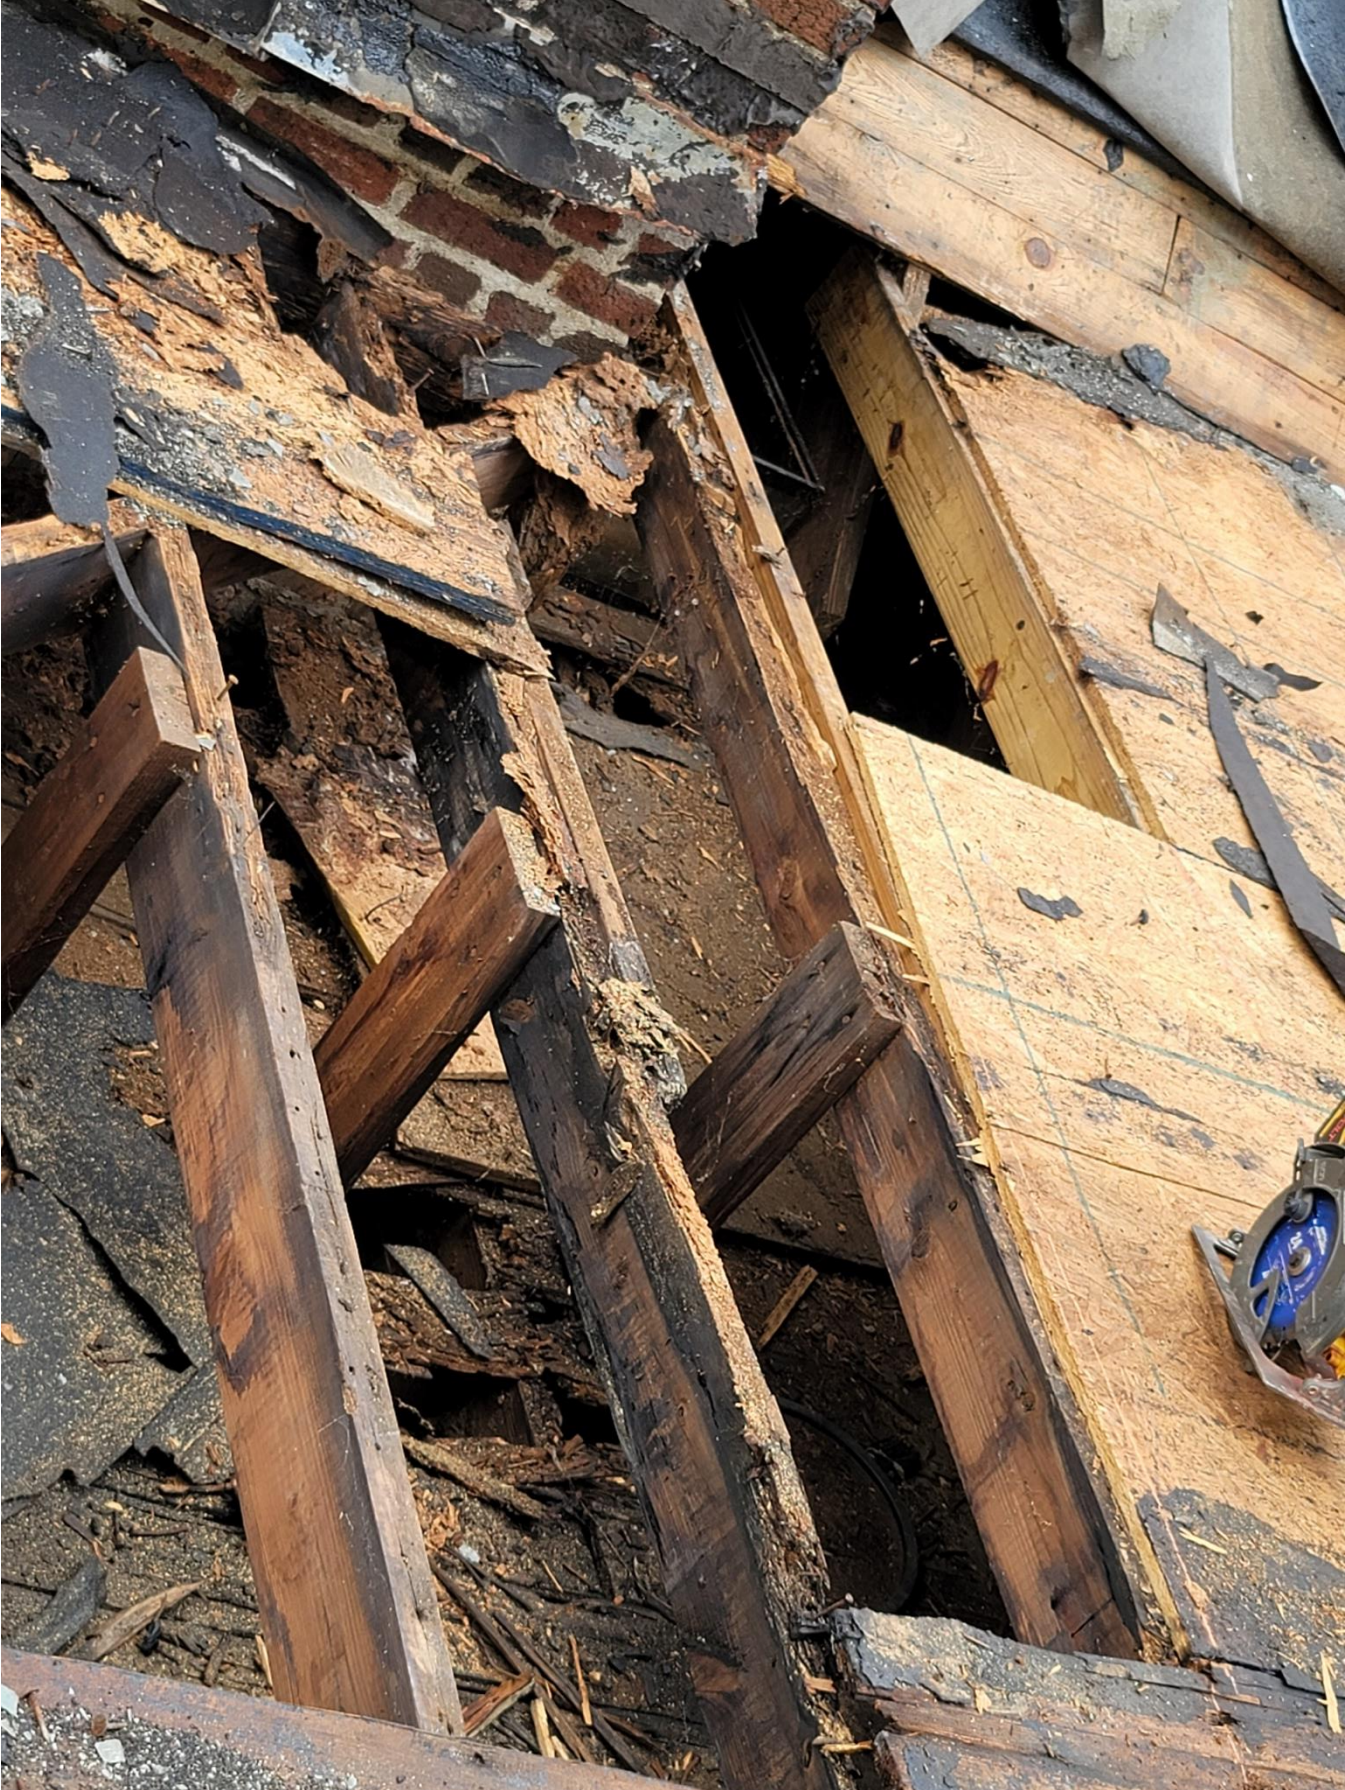
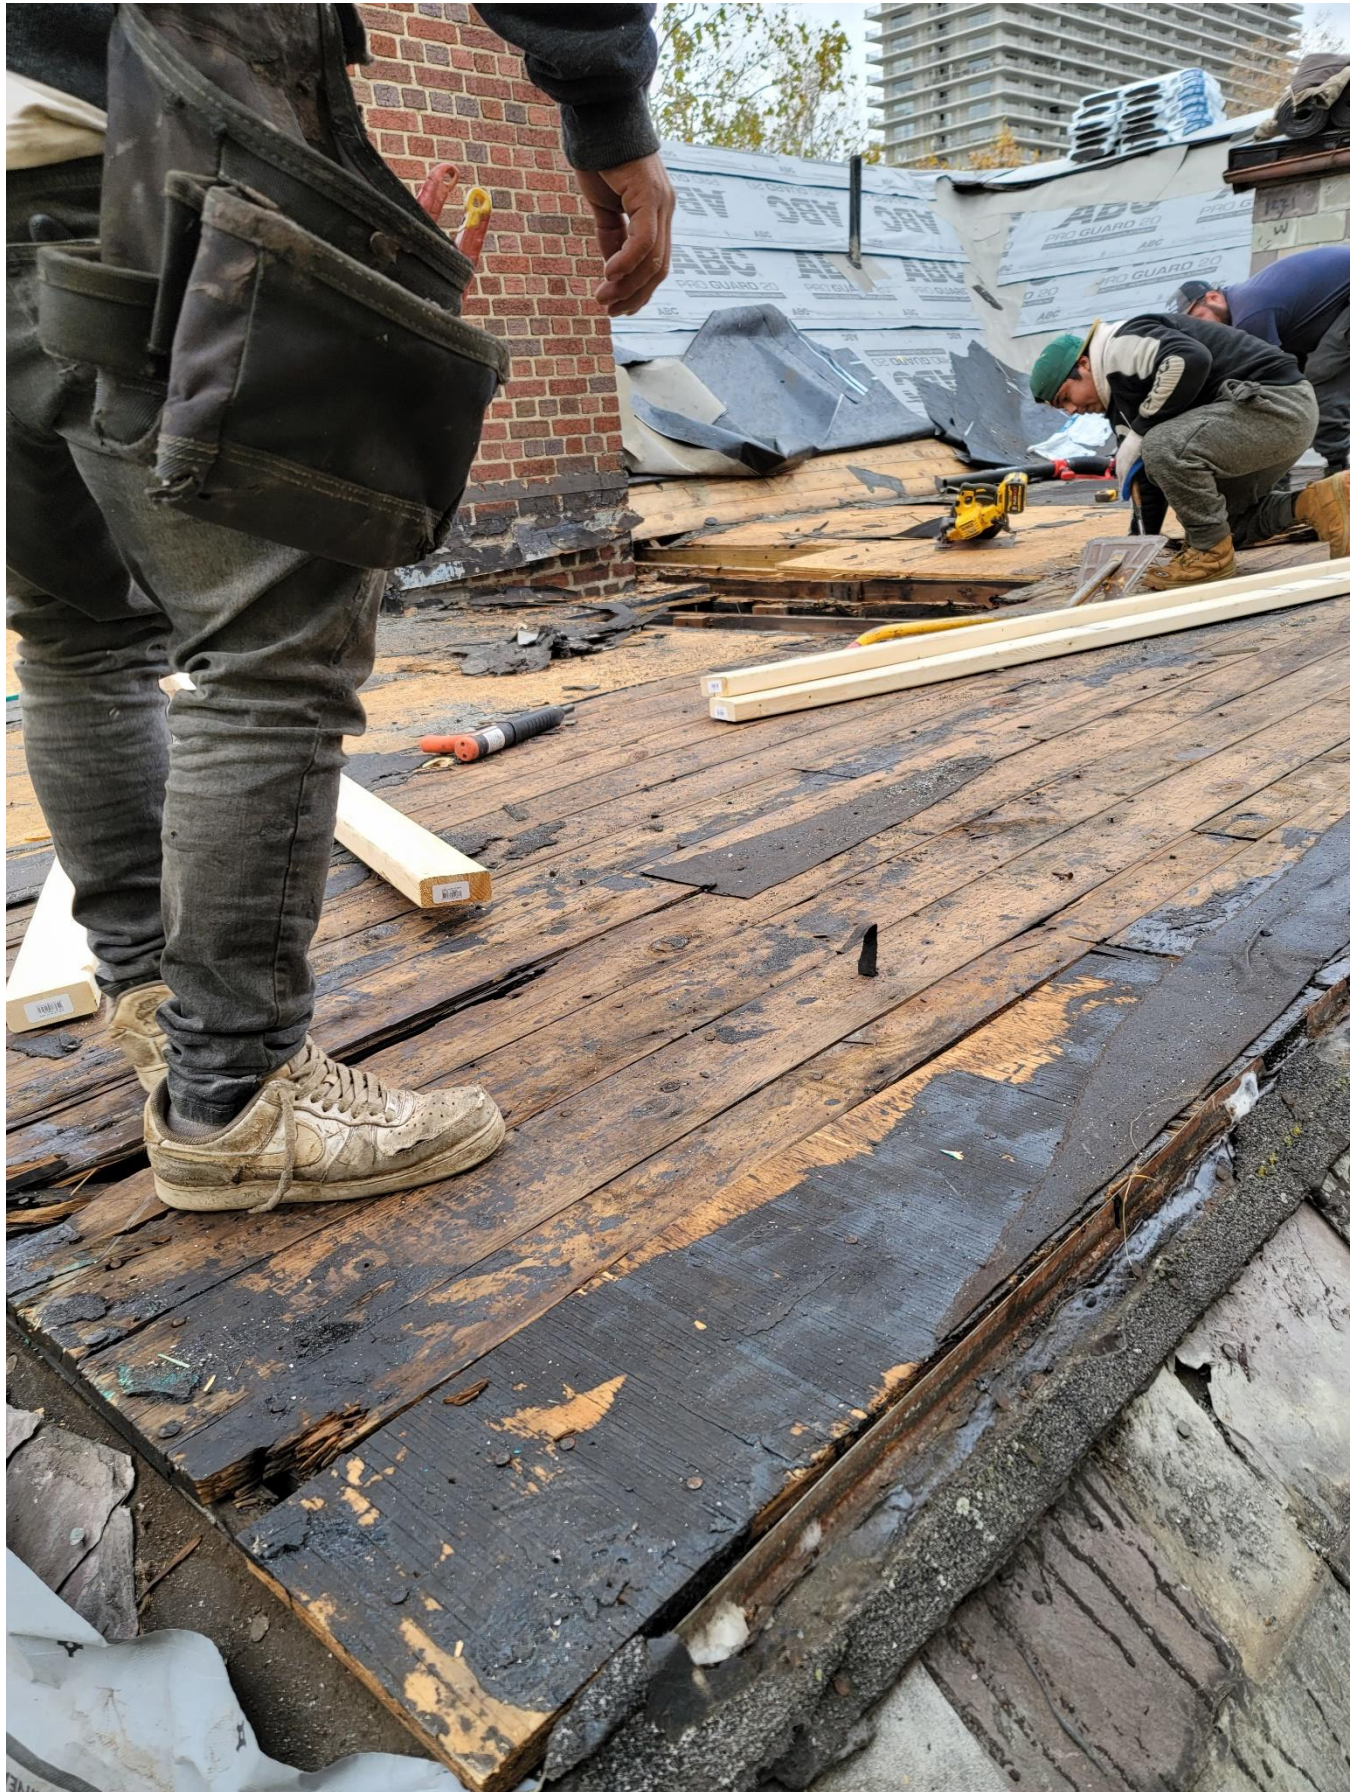
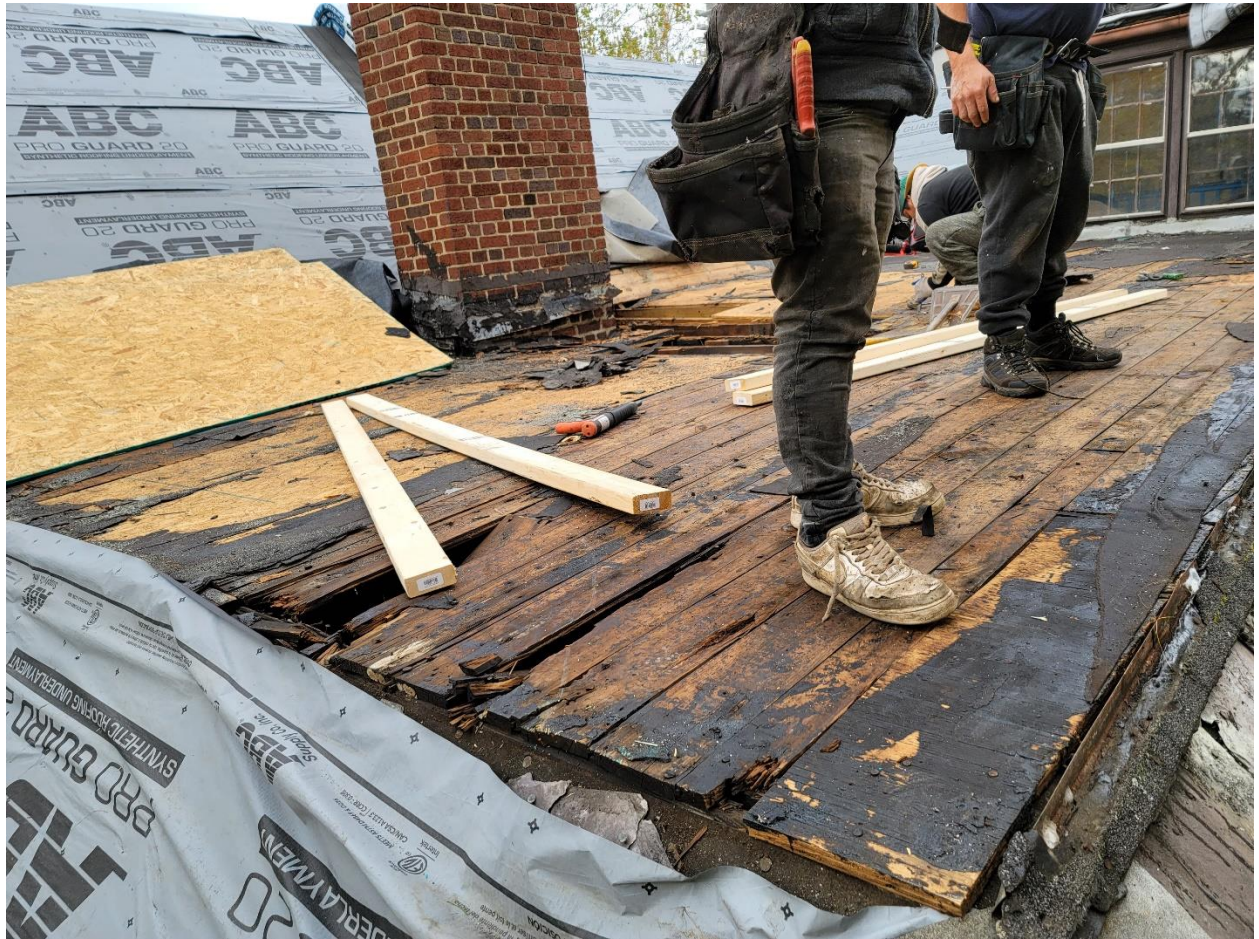
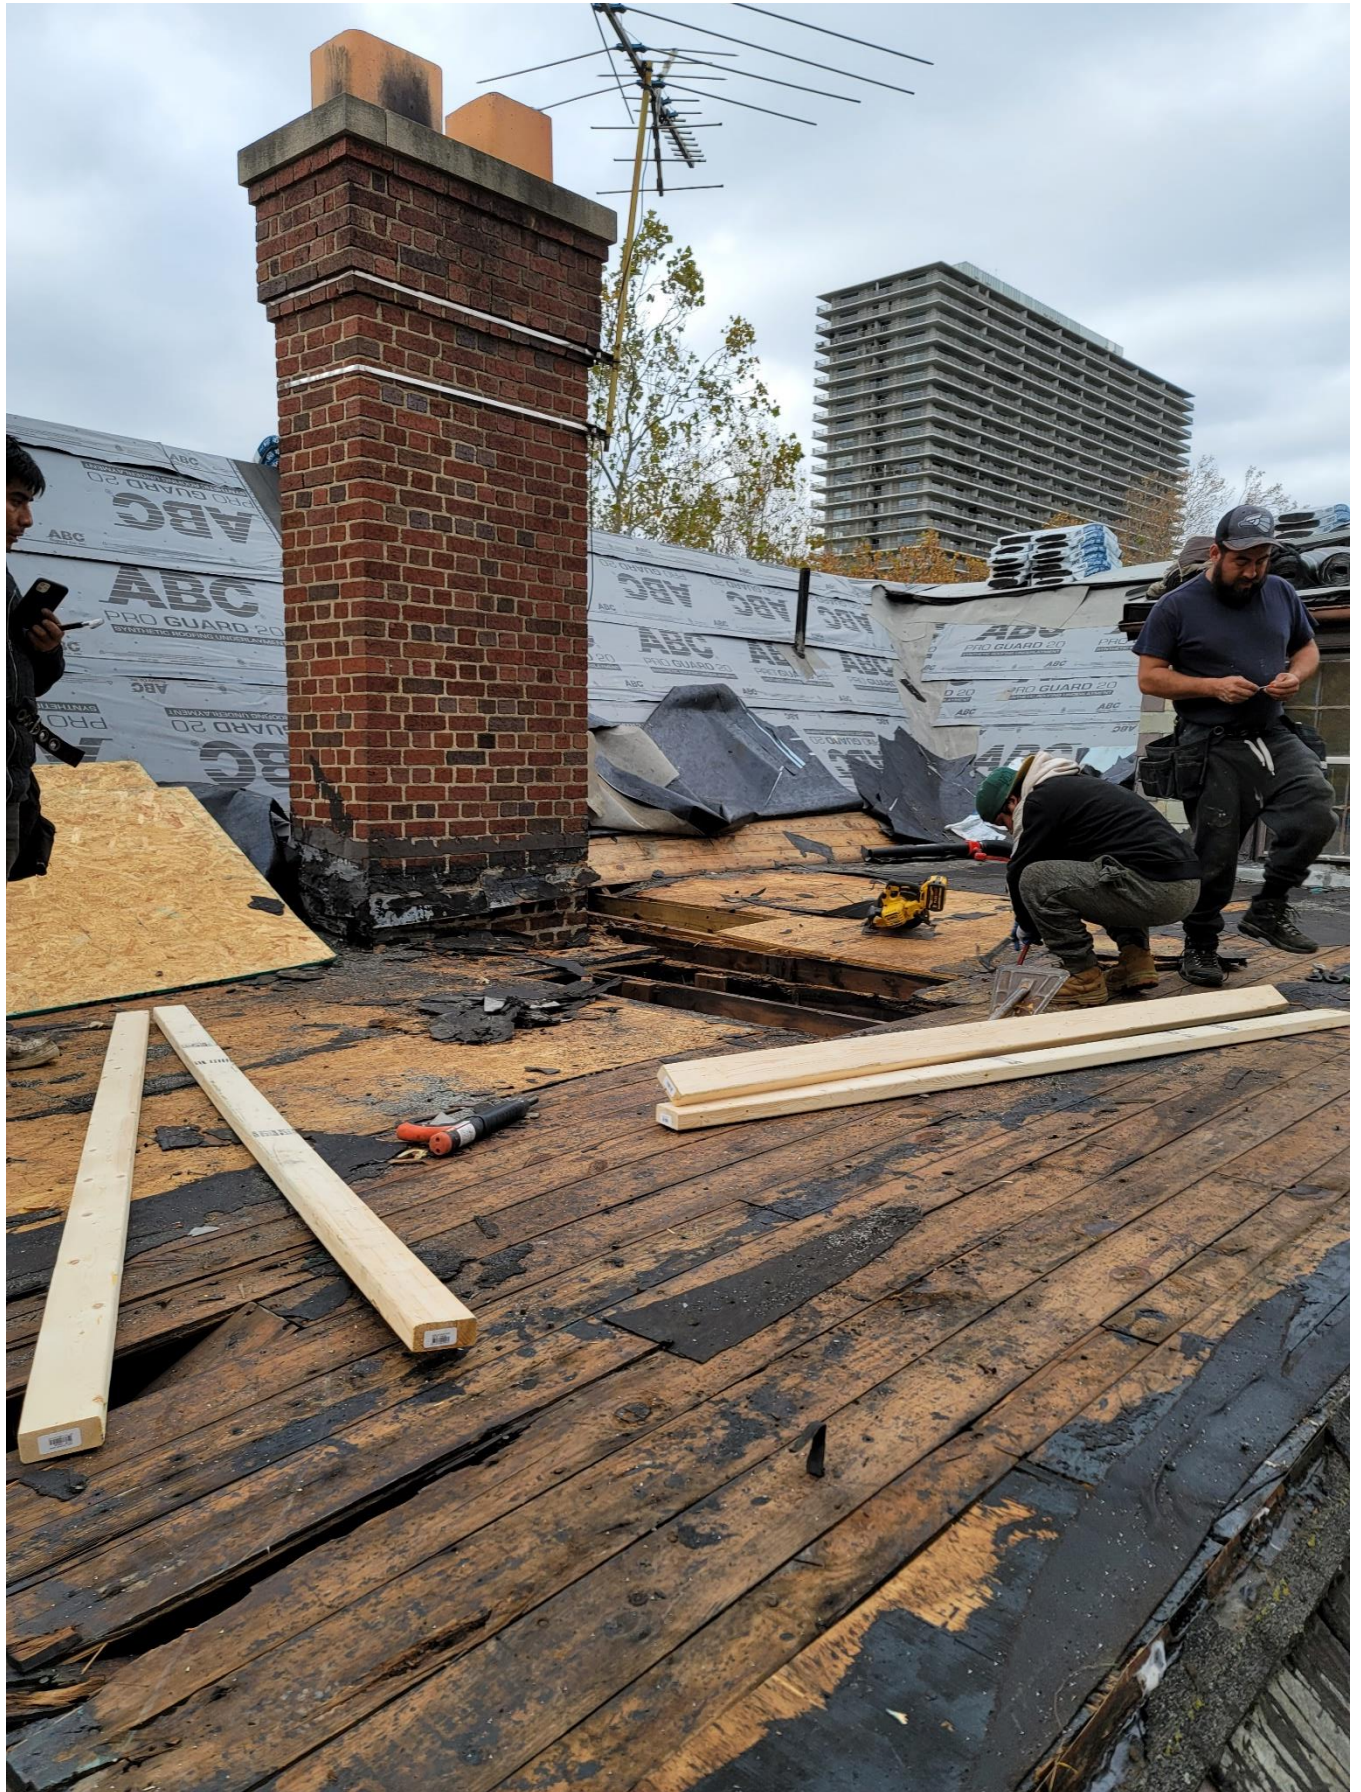
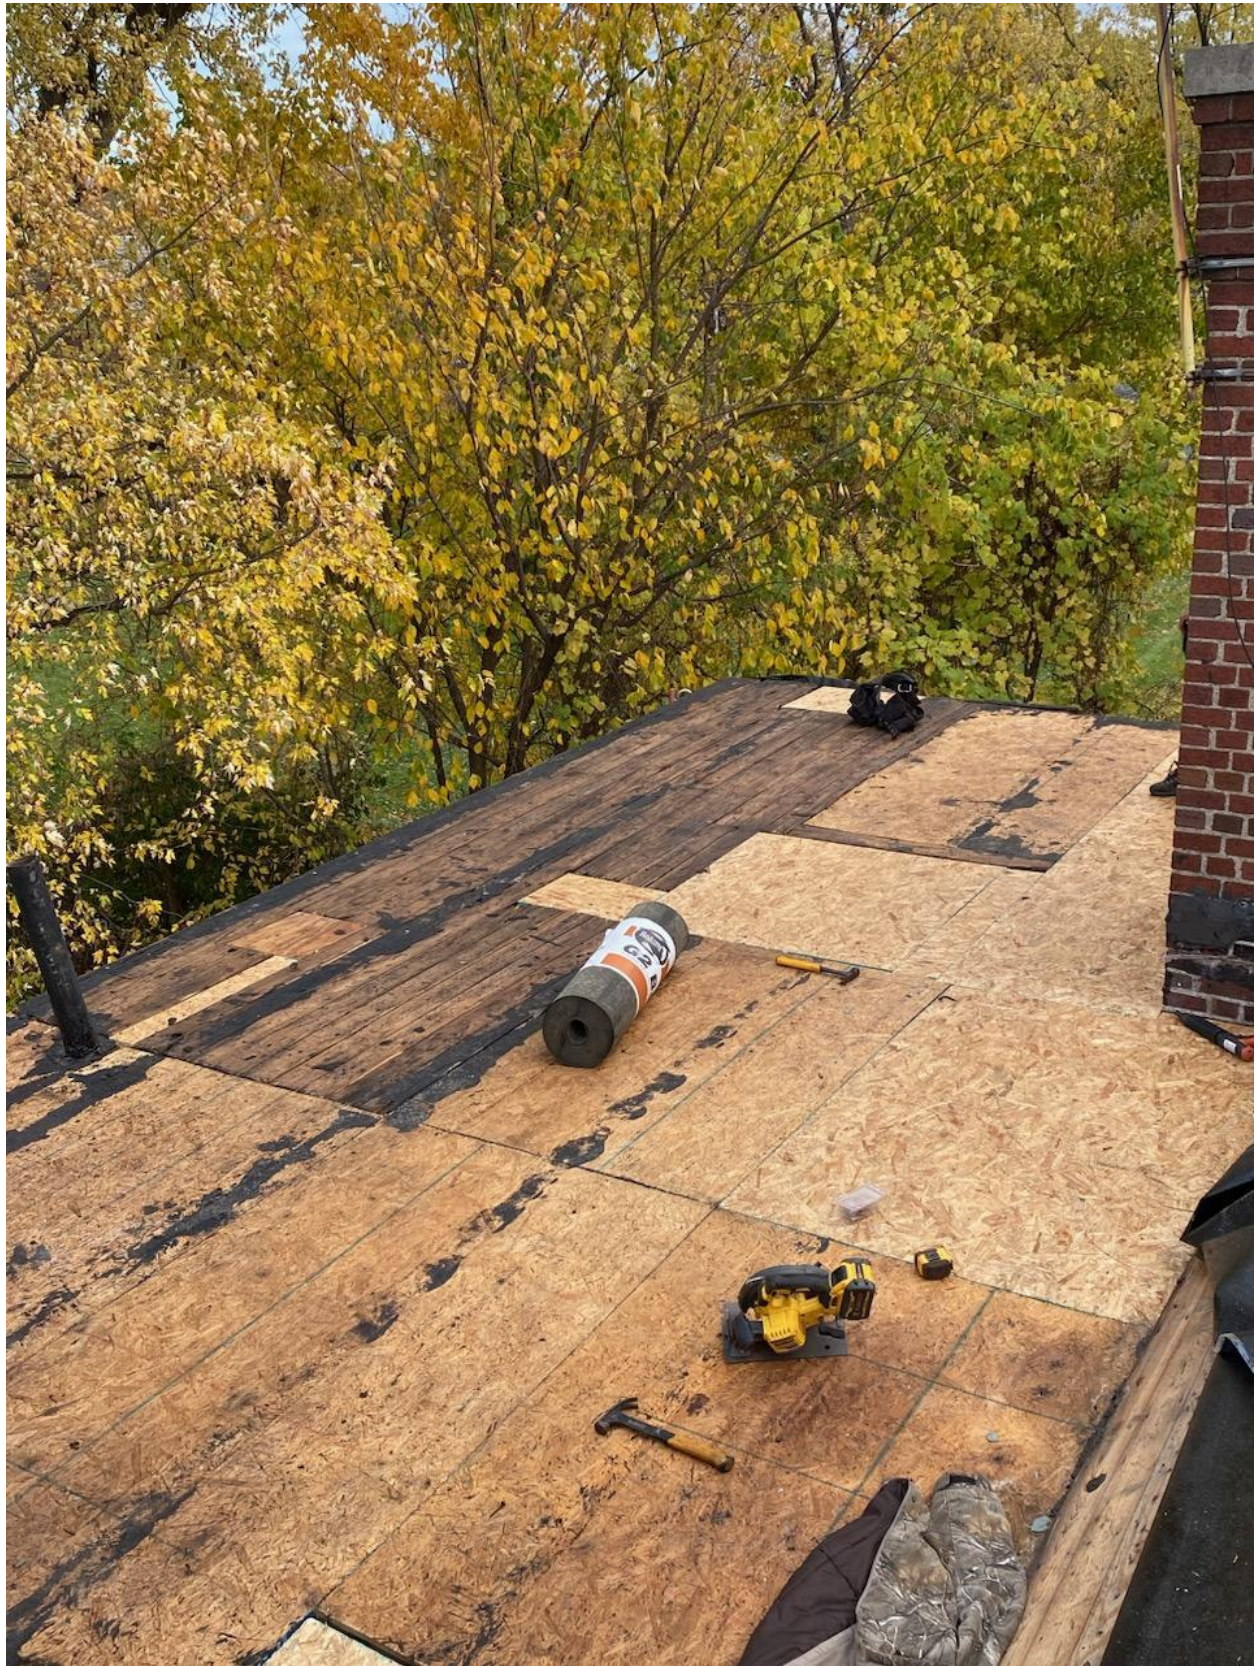
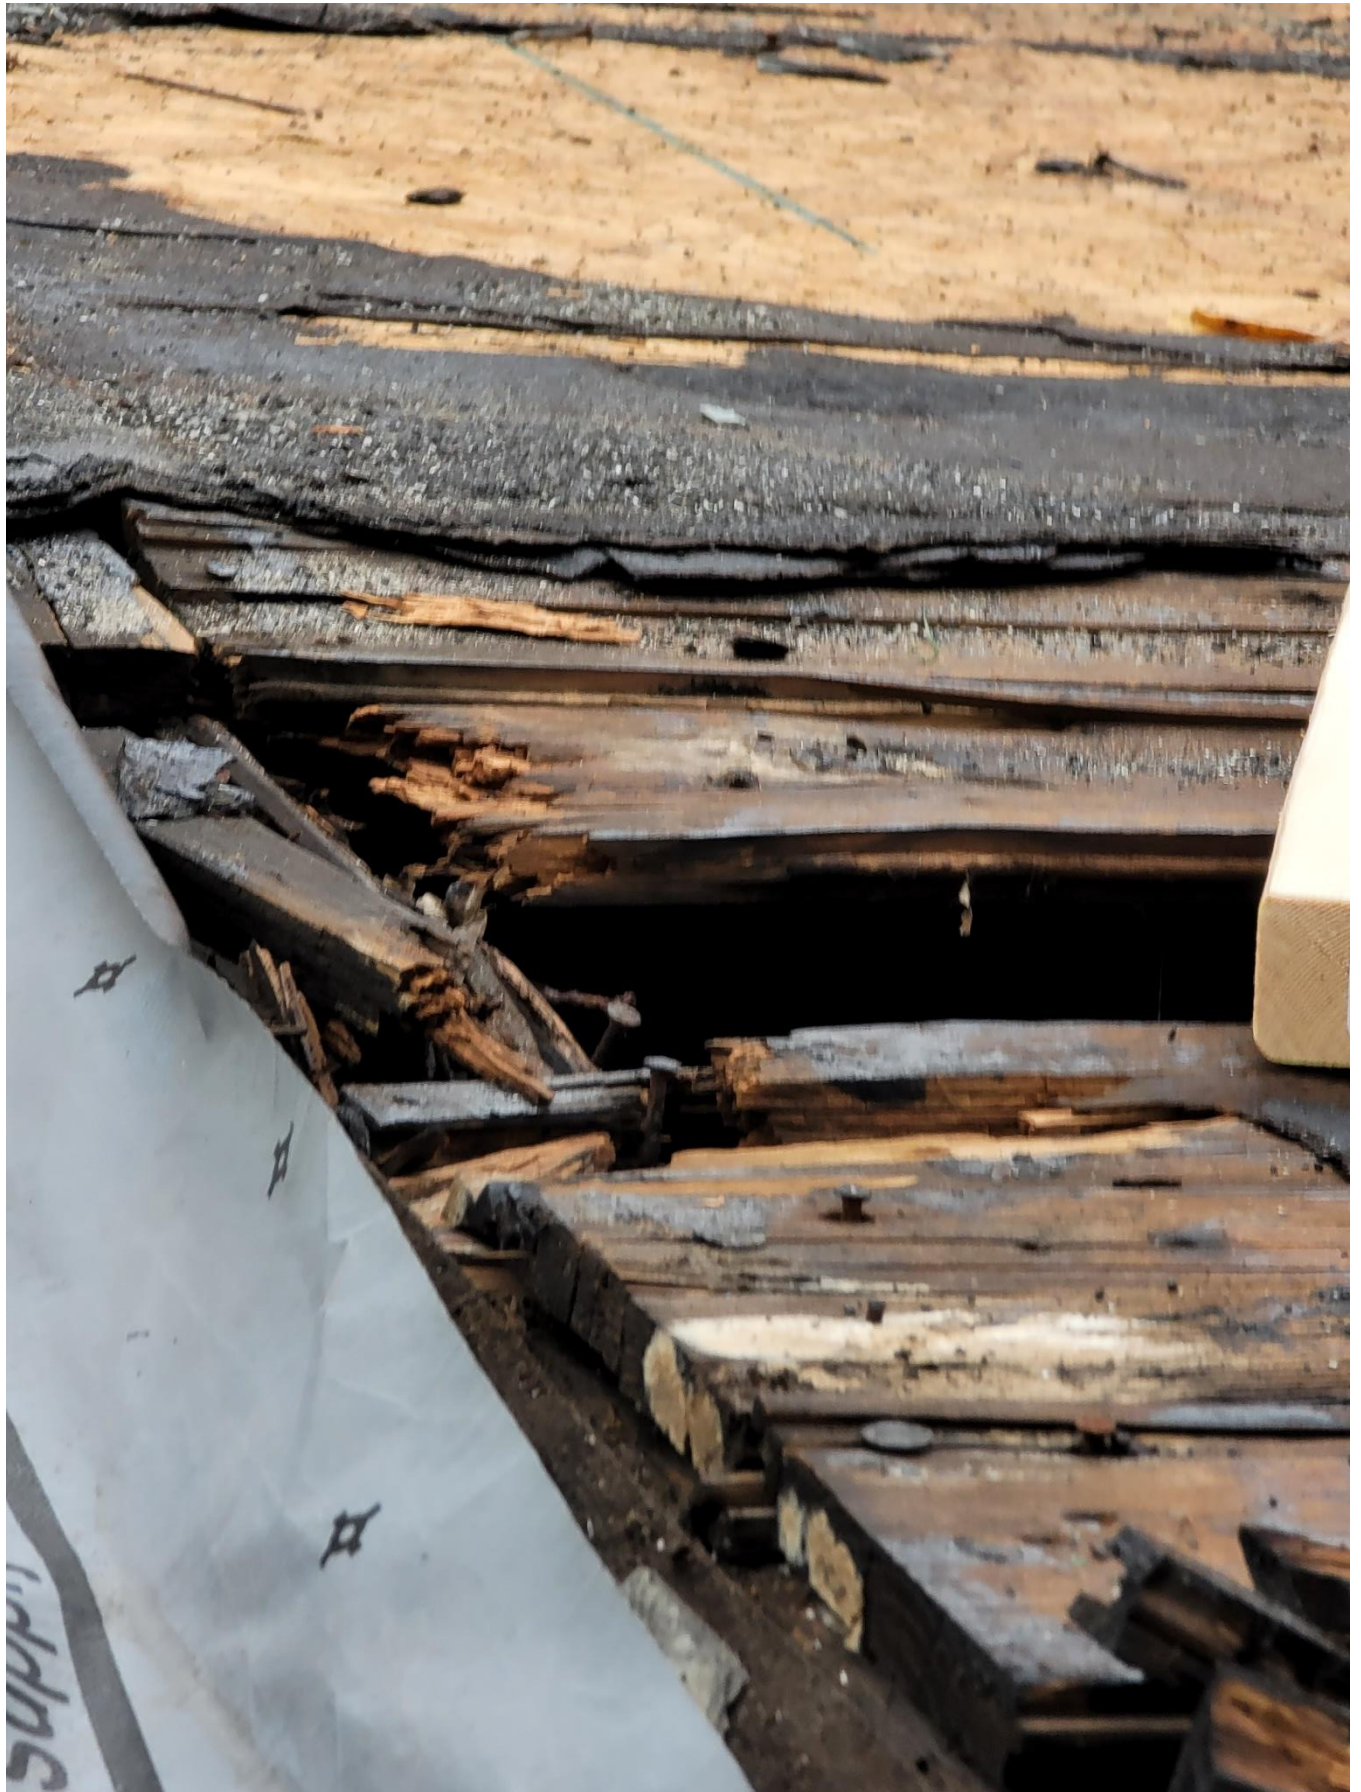
Photos of the deck at the rear flat roof, provided by applicant

- In an email dated 11/8/2023, the applicant stated that he had discovered that the wood behind the slate shingles at the dormer is rotted. He has provided photos of the decking at the flat roof, adjacent to the south dormer to demonstrate the condition of the wood beneath the dormer’s slate tiles (see below).
