REVISED STAFF REPORT: 11/08/2023 MEETING

APPLICATION NUMBER: HDC2023-~~0085~~00093

ADDRESS: 400 FISKE

SCOPE OF WORK: REPLACE SLATE ROOF WITH ASPHALT SHINGLES (WORK PARTIALLY COMPLETE)

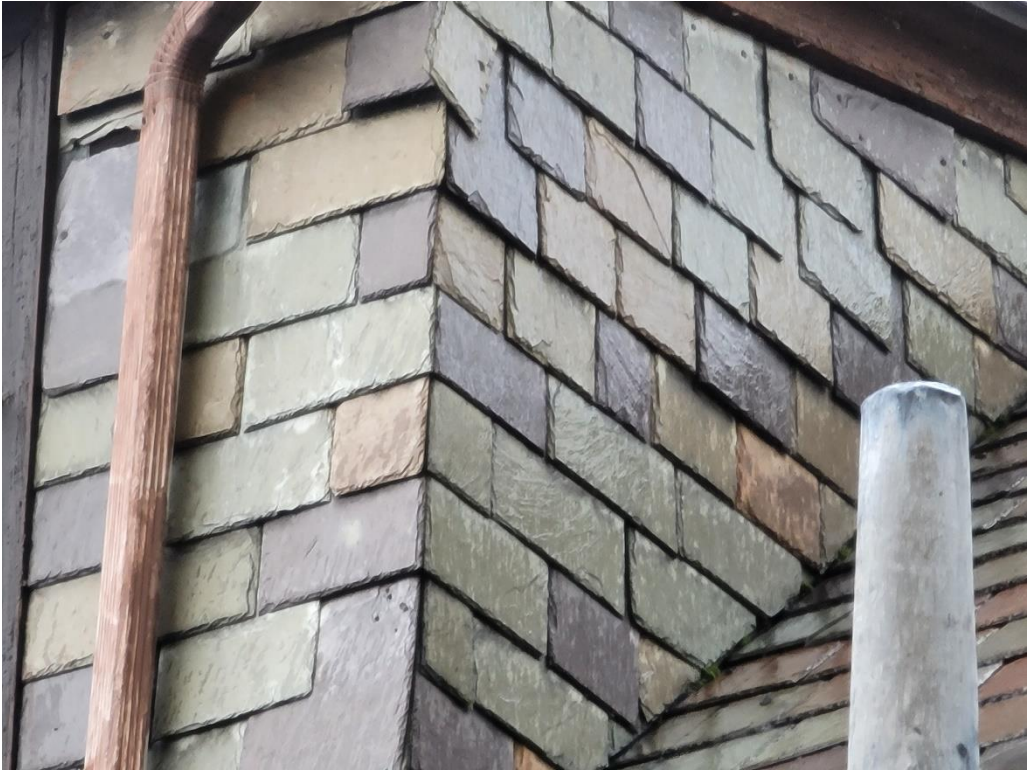
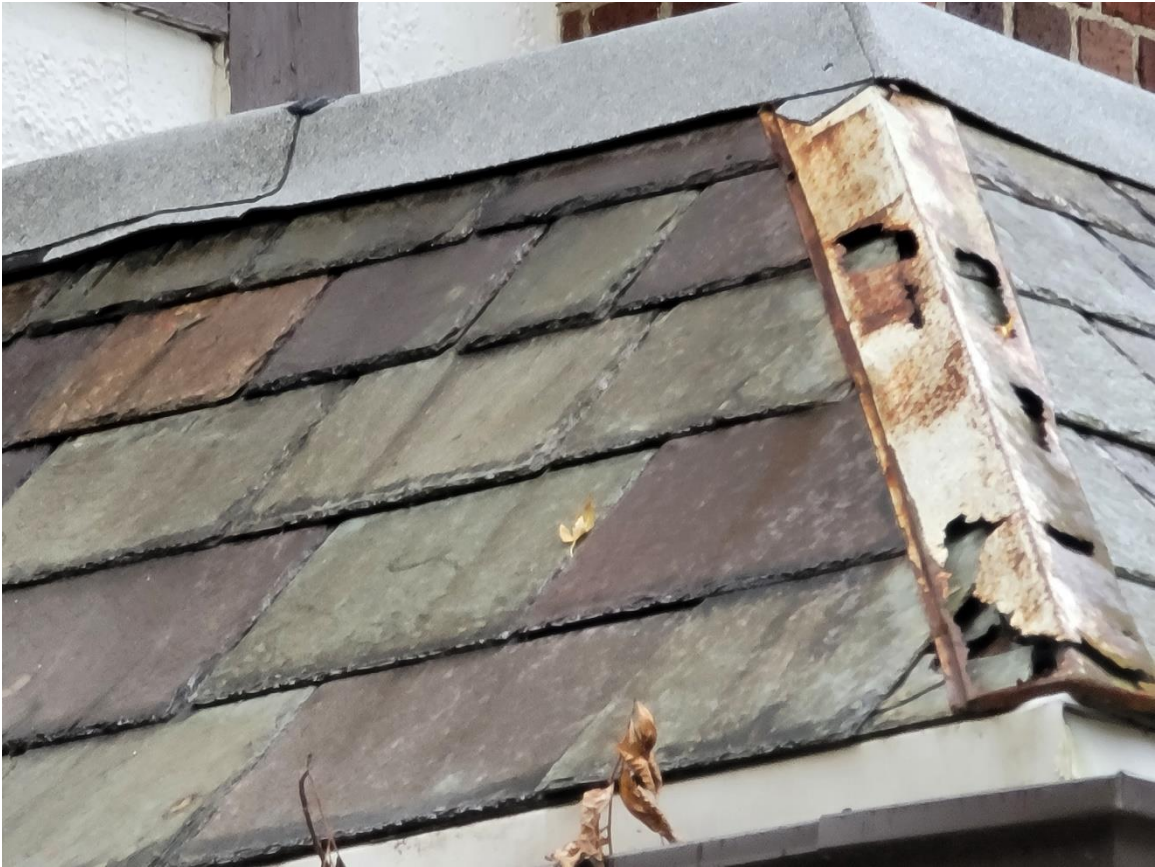
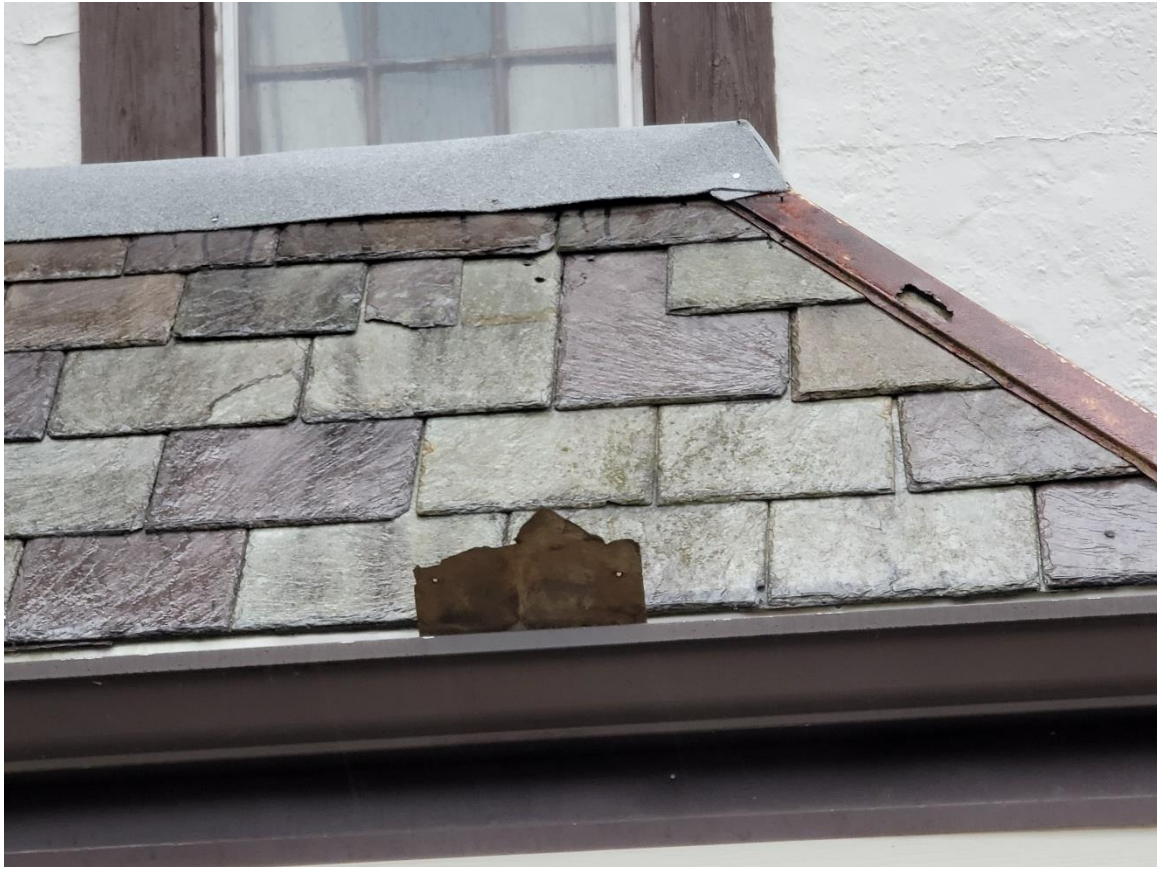
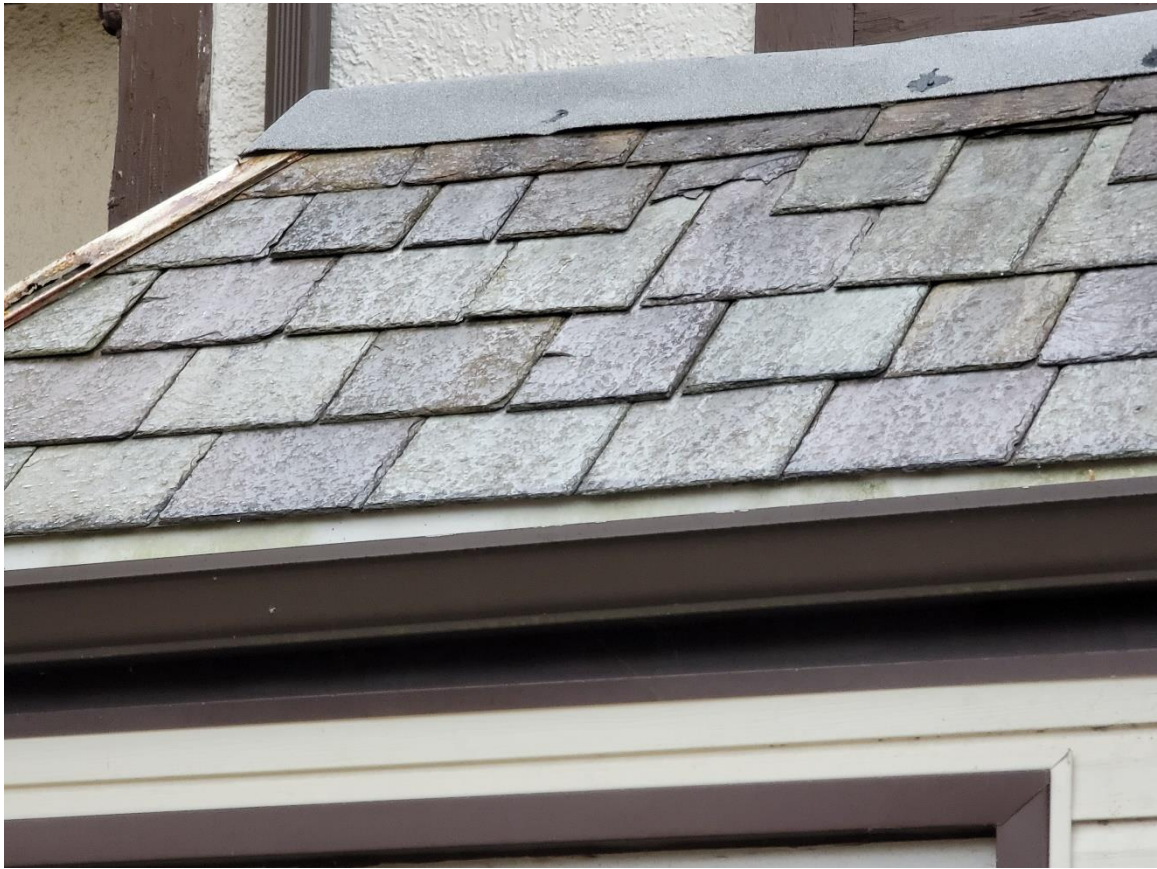
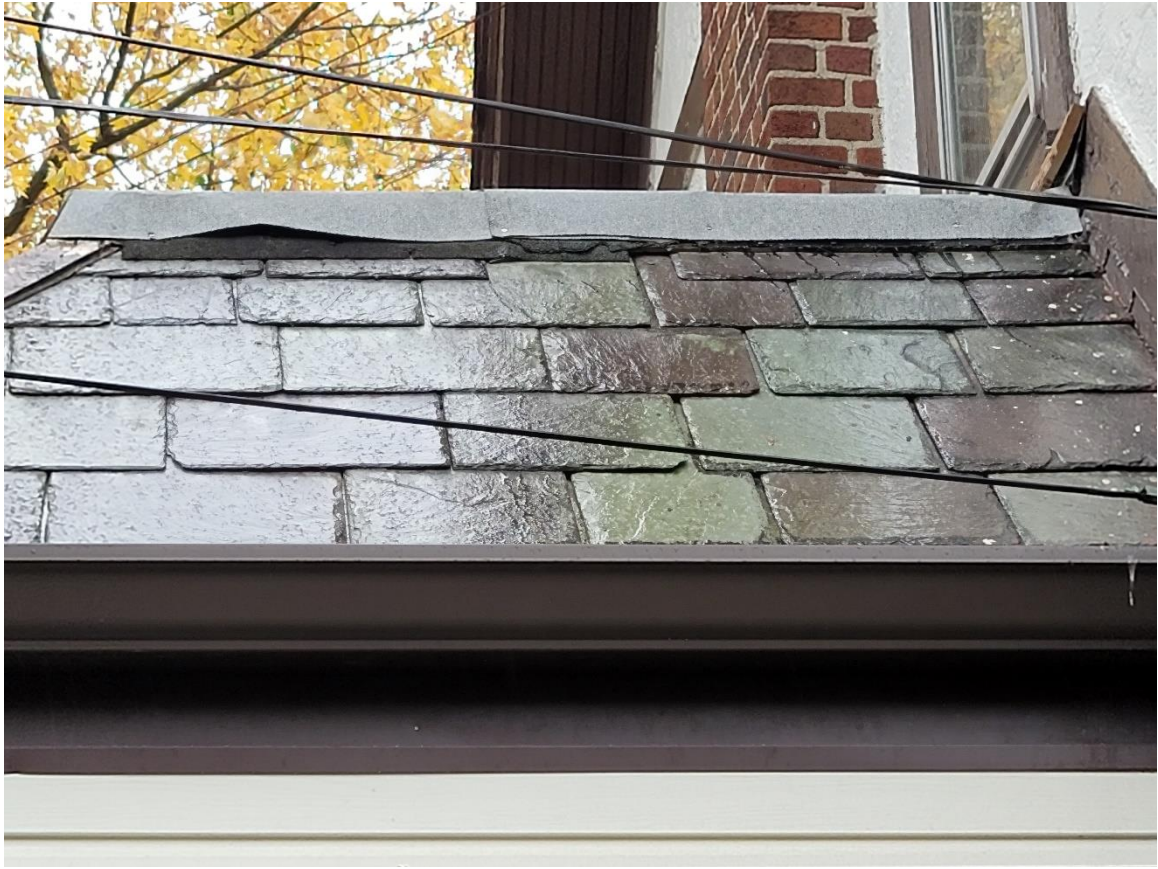
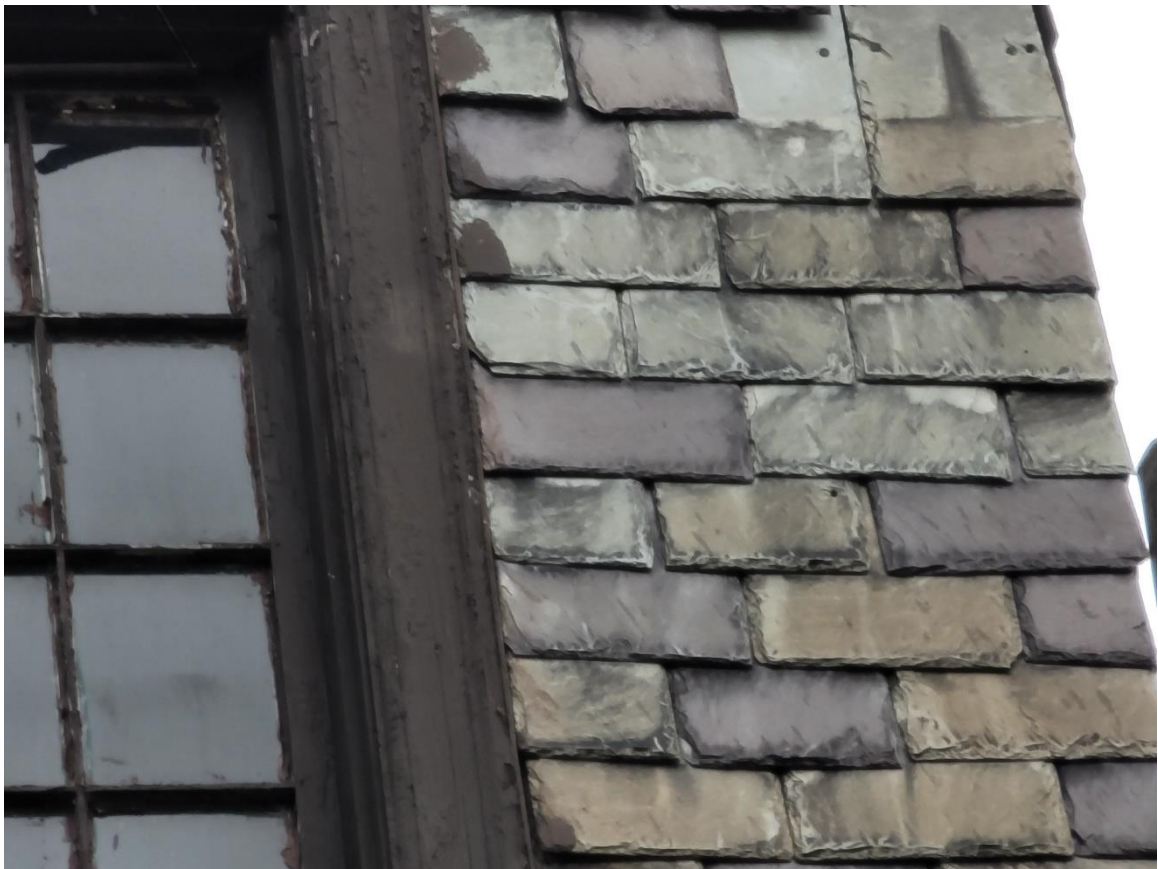
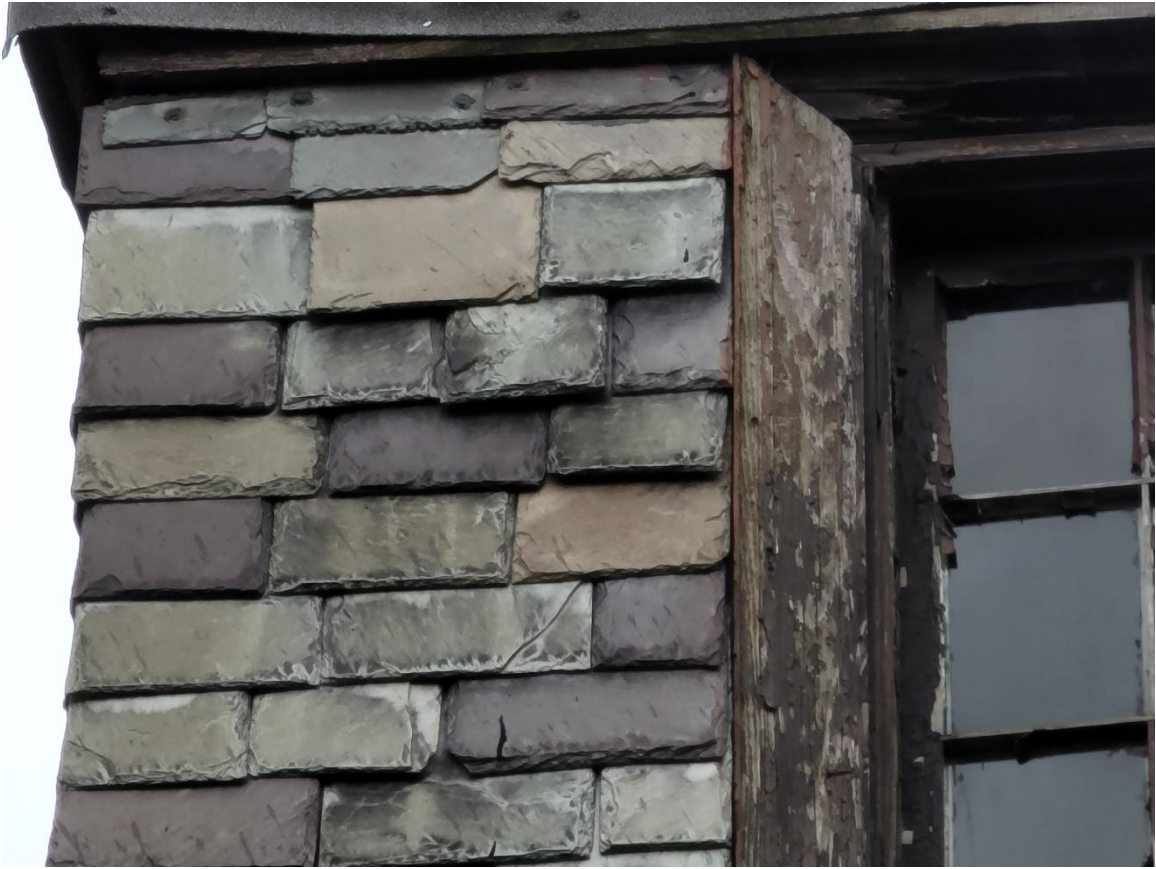
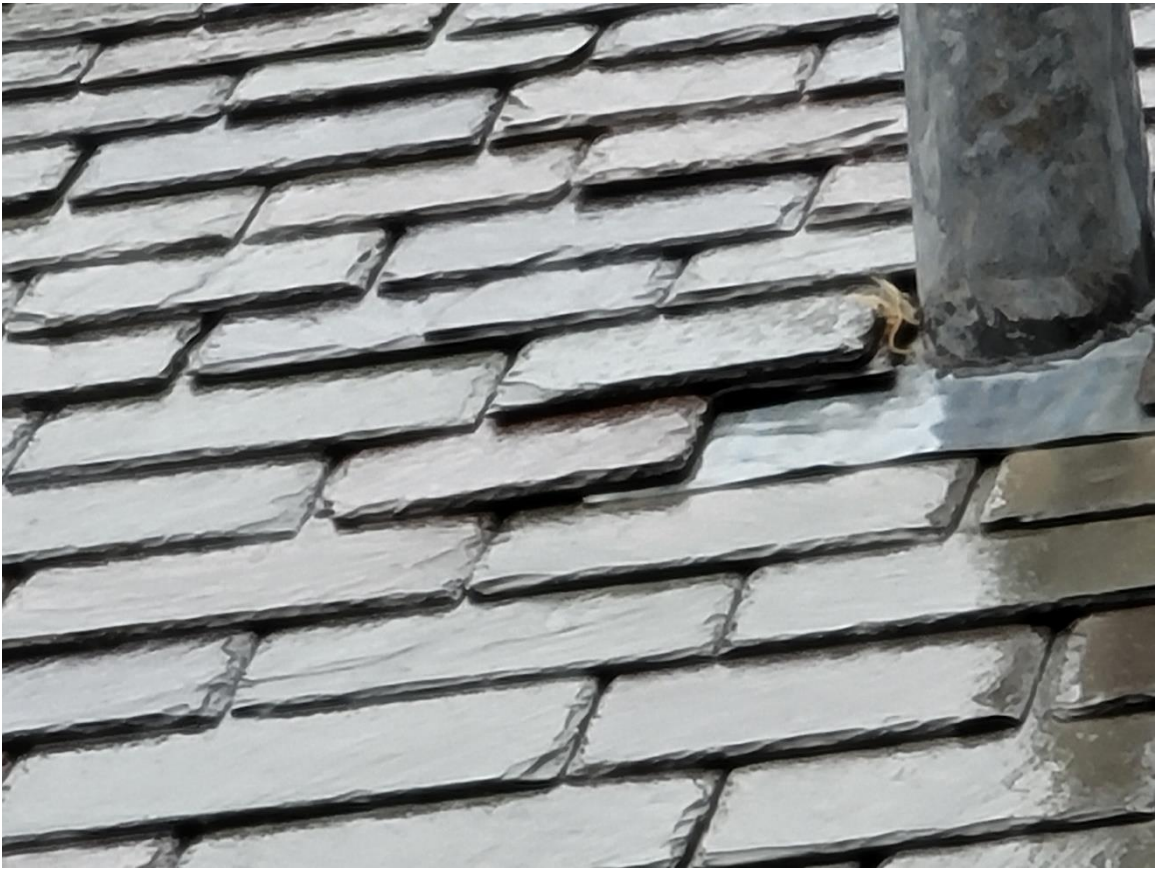
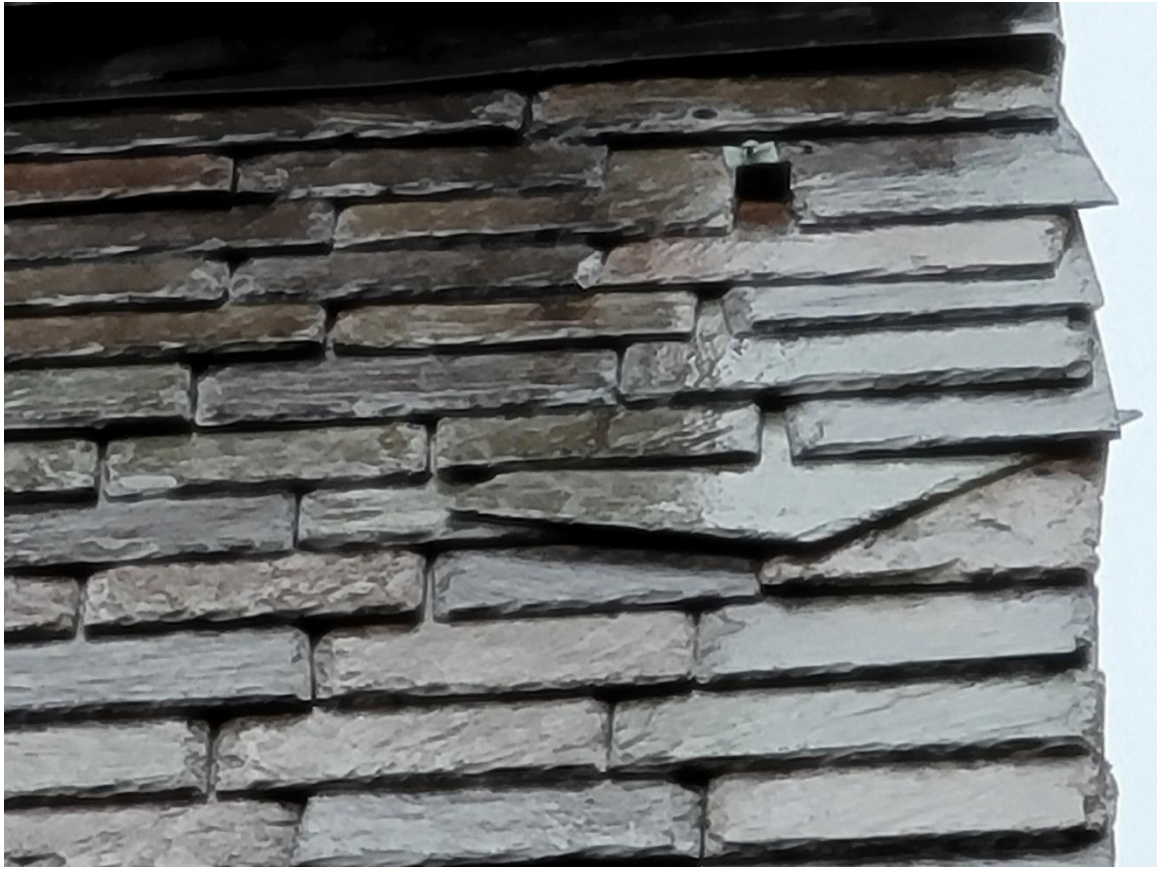
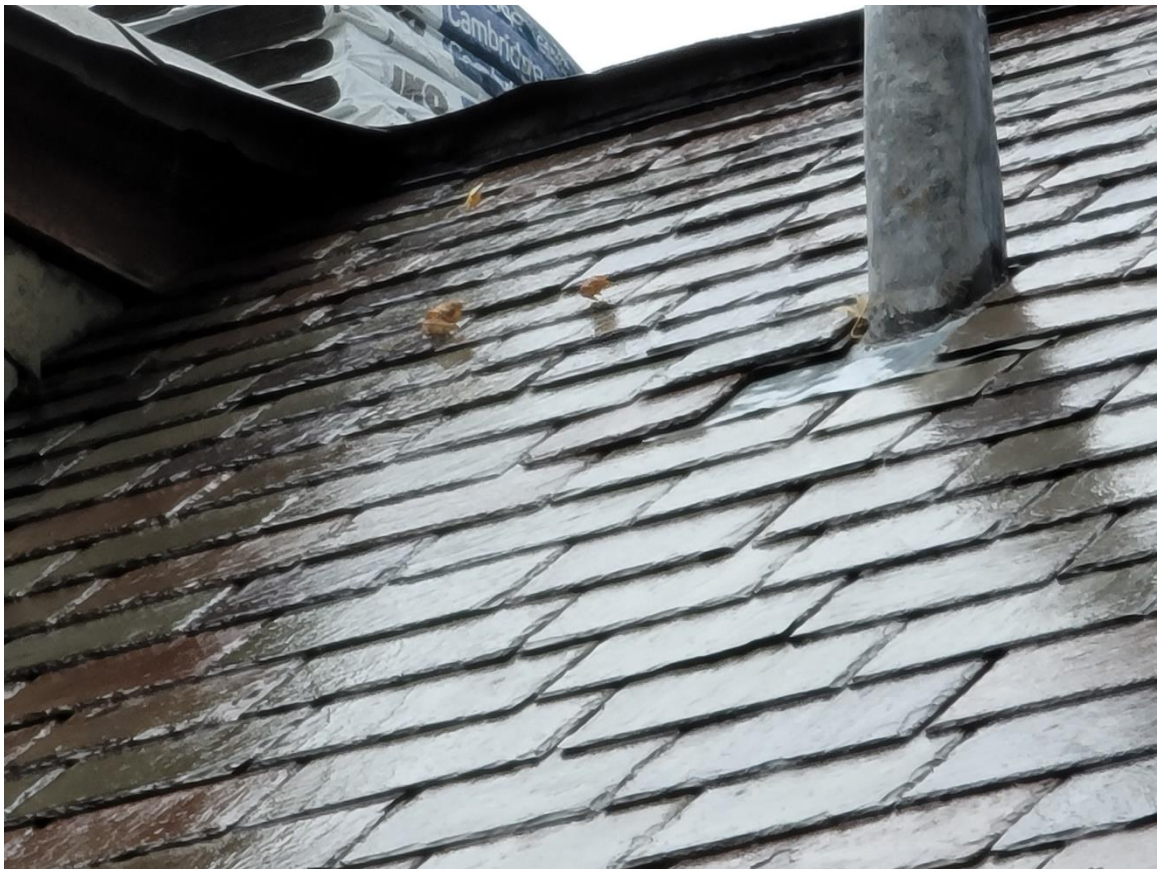
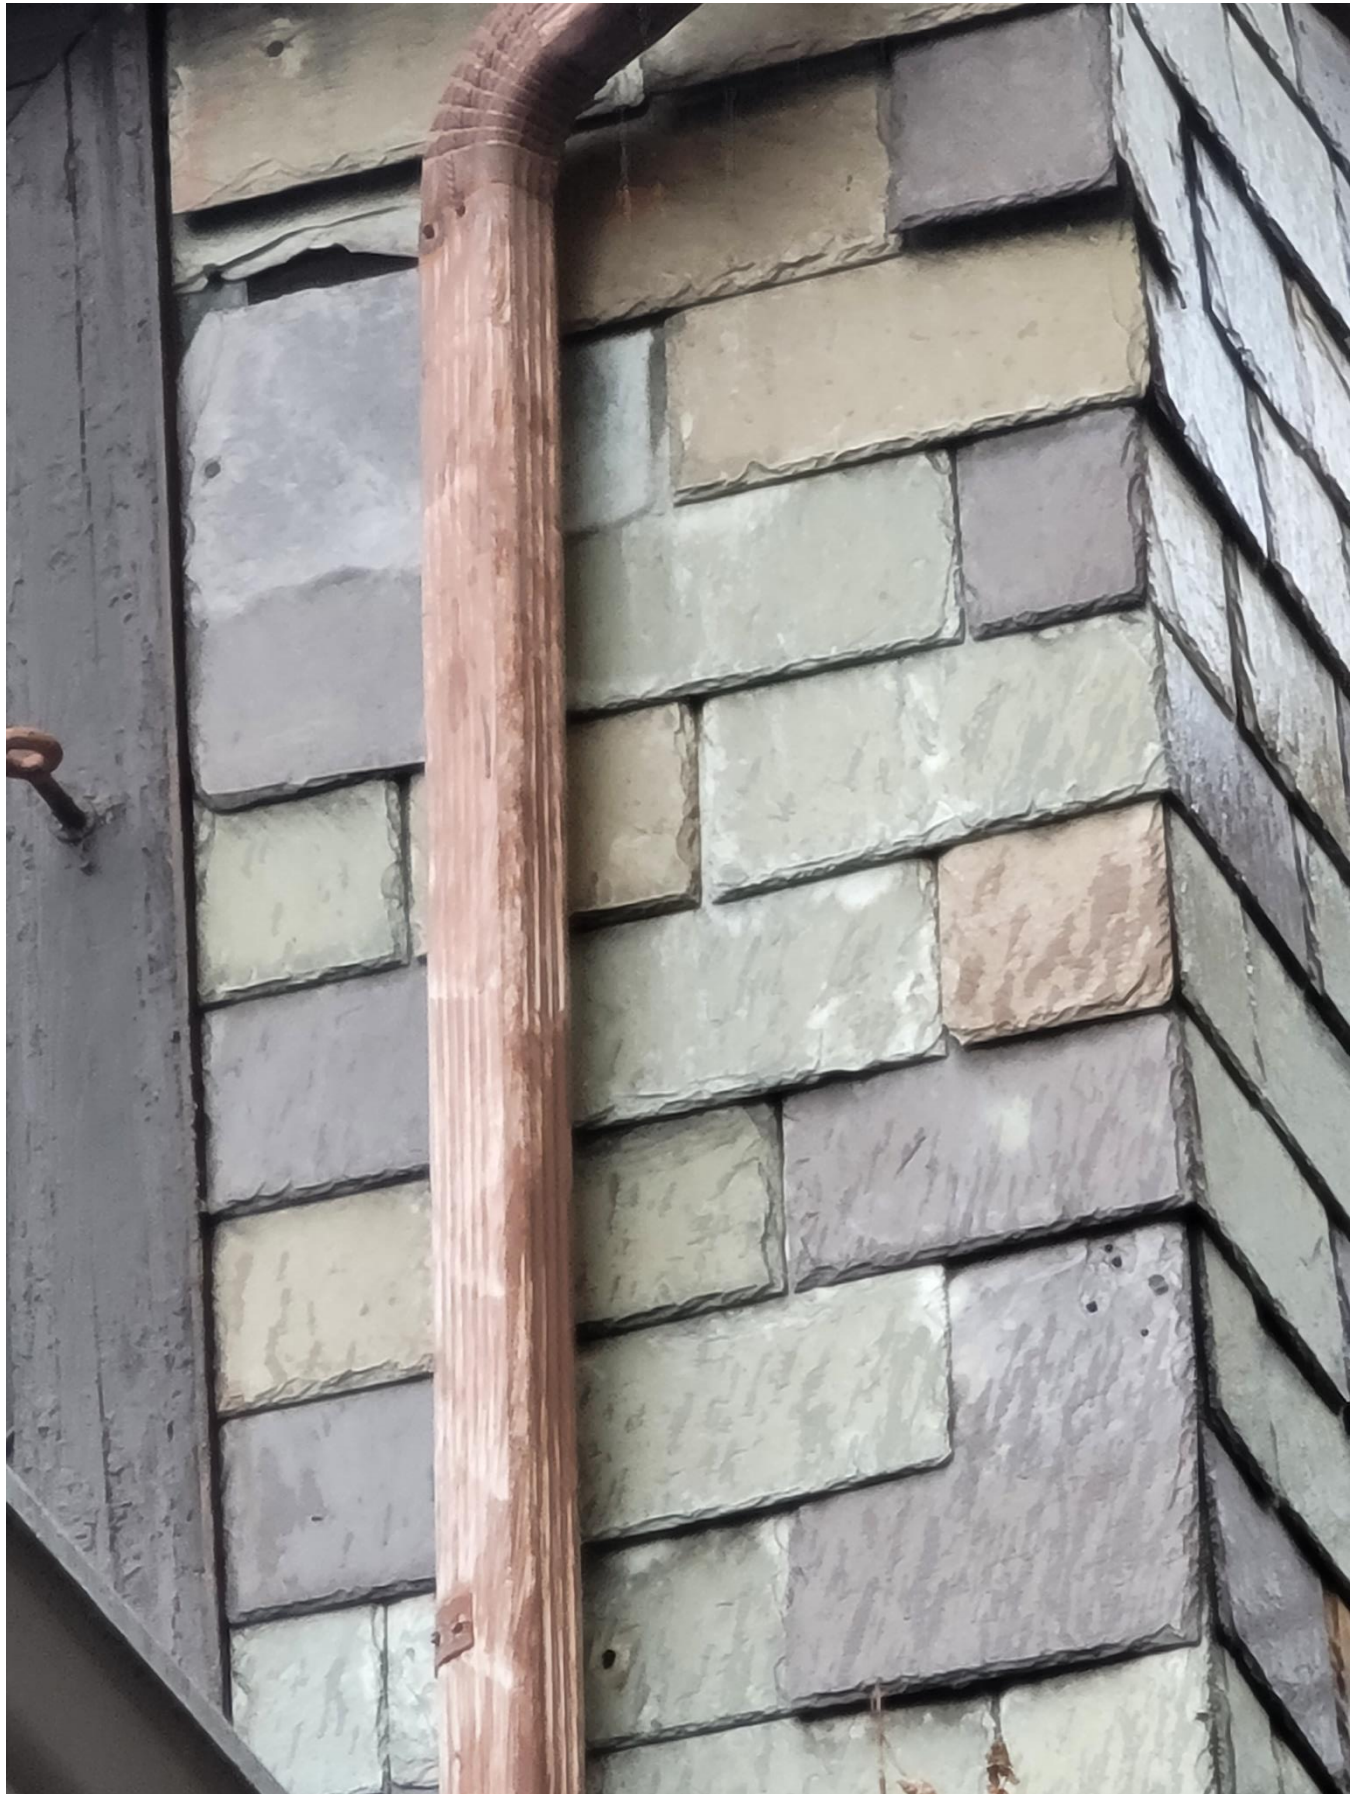
Detailed photos of the remaining slate at the rear roof and dormers, provided by applicant

- Areas of the existing slate at the rear of the roof were damaged due to a past roof repair effort. Specifically, contractors walked on the portions of the rear slate roof which adjoin the flat/mansard roof as they were in the process of repairing the membrane, causing hairline cracks throughout.

- Slate tiles were missing at the front surface of the main side-gabled roof (per the submitted narrative)
- Slate tiles at the vertical areas of the roof/the dormer front and side walls are sliding out of place per submitted photos

- All metal flashing at hips and valleys were/are heavily corroded/rusted. The applicant has noted that the cost to replace these corroded flashing and any abutting slate tiles would have cost approximately \$7,000 to \$10,000 for materials and \$2600.00 for labor.

- An email which the applicant sent on 11/8/2023 states that “only 10 to 20% of the Slate as damage crack missing areas but it can be replaced and repaired of the remaining tiles.” This email was referring to the remaining slate at the rear roof gabled wing
