**STAFF REPORT:** 12/13/2023 REGULAR MEETING

**APPLICATION NUMBER:** HDC2023-00101 **VIOLATION NUMBER:** 669

**ADDRESS:** 2465 CHICAGO

**SCOPE:** ALTER FRONT PORCH AND LANDSCAPING, INSTALL SECURITY CAMERAS

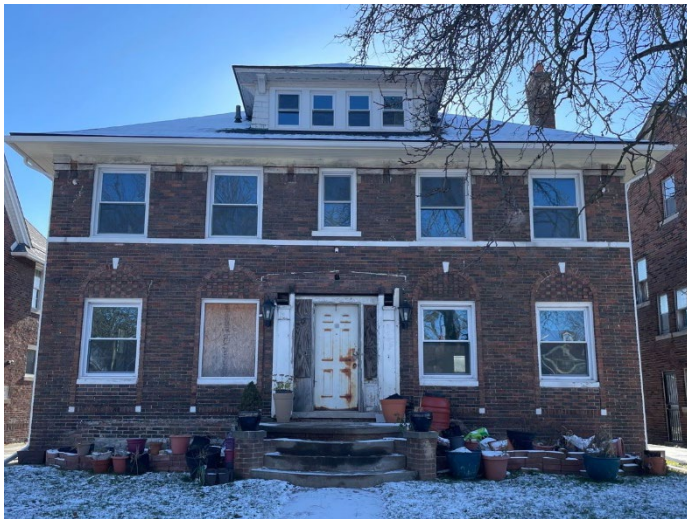
*Site Photo 1, by Staff November 28, 2023: (North) front elevation showing current conditions.*

This application seeks an approval for the existing changes to the historic front porch to remain, which include the removal of the historic front porch with the metal railing, porch overhang and detail over the doorway, and alteration of the porch steps from a rectangular shape to a curvilinear form and relocation of the steps wingwalls. This work was done by a previous owner without approval.

front elevation has cameras mounted on brick masonry at the upper left and right sides, and centered over the front door.

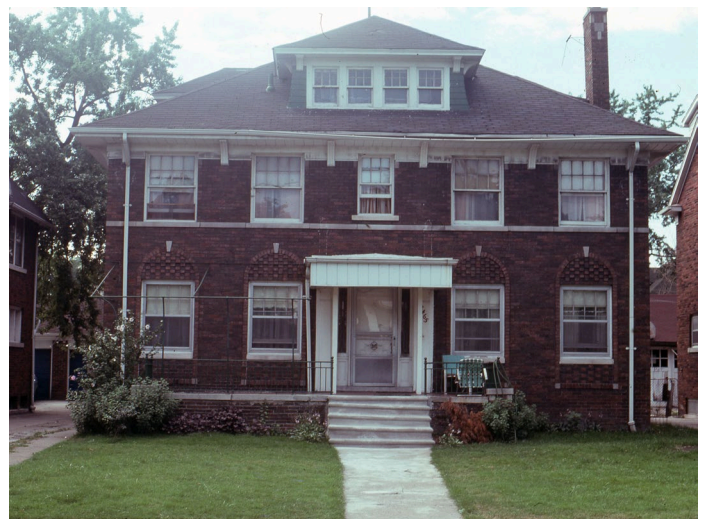
*Photo 2 Designation Slide, 1974: (North) front elevation showing original windows, porch, entrance, and landscape.*

- Staff has the opinion that the original front porch, with its asymmetrically positioned raised, rectangular front floor/deck with the metal railing, brick piers with cast stone detailing that matches the house, matching brick clad wingwalls and wingwalls are historic, distinctive character-defining features. The removal of this feature, although completed without approval by a previous owner, and replacement with diagonally placed wingwalls with curvilinear steps is not appropriate, as this greatly alters the design and scale of this historic property, leaves scarring to the front façade, and creates a barren foundation. (See photos 1-5)

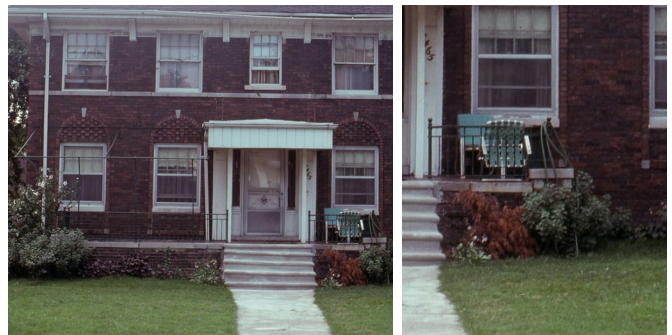
Photos 4-5, from 1974 Designation Photo: front porch detail with brick pier end posts, metal railing, concrete coping with concrete steps, brick clad walls and wingwalls.

- The original front porch elements that were removed without HDC approval were distinctive, character-defining features that characterized the property.
- The application does not include documentation that these historic features were deteriorated beyond repair to an extent that merited their replacement.
- If the porch had been shown to be deteriorated beyond repair, it should have been replicated to match the old.
- The removal of the non-historic wood porch roof and columns should have included a proposal to install a new roof of a design which is compatible with the home's historic appearance as the front entrance would have originally been sheltered by some sort of overhang.

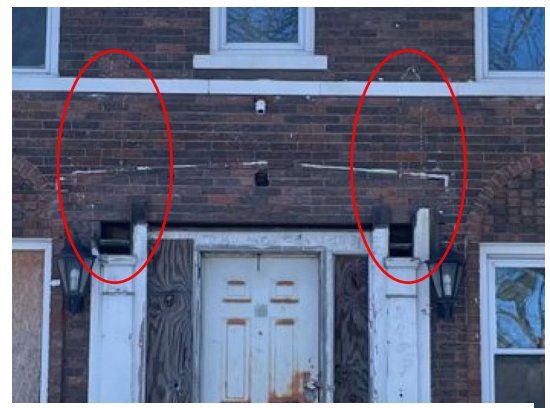
Photo 6, by staff November 28, 2023: front elevation detail showing hints of a Juliette balcony railing over the entrance façade, indicated inside the red circles.

- Although the above photos indicate that the front porch had a wood roof and columns at the time of designation, staff has the opinion that this feature is not historic, and its removal is appropriate. Through careful reading of site and historic photos, staff perceives an outline of a Juliette balcony railing that may have been attached to the front façade of the house. Although photos of this condition were not found, a potential example of this feature can be inferred from the main entrance of a neighboring house at 1686 Chicago. (See photos 6-7) Staff recommends that the scars may serve as an informative outline to repair the pediment and pilasters around the top of the entrance. While the removal of the wood porch roof and columns is appropriate, staff has the opinion that this area of the front entrance requires attention and that leaving this area empty is not historically appropriate.

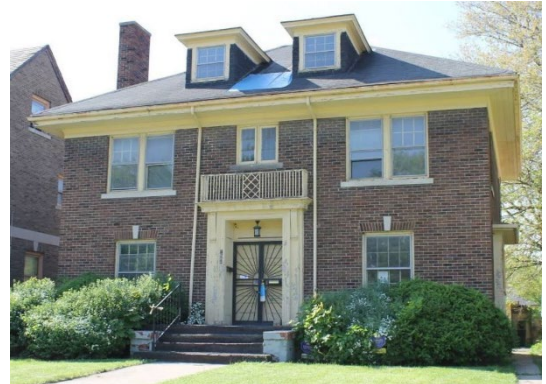
*Photo 7, by Facebook Detroit Area Historic group (date unknown, showing a Juliette balcony railing and entrance façade.*
