**ADDRESS: 1760 VAN DYKE**

**APPLICATION NO: HDC2023-00140**

**HISTORIC DISTRICT: WEST VILLAGE**

**SCOPE: REPLACE FIVE WOOD WINDOWS WITH COMPOSITE WINDOWS**

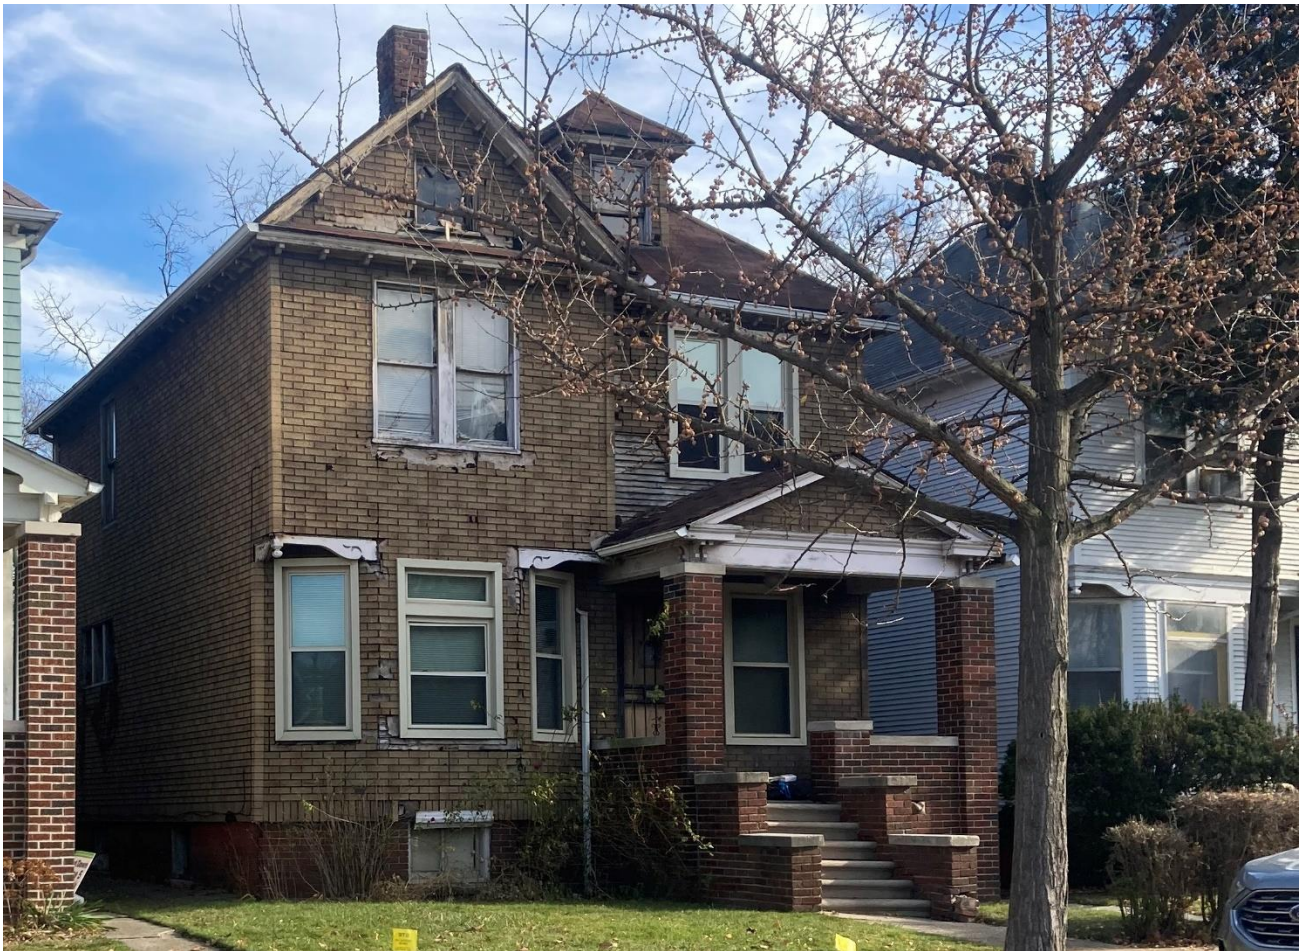
**1760 Van Dyke, current appearance (staff photo taken 11/30/2023)**

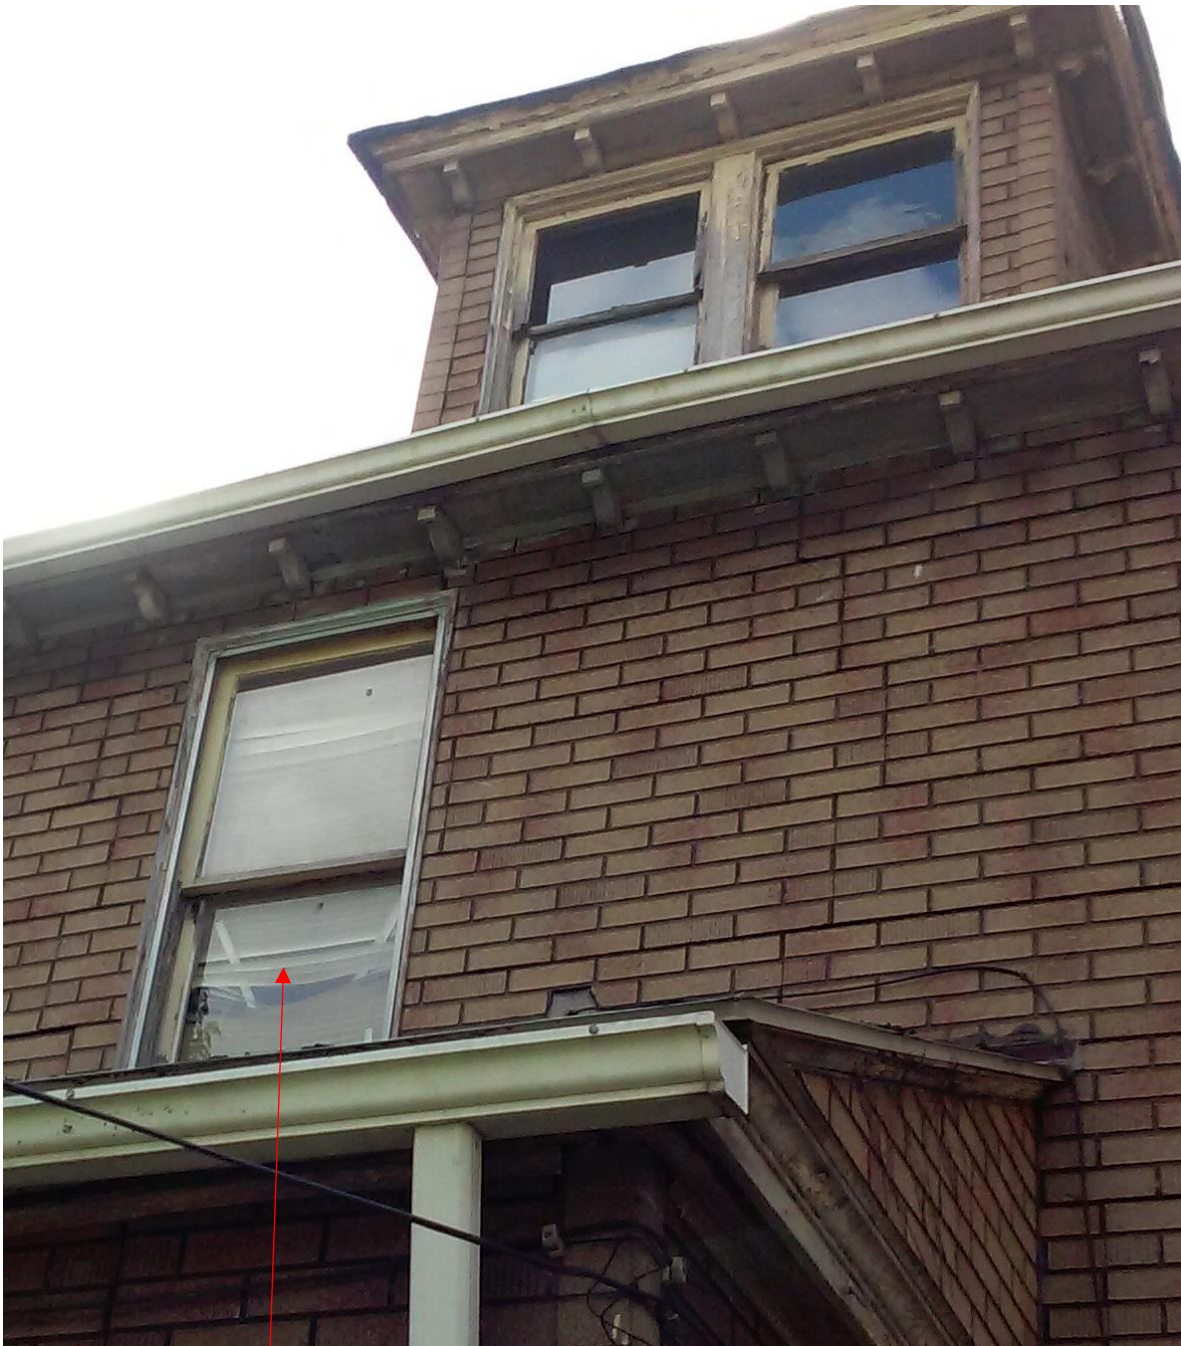
**Rear elevation, second story**

- The five wood windows and associated trim proposed for replacement are distinctive character defining features at the home and it appears that they are not deteriorated beyond repair. As the home is clad with asphalt shingles and several wood windows have been replaced with vinyl units, it is staff’s opinion that all remaining historic-age features (to include the five windows proposed for replacement) should be retained or replaced in kind if necessary in order to forestall any further diminution of the home’s historic character.

- The application does not provide the level of documentation necessary to determine if the five windows proposed for replacement are deteriorated beyond repair. Also, detailed specifications for the proposed new window product (Renewal by Andersen) have not been provided with the current application. Therefore, it is not clear if the new windows present an acceptable replication of the existing historic wood windows and trim should it be determined that the historic windows merit replacement
