STAFF REPORT: DECEMBER 13, 2023 MEETING

APPLICATION NUMBER: HDC2023-00143

ADDRESS: 1423 (1425) SIXTH STREET

SCOPE: REPLACE WINDOWS AND VINYL SIDING (WORK COMPLETED WITHOUT APPROVAL)

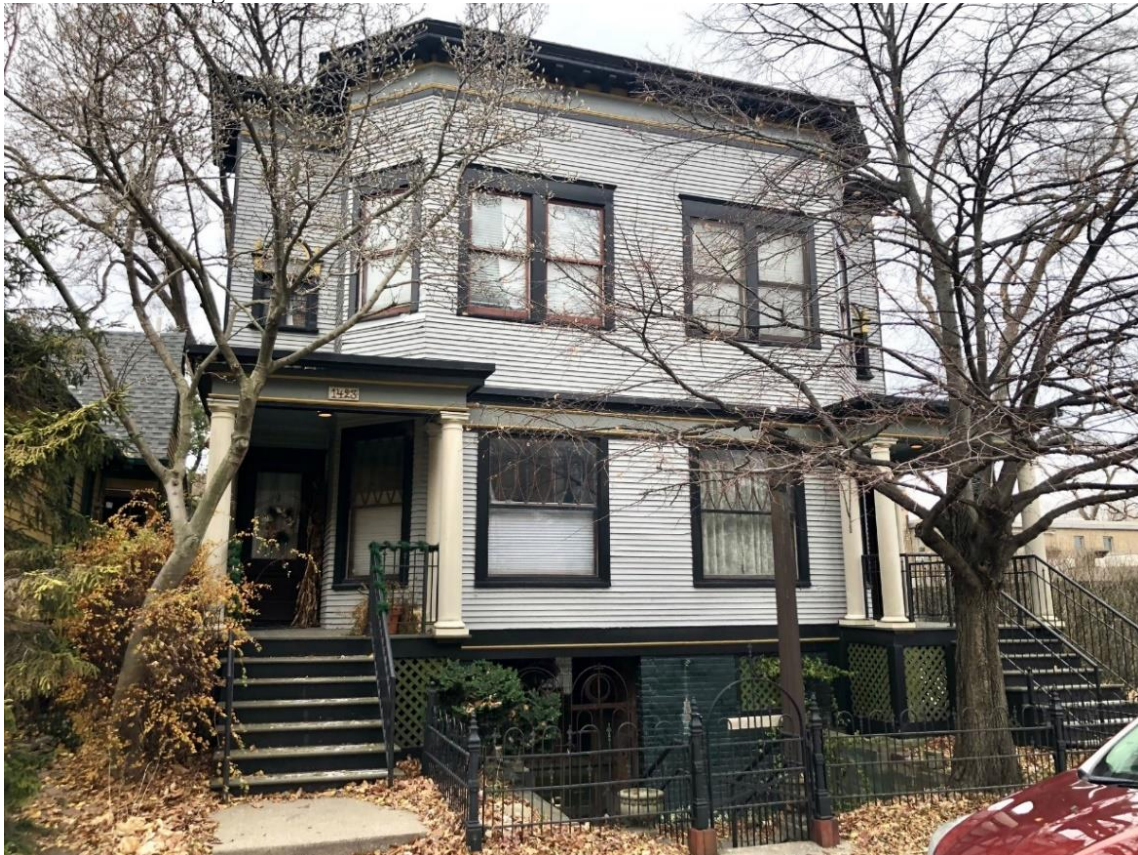
Staff photo, November 29, 2023.

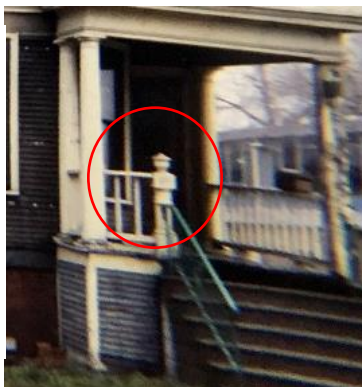
Comparing the 1985 scope of work with existing conditions (not including work at the north wall which is part of this application), it appears that the existing aluminum porch railings replaced 36-tall wood railings and most specifically the character-defining wood corner posts (which were individually identified in the 1985 grant for salvage and reinstallation.)

- The applicant states in his 12/8 reply to staff questions, that the corner posts were destroyed when a fire occurred at the company's shop who was crafting new wood posts to match the deteriorated historic posts. He states the existing aluminum railings have been in place since 1993. Staff believes they are a sympathetic contemporary design and are not demonstrably inappropriate; they also wrap around the corner posts so that the historic components/features remain intact and unaffected by the railings.

Designation photo, 1984. Circled is the corner post that was to be reinstalled upon installation of a new wood porch and stair railing. An identical post was similarly in place at the adjacent porch.

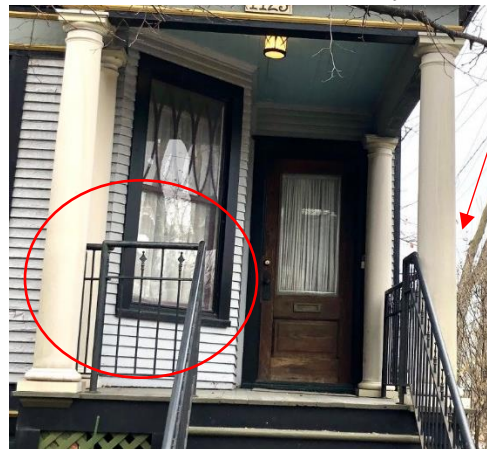
Staff photo, November 2023.

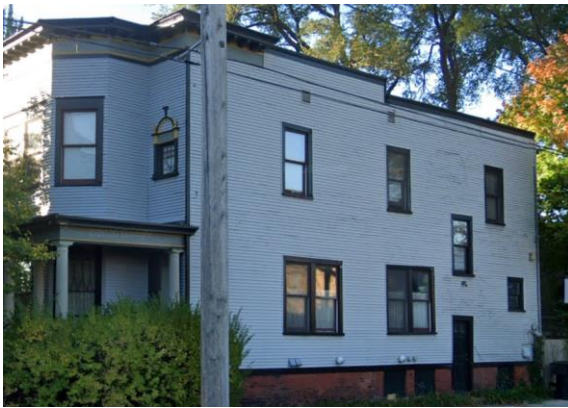
North elevation, Google street view, October 2020.

- While vinyl siding was present on the north elevation at time of designation, the historic wood window trim was intact and fully covered. The features and dimensions of the side windows more closely matched those at the front elevation. The 2020 photo shows a similar appearance to the 1984 designation photo (with the exception of the trim being painted black).

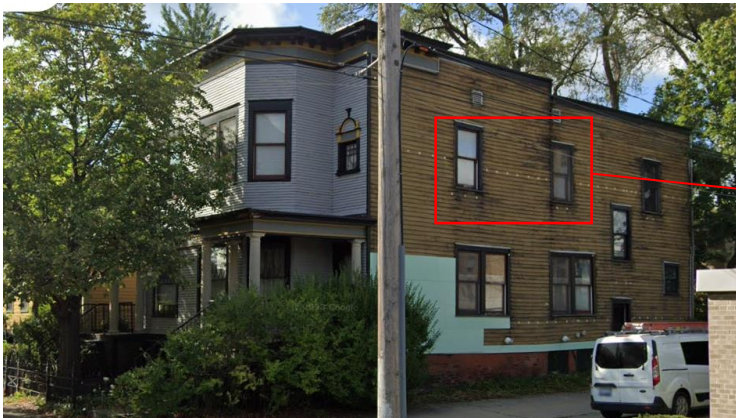
Google street view, September 2023.

- The work within the current application began a few months ago and was captured in progress by Google street view cameras. The close-up view shows some of the historic window trim and wood siding. Staff identifies the wood window trim as a distinctive character-defining feature. When the historic wood siding was re-exposed, there was an opportunity for staff to assess its condition and determine the level of repair and replacement needed. The photo does show some level of water damage, most notably at the wall corners and around/under the window openings.

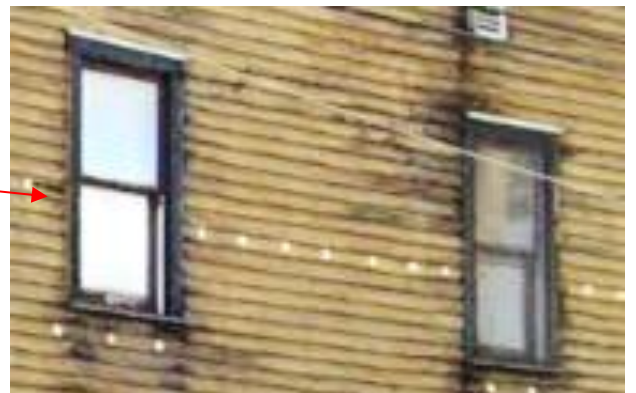
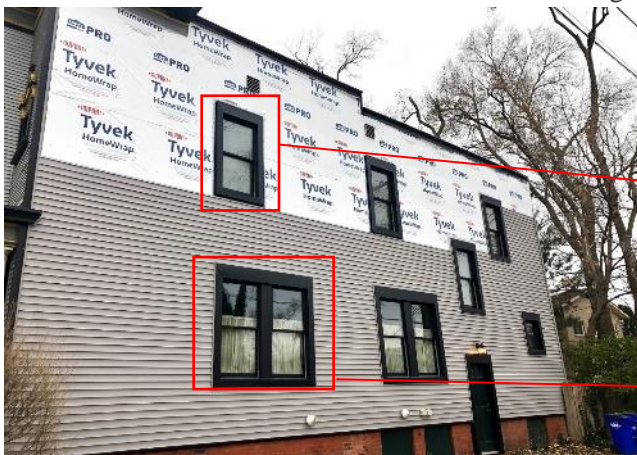
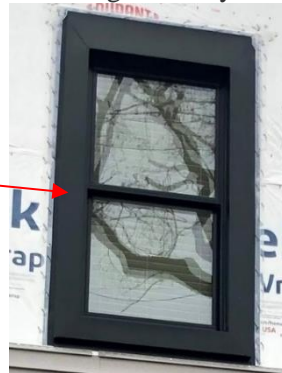
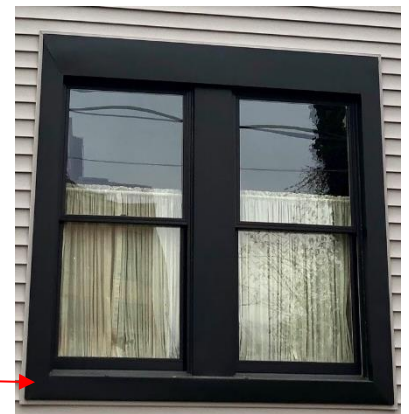
Staff photos, November 29, 2023.

- The photo of the existing conditions shows how the historic wood window casings were wrapped with aluminum and their dimensions and configuration were significantly altered.

Recommendation One – Denial – Installation of vinyl siding at north elevation and the wrapping of window trim with aluminum, north and west/rear elevation

Staff therefore recommends that the Commission issue a Denial for the work as proposed, as it does not meet the Secretary of the Interior's Standards for Rehabilitation, specifically Standards 2, 5, and 6:

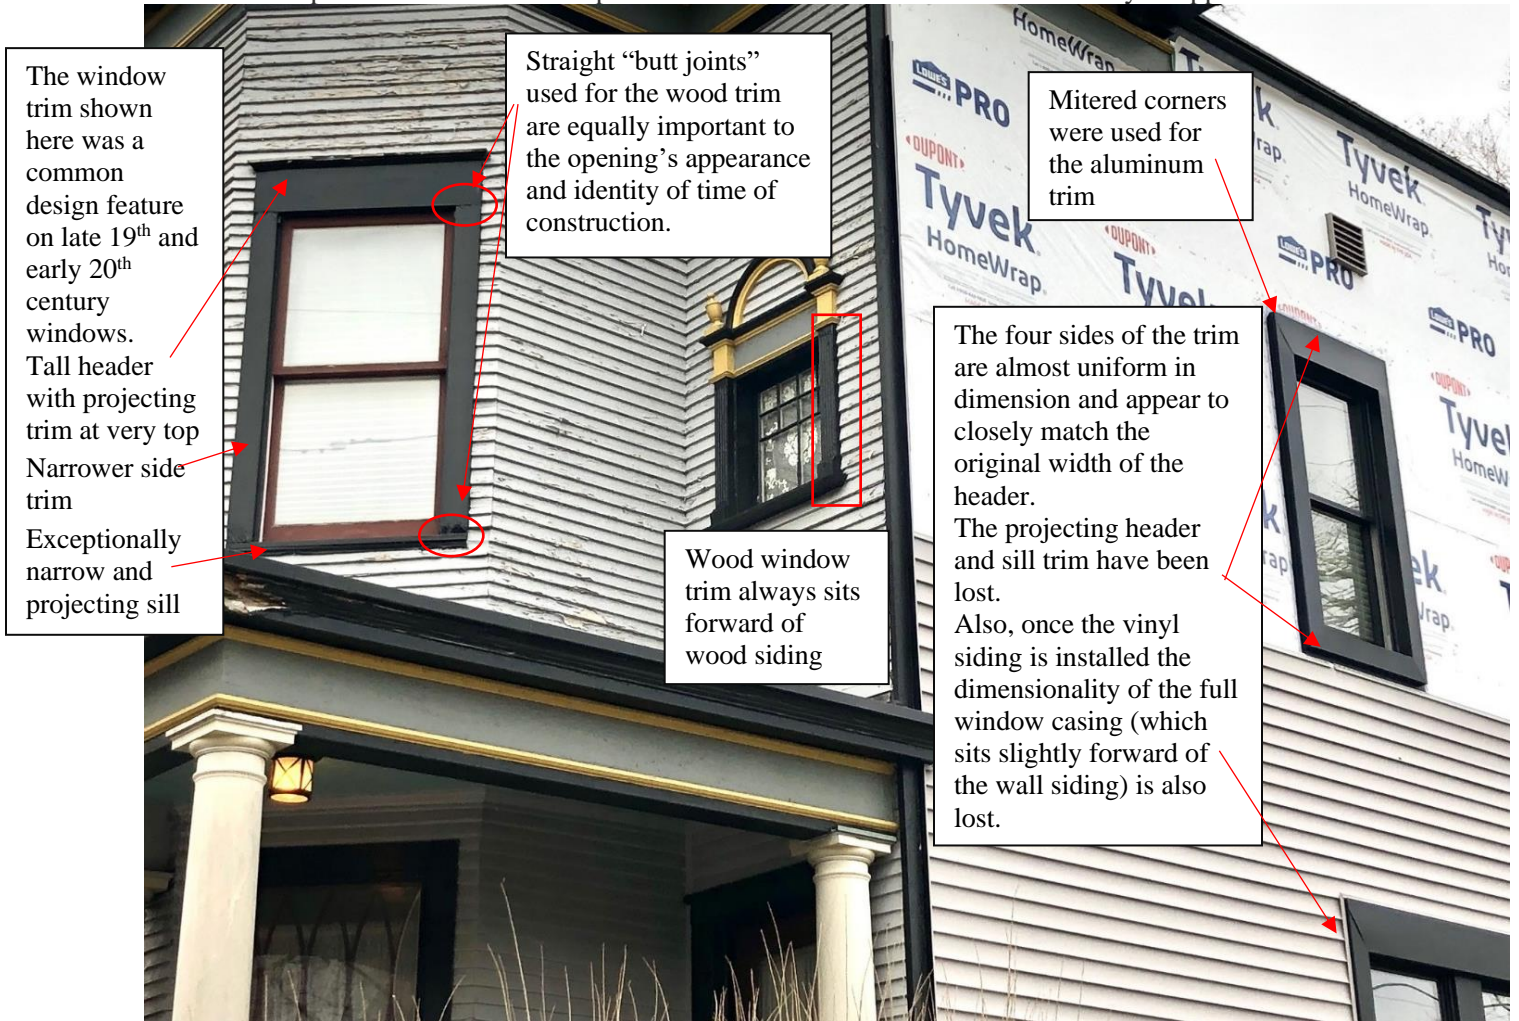
Staff photo, November 29, 2023.

- This corner photo offers a clear comparison of historic window trim and the newly wrapped window trim.

- The historic wood window trim is a distinctive character-defining feature for this dwelling and offers a dimensionality, proportionality, and placement against the wall’s siding that is identifiable to late 19th and early 20th century buildings.
- The thickly wrapped, uniformly dimensioned aluminum casings are a contemporary design for window openings and has altered the features that characterize this property.
- Vinyl siding is not an appropriate replacement product as it does not match the surface texture, reflectivity, finish, edge details, and at times width and reveal, of original wood clapboard siding. Additional details, such as vertical joints in the cladding and protrusion of the siding (either past or in-line with the window casings) further obliterates the “matching” look of wood siding.

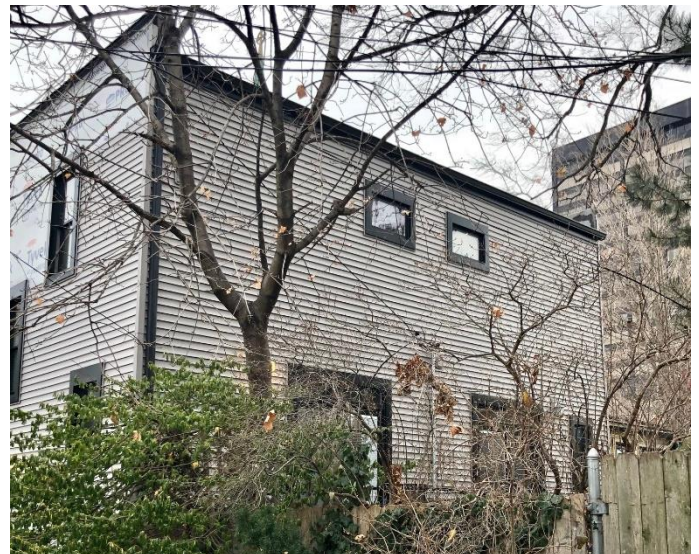
Staff photo, November 29, 2023.

- The north-side elevation is a highly visible wall due to its location abutting an alley. The applicant confirmed the
- Similar vinyl siding and aluminum wrapped windows casings are present at the rear elevation. The applicant confirmed in the 12/8 reply document that new windows and doors were installed in 2015.

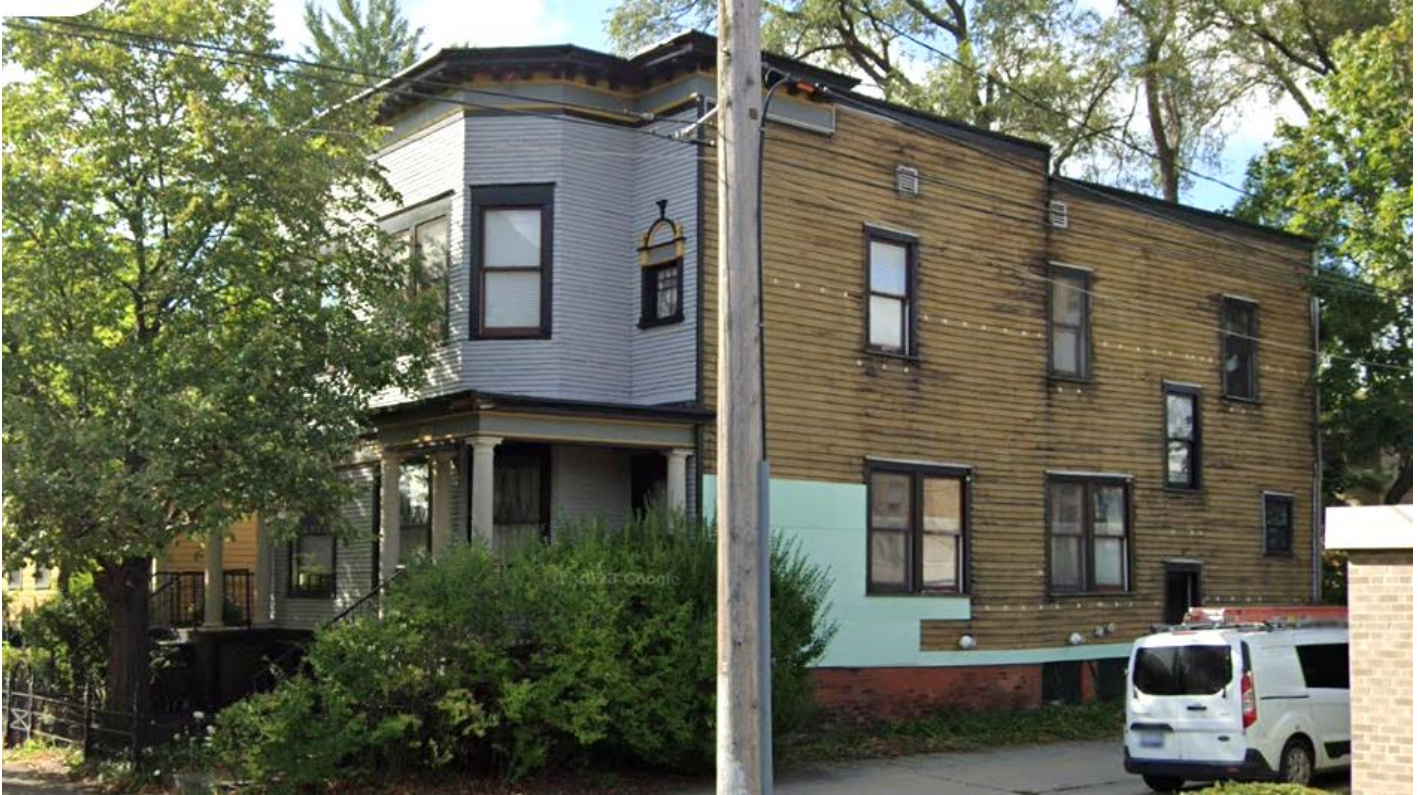
Google street view, September 2023.

- Staff emailed the applicant to confirm if this photo shows exposed wood siding, or if this is wood underlayment on which the insulation is being installed.
