STAFF REPORT: DECEMBER 13, 2023 MEETINGPREPAAPPLICATION NUMBER: HDC2023-00142ADDRESS: 19650 CANTERBURYHISTORIC DISTRICT: SHERWOOD FOREST HDAPPLICANT: JOHN FLOYDPROPERTY OWNER: JOHN FLOYDDATE OF PROVISIONALLY COMPLETE APPLICATION: NOVEMBER 17, 2023DATE OF STAFF SITE VISIT: NOVEMBER 29, 2023

SCOPE: REPLACE SLATE ROOF WITH ASPHALT SHINGLES (WORK COMPLETED WITHOUT APPROVAL),

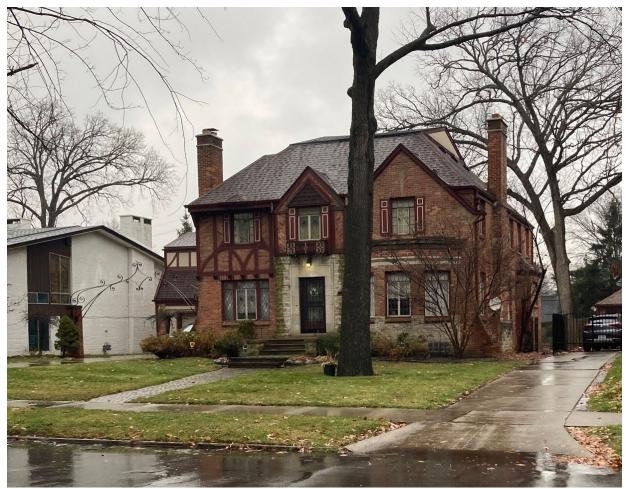
Figure 1: View of 19650 Canterbury, looking northeast.

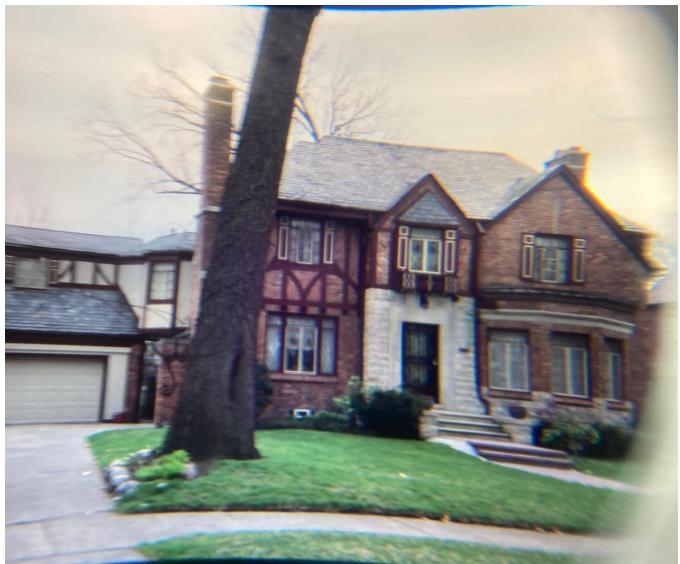
Figure 2: 2002 designation photograph of 19650 Canterbury showing the original slate roof. HDAB

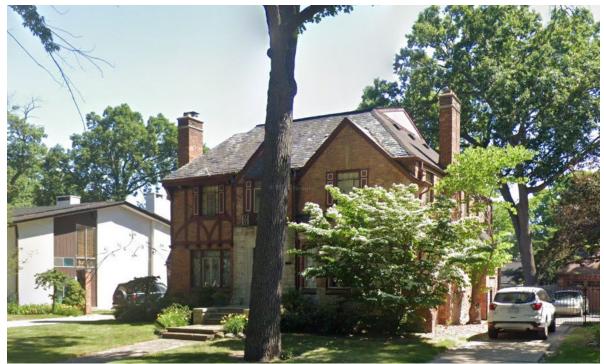
- The Sherwood Forest Historic District was established in 2002.
- The removal of the slate roof tiles at the rear and sides of the home was completed ca. 2019, while the slate at the front of the home and garage was removed in 2022.

Figure 2: Image of 19650 Canterbury from 2019, showing the partial replacement of the slate roof at the side elevation. Google Street View

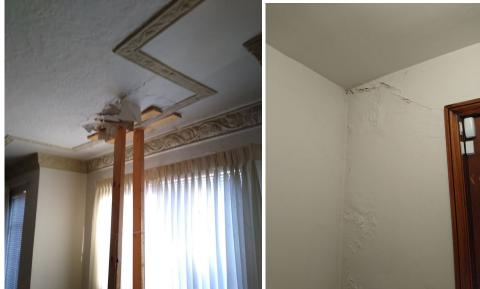
• The applicant provided photographs of plaster and paint damage occurring at the second floor of the home caused by prior leaks from the slate roof.

Figures 3,4: Images provided by the applicant showing paint and plaster damage at the second floor of the home.

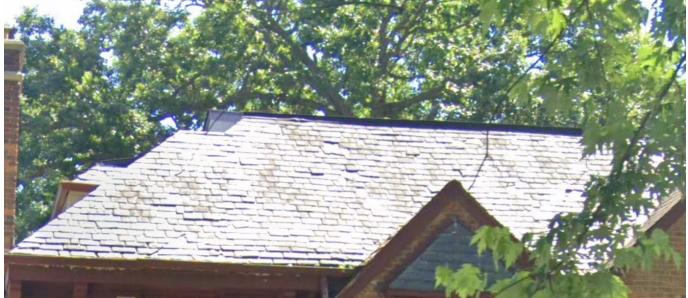
Images of the former slate roof on Google Street View show the slate was experiencing significant deterioration, including large numbers of broken, delaminated, and dislodged tiles, as well as heavy biological growth. The damage is especially prevalent at the courses of tiles directly above the eaves.

Figure 5: Image of 19650 Canterbury from 2022 showing deterioration of the slate roof. Google Street View

- According to the National Park Service's Preservation Brief 29: "The Repair, Replacement and Maintenance of Historic Slate Roofs," the replacement rather than repair of slate roofs should be considered when more than 20% of the slate is "damaged or missing." As observed in images from Google Street View, it appears that 20% or more of the slate roof was damaged or dislodged, meriting complete replacement. Assuming that the slate roof was original to the building, it was also likely the slate was reaching the end of its lifespan as an effective roofing material.

Staff finds that the proposed replacement of the slate roof with asphalt shingle roofing adheres to the Secretary of the Interior's Standards for Rehabilitation when taking into consideration reasonable economic feasibility, and therefore recommends the Commission issue a Certificate of Appropriateness for the work as completed.
